# THIRD EYE HOME INSPECTIONS

## RESIDENTIAL REPORT

205 Palafox Dr  
Chapel Hill, NC 27516

08/21/2026

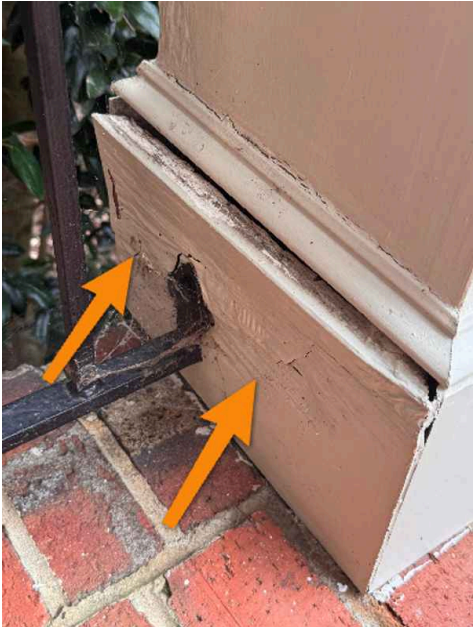
### 3.2.1 Siding, Flashing & Trim

Areas of siding and/or trim were noted to be deteriorated. This can allow moisture intrusion into the walls of the home. Recommend having the areas evaluated for repair by a siding contractor.

Rot at right front porch post on back side

Recommendation  
Contact a qualified siding specialist.

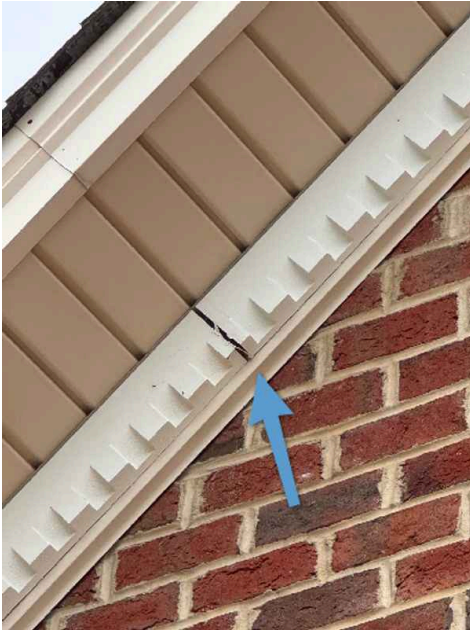
### 3.3.1 Eaves, Soffits & Fascia

There is a gap between trim materials in the eaves. This can allow in water and is an aesthetic concern. Consult a carpenter or roofing for further evaluation and repair.

Multiple gaps noted in trim work

Recommendation  
Contact a qualified siding specialist.

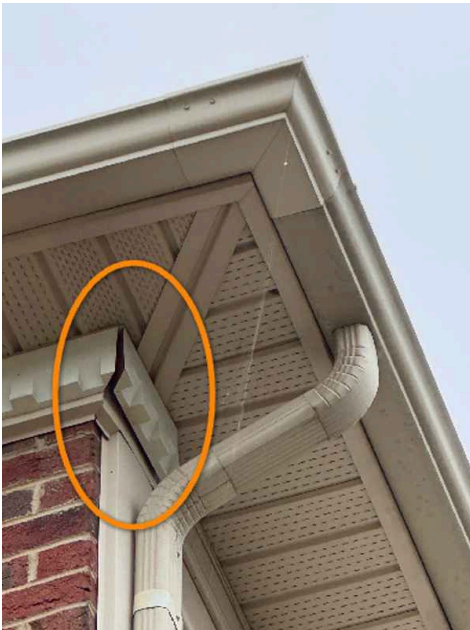
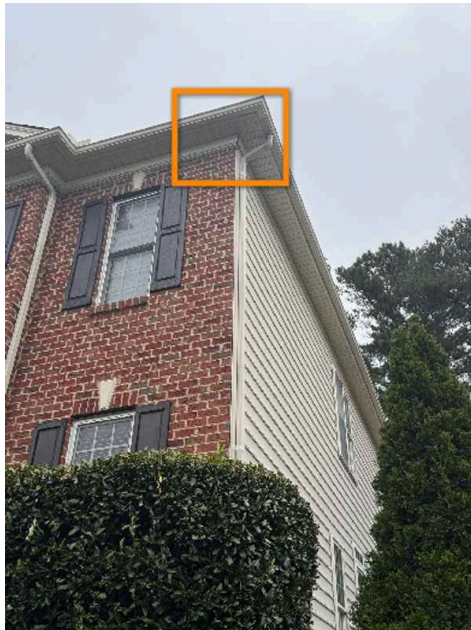
### 3.3.2 Eaves, Soffits & Fascia

One or more sections of the fascia are loose. Recommend qualified roofer evaluate & repair.

Loose piece at front right corner

Location shot

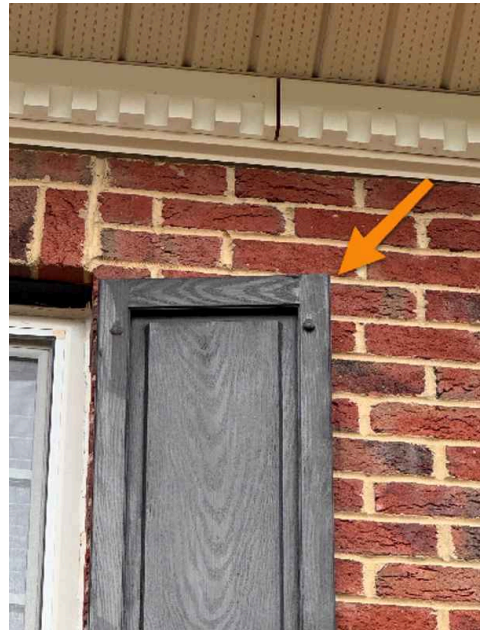
Several shutters appear loose and need securing

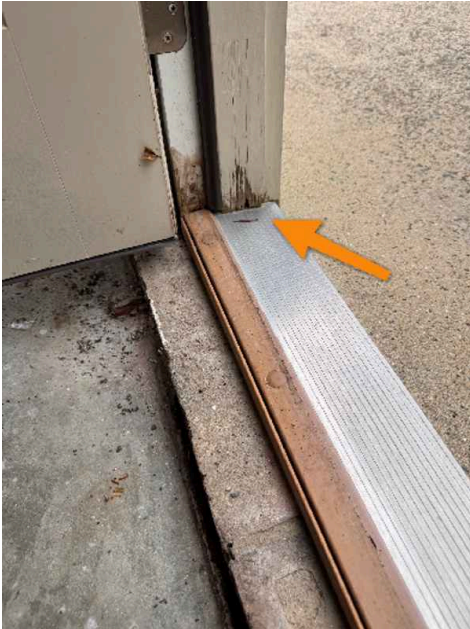
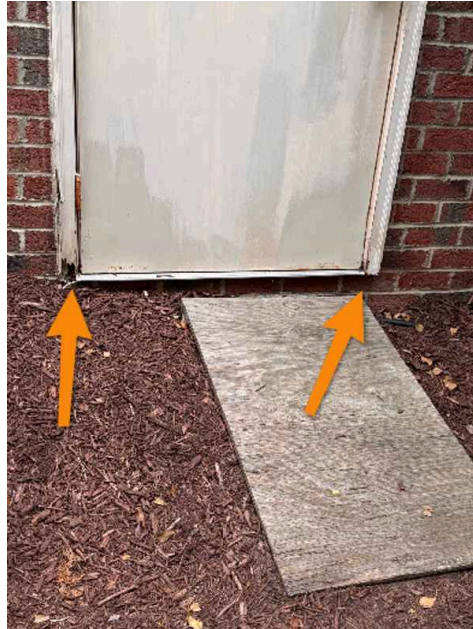
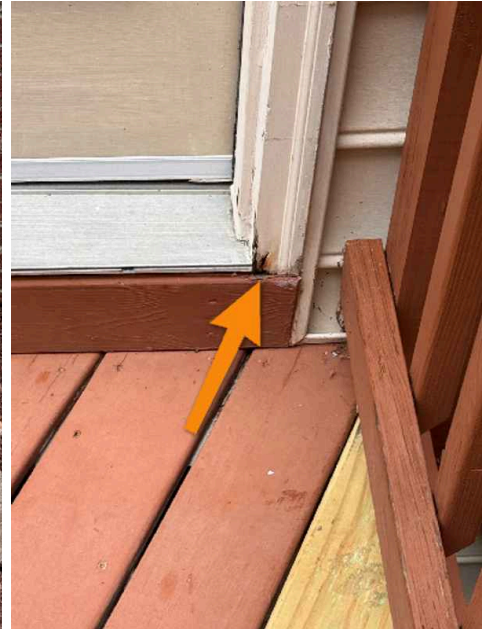
### 3.4.1 Exterior Doors

Rot was noted on the bottom of an exterior door. This can inhibit function and is an aesthetic concern. Consult a carpenter or contractor for evaluation.

Exterior doors and trim had noticeable amounts of rot along bottom

Contact a qualified carpenter.

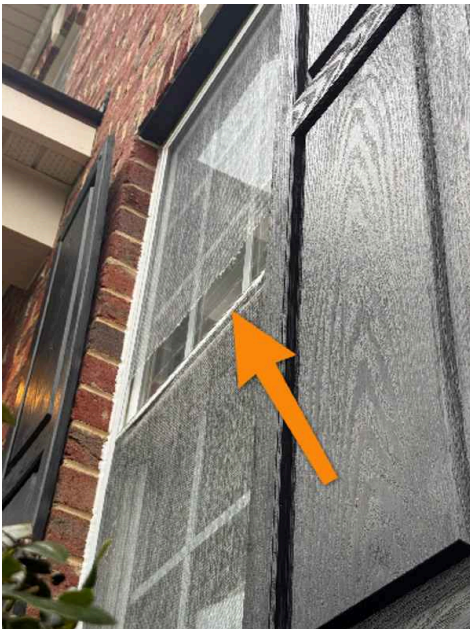
### 3.5.1 Exterior of Windows

Several screens were noted to be damaged and/or missing at the exterior of the home. This may inhibit function or be an aesthetic concern. Consult a windows contractor for evaluation.

Example of torn screen

Contact a qualified window repair/installation contractor.

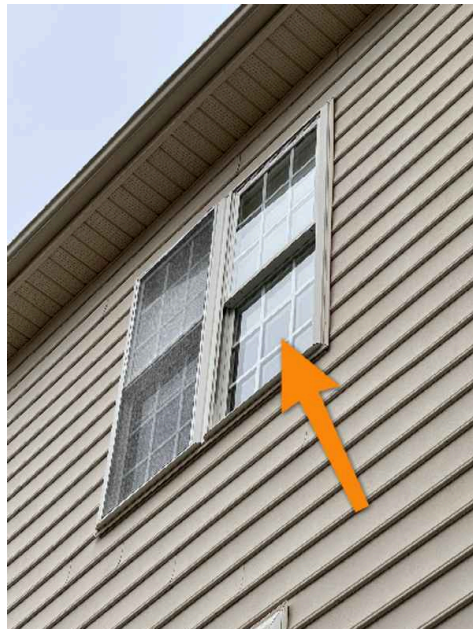
Example of missing Screen

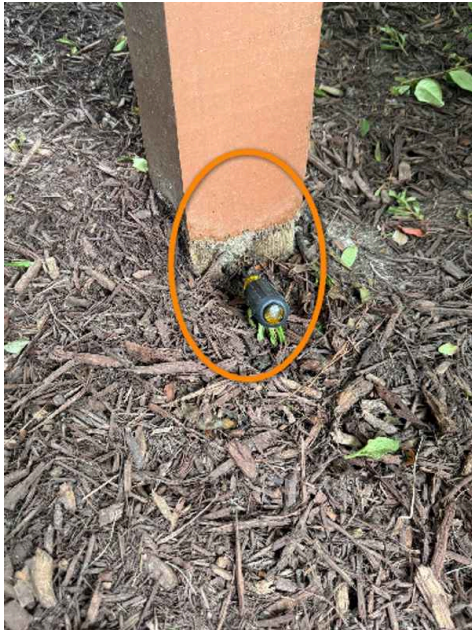
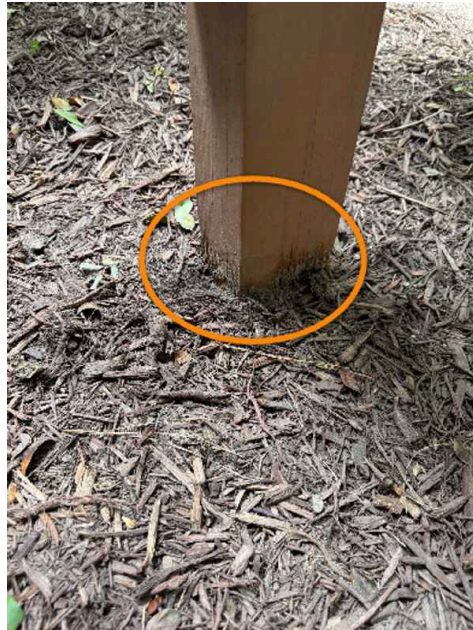
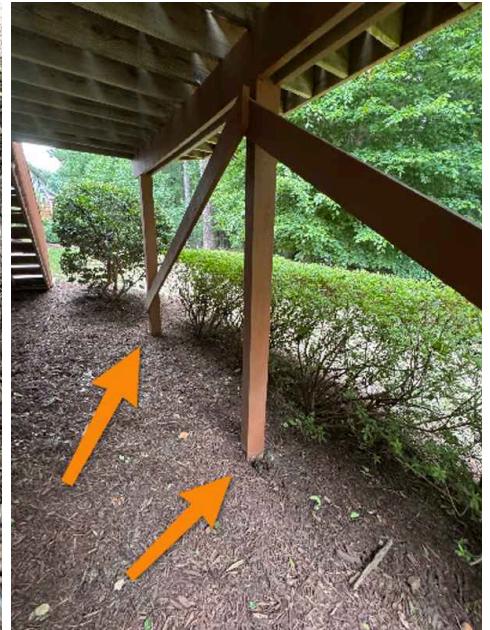
### 3.6.1 Decks, Balconies, Porches & Steps

Deteriorated wood was noted in the deck. This can present structural issues and be a safety concern. Further evaluation by a deck contractor or general contractor is recommended.

Several deck posts have significant deterioration at grade level

Contact a qualified deck contractor.

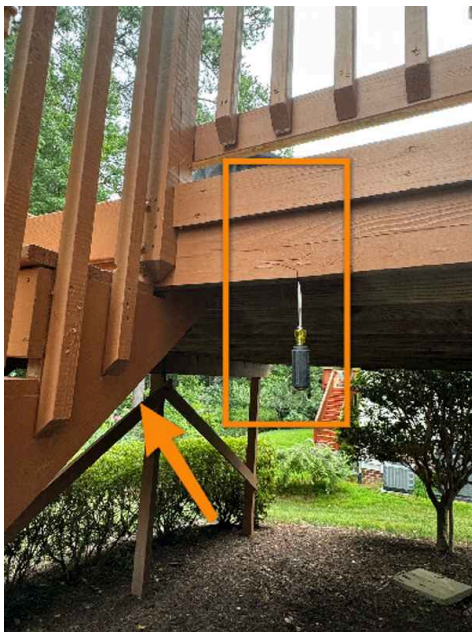
Exterior band member that supports stairs is cracked and needs review

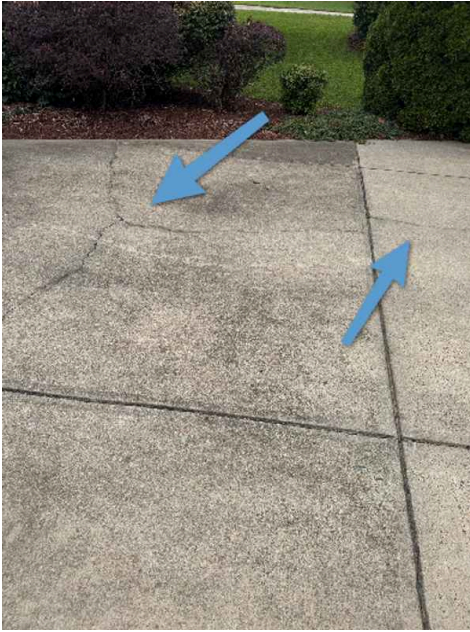
### 3.7.1 Walkways, Patios & Driveways

Typical cracking was noted in parts of the driveway slab. This is common with most homes. Cracks can be caulked to help prevent water intrusion and extend the life of the driveway. Consult a handyman or driveway specialist.

Typical slab cracks noted in driveway

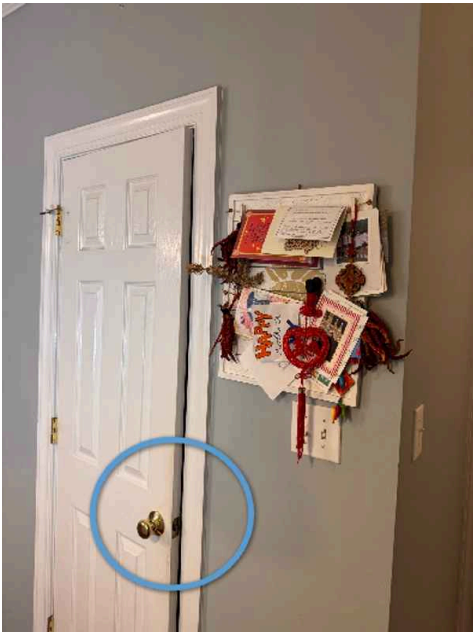
### 4.1.1 Interior Doors

Door doesn't latch properly. Recommend handyman repair latch and/or strike plate.

Multiple doors throughout the home do not latch and need adjustment

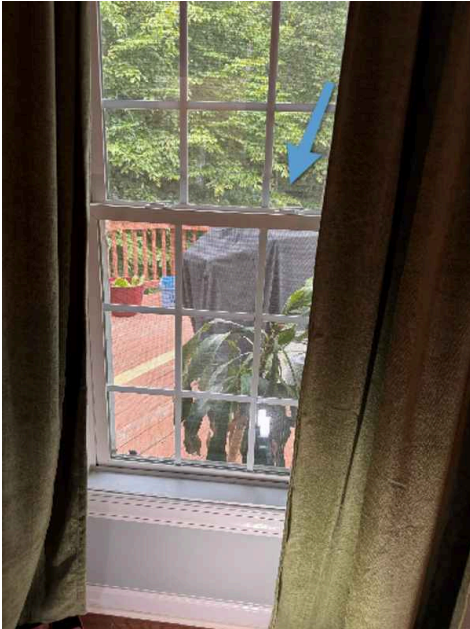
### 4.2.1 Interior of Windows

One or more windows did not operate as expected. As windows age, they often suffer minor flaws, such as not staying open, being difficult to lock, or having the top sash drop down. Consult a handyman for maintenance and/or a window professional for a quote for replacement.

Several windows did not stay open

Contact a qualified window repair/installation contractor.

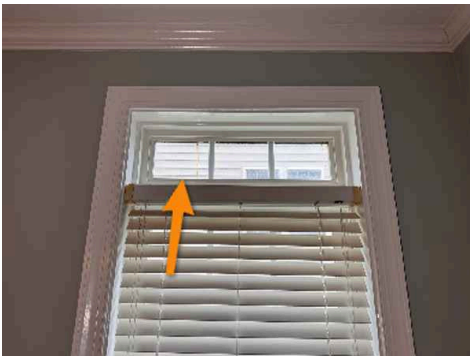
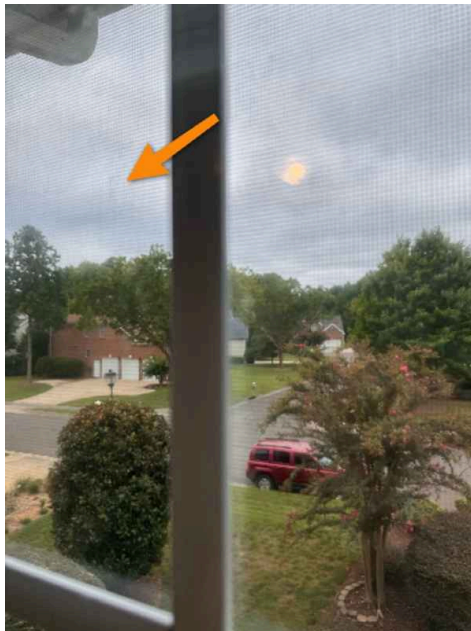
#### 4.2.2 Interior of Windows

Observed condensation between the window panes, which indicates a failed seal. Recommend qualified window contractor evaluate & replace.

At least two sashes showed evidence of fogging

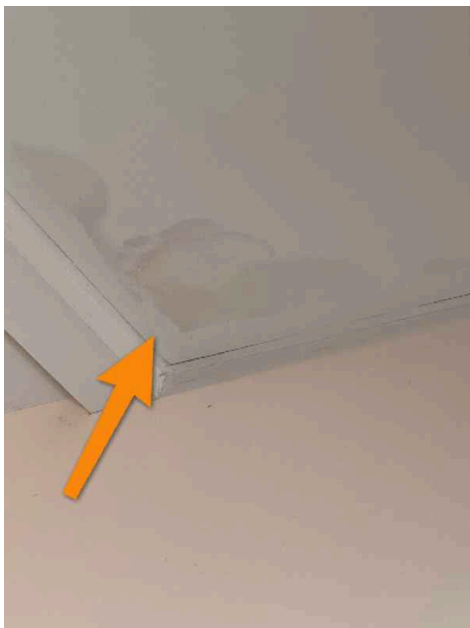
#### 4.4.1 Walls and Ceilings

Water stains were noted in an area of the ceilings and/or walls of the home. This can have numerous sources such as possible roof leaks, water leaks, condensate overflow from air handler pans, condensation on ductwork or plumbing vents, or other sources.

Water stain in garage ceiling at right middle

Contact a qualified roofing professional.

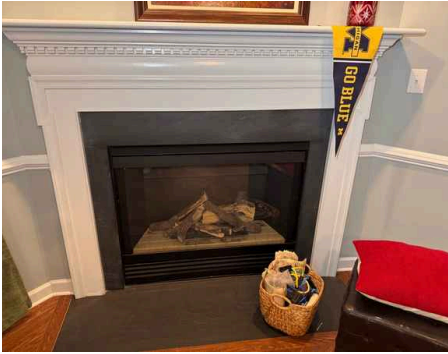
The gas to the fireplace was off, and it could not be tested

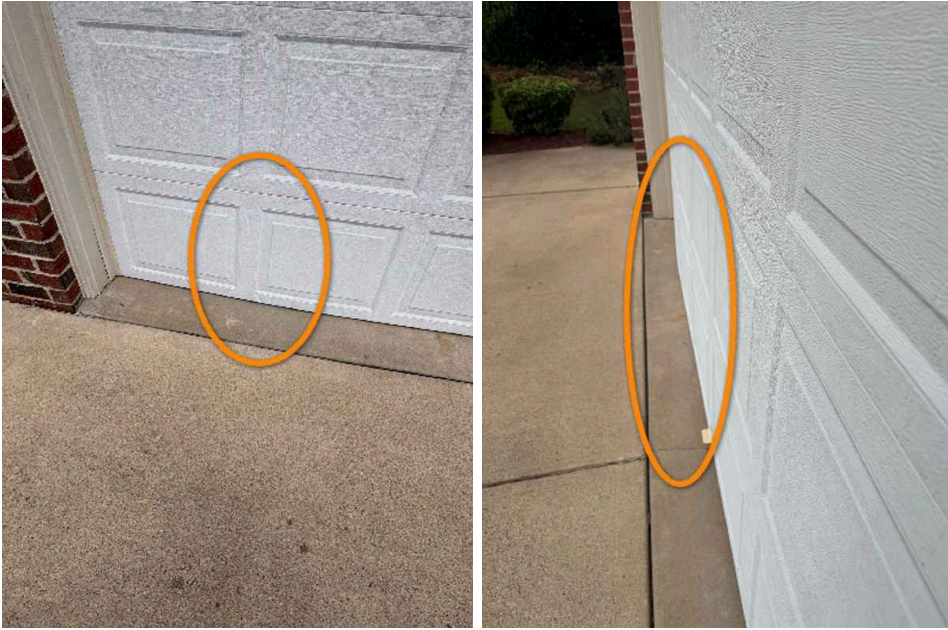
6.3.2 Overhead Door

Garage door panel is damaged. This can create a dangerous situation during operation. Recommend a qualified garage door contractor evaluate.

Dented area of bottom panel on left side

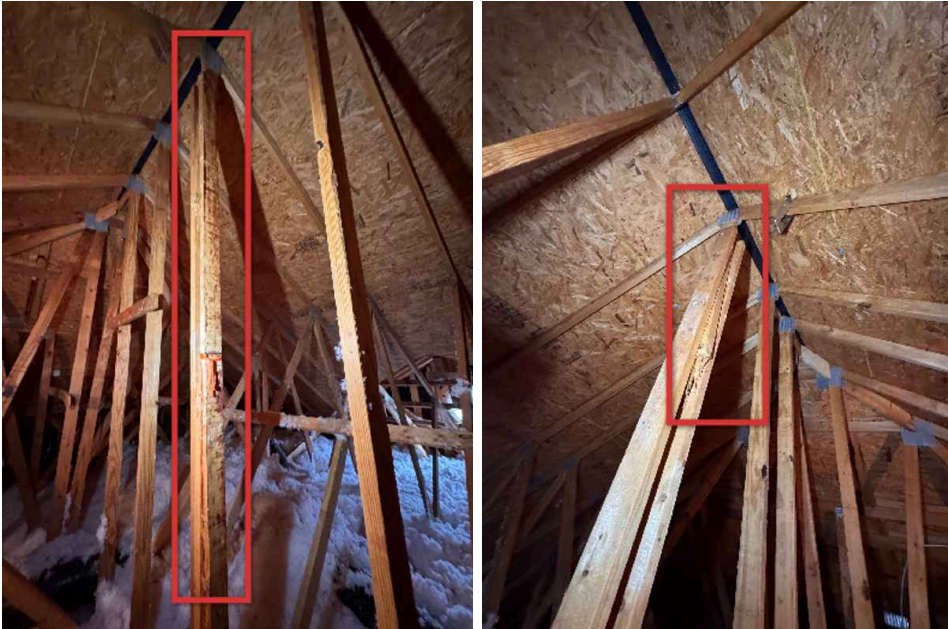
7.1.1 Attic Framing

A truss was noted to be damaged in the attic. This can lead to roof failure under conditions of high winds and/or snow. Trusses are an engineered system, and any repair must be at the direction of a structural engineer to ensure it is adequate.

A truss at the center of the attic is damaged and the repair may be inadequate. Consult the sellers for any information on the repair and/or consult a structural engineer

Contact a qualified structural engineer.

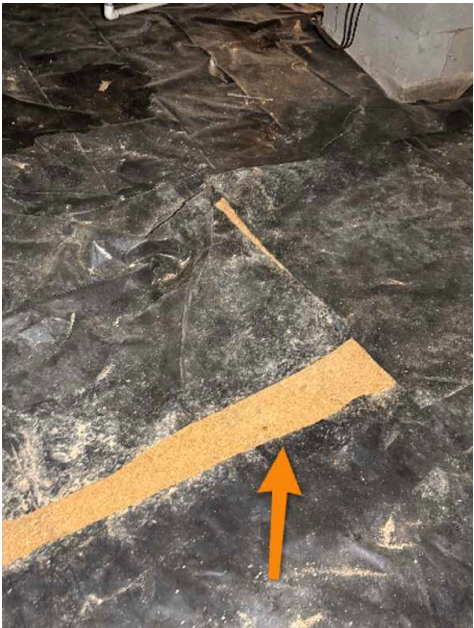
8.1.1 Foundation

The vapor barrier is in poor repair and/or missing in parts of the crawlspace. This can allow unwanted moisture buildup that can lead to organic growth and/or termite infestation. Consult a foundation contractor for evaluation.

Vapor barrier bunched in multiple spots

Recommendation  
Contact a foundation contractor.

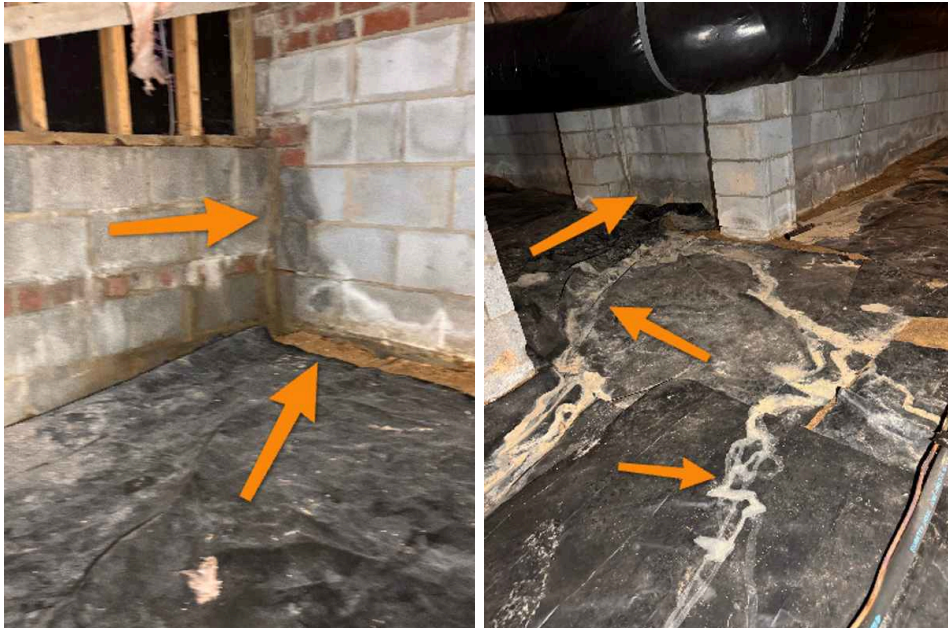
## 8.1.2 Foundation

Water intrusion was evident on the surface of the floor slab or in the basement/crawlspace. This can compromise the soil's ability to stabilize the structure and could cause damage. Recommend a qualified contractor identify the source of moisture and remedy.

Evidence of water intrusion at the front center of the crawlspace

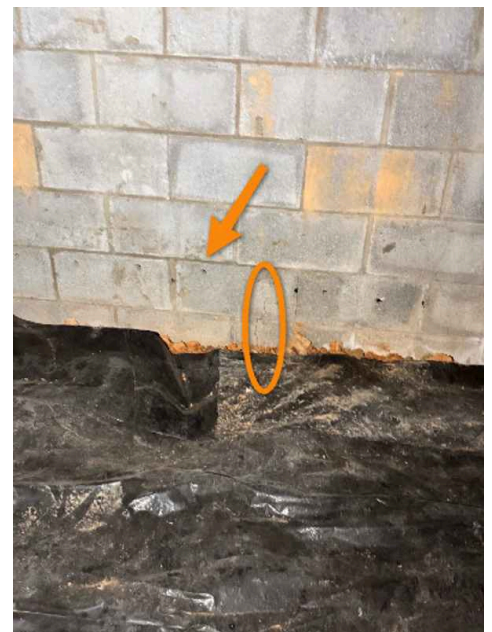
## 8.1.3 Foundation

An area of possible wood-destroying insect activity was noted. It appeared to be inactive, however, it is always prudent to have regular pest inspections performed by a professional.

Possible termite tube at front center of the crawlspace. Drill marks for treatment were also noted.

Contact a qualified pest control specialist.

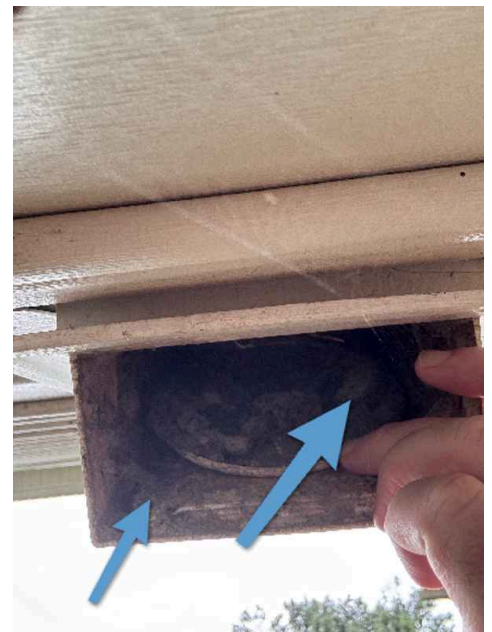
### 9.4.1 Vent Systems

Recommend cleaning lint buildup at dryer vent for fire safety reasons.

Lint buildup at exterior dryer vent

Contact a handyman or DIY project

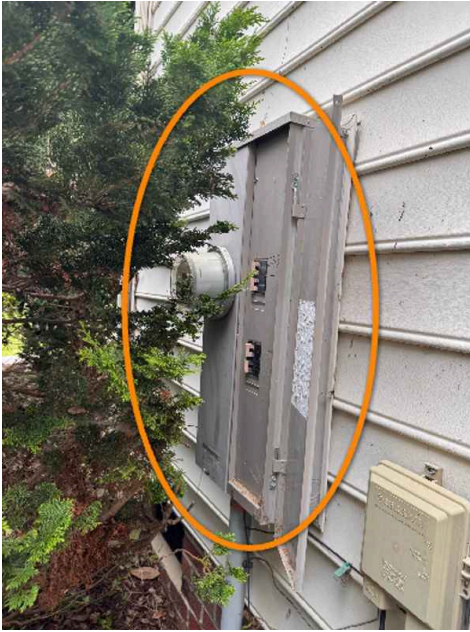
Exterior panel access is blocked by vegetation

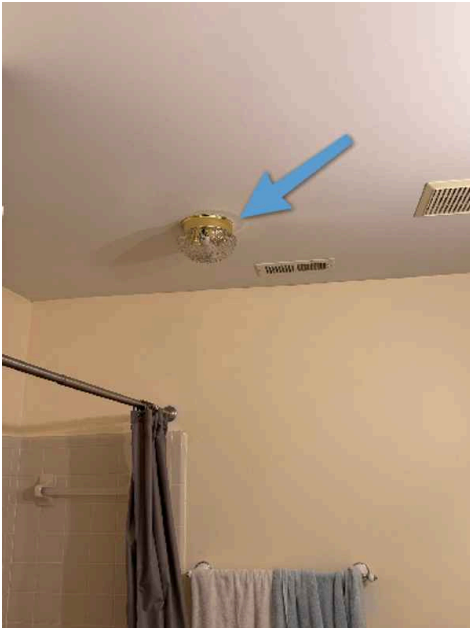
### 10.3.1 Lighting and Receptacles

Several lights are not operating. Most likely this indicates the need for replacement bulbs, but improper wiring can sometimes be the cause when multiple fixtures do not function. Recommend further evaluation by a licensed electrician.

Multiple lights throughout the home did not come on and probably need new bulbs

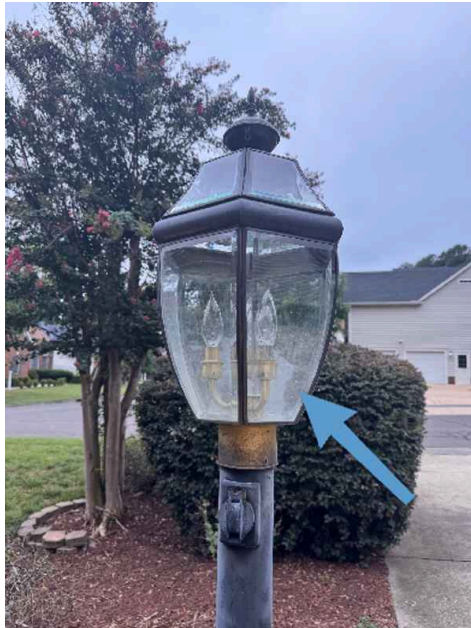
The front yard light did not come on and the cap is very loose
