# REPAIR REQUEST LIST

205 Palafox Dr, Chapel Hill, NC 27516  
08/21/2026 2:04 pm

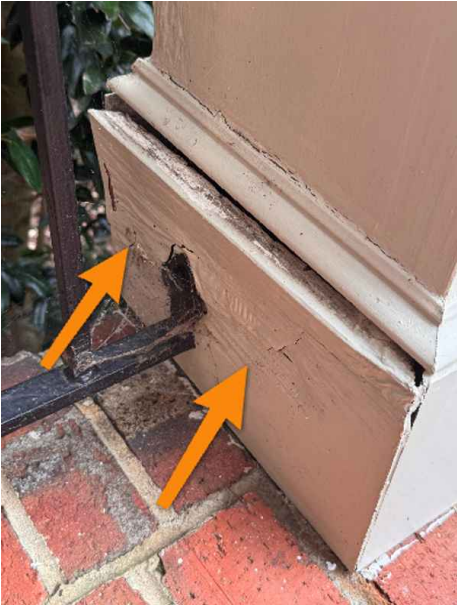
3.2.1 - Exterior: Siding, Flashing & Trim  
**DETERIORATION**

Areas of siding and/or trim were noted to be deteriorated. This can allow moisture intrusion into the walls of the home. Recommend having the areas evaluated for repair by a siding contractor.

Rot at right front porch post on back side

Recommendation  
Contact a qualified siding specialist.

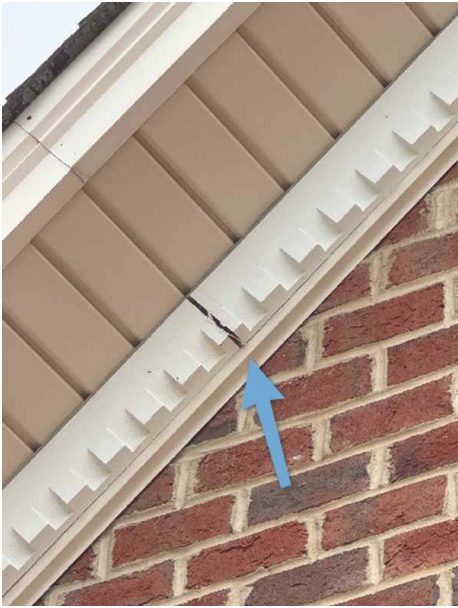
3.3.1 - Exterior: Eaves, Soffits & Fascia  
**GAP**

There is a gap between trim materials in the eaves. This can allow in water and is an aesthetic concern. Consult a carpenter or roofing for further evaluation and repair.

Multiple gaps noted in trim work

Recommendation  
Contact a qualified siding specialist.

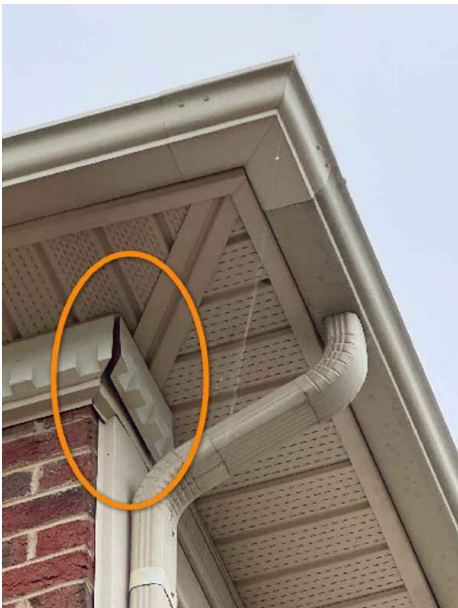
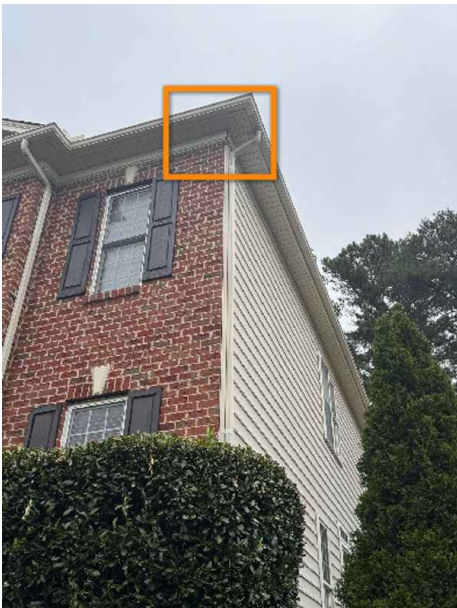
3.3.2 - Exterior: Eaves, Soffits & Fascia

One or more sections of the fascia are loose. Recommend qualified roofer evaluate & repair.

Loose piece at front right corner

Location shot

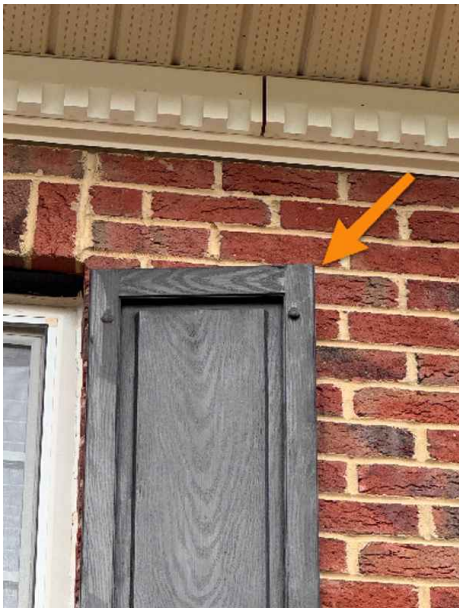
Several shutters appear loose and need securing

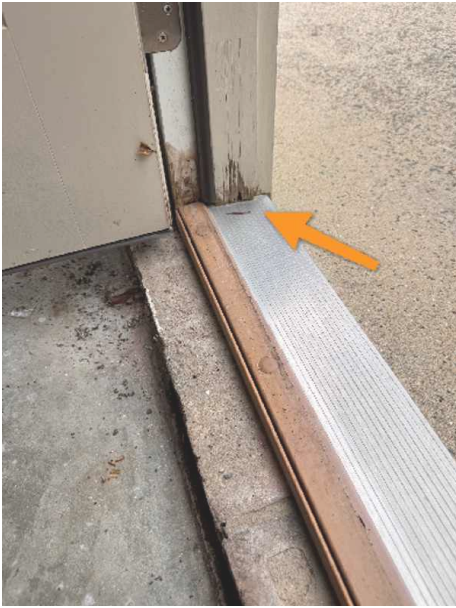
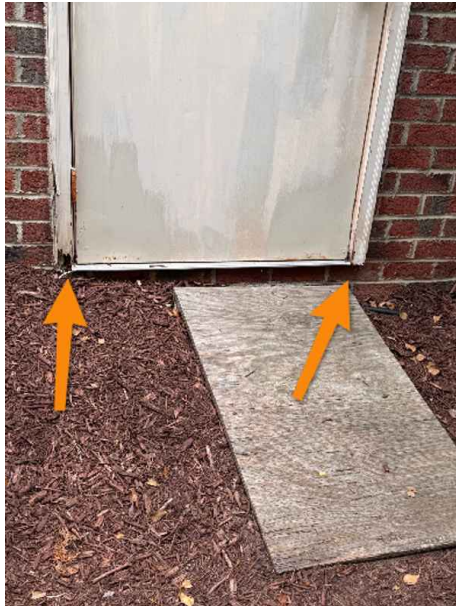
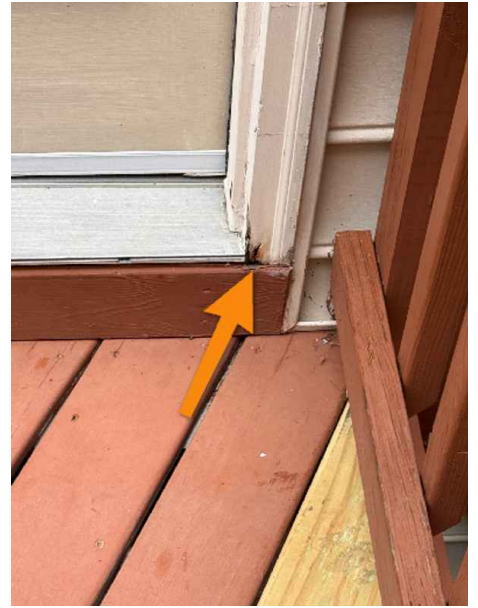
3.4.1 - Exterior: Exterior Doors

Rot was noted on the bottom of an exterior door. This can inhibit function and is an aesthetic concern. Consultant a carpenter or contractor for evaluation.

Exterior doors and trim had noticeable amounts of rot along bottom

Recommendation  
Contact a qualified carpenter.

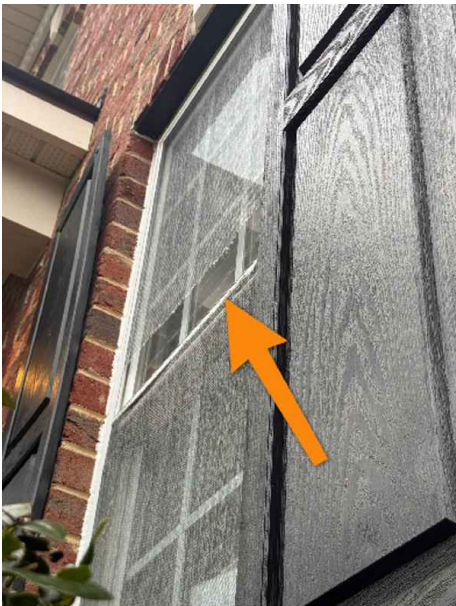
#### 3.5.1 - Exterior: Exterior of Windows SCREENS DAMAGED/MISSING

Several screens were noted to be damaged and/or missing at the exterior of the home. This may inhibit function or be an aesthetic concern. Consult a windows contractor for evaluation.

Example of torn screen

Contact a qualified window repair/installation contractor.

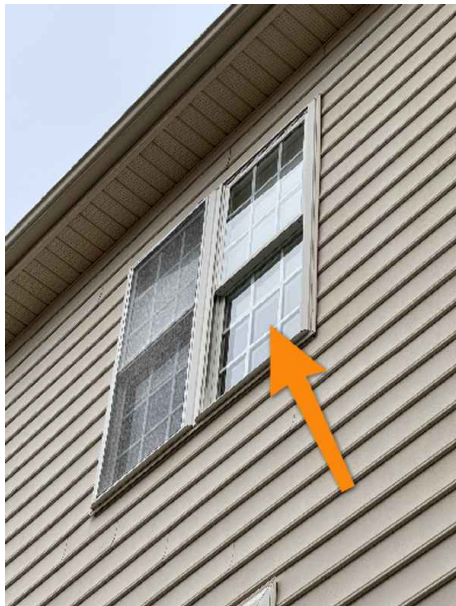
Example of missing Screen

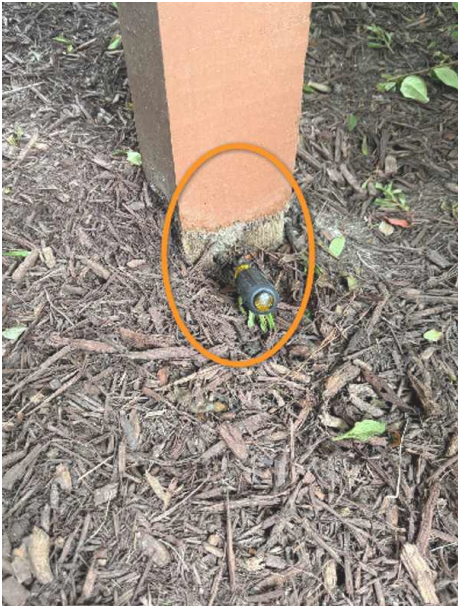
#### 3.6.1 - Exterior: Decks, Balconies, Porches & Steps DETERIORATION

Deteriorated wood was noted in the deck. This can present structural issues and be a safety concern. Further evaluation by a deck contractor or general contractor is recommended.

Several deck posts have significant deterioration at grade level

Contact a qualified deck contractor.

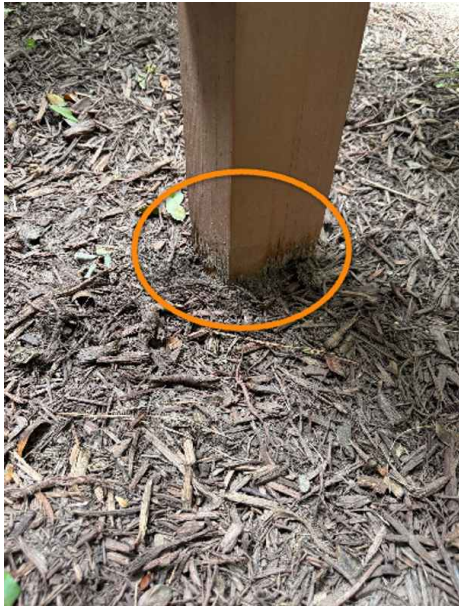
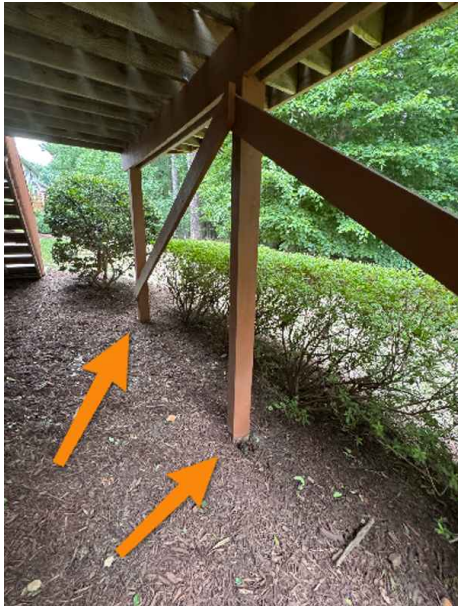
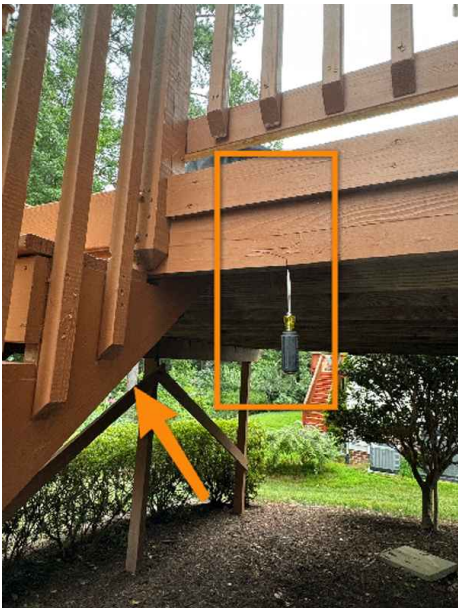
Exterior band member that supports stairs is cracked and needs review

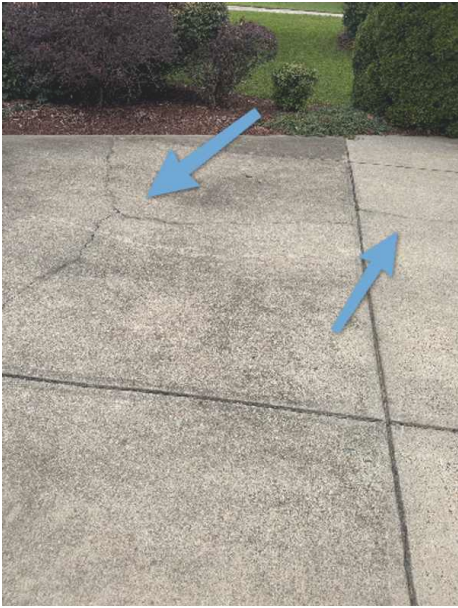
3.7.1 - Exterior: Walkways, Patios & Driveways

Typical cracking was noted in parts of the driveway slab. This is common with most homes. Cracks can be caulked to help prevent water intrusion and extend the life of the driveway. Consult a handyman or driveway specialist.

Typical slab cracks noted in driveway

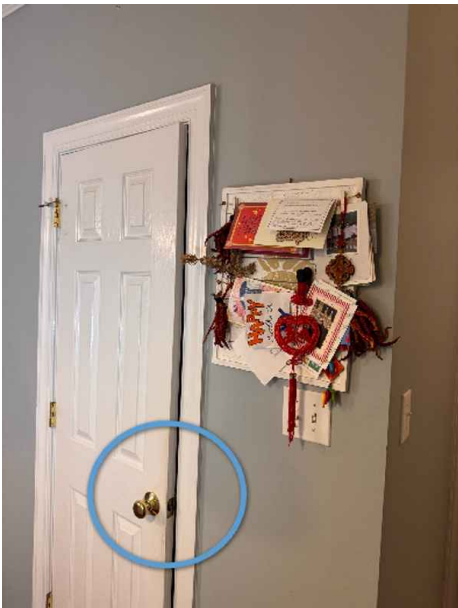
4.1.1 - Interior: Interior Doors  
**DOOR DOESN'T LATCH**

Door doesn't latch properly. Recommend handyman repair latch and/or strike plate.

Multiple doors throughout the home do not latch and need adjustment

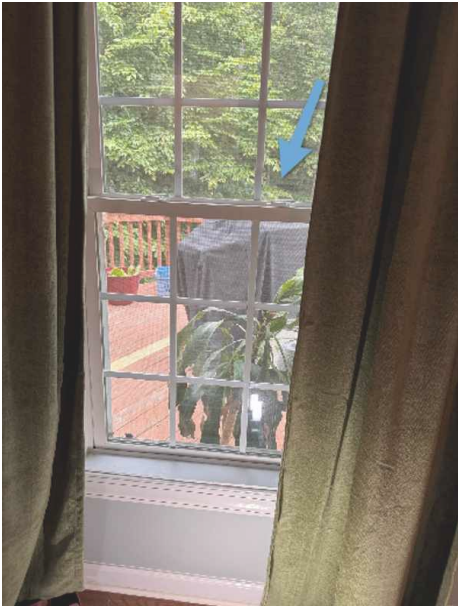
4.2.1 - Interior: Interior of Windows  
**OPERATION**

One or more windows did not operate as expected. As windows age, they often suffer minor flaws, such as not staying open, being difficult to lock, or having the top sash drop down. Consult a handyman for maintenance and/or a window professional for a quote for replacement.

Several windows did not stay open

Recommendation  
Contact a qualified window repair/installation contractor.

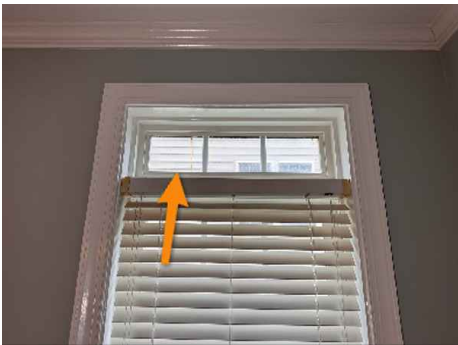
4.2.2 - Interior: Interior of Windows  
**FAILED SEAL**

Observed condensation between the window panes, which indicates a failed seal. Recommend qualified window contractor evaluate & replace.

At least two sashes showed evidence of fogging

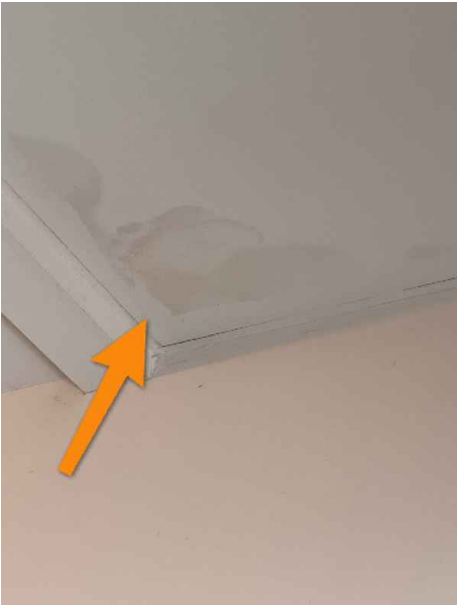
4.4.1 - Interior: Walls and Ceilings

Water stains were noted in an area of the ceilings and/or walls of the home. This can have numerous sources such as possible roof leaks, water leaks, condensate overflow from air handler pans, condensation on ductwork or plumbing vents, or other sources.

Water stain in garage ceiling at right middle

Recommendation  
Contact a qualified roofing professional.

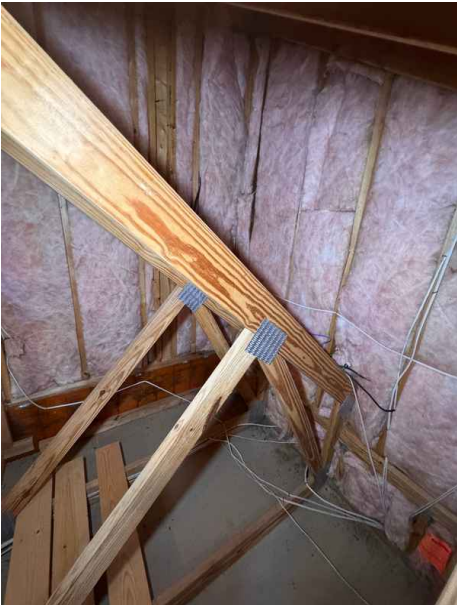
The corresponding area of the attic did not show any visible staining or damage

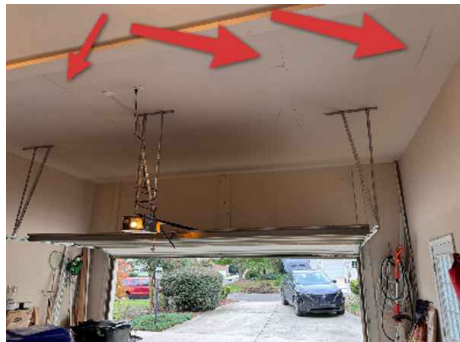
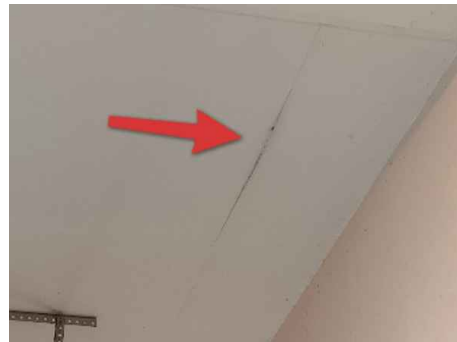
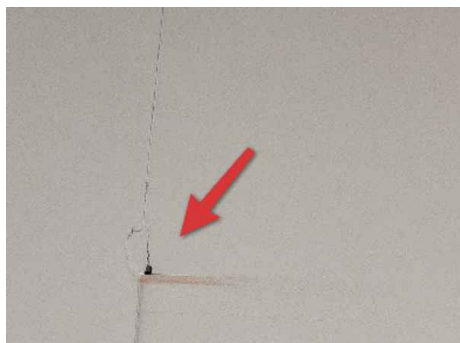
### 6.3.1 - Garage: Overhead Door OPERATION

The overhead door is causing the garage ceiling to crack. This is a safety hazard as it could result in failure. Consult a garage door specialist for further evaluation.

Garage door is causing ceiling drywall to crack and separate indicating poor support

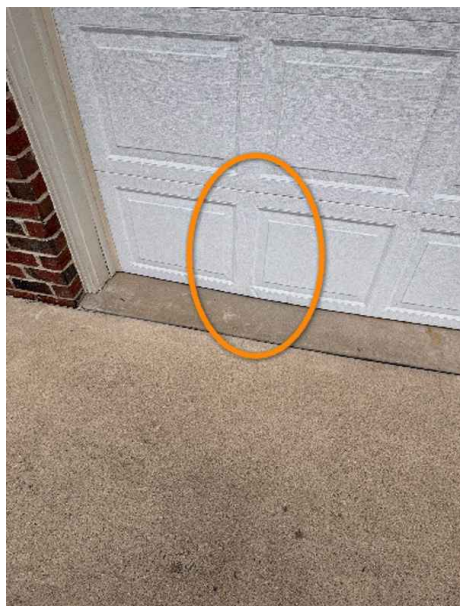
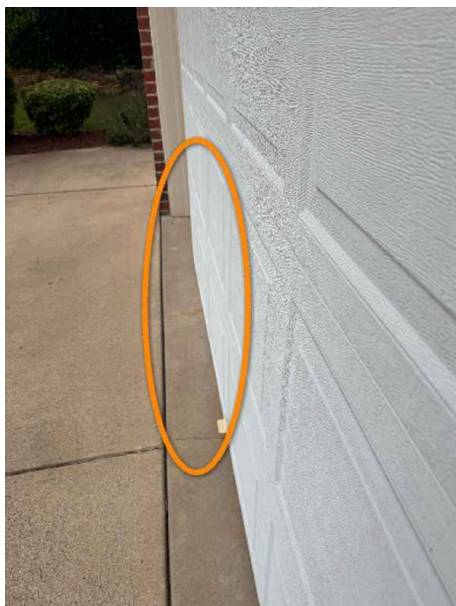
### 6.3.2 - Garage: Overhead Door PANEL DAMAGE

Garage door panel is damaged. This can create a dangerous situation during operation. Recommend a qualified garage door contractor evaluate.

Dented area of bottom panel on left side

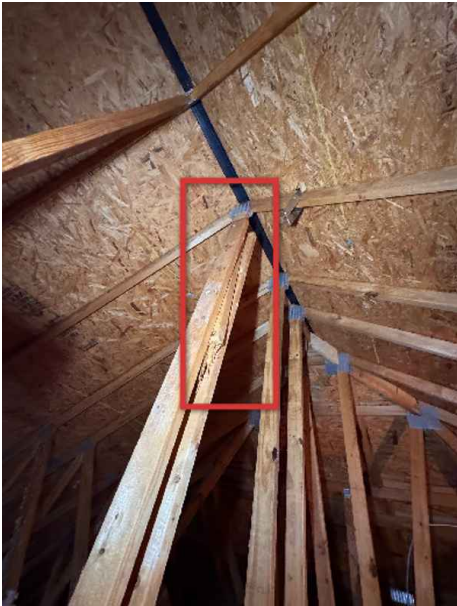
### 7.1.1 - Attic: Attic Framing TRUSS DAMAGE

A truss was noted to be damaged in the attic. This can lead to roof failure under conditions of high winds and/or snow. Trusses are an engineered system, and any repair must be at the direction of a structural engineer to ensure it is adequate.

A truss at the center of the attic is damaged and the repair may be inadequate. Consult the sellers for any information on the repair and/or consult a structural engineer

Recommendation  
Contact a qualified structural engineer.

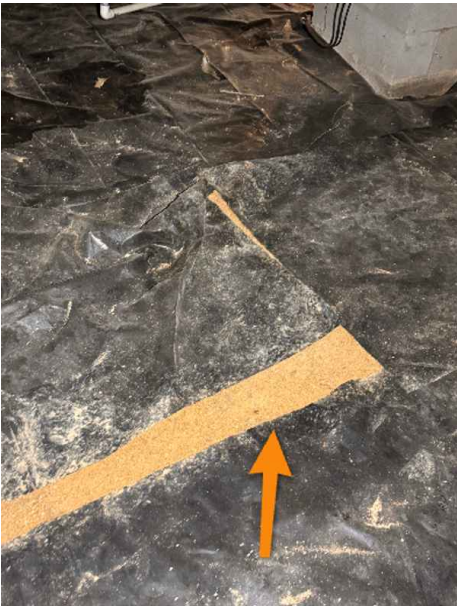
8.1.1 - Foundation: Foundation  
VAPOR BARRIER IN POOR REPAIR

The vapor barrier is in poor repair and/or missing in parts of the crawlspace. This can allow unwanted moisture buildup that can lead to organic growth and/or termite infestation. Consult a foundation contractor for evaluation.

Vapor barrier bunched in multiple spots

Recommendation  
Contact a foundation contractor.

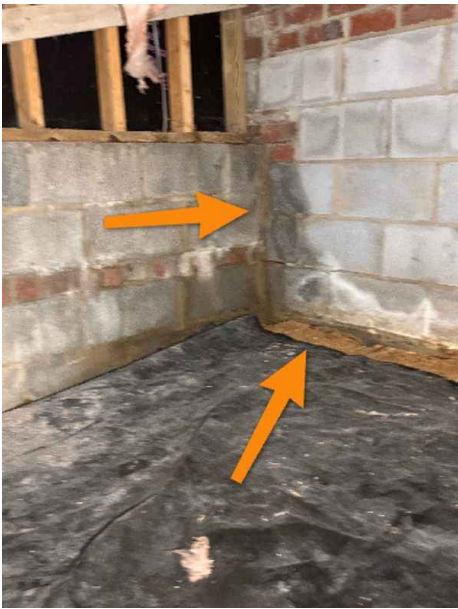
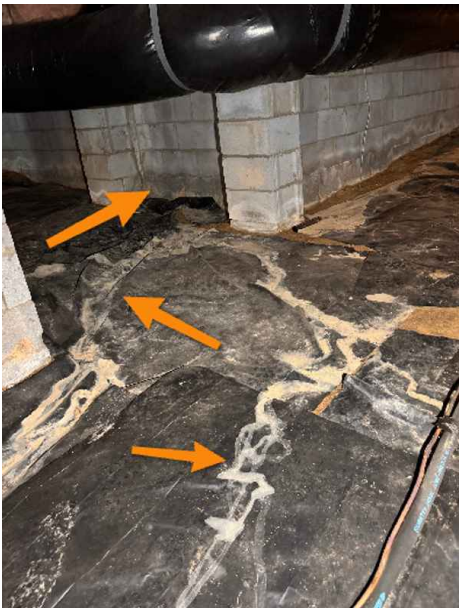
8.1.2 - Foundation: Foundation  
WATER INTRUSION THROUGH CRAWLSPACE WALL

Water intrusion was evident on the surface of the floor slab or in the basement/crawlspace. This can compromise the soil's ability to stabilize the structure and could cause damage. Recommend a qualified contractor identify the source of moisture and remedy.

Evidence of water intrusion at the front center of the crawlspace

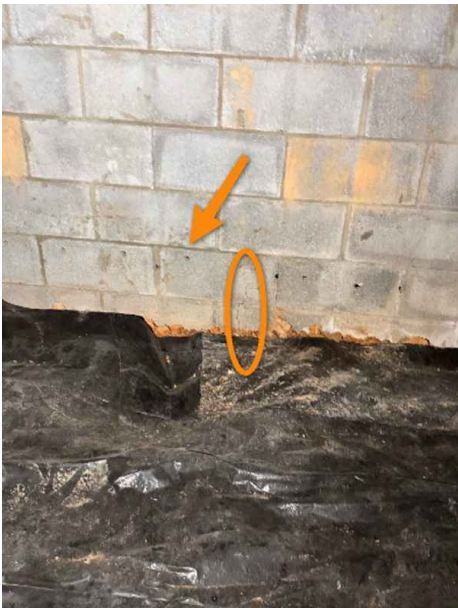
8.1.3 - Foundation: Foundation  
POSSIBLE TERMITE ACTIVITY

An area of possible wood-destroying insect activity was noted. It appeared to be inactive, however, it is always prudent to have regular pest inspections performed by a professional.

Possible termite tube at front center of the crawlspace. Drill marks for treatment were also noted.

Recommendation  
Contact a qualified pest control specialist.

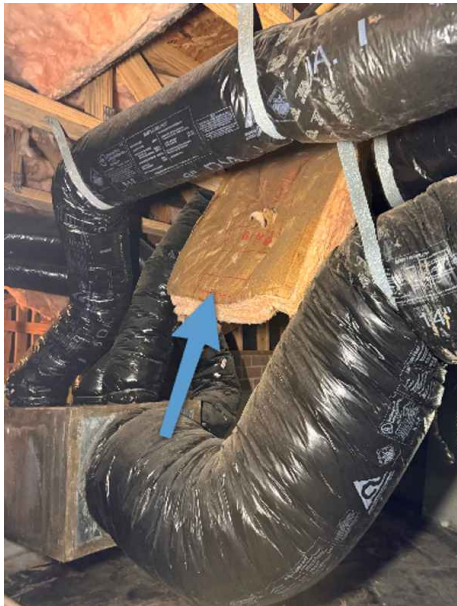
8.2.1 - Foundation: Floor Framing  
**FLOOR INSUALTION FALLING DOWN**

Insulation was falling down in several areas of the crawlspace. Consult a handyman or insulation contractor for repair.

Several pieces of insulation have fallen down in the crawlspace

Contact a qualified insulation contractor.

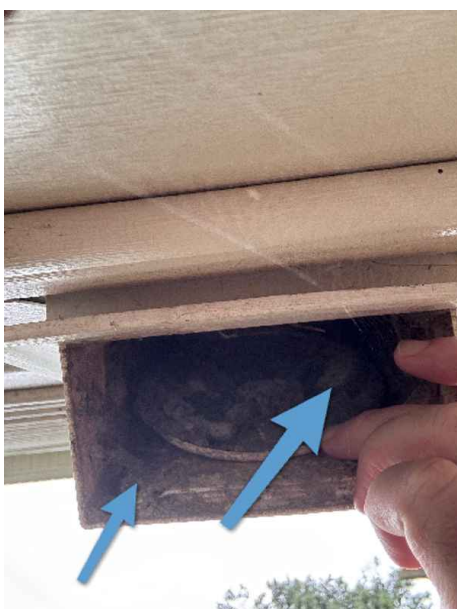
9.4.1 - Heating/Venting/Air Conditioning (HVAC): Vent Systems  
**DRYER VENT NEEDS CLEANING**

Recommend cleaning lint buildup at dryer vent for fire safety reasons.

Lint buildup at exterior dryer vent

Contact a handyman or DIY project

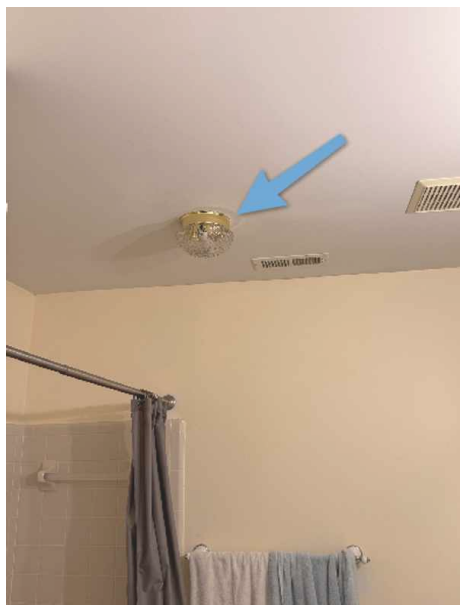
10.3.1 - Electrical: Lighting and Receptacles  
**MULTIPLE LIGHTS INOPERABLE**

Several lights are not operating. Most likely this indicates the need for replacement bulbs, but improper wiring can sometimes be the cause when multiple fixtures do not function. Recommend further evaluation by a licensed electrician.

Multiple lights throughout the home did not come on and probably need new bulbs

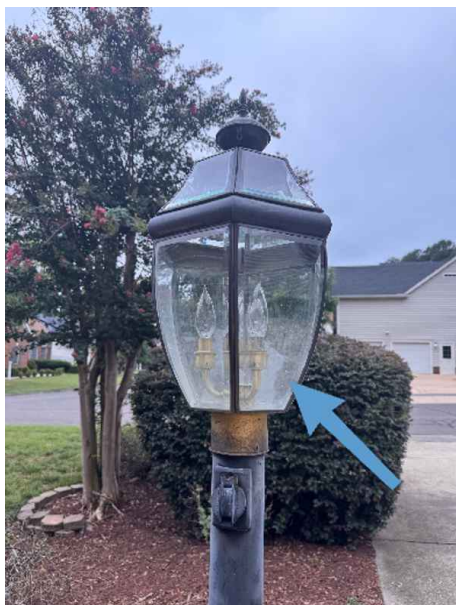
The front yard light did not come on and the cap is very loose
