WOOD DESTROYING PESTS AND ORGANISMS INSPECTION REPORT

Building No.	Street	City	Zip	Date of Inspection	Page
11609	Cardelina Ln	Atascadero	93422	11/24/26	1 of 4

Report # 19760

General Description:	Inspection Tag Posted:
Two story town home; Stucco and slate siding; Tile roof; Partially furnished	**Garage**
	Other Tags Posted:

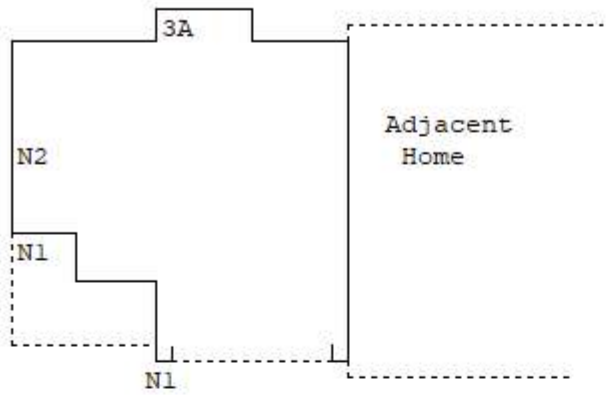
FINDING: Fungus damage was noted at the base of the exterior door frame.

RECOMMENDATION: Replace the damaged portion of the door frame. (SECTION I ITEM)
