**\*\*\*Update\*\*\***

Previous buyer terminated contract after they received the report from their home inspector but before negotiations took place. This is the original report with recent repairs noted.

# Inspection Report

2214 Pathway Dr  
Chapel Hill NC 27516

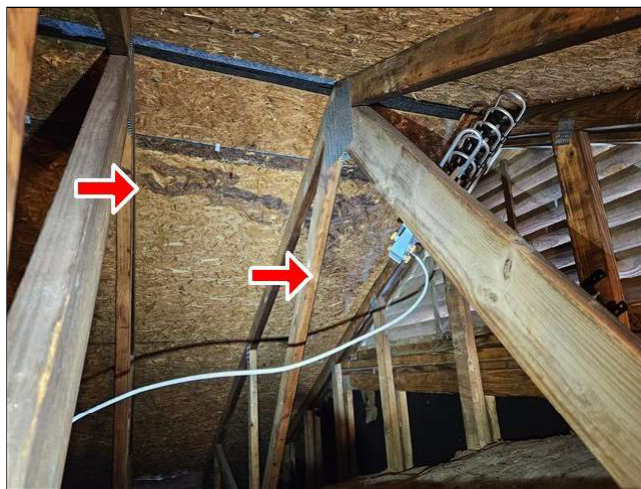
1.5 Item 2(Picture)

**1.5** (1) Evidence of leaks were noted in the attic in one or more areas. These were noted from the discolored sheathing. The wood was dry at the time of the inspection which could mean these leaks are historical, or they could be active. Attic sheathing dries out very quickly making it hard to determine if leaks are active or not when it is not raining. The wood in these areas was discolored in a manner typical of a long term leak. Leaks should be repaired as soon as possible to keep the damage from getting worse. All adjacent areas should also be evaluated for any hidden damage and repaired. A licensed general contractor or roofing contractor should be consulted to fully evaluate the roof and the sheathing and to repair as necessary.

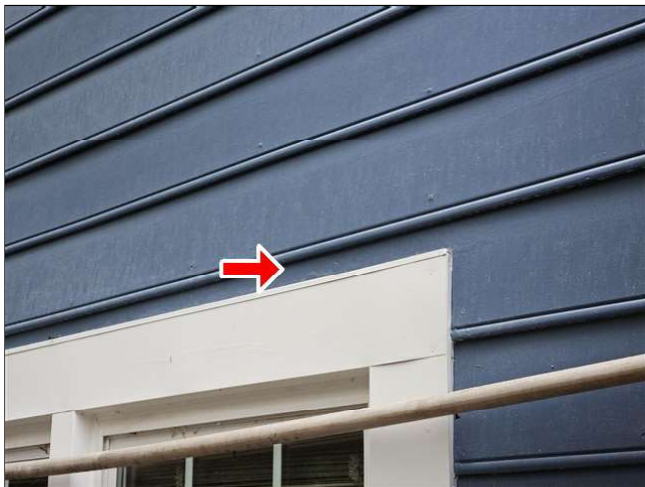
2.0 Item 2(Picture)

**2.0** Portions of the hardboard siding are decayed/damaged from exposure to moisture. The damage was noted on all sides of the home along the bottom edges of the siding, at face nails, and at joints. Hardboard siding needs to be properly maintained to keep water and pests from entering the home. Damaged/decayed siding can lead to property damage and undesirable living conditions. A licensed general contractor or siding specialist should be consulted for a complete evaluation of the siding and adjacent components and for repair where necessary.

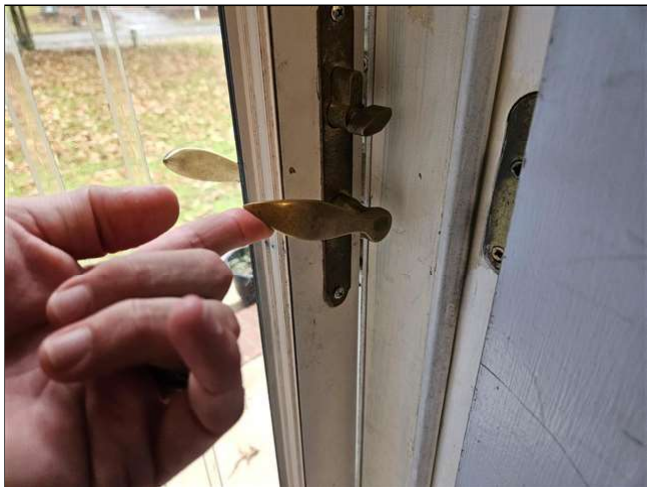
2.2 Item 2(Picture)

**2.2** (1) The door handle for the front storm door does not operate properly. The handle does not turn downward, only upward, to recess the strike pin. This is backwards from normal. Also holes were not cut into the door frame to allow the latch pin or the deadbolt to properly seat to secure the door. These items need to be repaired for the door to function as intended. A general repair specialist can be consulted as needed.

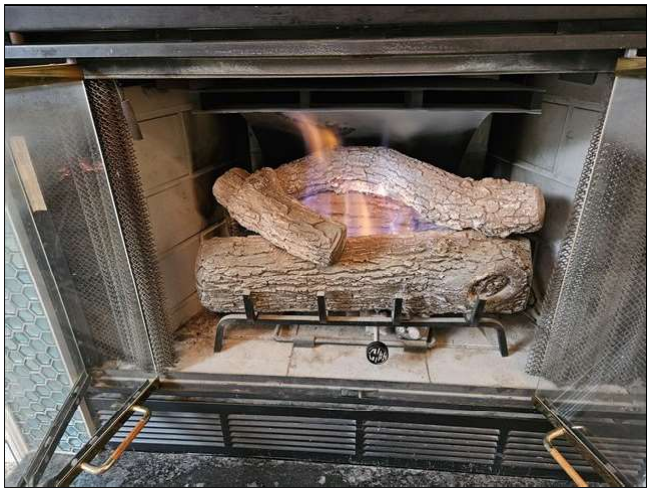
4.1 Item 1(Picture)

4.1 The gas log fire unit is functional. It was turned on long enough to see if it would light and burn properly and was then turned off. The efficiency and drafting of the unit was not tested.

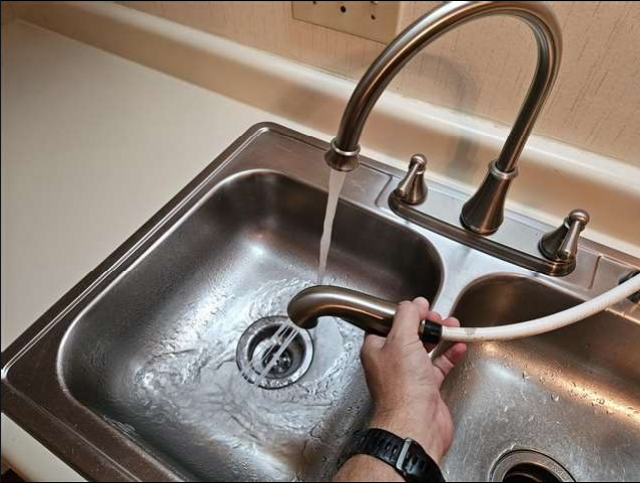
5.0 Item 1(Picture)

**5.0** (1) The spray wand in the kitchen does not fully convert the water flow from the main faucet when operated. A licensed plumbing contractor can be consulted for repair/replacement as needed.

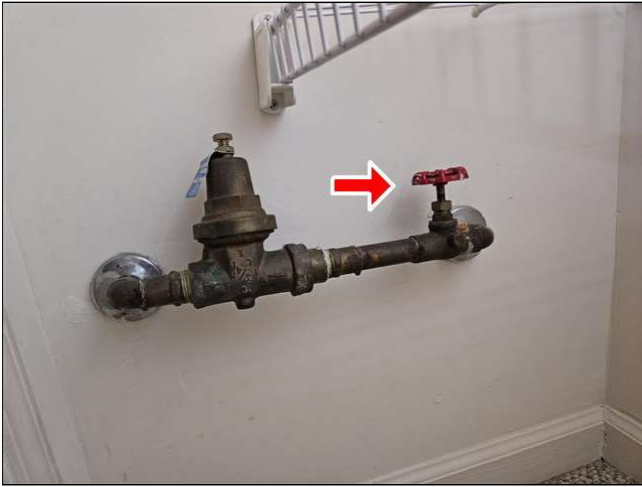
5.3 Item 1(Picture)

**5.3** The main shut off is the red knob located in the hall closet. This is for your information.

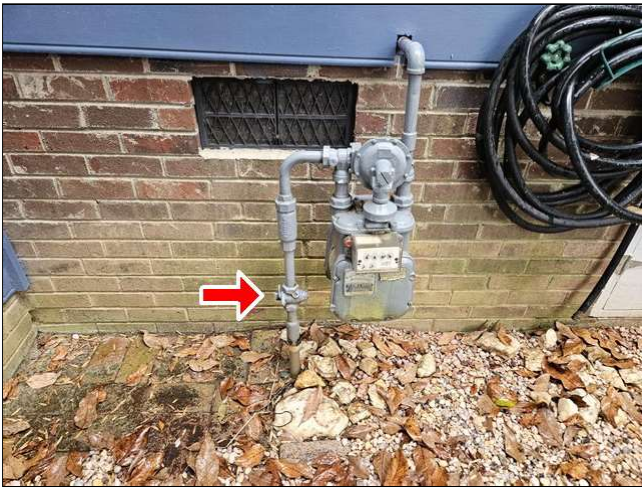
5.5 Item 1(Picture)

**5.5** The main fuel shut off is at the gas meter outside

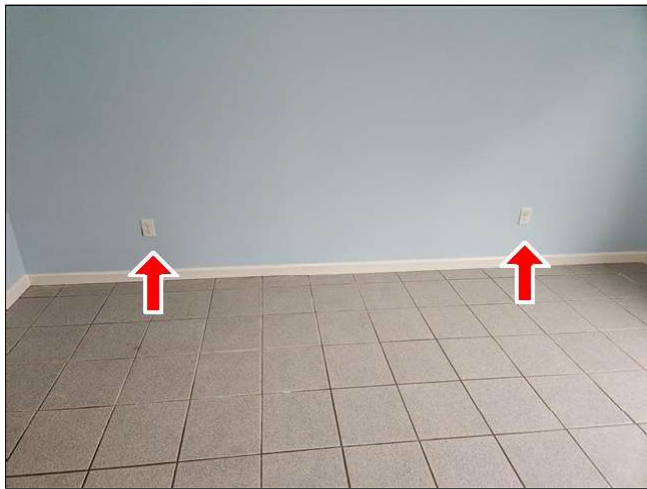
6.3 Item 4(Picture)

Open ground outlets were located:

- 1. Four of the outlets in the rear right sunroom.

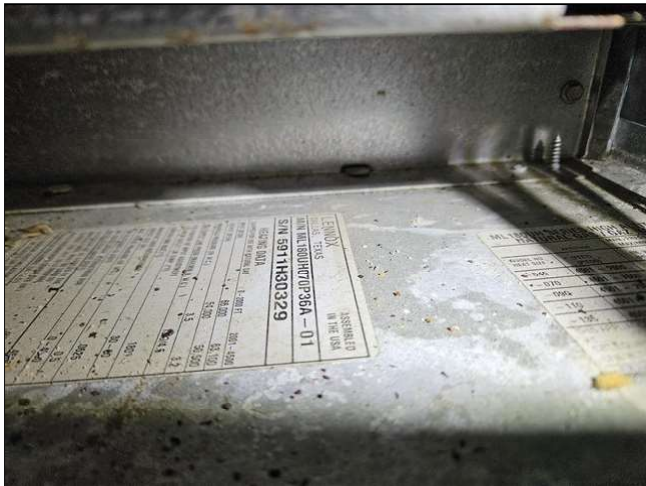
7.0 Item 1(Picture)

**7.0** (1) System one information:  
Exterior unit  
Manufacturer: Lennox  
Mod #: 13ACX-030-230-15  
Ser #: 1911H30774  
MFD: 08/2011

Furnace  
Manufacturer: Lennox  
Mod #: ML180UH070P36A-01  
Ser #: 5911H30329  
MFD: 08/2011

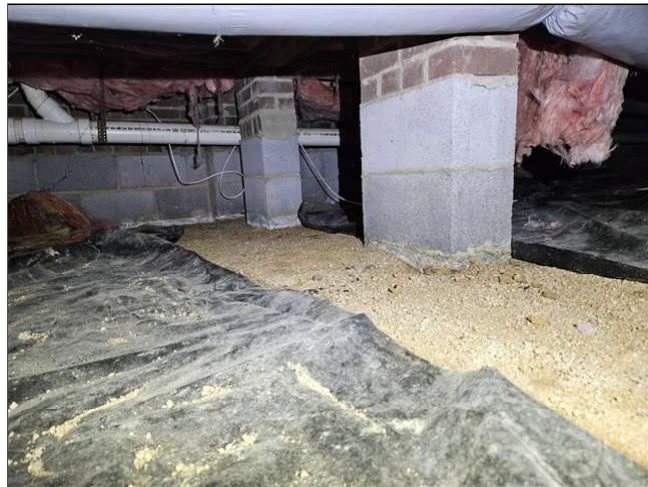
8.2 Item 2(Picture)

**8.2** The vapor barrier in the crawl space is missing in a few areas. Vapor barriers should cover the entire floor space to work properly. Missing sections can allow higher levels of moisture into the crawl space which can lead to undesirable living conditions. A general repair specialist should be consulted for repair.

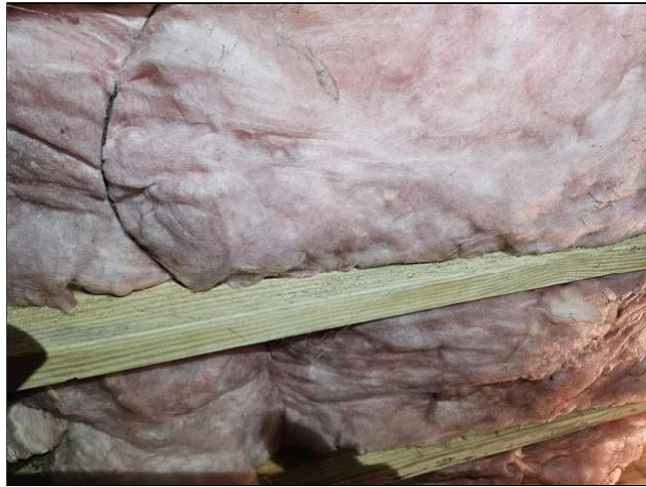
8.3 Item 2(Picture)

**As noted by home inspector “Missing sections can allow higher levels of moisture into the crawl space...” As the new vapor barrier was installed on 10/10/25 throughout the crawl space (after previous buyer inspection), there are no longer any missing sections.**

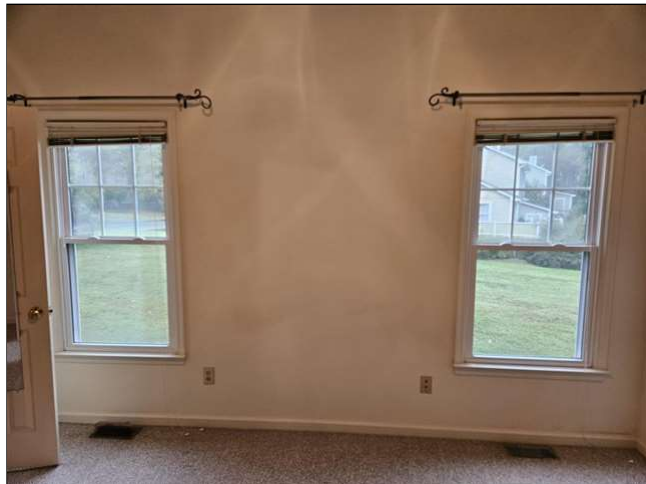
9.6 Item 2(Picture)

**9.6** (1) One or more of the window panes in the house have evidence of broken hermetic seals, which should be replaced. Windows with damaged seals are usually noticed by condensation build up or cloudy/ghosting panes. Damaged seals or ghosting windows no longer contain the gas that makes them energy efficient and thermally insulated. The ghosting can change with the weather and therefore not all damaged windows may have been noticeable at the time of the inspection. A window specialist should be consulted to evaluate all the windows and to repair/replace as necessary.

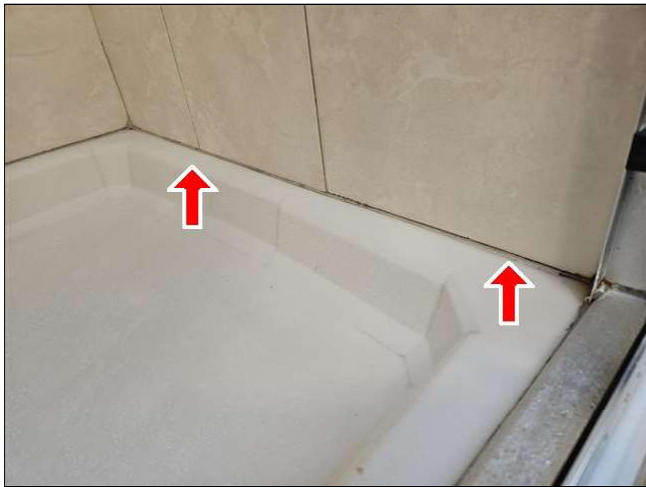
9.8 Item 3(Picture)

**9.8** (1) The stall shower in the master bathroom needs new caulk at the floor to wall junction. The grout is starting to crack and pop away and caulk will help to keep water from getting under the tile which can lead to property damage. A flooring/tile specialist can be consulted for repair as needed.

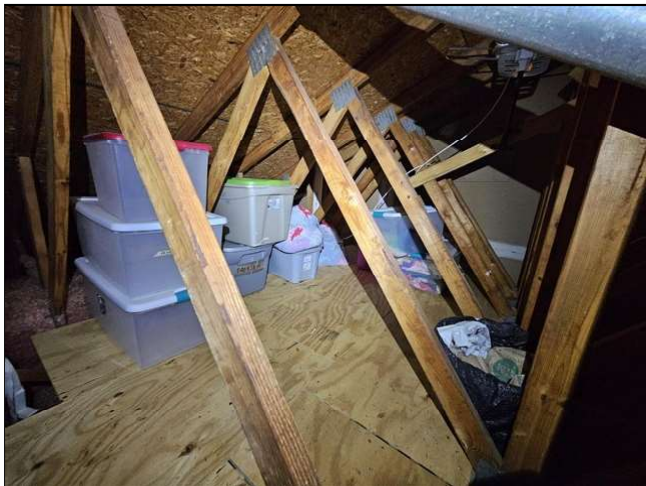
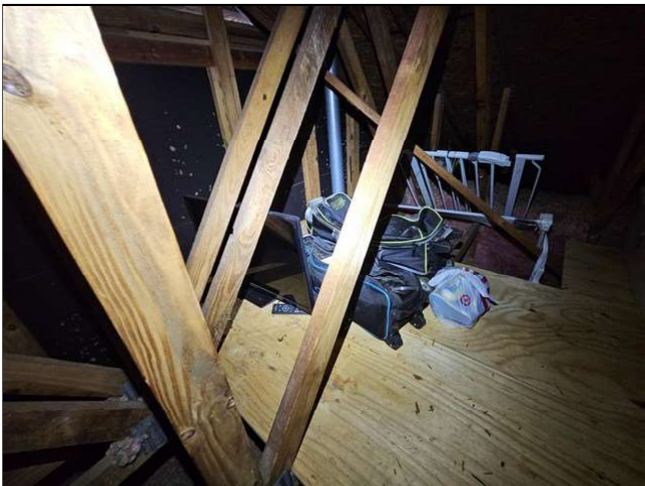
**9.8** (2) FYI: There is still some of the current owners belongings in the attic. You may want to have the seller remove these so that you don't have to deal with it after you close on the house. Consult the seller for removal.

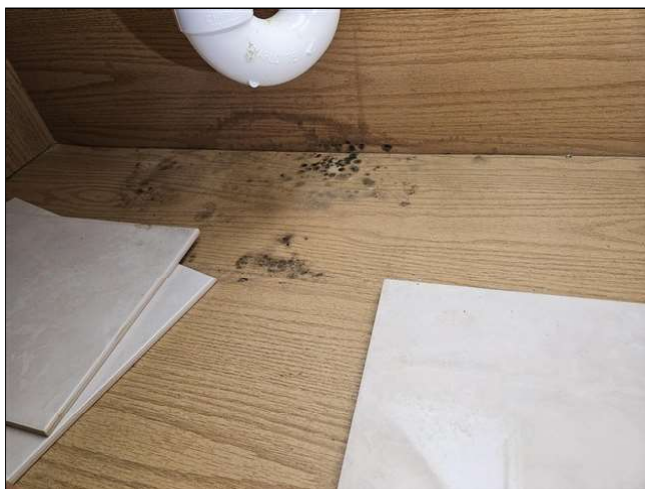
9.9 Item 1(Picture)

**9.9** Mold was noticed in one or more areas throughout the house. Mold growth indicates higher than typical levels of moisture and can be a symptom of issues with the home's ventilation. While we did not test for mold and were not doing a mold inspection, you may want to have an industrial hygienist evaluate the house for mold and other contaminants. Please note, the home inspector is not concerned with health issues related to mold, only moisture issues and possible damage to the home. All health concerns should be addressed to your doctor or industrial hygienist.

1. Under the sink in the master bathroom downstairs.
2. The ceiling in the rear storage closet.
