Inspection Report

Property Address:
2214 Pathway-3
Chapel Hill NC

ODUM SQUIRES INC

1/31/2026

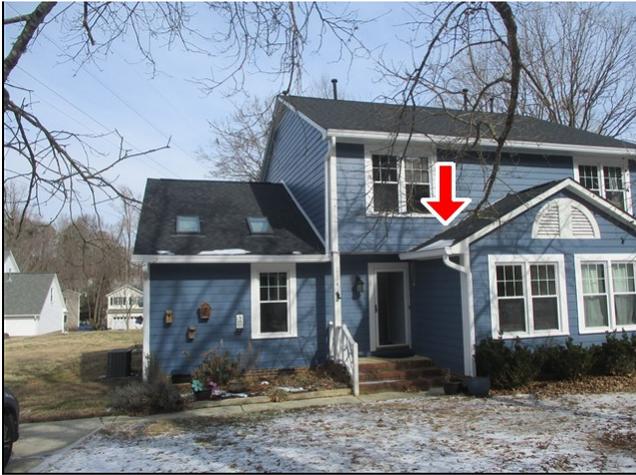
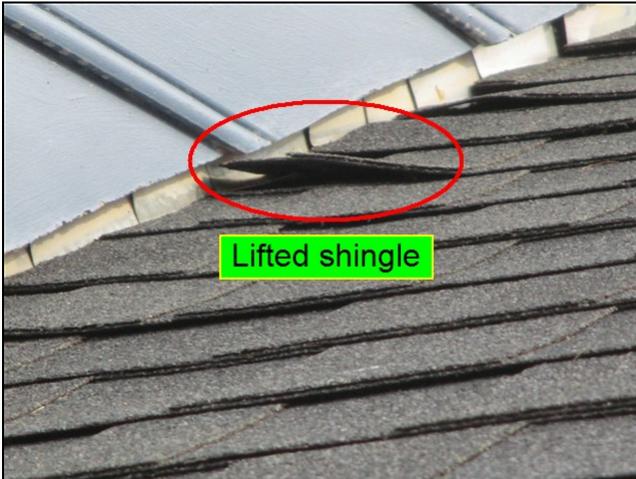
(4) Noted one or more lifted shingles above the lower kitchen roof. Raised or damaged shingles can act as entry point for moisture. A Lifted shingle is also susceptible to wind damage. Recommend the raised shingle be secured to the roof deck and any damage be repaired. Recommend repairs by a qualified roof contractor.

Note: in this case, the shingles are above the flashing and are less likely to leak. However, lifted shingles are prone to wind damage.

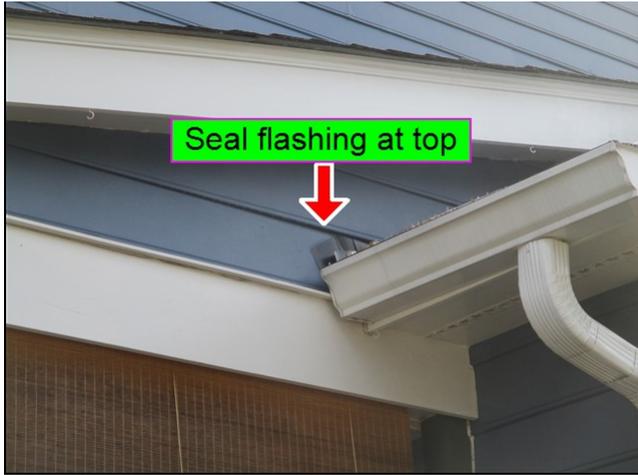
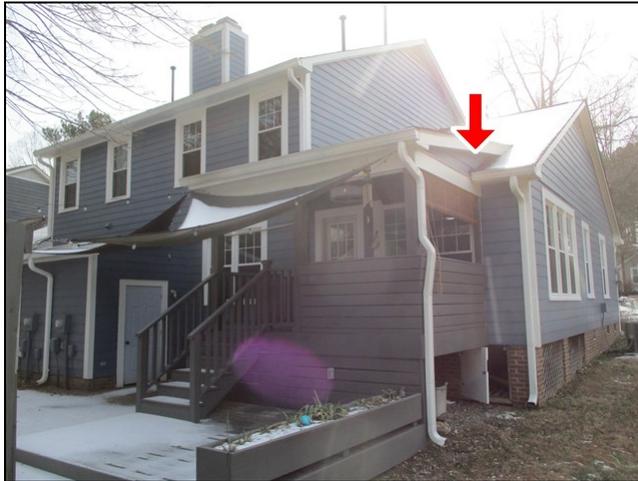
(1) The flashing of the lower left hand roof/s is surface mounted at the outer edge, next to the covered porch. The flashing should be woven under the shingles at the bottom and ideally would be tucked in behind the siding at the top (the siding should lap over the top of the flashing). The flashing should and does run the entire length of the roof and has been let out at the outer edge of the roof to daylight (meaning the edge of the flashing should be visible). In some cases, with different types of siding and roof angles it can be difficult to properly tuck the siding in a normal manner, at the top. The exposed surface mounted flashing should be sealed with caulk at the exposed top edge. This will create a seal, to prevent water entry, but this also creates a maintenance issue; the caulk must be checked and re-sealed/touched up periodically. Recommend repairs by a qualified roofing contractor (this flashing edge should be sealed with an approved exterior grade roofing material).

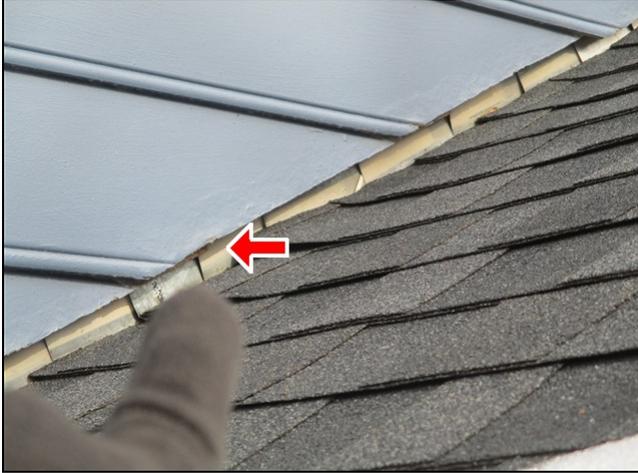
(6) Noted un-painted or partially painted siding in the following locations, including but not limited to:

2.0 Item 5 (Picture) siding above kitchen roof

This siding needs to be caulked and painted. Most manufactures require primed siding to be painted within 180 days of installation. Paint protects wood and other materials from the elements. Moisture exposure can lead to decay or deterioration. Recommend this exposed primed siding be caulked and painted.

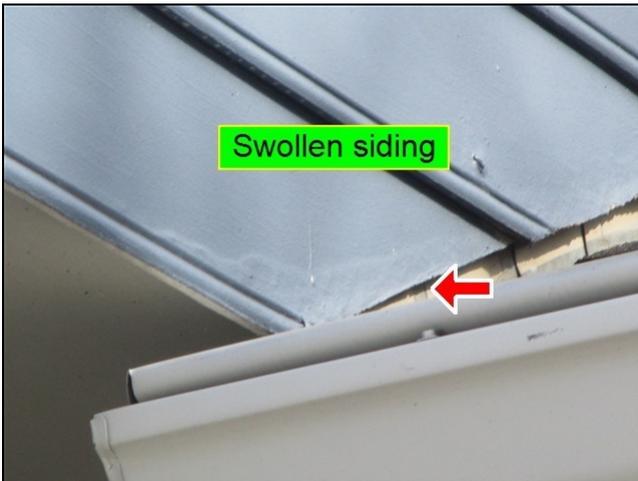
- 1.)the bottom piece of siding at the kitchen roof (next to the porch ceiling) has decay on the cut end (photo #7,8&9)
- 2.)The chimney has loose and/or damaged siding present. The bottoms of the corner boards are breaking down at the cut edge (likely caused by water absorption due to lack of paint). (photo #10)
- 3.)at the right side of the shed: there is gaping at the repairs, un-painted siding and damage near the base. (photo #11)
- 4.)decay is present at the base of the door on the shed (photo #12)
- 6.)at the base of the front porch columns (photo #13)

2.0 Item 8 (Picture) above kitchen

Any opening in the veneer can be a potential entry point for moisture. Recommend the damaged pieces of siding be replaced.

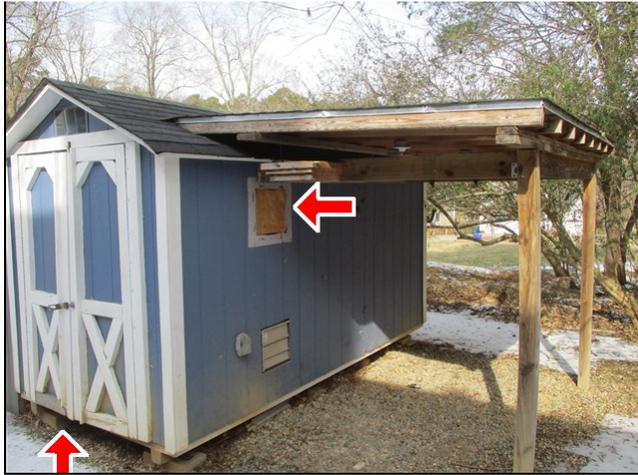
2.0 Item 11 (Picture) shed

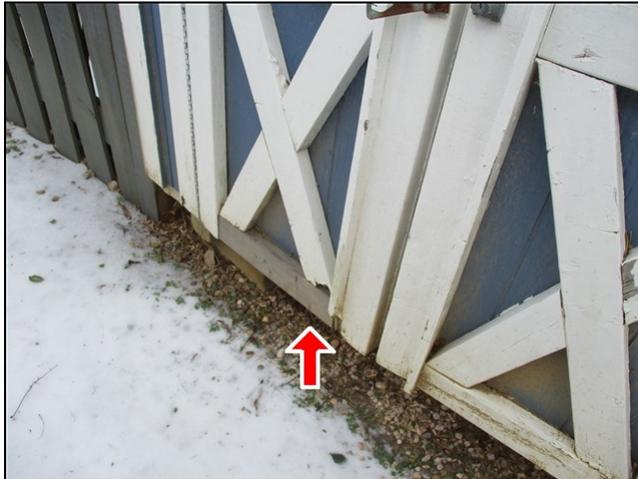
2.0 Item 12 (Picture) shed door

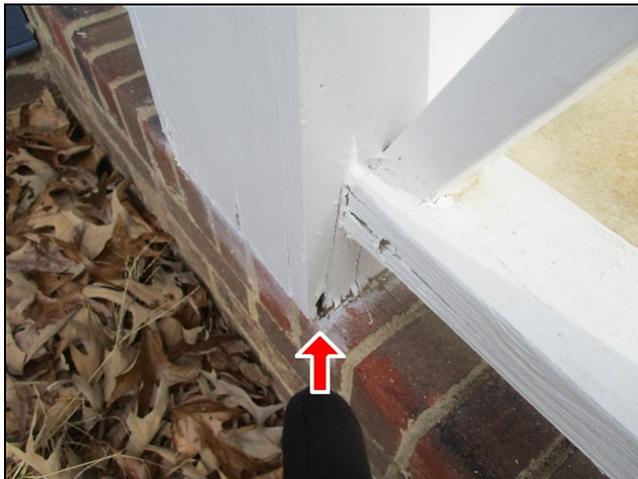
2.0 Item 13 (Picture) porch column

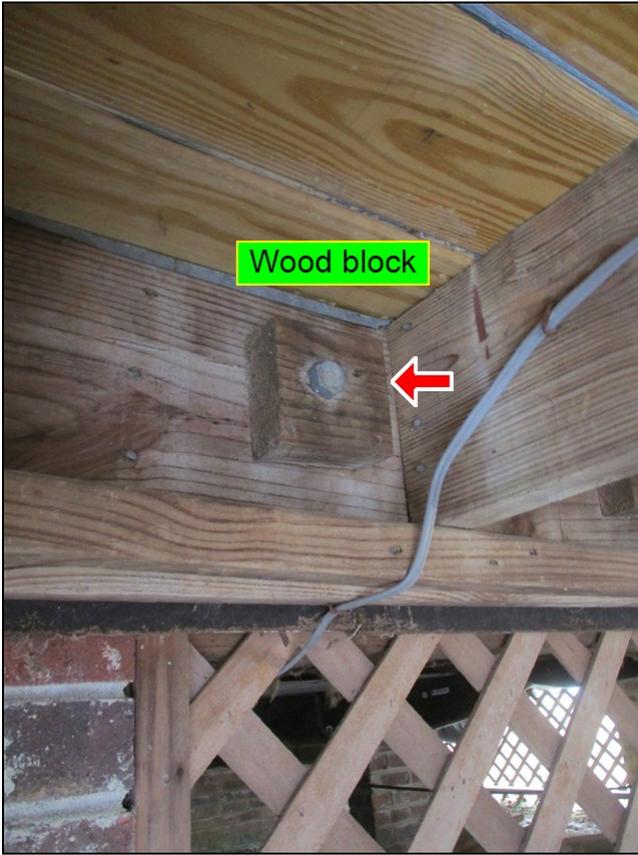
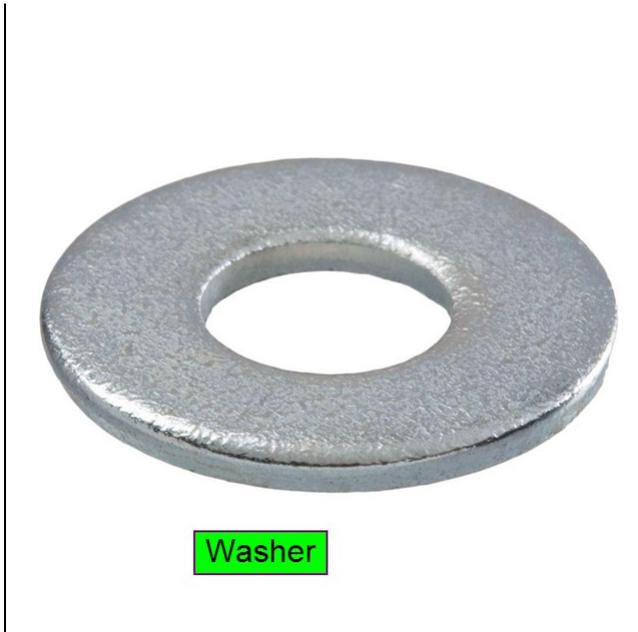
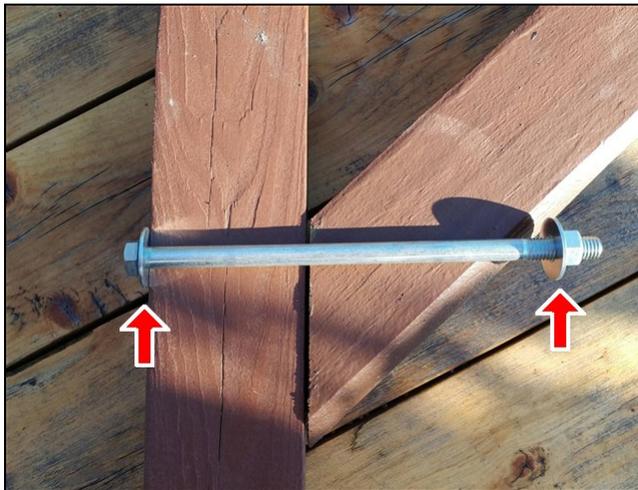
(3) The deck band/rim is attached to the home with bolts. On the subject home, makeshift wood washers are present. These wood washers appear to be functioning (at this time). However, wood washers can shrink, crack, wear and/or fail in exposure. This is a not standard installation. With a 5/8 galvanized bolt it is expected that two steel washers be used. One on the hex head end and a second at the nut side of the bolt (example Photo #5). Galvanized steel is less susceptible to the elements and wear (in exposure). Recommend repairs as needed.

2.3 Item 3 (Picture) wood washer?

2.3 Item 4 (Picture) steel washer

2.3 Item 5 (Picture) washer

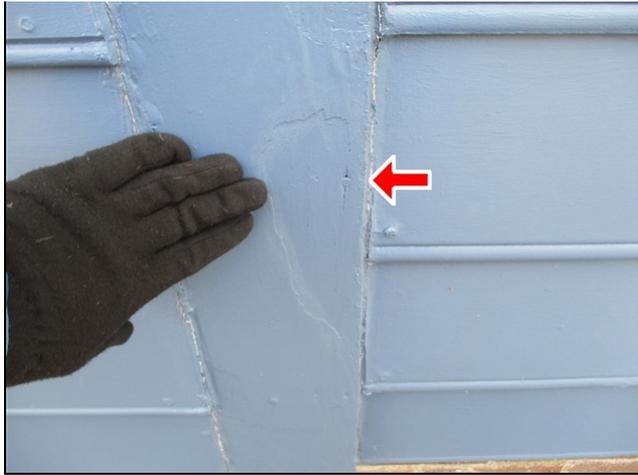
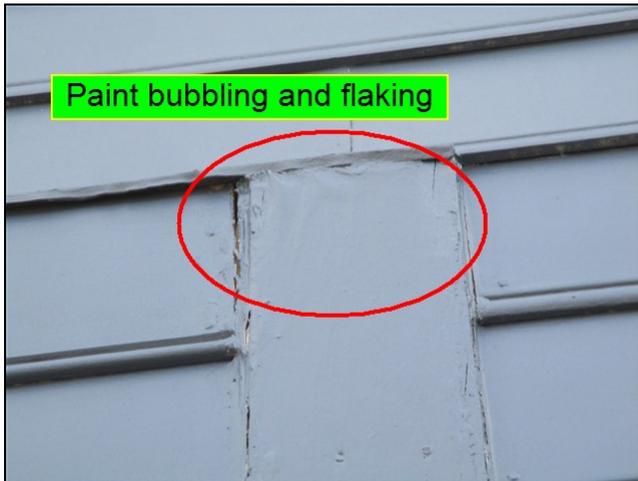
3.1 Item 1 (Picture) vertical board

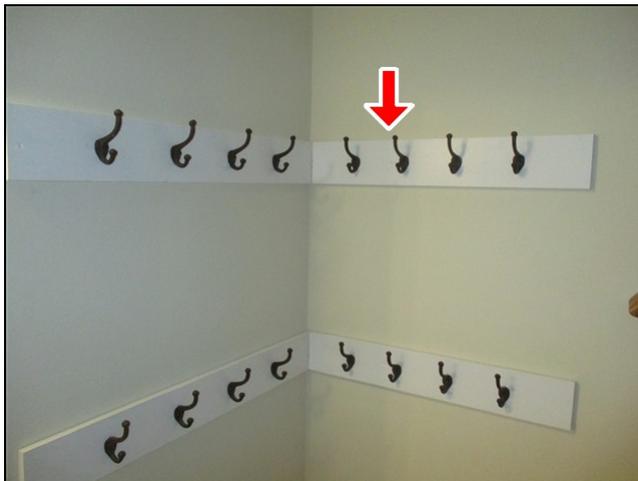
3.1 Item 6 (Picture)

(5) FYI: Noted a row of hangers at the base of the stairs. The hangers take advantage of the unused wall space for storage. However, this location is an area that is more susceptible to falls, from the stairway. The hanger could cause addition injuries (if a fall was to occur in this location). The buyer should evaluate and decide whether or not they will retain the hanger racks, after considering all safety concerns.

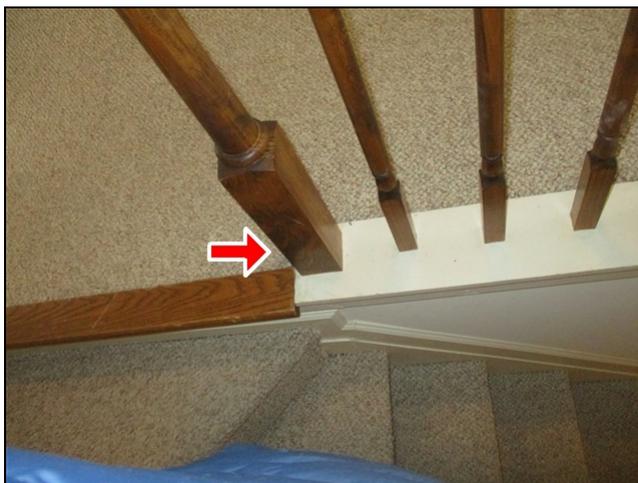
(1) There is a little bit of movement in the base cap of the railing at the second floor. This cap can be secure to the floor with screws or nails as needed.

3.3 Item 1 (Picture) hallway railing

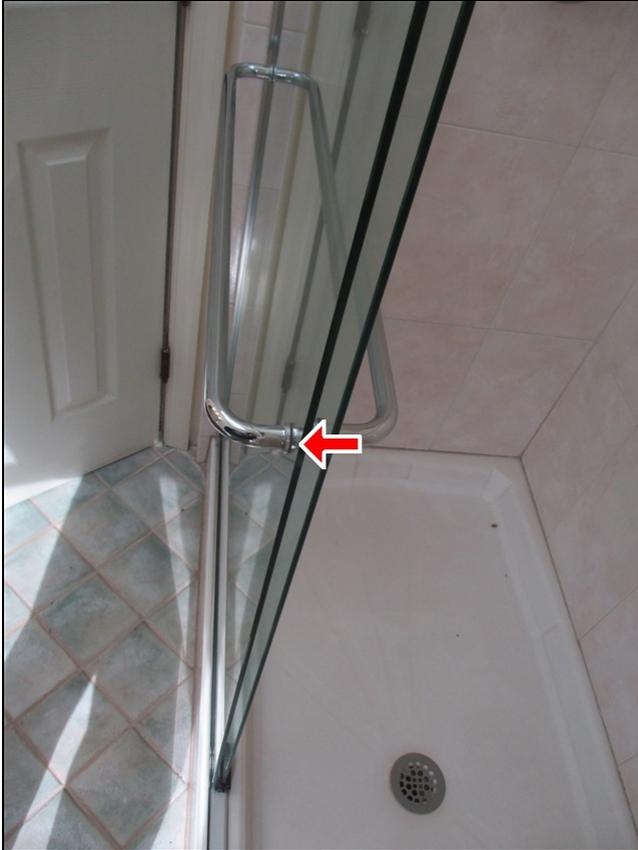
3.5 Item 4 (Picture)

- 1.)the front door on the shower enclosure is difficult to open and close

Dragging carpet or hard surfaces can put stress on the door's handle and hinges. Recommend this door be adjusted so it will function as intended.

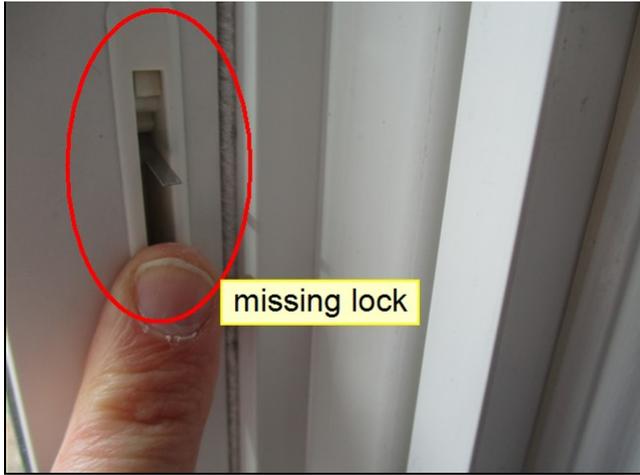
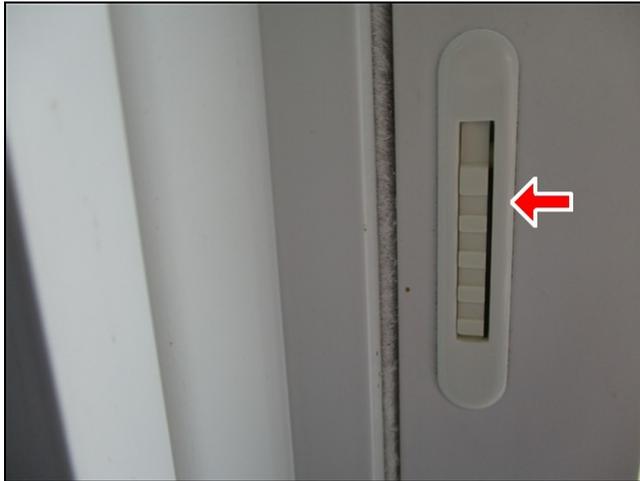
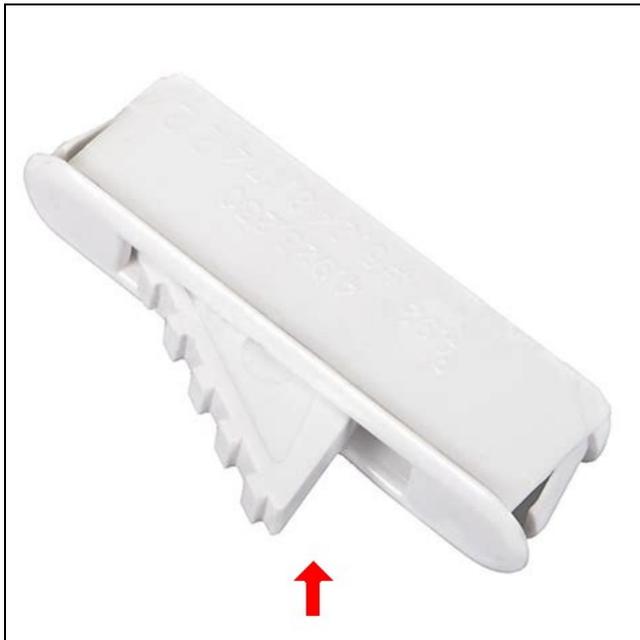
(4) The sunroom windows have opening restrictor (child safety locks). One of the center windows has a damaged or missing restrictor lock (these windows have two on each sash). These locks block the windows from being opened by a child, in situations where a child/children could fall and injure themselves. Certain windows may not need these locks depending on the size of the window, distance above the floor, and the distance of the window above the grade. Most replacement windows have these restrictor/locks whether they are required or not. They are also referred to as "night vents" which can be used as a security feature, if you were to leave your windows cracked open in the evening. (though I would not expect these tilt locks could keep out an intruder).

3.6 Item 7 (Picture) Example lock

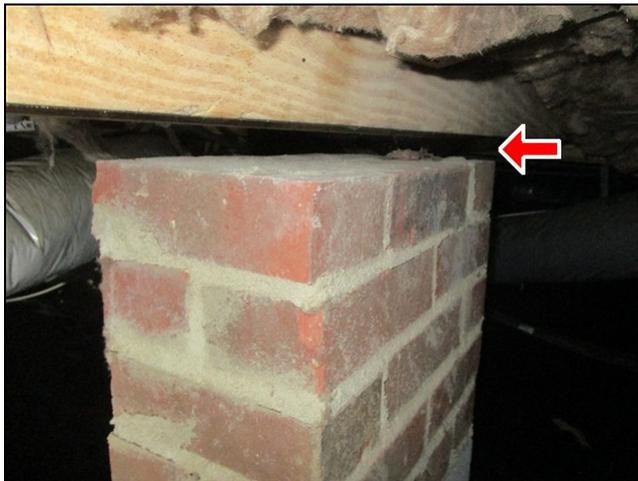
4.2 Item 2 (Picture) no blocking present

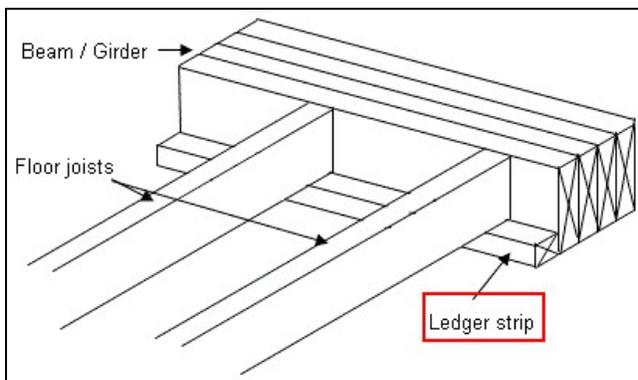
4.3 Item 1 (Picture)

FYI: In some areas the ledger supports less than three nails below the joists. This is acceptable if the nails are a hand drive 16d. With gun nails four nails should be used because they are a 12d nail. 12d nails are a 1/4 of an inch shorter than a 16d nail. Extra nails can be added to the ledger directly below the joists to correct this issue.

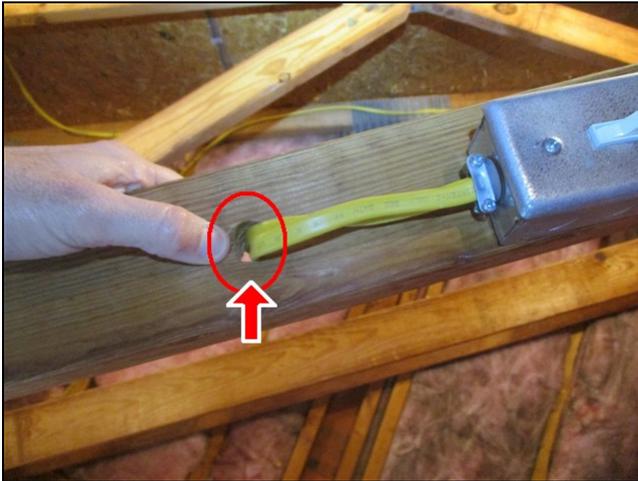
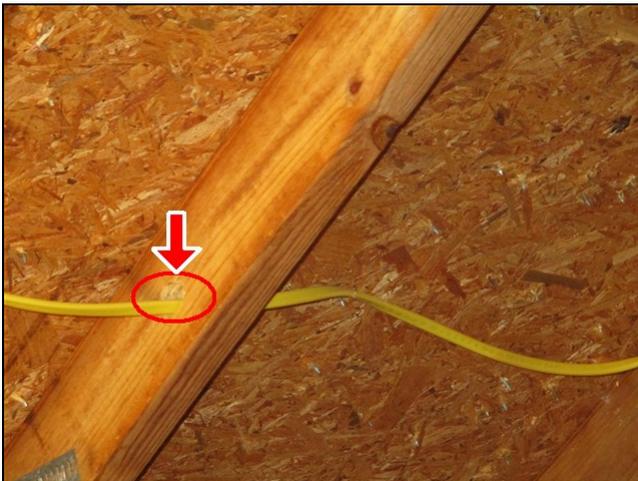
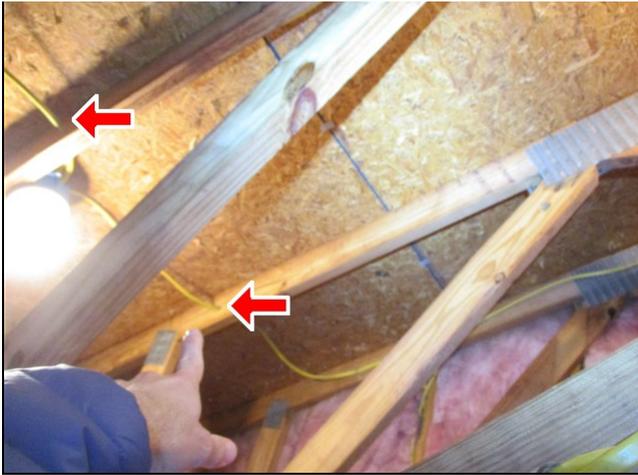
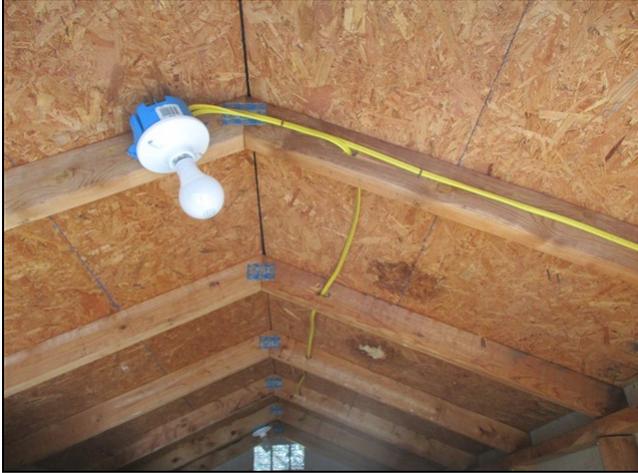
4.5 Item 1 (Picture) sunroom attic

4.5 Item 2 (Picture) top cord

4.5 Item 3 (Picture) top cord

4.5 Item 5 (Picture) storage shed

These trusses should be evaluated and repaired, as needed. Repairs to trusses not uncommon. However, trusses are engineered members and any repairs to a truss must have a repair letter stamped by a licensed engineer. Recommend an engineer's letter be provided for this repair. An engineer should review the damage and specify repairs in a detailed letter. Once the repairs have been completed the licensed engineer can observe the repairs to ensure they have been performed properly, to confirm their adequacy.

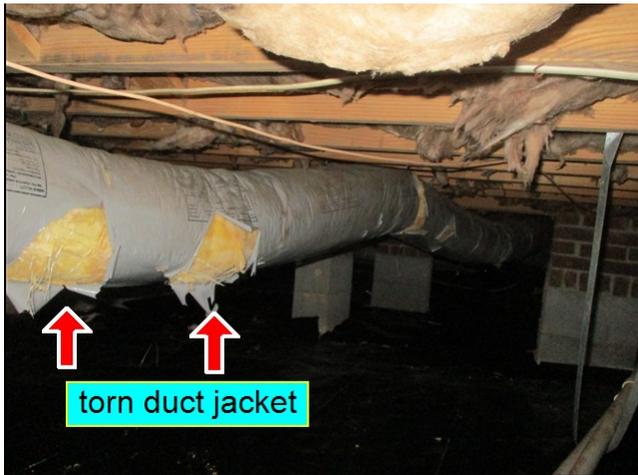
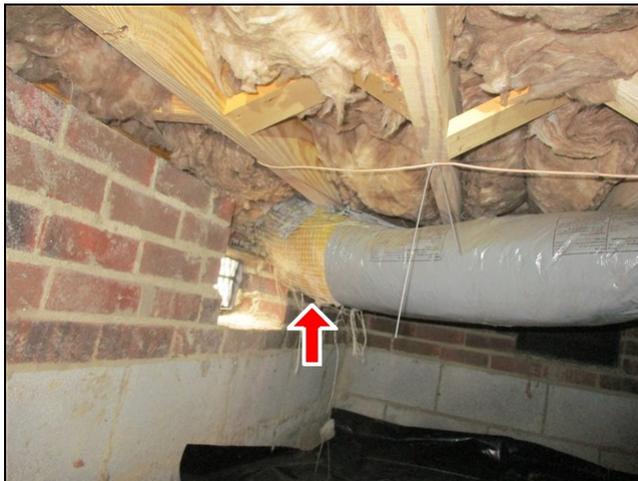
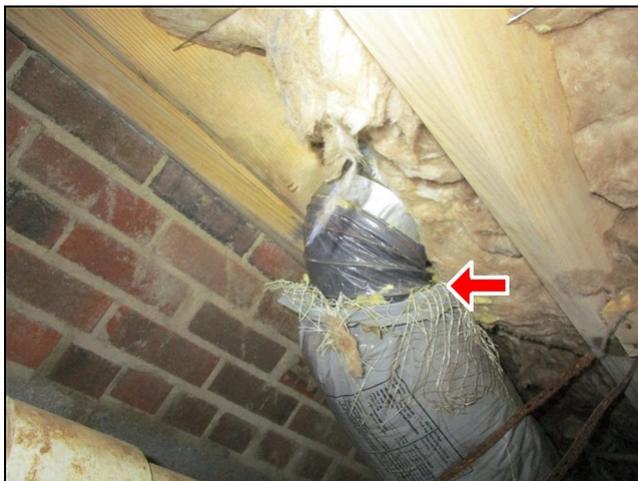
The realtor provided photos of repairs. However, the inspector did not verify the repairs on site and cannot confirm that every section of the damage duct was repaired (without an on site visit).

The duct needs to be repaired. This should be repaired with a rated HVAC tape.

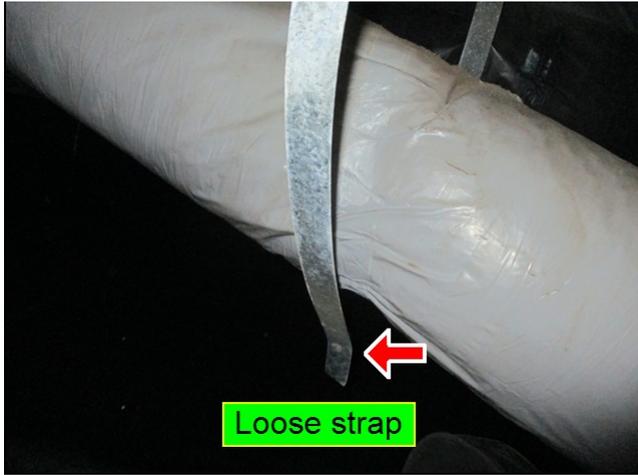
(7) The supply ductwork near the crawlspace metal HVAC distribution box has a loose/disconnected support strap. This can lead to duct sagging at the unsupported location. This duct should have support to prevent sagging. Recommend loose support strap be reattached. A licensed HVAC contractor should install proper support to the duct work, as needed.

7.3 Item 10 (Picture) loose strap

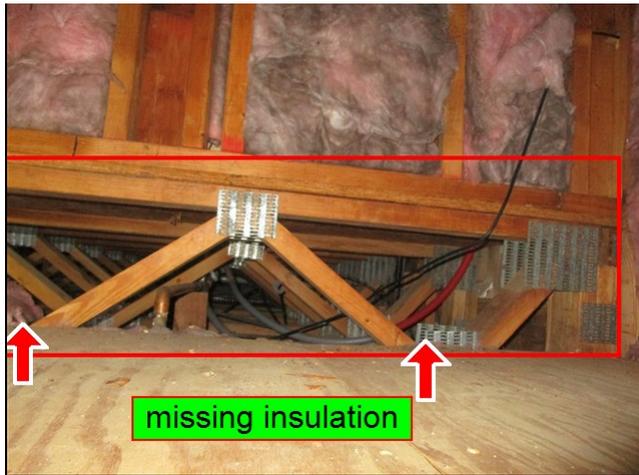
8.1 Item 1 (Picture)

Noted a missing section of insulation at the living ceiling/floor truss, next to the sunroom attic platform. This is a void in the insulation envelop. Unconditioned air from the sunroom attic space can flow into the floor system between the living room ceiling and the second floor, a source of energy loss. This end truss, next to the platform, should be filled in with insulation. Recommend repairs by a qualified contractor.

Note: This is a easy repair that would greatly improve the homes insulation system.

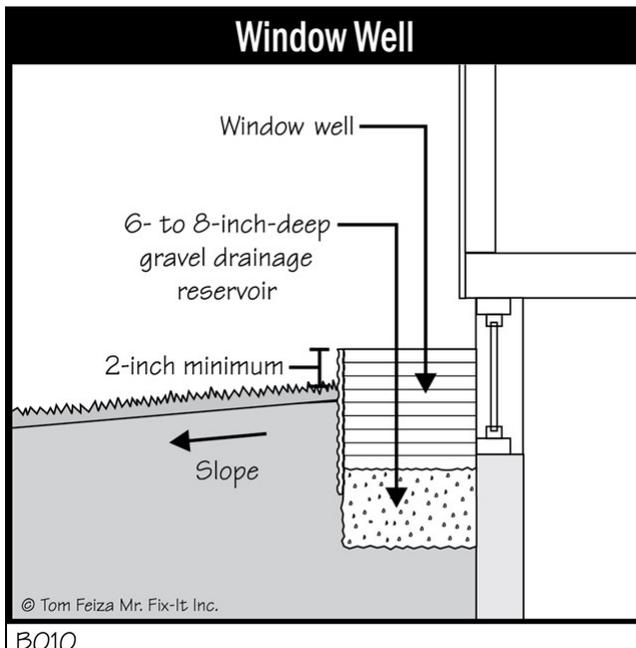
8.3 Item 1 (Picture) proper well

A half-round window well was present at the front foundation vent installed. It is recommended that the dirt inside the well should be replaced with approximately four inches of gravel. A couple of inches clearance between gravel and vent opening is recommended.

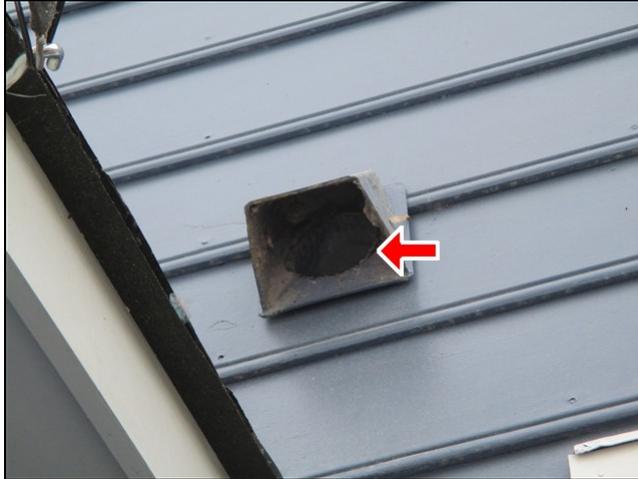
8.4 Item 1 (Picture)

(1) The flap on the exhaust cap is missing, above the storage room roof. A missing flap will allow unconditioned air into the exhaust pipe. This can lead to energy loss and potentially condensation, in the summer months. An open exhaust cap can also allow unobstructed access into the pipe for insects and animals. The flap on the exhaust vent cap should be replaced. Recommend further investigation and repairs to correct this issue by a qualified contractor.

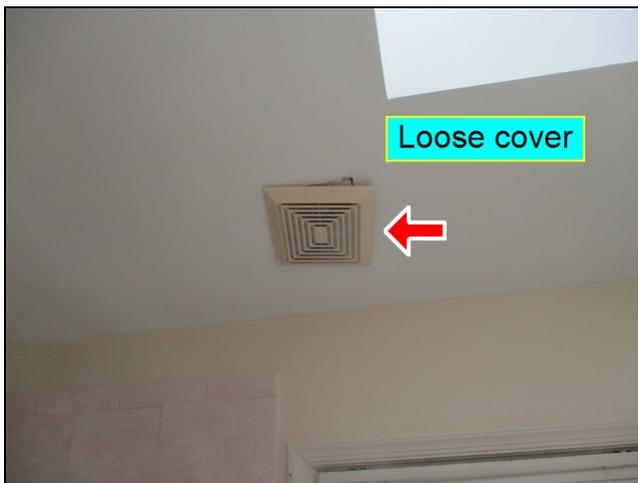
8.4 Item 2 (Picture)

(3) The hall bath exhaust fan cover is loose. This cover should be secured to the ceiling. Recommend the cover be secured to the fan box or replaced, as needed. A qualified contractor can perform this repair.

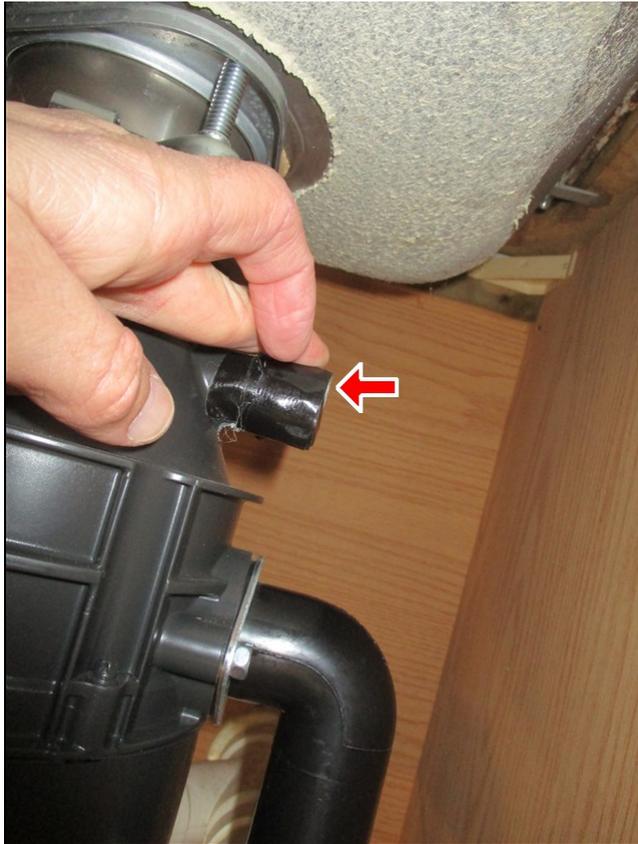
9.4 Item 1 (Picture)

The dishwasher hose connection stub, on the disposal, is covered with electrical tape. This connection tube/pipe normally should have a plug in place (is sealed during manufacturing). If the plug has been removed the connector should be capped with an approved plumbing material (not electrical tape). Tape can fail, wear and is not an acceptable plumbing sealant material. Recommend further investigation and repairs as needed.

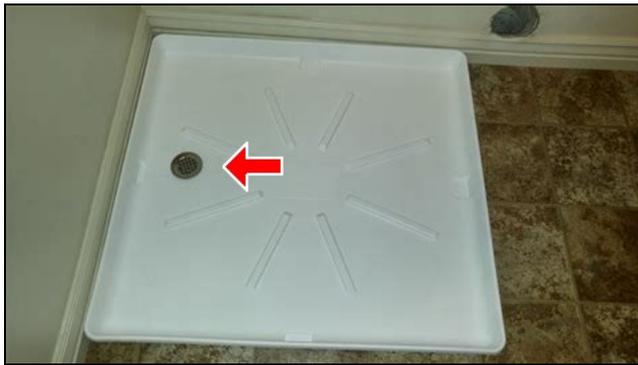
9.6 Item 2 (Picture)

(2) The Washer pan in the laundry room on the top floor is missing. This pan catches water, if the washer was to malfunction or leak, and would direct the water to the outside through a drain. With some of the newer models a standard pan will not work. In these cases a custom pan can be fabricated using sheet metal. Recommend repairs as needed.
