# ***Cornerstone Inspection***

## **Property Inspection Report**

***689 Woodland Dr, Arroyo Grande, CA 93420***

***Date of Inspection: 10/31/2025 Time: 9:00 AM***

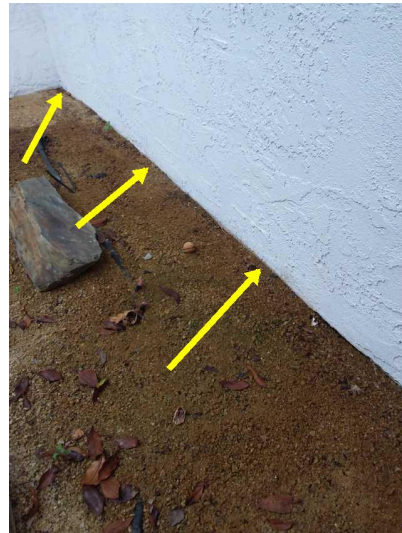
The soil is too high against the home at various areas around the home which should serviced.

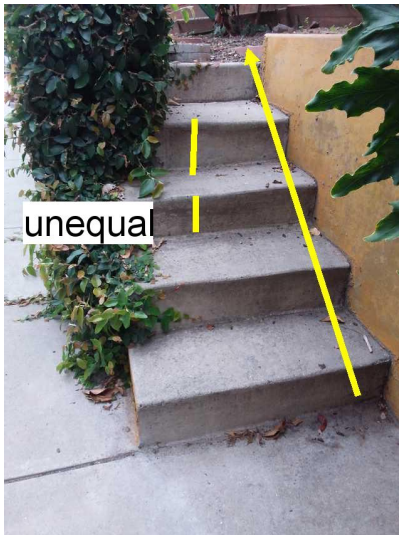
9.4. The width of the stairs is less than 36 inches, which does not meet current standards.

Current building standards require handrails to be installed on steps which have 4 or more risers, and particularly if children or the elderly visit or occupy this property.

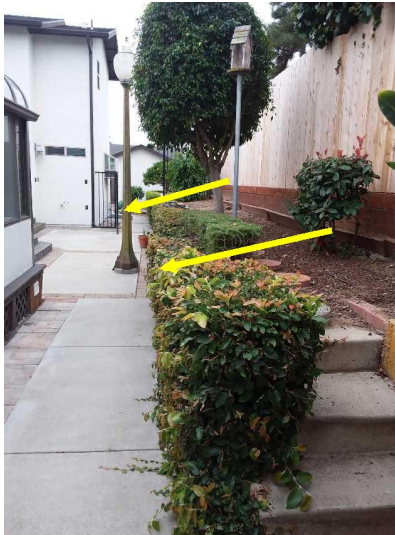
15.2. There are areas of this property that do not have guardrails, which are required for walk-offs greater than thirty inches, and appropriate precautions should be taken to safeguard children and the elderly.

There are areas of this property that do not have guardrails, which are required for walk-offs greater than thirty inches, and appropriate precautions should be taken to safeguard children and the elderly.

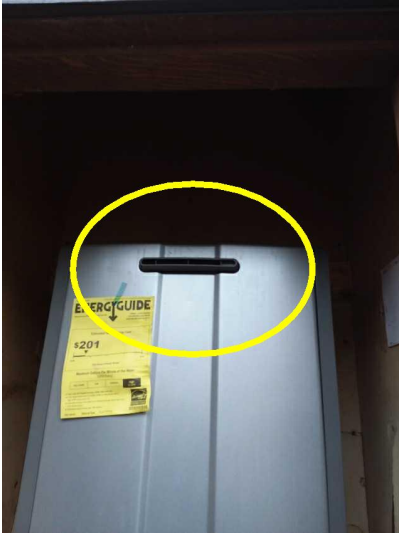
5.11. One vent pipe terminates in a closet which should be evaluated and serviced by a licensed specialist.

One vent pipe terminates in a closet which should be evaluated and serviced by a licensed specialist.

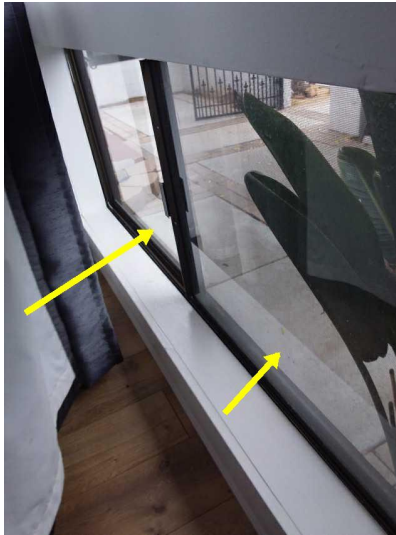
- 2.1. The living room is located adjacent to the main entry.
- 2.2. There's one or more windows installed within 18 inches of the finished floor that current standards require such windows to be tempered or safety glass.

There's one or more windows installed within 18 inches of the finished floor that current standards require such windows to be tempered or safety glass.

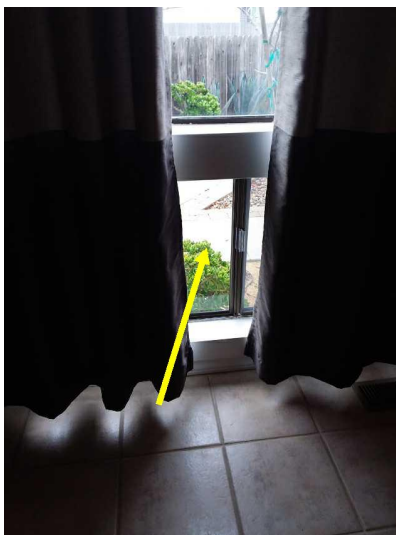
3.3. There's one or more windows installed within 18 inches of the finished floor that current standards require such windows to be tempered or safety glass.

There's one or more windows installed within 18 inches of the finished floor that current standards require such windows to be tempered or safety glass.

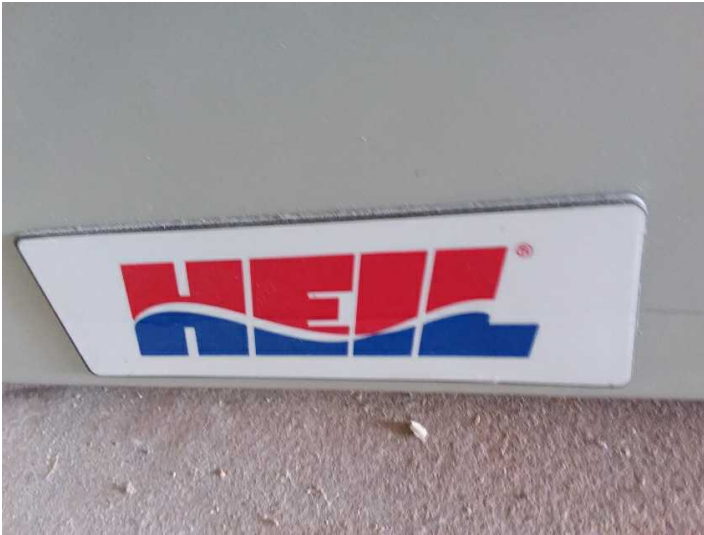
1.9. The furnace is functional. However, it is beyond the commonly accepted design life of twenty years, and will need to be monitored more closely for evidence of metal fatigue. We recommend that you have it serviced and evaluated by an HVAC contractor prior to the close of the inspection period.

Central heat is provided by a forced-air furnace that is located in the garage.
