# **Cornerstone Inspection**

## **Property Inspection Report**

**689 Woodland Dr, Arroyo Grande, CA 93420**  
**Inspection prepared for: Nancy Lacsamana**  
**Real Estate Agent: Shannon Bowdey -**

**Date of Inspection: 3/11/2025 Time: 9:00 AM**  
**Age of Home: 1976 Size: 2954**  
**Order ID: 11854**

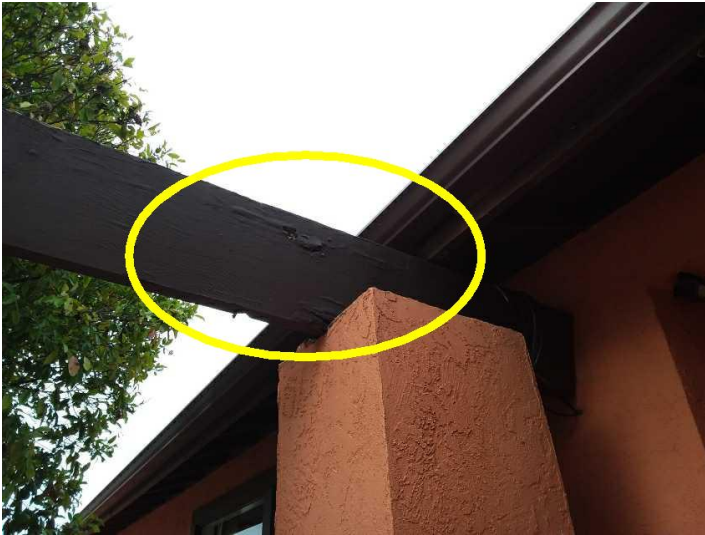
The patio roof-line or beam is deformed and should be evaluated by a licensed specialist such as a framing contractor.

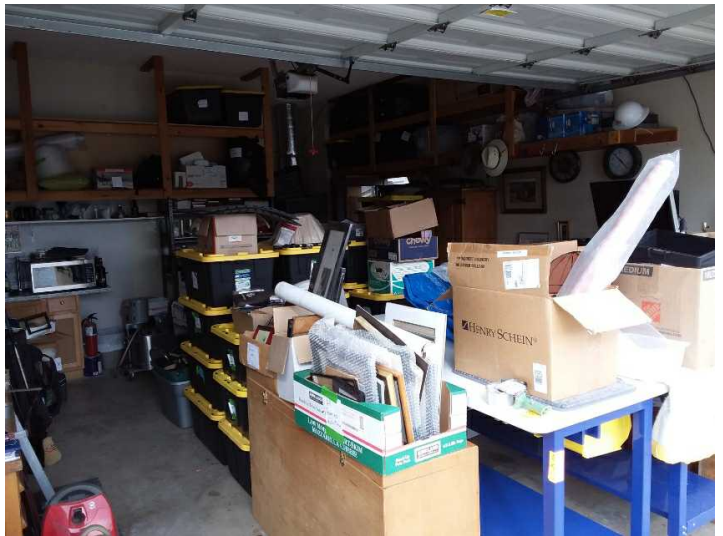
The garage is too full to permit a clear view of the entire slab and other components of the garage.
