Service: Pre-Listing Inspection

Prepared for: Amy Gulden

Aaron McBride

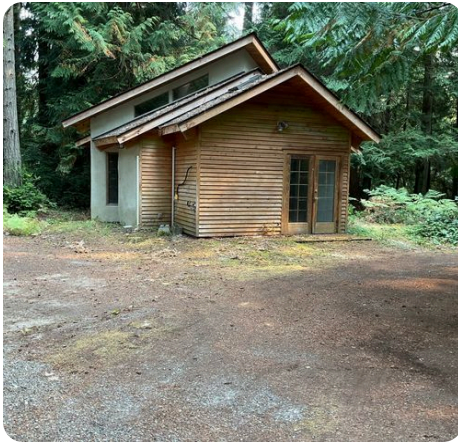
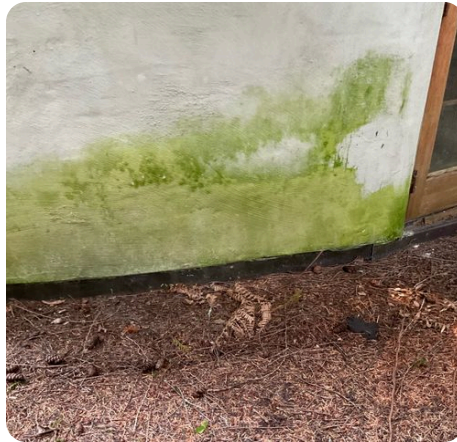
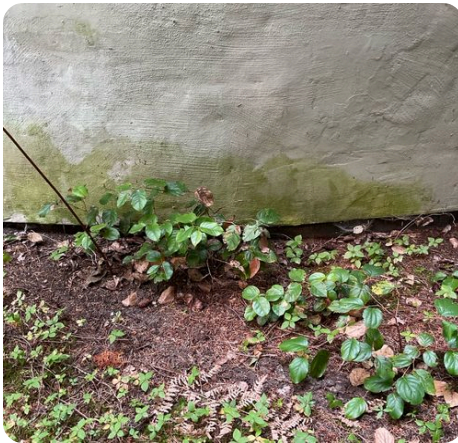
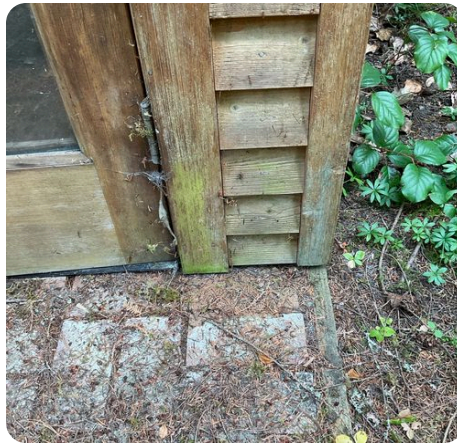
📍 Location: Detached Studio

The presence of mildew and lichen on the siding can indicate excessive moisture levels, which may lead to degradation of the siding material over time. It is recommended to evaluate and address the moisture source to prevent further growth and potential damage. A qualified contractor can assist in properly cleaning and treating the affected areas to restore the exterior appearance of the property.

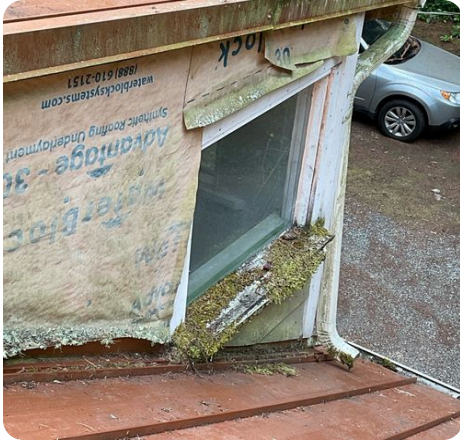
2 Unfinished Siding

The siding on the house appears to be unfinished. This can lead to moisture penetration, which may result in water damage and mold growth. It is recommended to evaluate and repair the unfinished siding to prevent further damage. A qualified siding contractor can help in completing the siding installation properly to ensure the protection of the exterior walls.

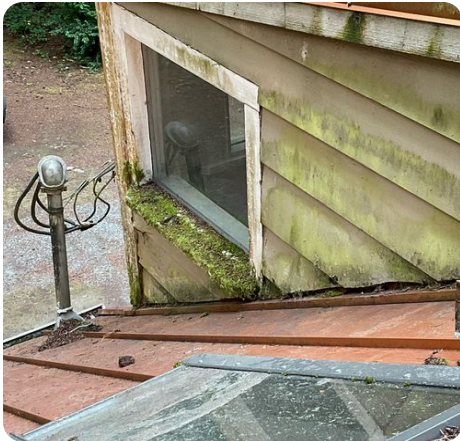
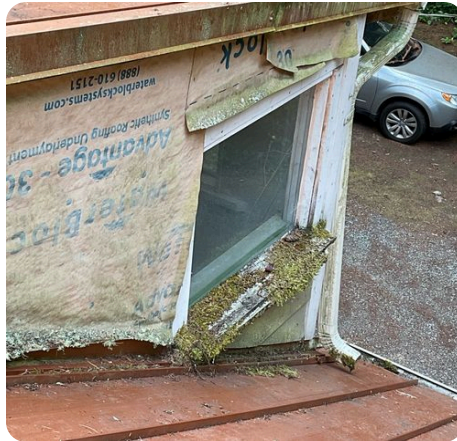
3 Trim With Moss Growth

The trim on the exterior of the property shows signs of deterioration and moss growth. It is recommended to address this issue promptly to prevent further damage and maintain the aesthetic appeal of the home. A qualified carpenter or general contractor can evaluate the extent of the damage and repair or replace the trim as needed. To prevent future moss growth, ensure proper drainage and sunlight exposure in the area.

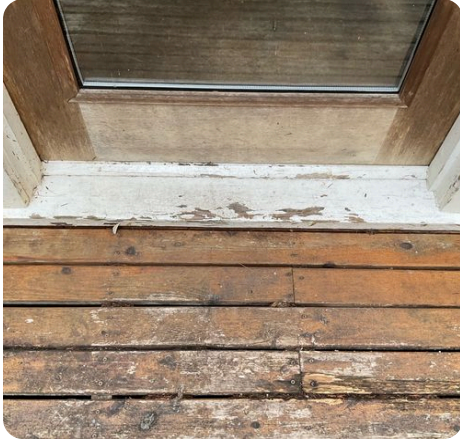
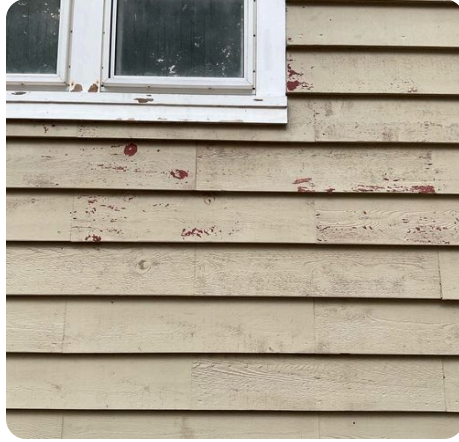
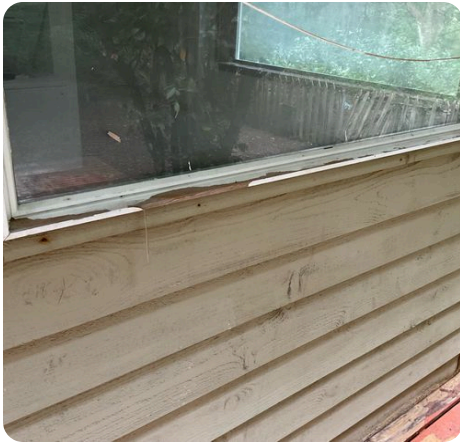
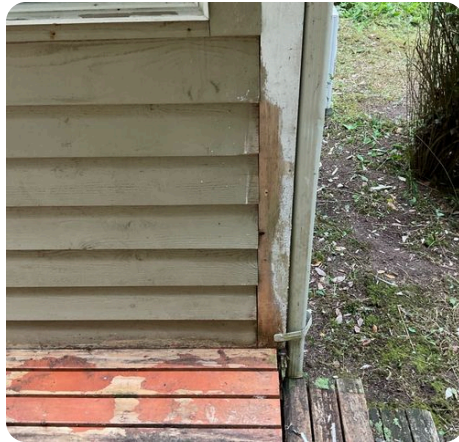
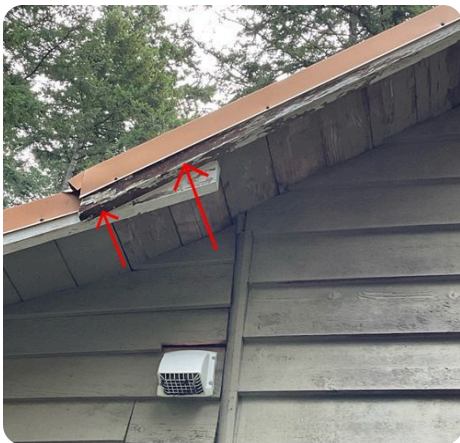
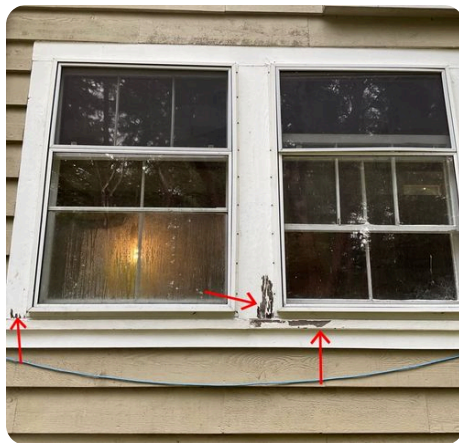
4 Exterior Touchup Paint

The exterior of the property shows signs of wear and tear with areas of chipped or faded paint observed. It is recommended to evaluate and repair the affected areas by touching up the paint to maintain the aesthetics and protect the surfaces from weather damage. Hiring a qualified painter for the paint touchup is advised for a professional finish.

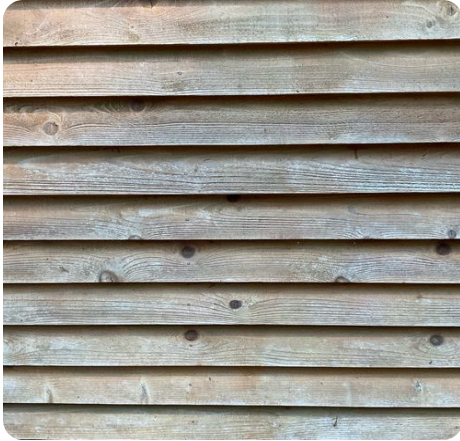
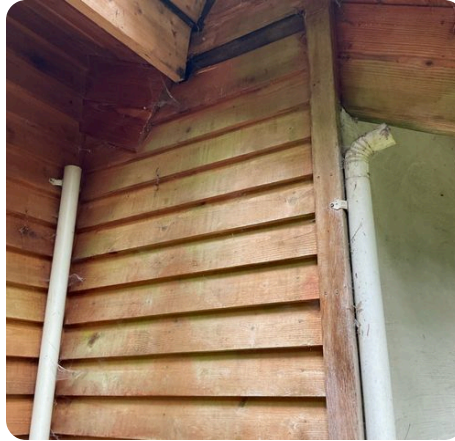
5 Faded Sealant On Exterior Surface

The exterior sealant on the surfaces is faded. This can lead to reduced protection against moisture intrusion and may result in damage to the underlying structure. It is recommended to evaluate the sealant and reapply as necessary to maintain the integrity and weather resistance of the surfaces. A qualified contractor can assist with this task.

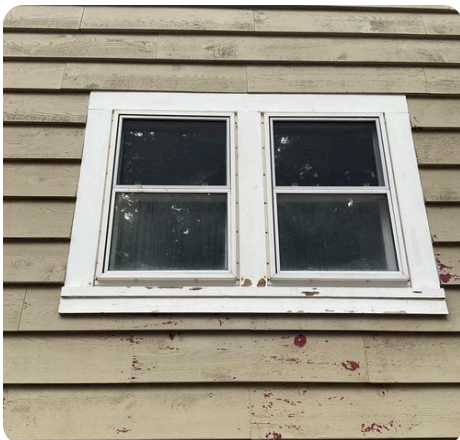
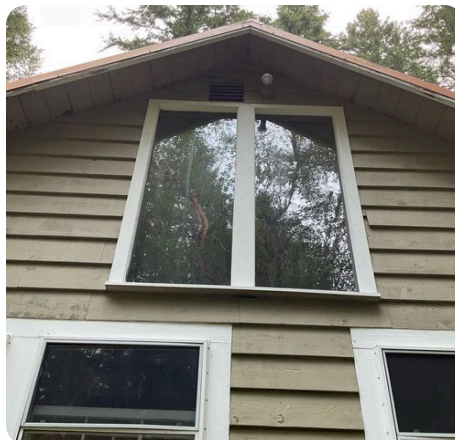
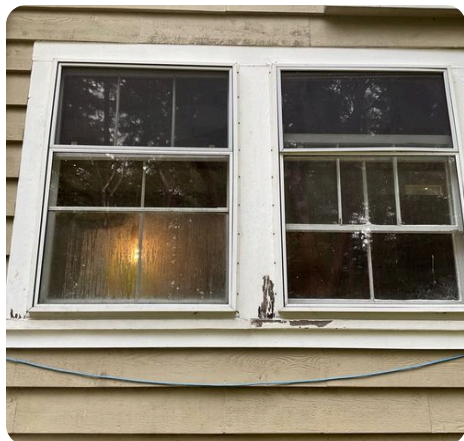
6 Failed Seals On Storm Windows

The storm windows show signs of a failed seals. This can lead to decreased energy efficiency and potential water leaks. It is recommended to replace the seal or consider recaulking around the edges to prevent further damage.

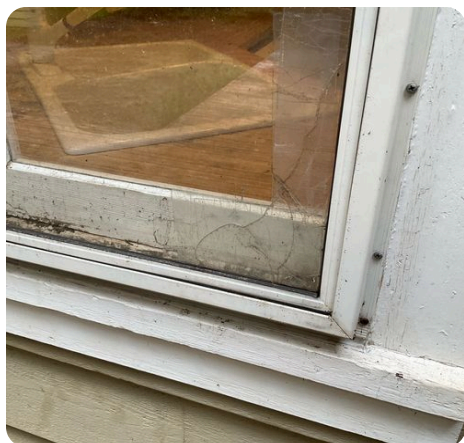
7 Broken Glass Pane

There is a broken window pane at the structure. Replacing the glass pane is needed to provide proper security and for preventative safety measures. Repairs are recommended by a qualified glass company.

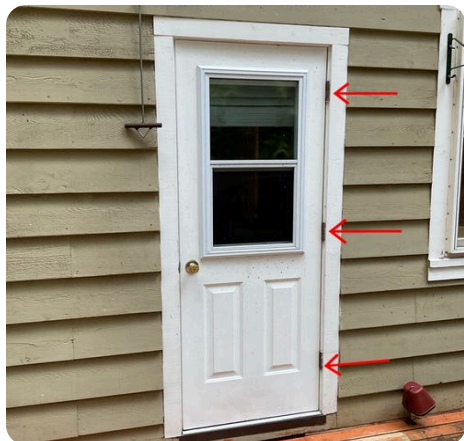
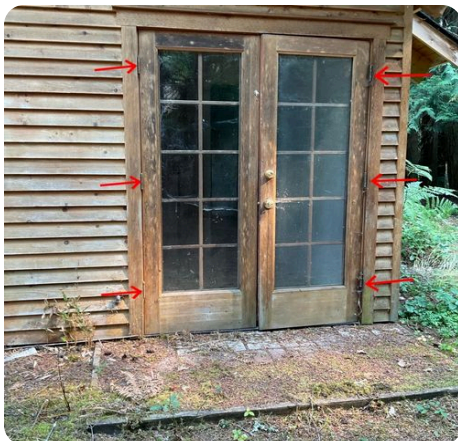
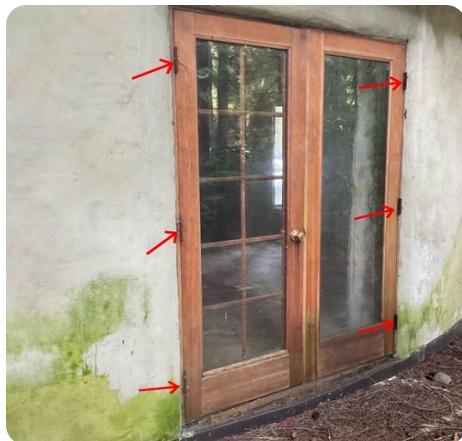
8 Door Hinge Pins Exposed

The exterior door(s) appear to be functional; however, further investigation may be needed to determine if the doors were properly installed. By having the hinges on the exterior of the door, removal of the pins could allow the doors to be pulled open and access be gained. Contact a qualified trade for evaluations.

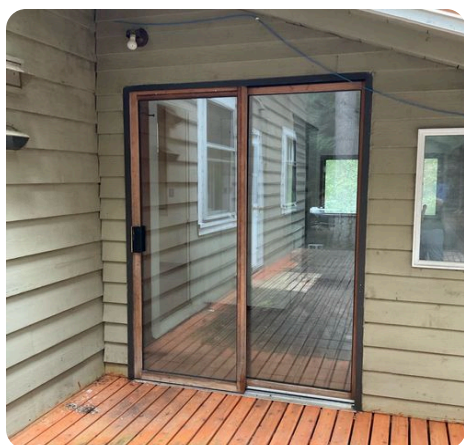
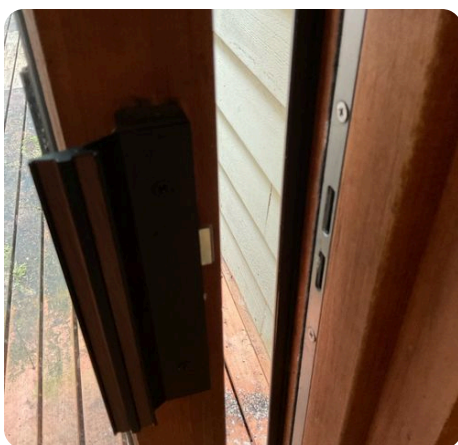
9 Sliding Glass Door Lock Damage

The sliding glass door lock is damaged. Evaluate and repair the lock to ensure proper security and functionality. It is recommended to consult a qualified locksmith to repair or replace the damaged lock for optimal safety.

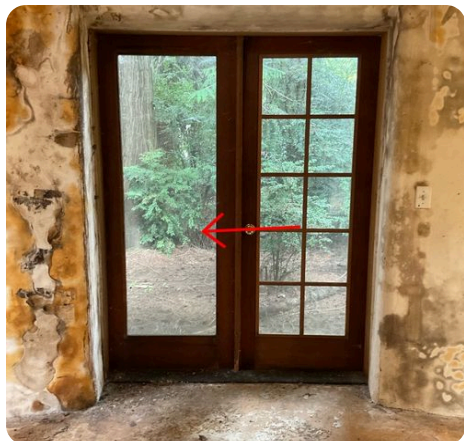
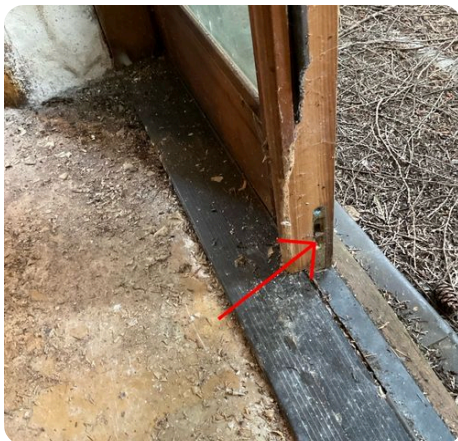
10 French Door Latch Issue

The French door latch is not functioning properly, which can impact security and ease of access. It is recommended to evaluate and repair the latch to ensure the door can be securely closed and locked when needed. Seeking the expertise of a qualified locksmith or door repair specialist can help in resolving this issue effectively.

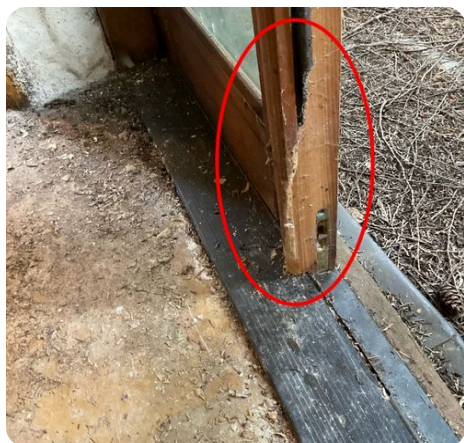
11 Damaged Weather Stripping

Damaged or missing weather stripping was noted at the exterior door. Having the affected weather stripping replaced is recommended to help prevent moisture penetration and heat loss.

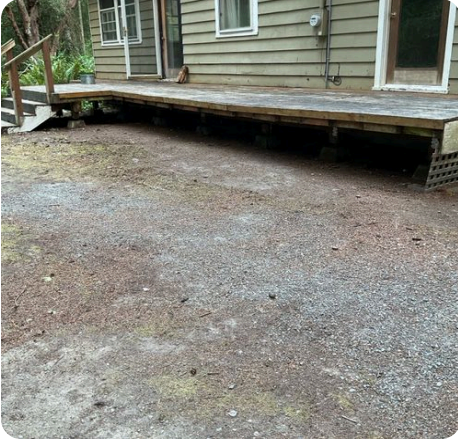
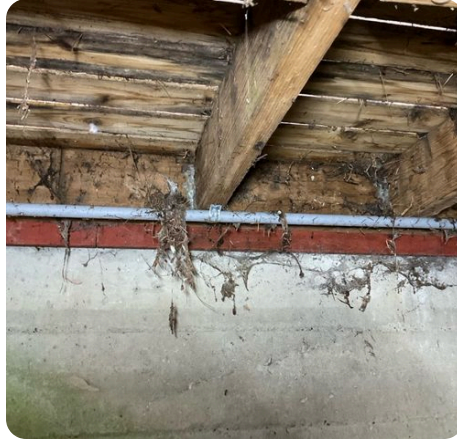
12 Lag Bolts Not Present

The current structure does not appear to be lag bolted or positively anchored. Proper anchoring is essential for supporting both vertical and lateral loads, as nails or toe-nails are prone to withdrawal. It is recommended that all elevated structures be properly lag bolted as a preventative safety measure. Consult with your local jurisdiction department for current requirements and contact a qualified building contractor for repair estimates.

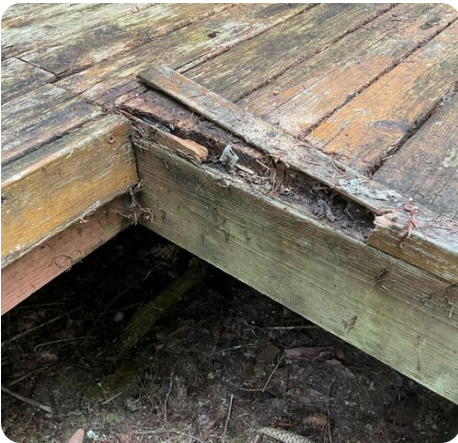
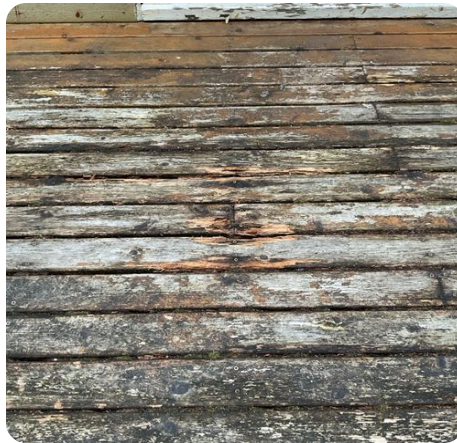
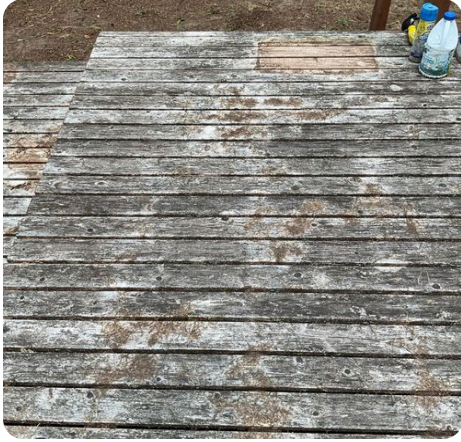
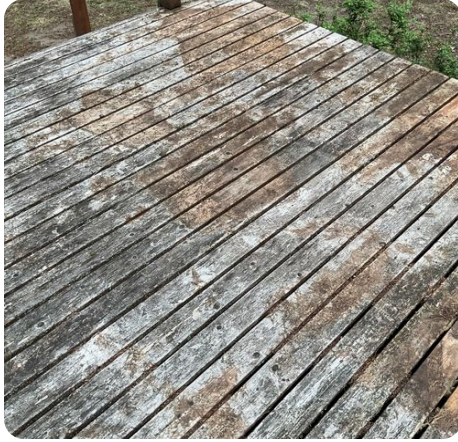
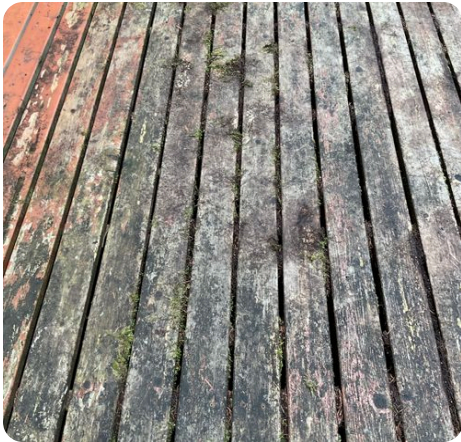
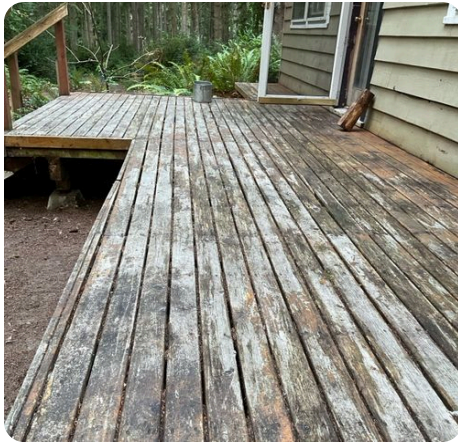
13 Deteriorated Deck Boards

The inspector noted that the surface is in need of repairs. There were some deteriorated boards noted. We recommend evaluating all of the decks and replacing the deteriorated boards to prevent any further issues. Any repairs should be completed by a qualified professional.

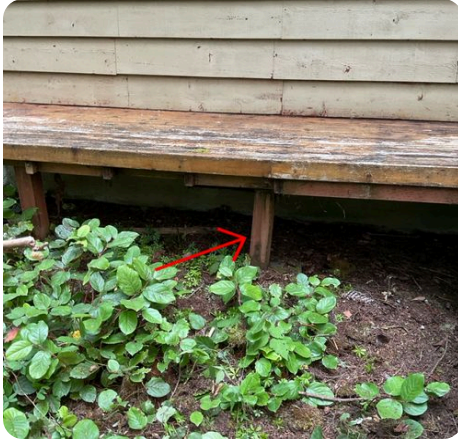
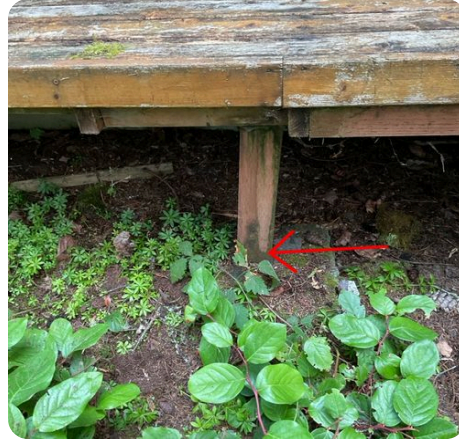
14 **Loose Post** **✚ Repairs Recommended**

The deck has a loose post. This issue can lead to structural instability and compromise the safety of the deck. It is recommended to evaluate and repair the post promptly to prevent any further damage or safety hazards. A qualified contractor should be hired to properly secure the post to ensure the stability of the deck.

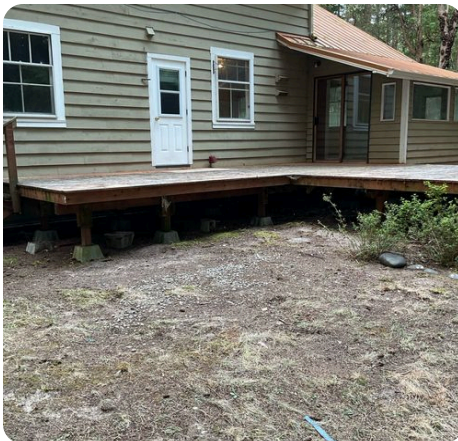
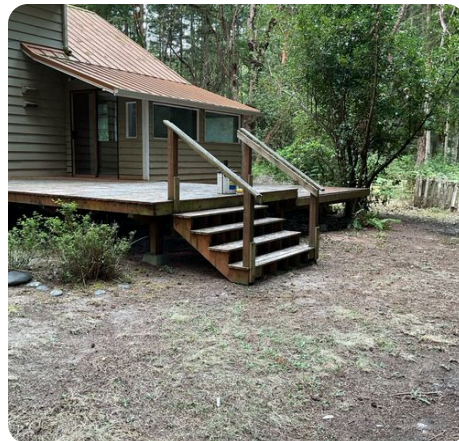
15 Railings Issue

The missing railings pose a safety hazard by not providing necessary support and fall protection. It is recommended to install railings in compliance with building codes to ensure the safety of occupants, especially in elevated areas. Evaluation and repair by a qualified contractor are advised to prevent accidents.

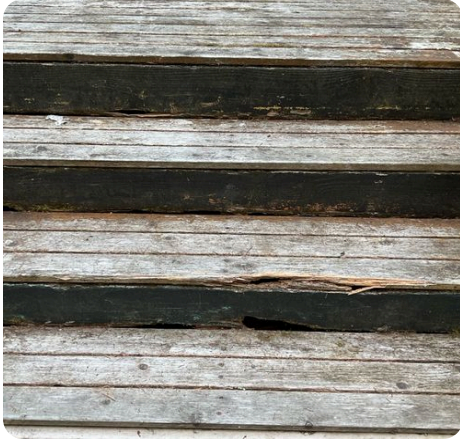
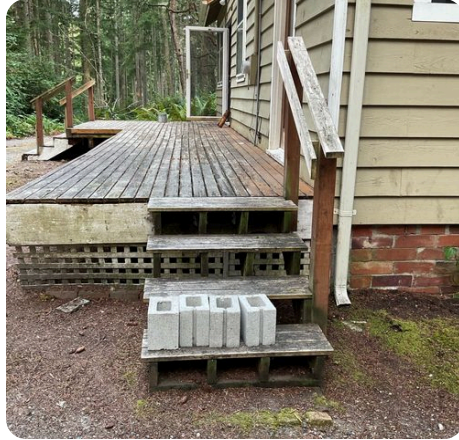
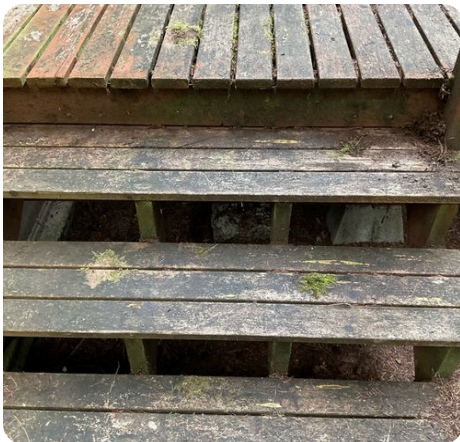
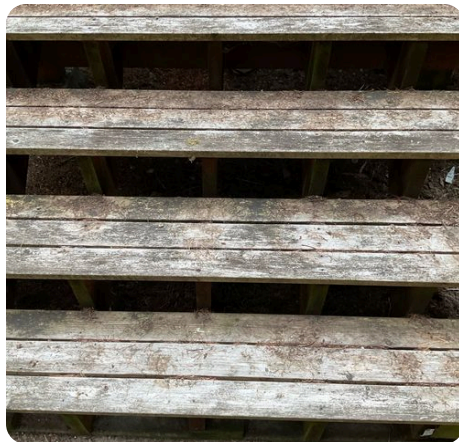
16 Damaged Steps

Location: Rear Deck, Front Deck

Damage to the steps was observed, which could present a safety hazard. It is important to have a qualified contractor evaluate and repair the damaged steps promptly to prevent accidents or further deterioration.

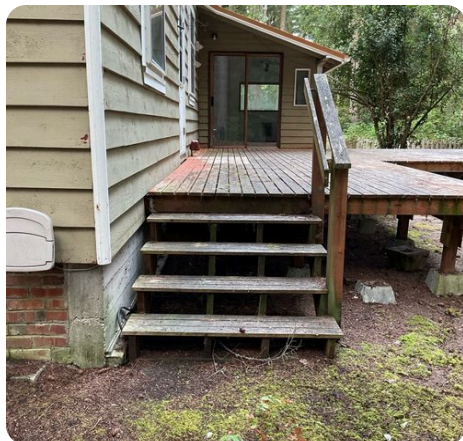
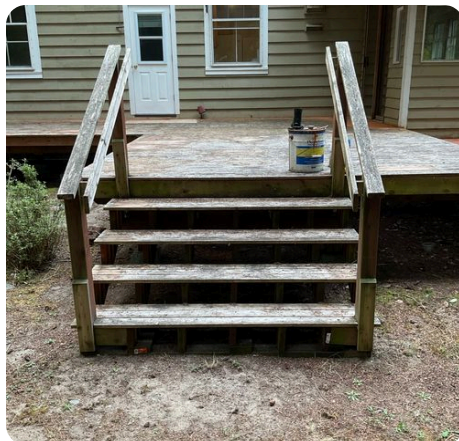
17 Weathered Steps Evaluation

📍 Location: Rear Deck

The steps on the deck appear weathered, which can impact their structural integrity and safety over time. It is recommended to have a qualified carpenter evaluate the steps for any signs of rot or damage. Repairing or replacing the weathered steps will help ensure the safety of individuals using the deck.

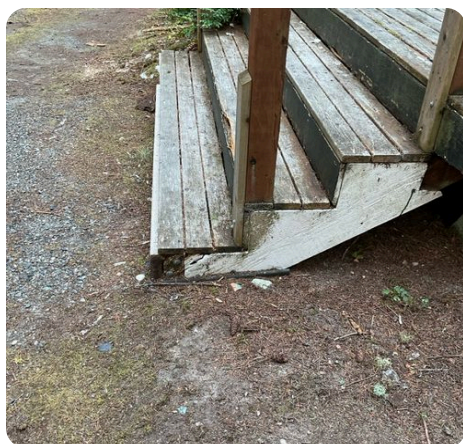
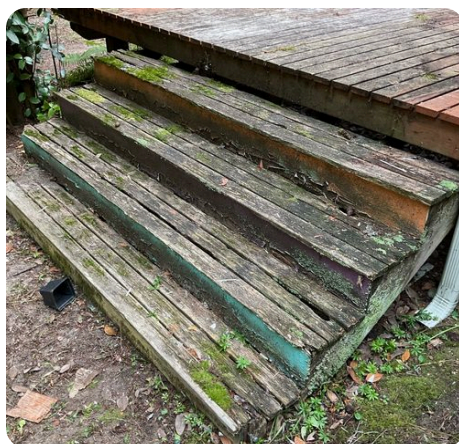
18 Wood/Ground Contact

The front and back deck steps are in contact with the ground beneath them. This is a conducive condition that can lead to pest infestation. There should generally be at least 4-6 inches of clearance between non-pressure treated wood and the ground to prevent moisture wicking and deterioration. No deterioration appeared to have occurred thus far; however, providing clearance would assist in preventing future deterioration.

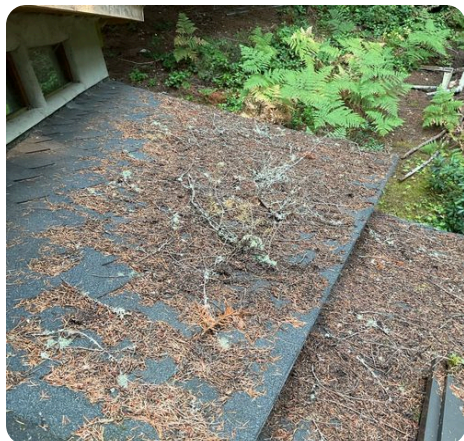
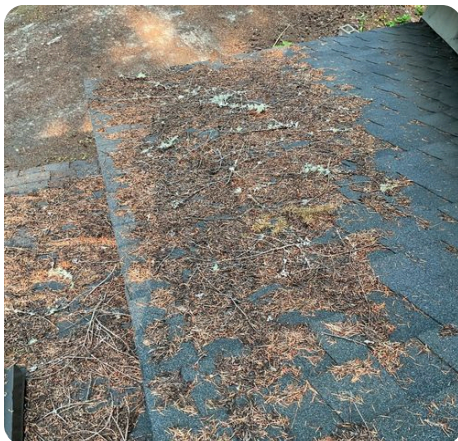
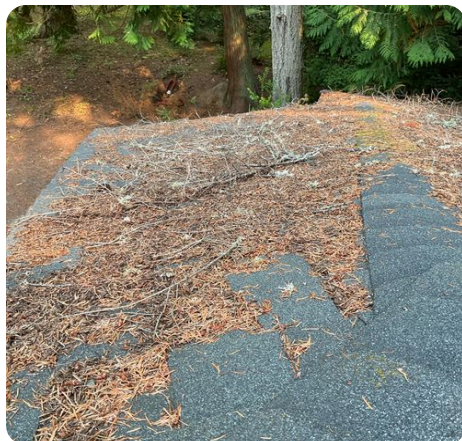
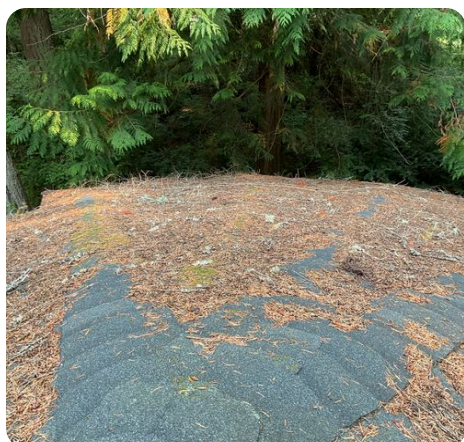
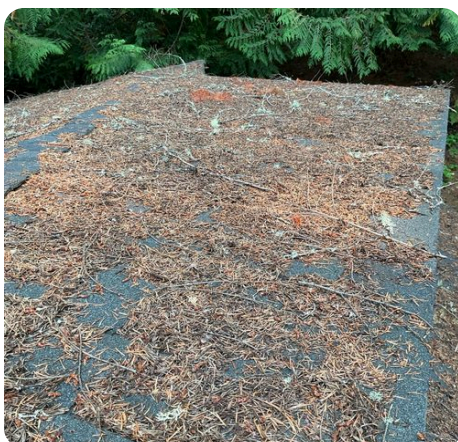
19 Debris On Roof

📍 Location: Detached Studio

There is debris on the roof. Leaves, branches, or other material that should be removed. This debris will hold moisture and can cause damage to the roof system. Inspection of the areas under the debris is recommended after debris is removed.

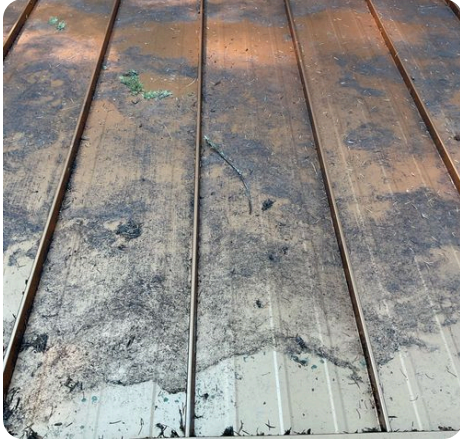
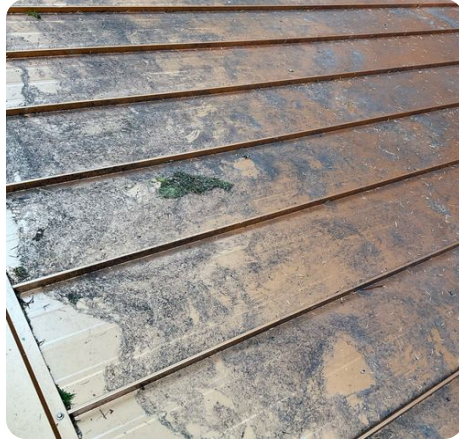
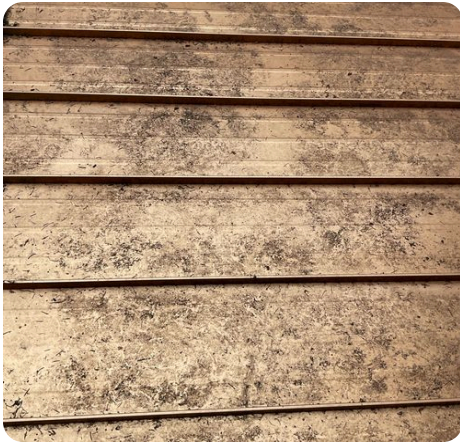
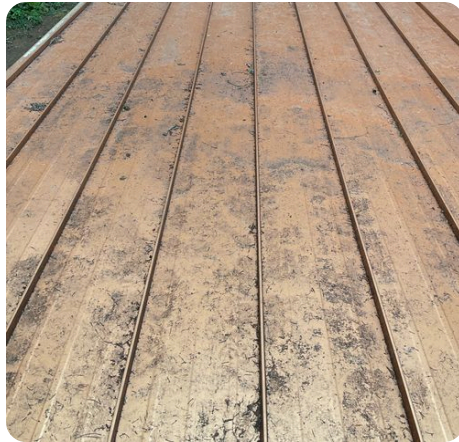
20 Algae On Metal Roof

📍 Location: Detached Garage, Main House

The presence of algae on the metal roof is noted. While algae growth does not typically pose an immediate threat to the roof's integrity, it can affect the aesthetics and longevity of the roof. Cleaning the algae off the metal roof can help improve its appearance and prevent any potential damage over time. It is recommended to address this issue by cleaning the roof surface using a solution of water and mild detergent, or by consulting with a qualified roofing contractor for professional cleaning services.

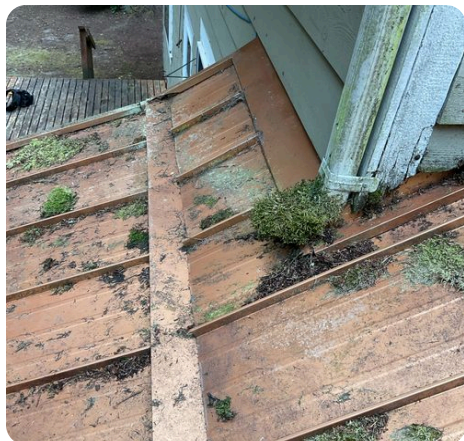
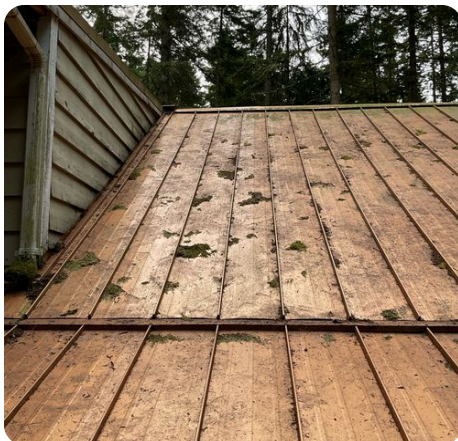
21 Moss Growth Issue

📍 Location: Main House

The presence of moss growth on a metal roof can trap moisture, leading to potential water damage and corrosion. It is recommended to evaluate and remove the moss to prevent further deterioration of the roof surface. A qualified roofing contractor can address this issue by safely cleaning the moss and applying treatments to inhibit regrowth. Additionally, ensuring proper ventilation and sunlight exposure can help prevent future moss growth.

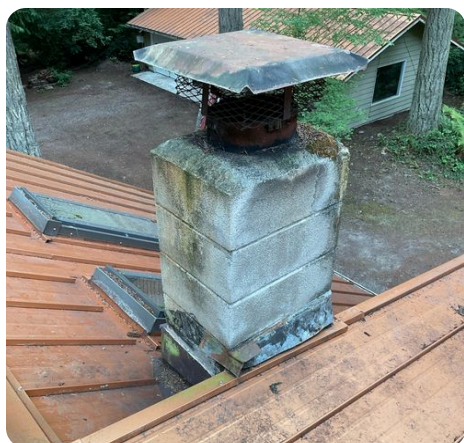
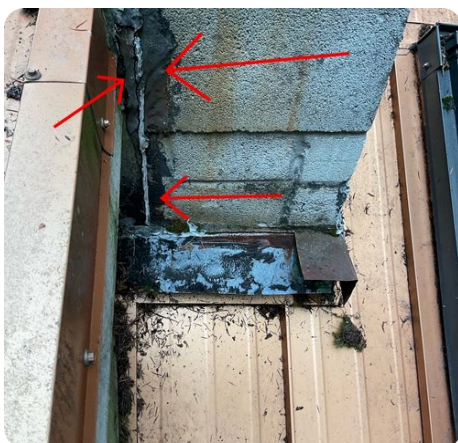
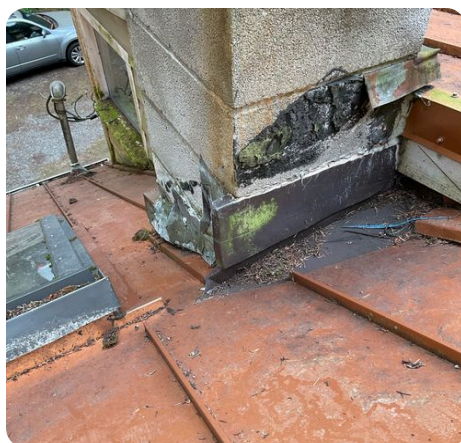
22 Excessive Caulking Concern

📍 Location: Main House

The excessive caulking around the chimney can indicate poor craftsmanship or an attempt to hide underlying issues. This can lead to trapping moisture, causing rot, and further damage. It is recommended to evaluate and repair the caulking by a qualified contractor to prevent water intrusion and maintain the chimney's integrity.

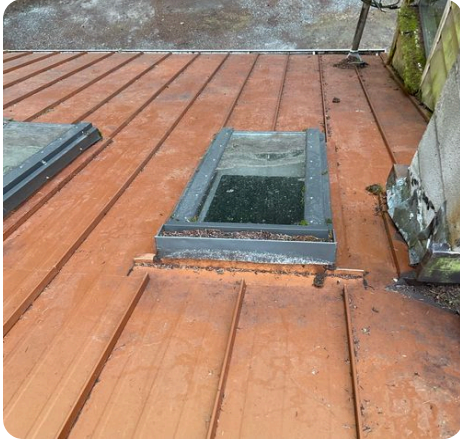
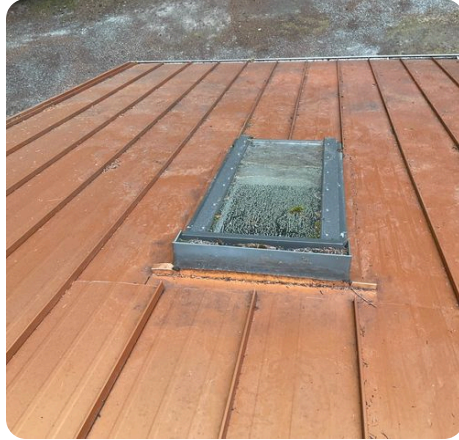
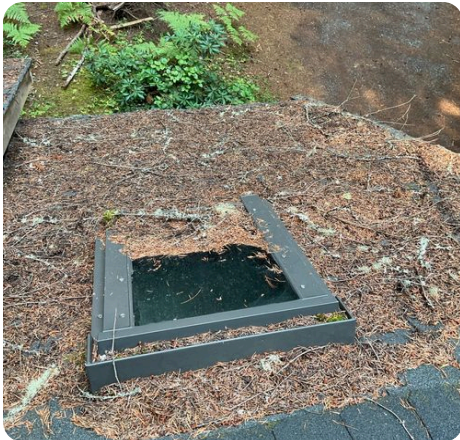
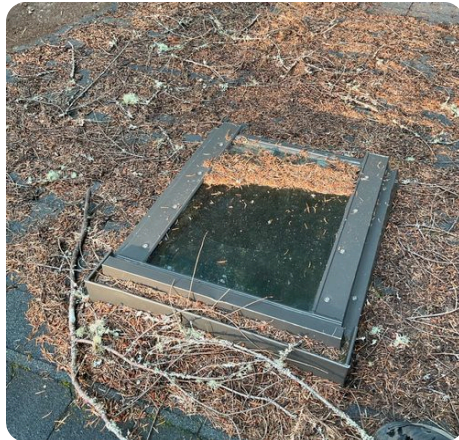
23 Skylight Debris Buildup

📍 Location: Main House, Detached Studio

Organic debris is covering the skylight. It is recommended to clean the skylight to prevent potential blockage and ensure proper drainage. Use a gentle cleaner and a soft cloth to remove debris. Regular maintenance can help prolong the lifespan of the skylight.

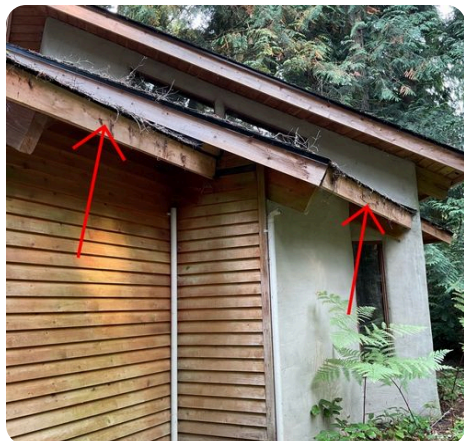
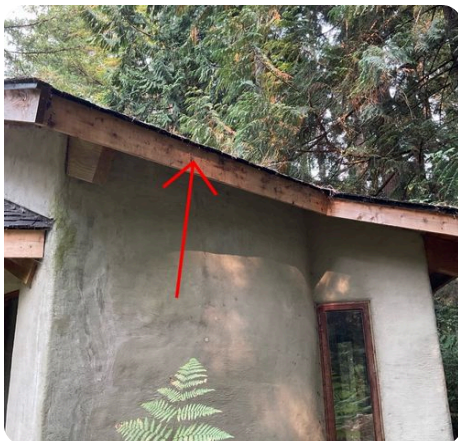
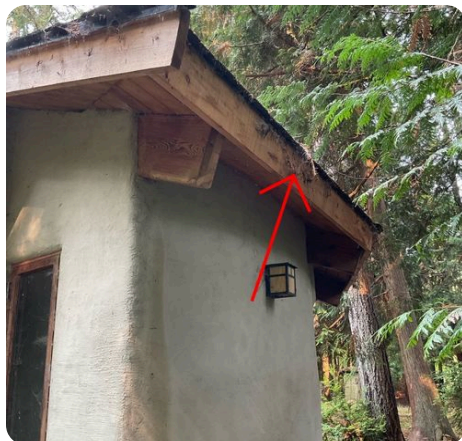
24 Gutters Missing

Location: Detached Studio

The gutters are missing on the roof, which could result in water damage to the foundation and siding of the property. It is recommended to install gutters to properly redirect water away from the home and prevent potential issues. A qualified gutter installation professional can evaluate and install gutters to improve drainage and protect the property.

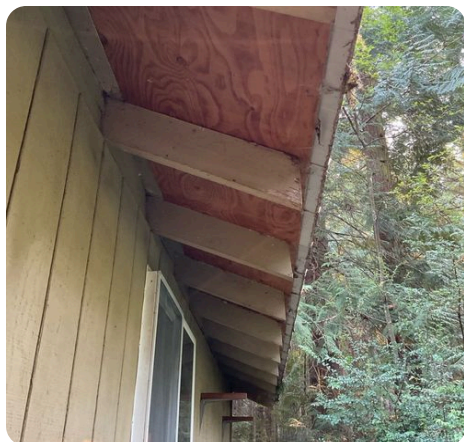
25 Missing Gutters

📍 Location: Detached Garage, South Side

There are areas on the roof where gutters are missing. Gutters play a crucial role in directing water away from the foundation of the house, preventing potential damage. Evaluating and repairing these missing gutters is recommended to ensure proper drainage and prevent water issues. A qualified gutter specialist should be contacted for further evaluation and installation if needed.

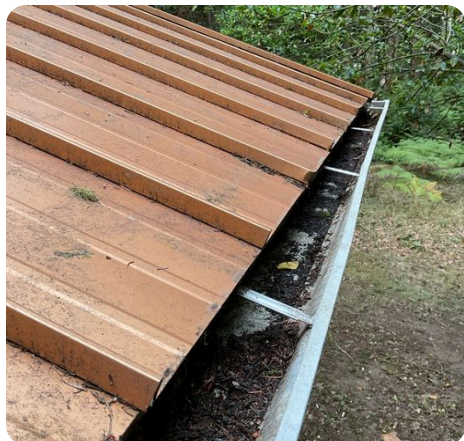
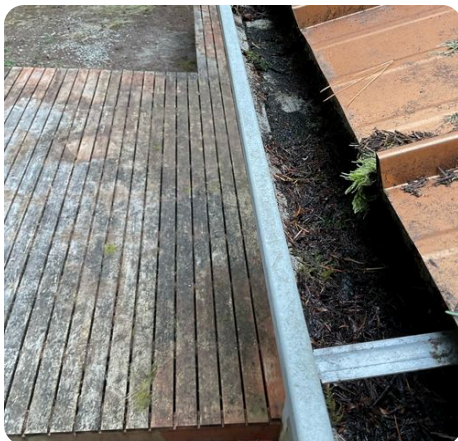
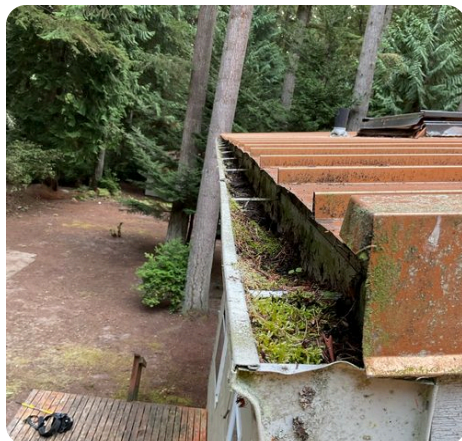
26 Debris In Gutters

📍 Location: Main House

The gutters have debris buildup which should be cleaned to prevent clogging of the gutters, downspouts, and/or drainage systems. It is recommended to clean the gutters semi-annually for proper care and maintenance of the gutter system. Contacting a qualified professional for this maintenance is advised.

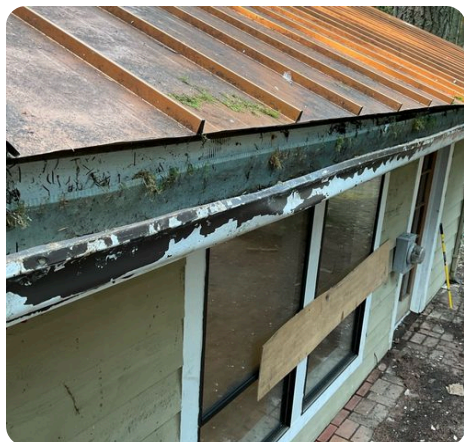
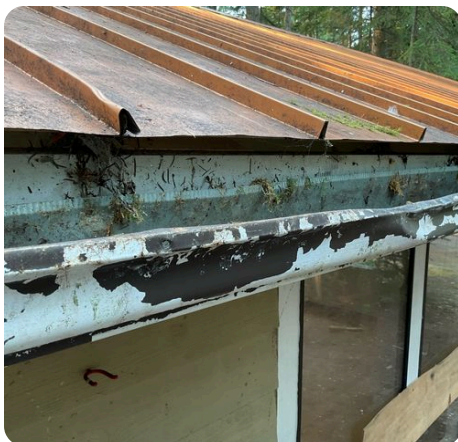
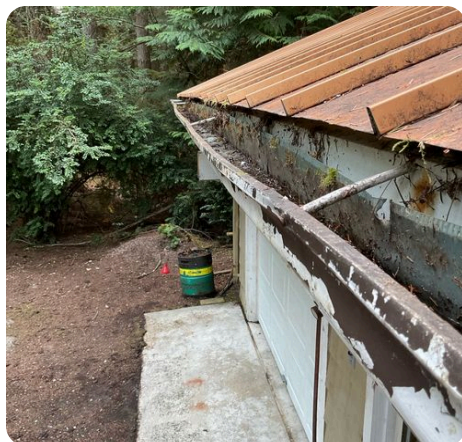
27 Loose Gutter

📍 Location: Detached Garage

There is a loose gutter on the roof area, which may cause water overflow and potential damage to the surrounding areas. It is recommended to evaluate and repair the loose gutter to ensure proper functionality and prevent any future issues. A qualified gutter repair professional should be contacted for further assistance.

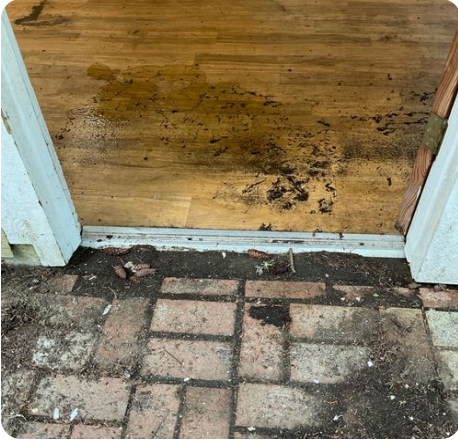
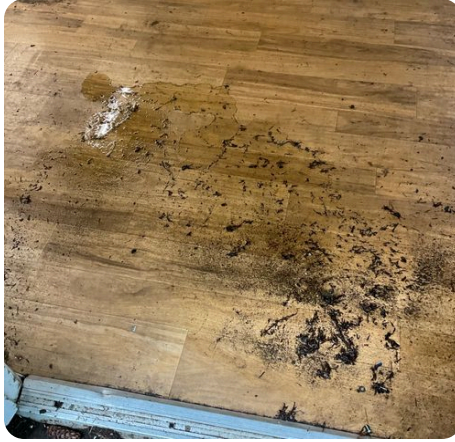
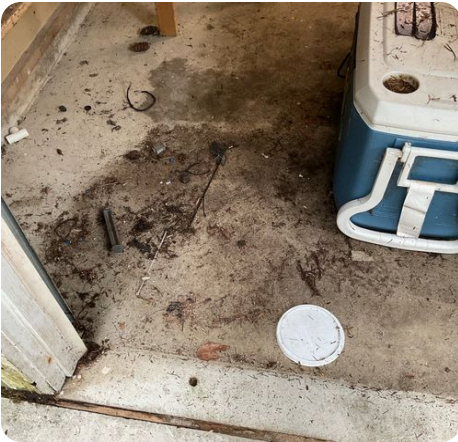
28 Moisture Issue On Garage Floor

The presence of moisture on the garage floor could indicate a potential water leakage issue. It is recommended to evaluate the source of moisture and repair it promptly to prevent further damage and potential mold growth. A qualified contractor can assess the situation and suggest appropriate solutions.

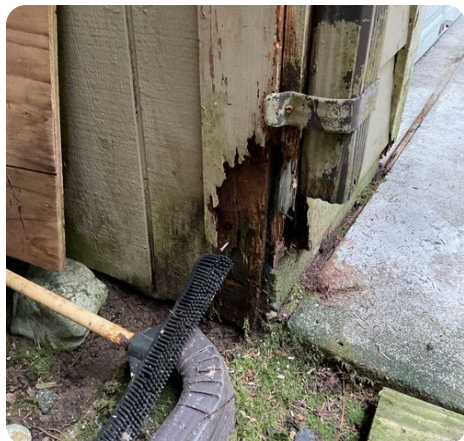
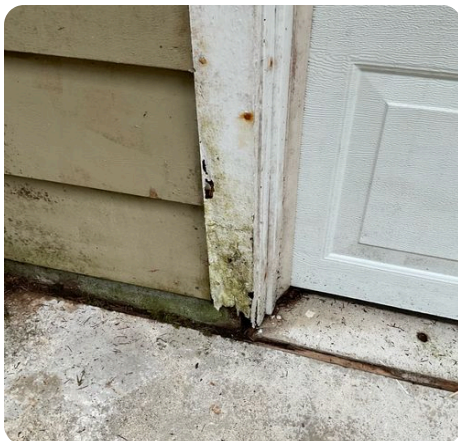
29 Deteriorated Trim/Siding Issue

📍 Location: NE Corner, East Door

The trim and siding on the corner of the garage and garage door trim are deteriorated. This can lead to further damage to the structure and should be evaluated and repaired by a qualified carpenter to prevent moisture intrusion and maintain the integrity of the garage.

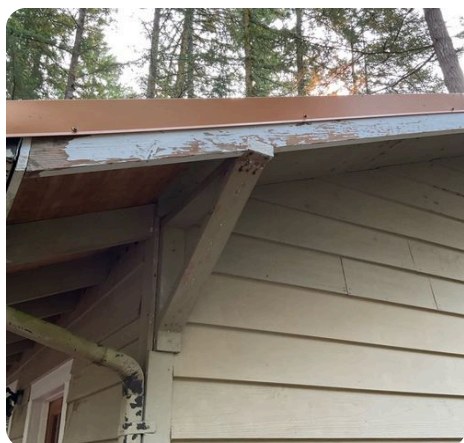
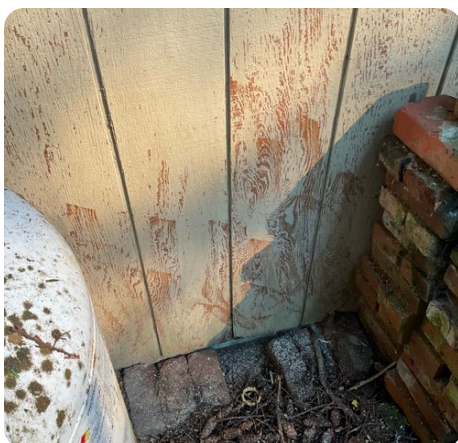
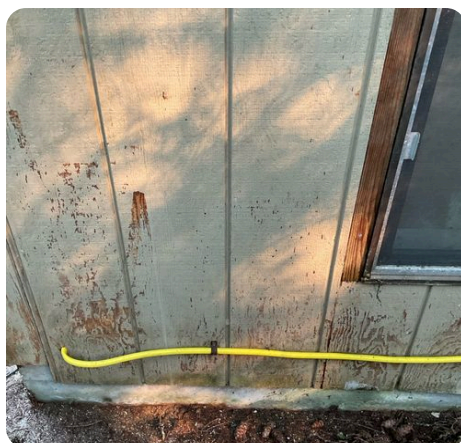
30 Exterior Paint Touch Up Required

Location: Detached Garage

The exterior of the detached garage shows signs of paint deterioration, with areas that require touch up to maintain protection against weather elements. It is recommended to evaluate the extent of the damage and hire a qualified painter to repair the affected areas to prevent further issues and ensure the aesthetics of the property.

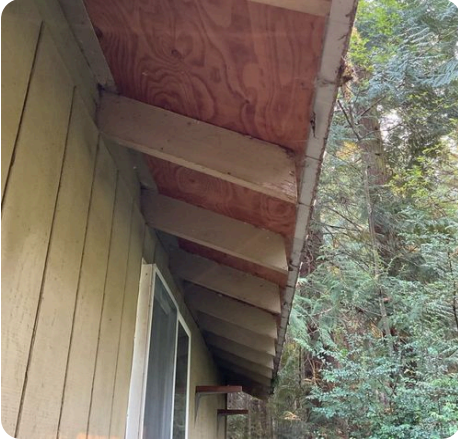
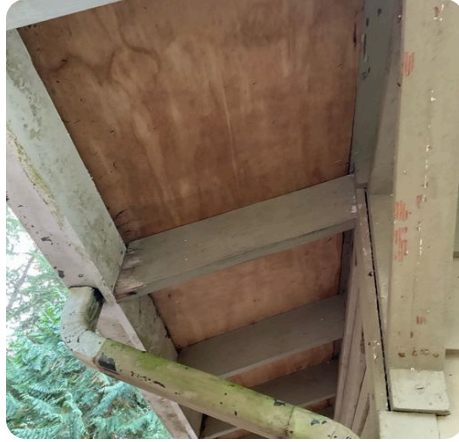
31 Unpainted Soffit Areas

Location: Detached Garage

The soffit areas in the garage are unpainted. It is recommended to paint the soffits to protect the wood from moisture damage and extend its lifespan. Painting the soffit areas also enhances the overall appearance of the garage interior. Consider evaluating and painting the unpainted soffit areas to maintain them in good condition.

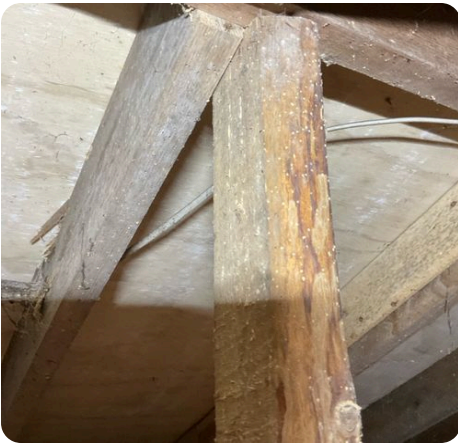
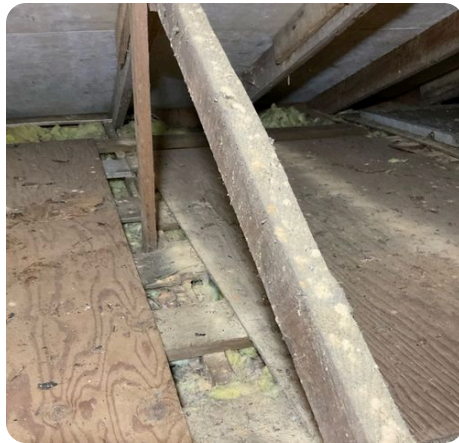
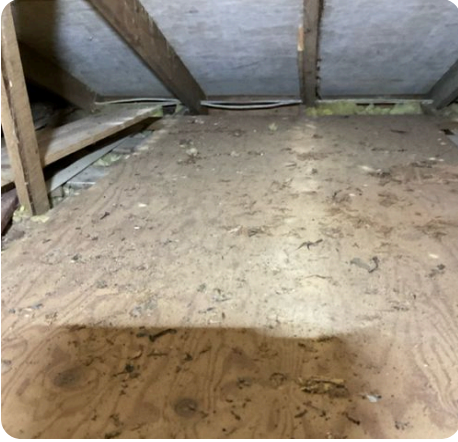
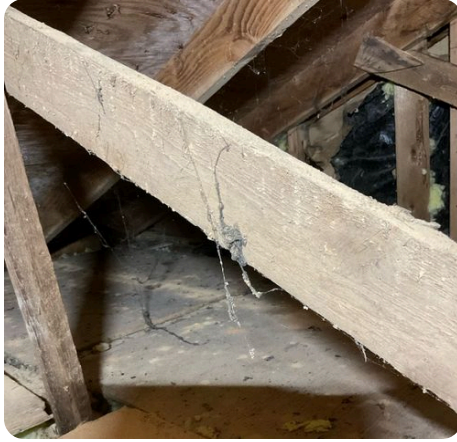
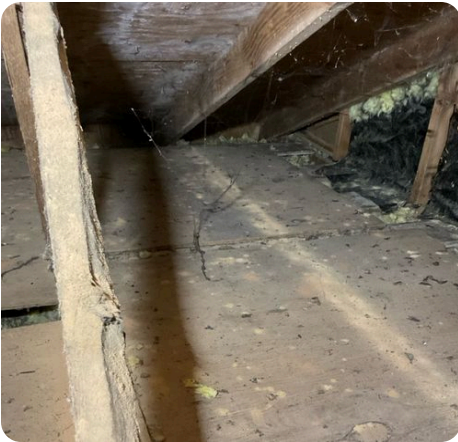
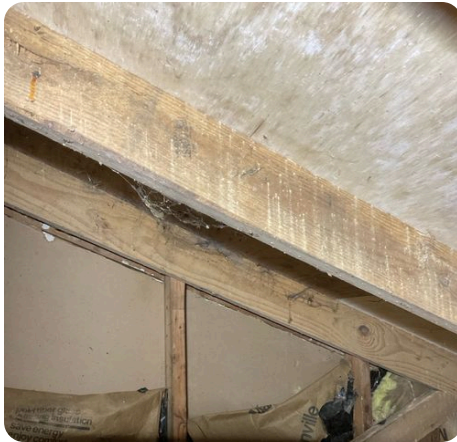
32 Insect Damage In Garage

Location: Attic, Detached Garage

The presence of insect damage is observed in the garage. It is recommended to evaluate and repair the affected areas to prevent further damage and infestation. Hiring a qualified pest control professional can help address the issue effectively.

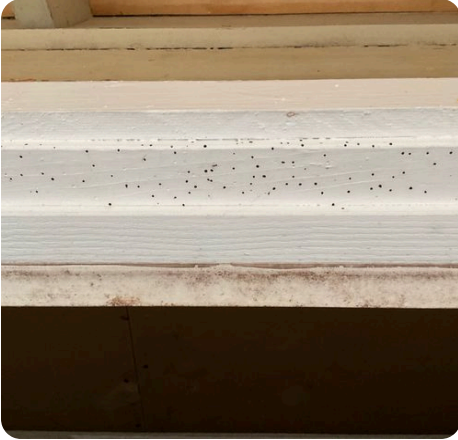
33 Door Trim Holes

📍 Location: Detached Garage

The emergence holes in the door trim should be properly evaluated and repaired. These holes may indicate the presence of wood-destroying insects such as termites or carpenter ants. It is recommended to consult with a licensed pest control professional to assess the extent of the infestation and to treat it accordingly.

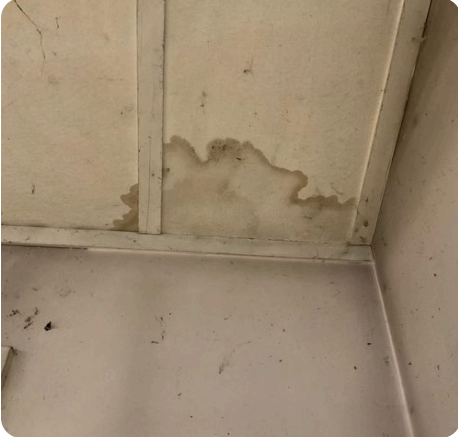
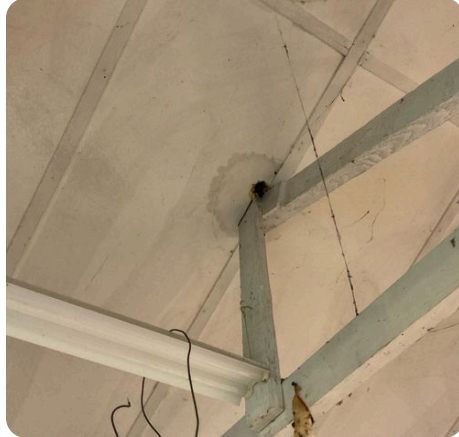
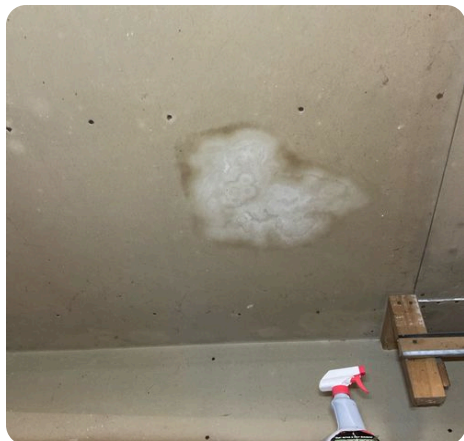
34 Dry Moisture Stains Issue

Location: Detached Garage

The presence of dry moisture stains on the ceiling may indicate a previous water leak or high humidity levels. It is recommended to evaluate the source of the moisture and repair accordingly to prevent any further damage. Depending on the extent of the issue, a qualified contractor may need to address the underlying cause and repair the affected area to ensure the structural integrity of the ceiling.
