Service: Pre-Listing Inspection

Prepared for: Amy Gulden

Aaron McBride

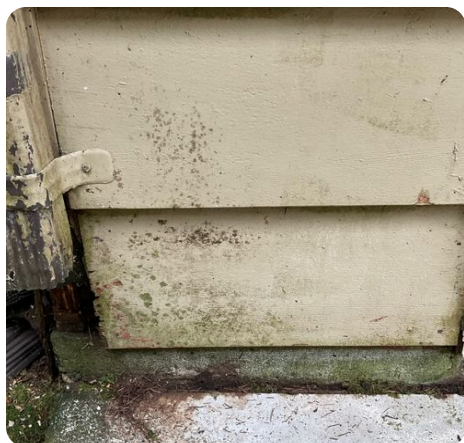
35 Mildew On Exterior Siding

📍 Location: Detached Garage

The presence of mildew on the exterior siding. It is recommended to clean the affected areas with a mixture of water and bleach to inhibit further growth. Consider improving ventilation around the siding to prevent future mildew growth. If the issue persists, contact a qualified professional.

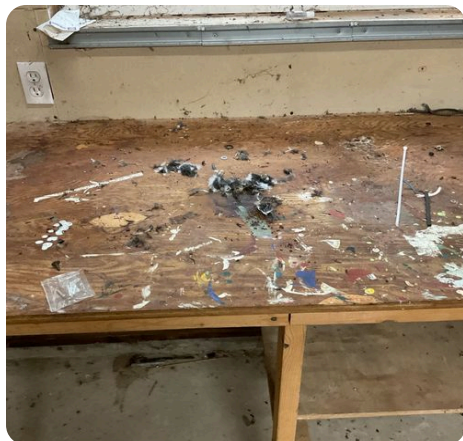
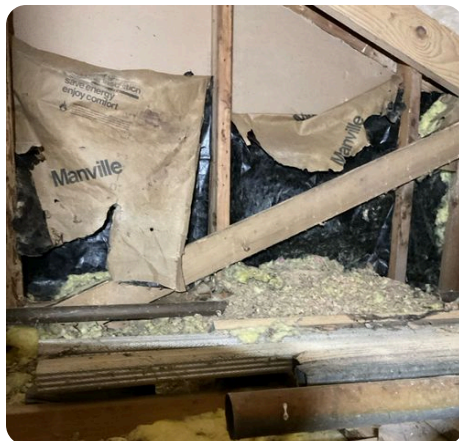
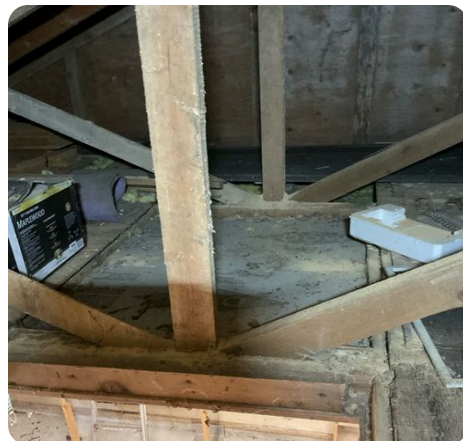
36 Rodent Intrusion In Garage

📍 Location: Detached Garage

The presence of rodent intrusion in the garage is noted. This can lead to damage to property, contamination, and potential health hazards. It is recommended to evaluate and remove any nesting materials, seal entry points, and consider contacting a pest control specialist to address the issue.

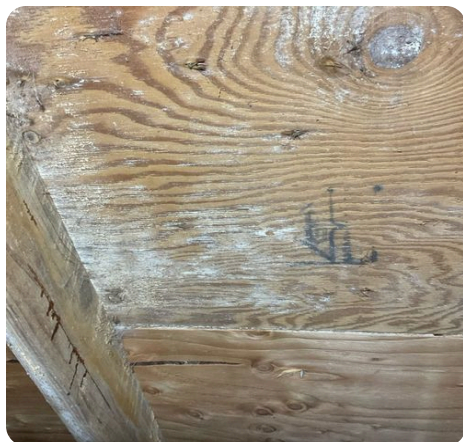
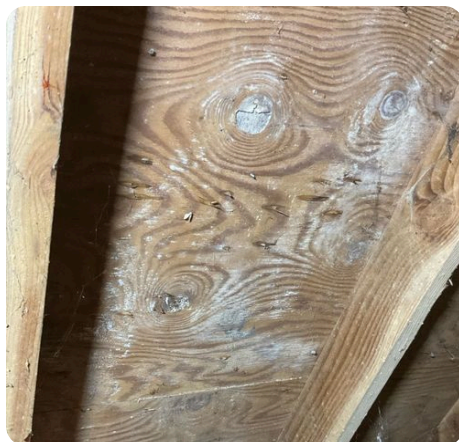
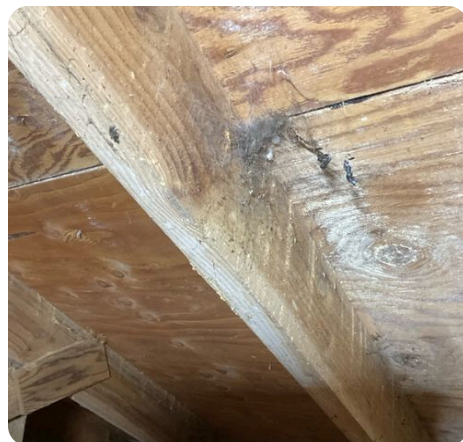
37 Organic Staining Observation

📍 Location: Attic, Detached Garage

The presence of organic staining on the sheathing has been noted. This could be an indication of water intrusion or potential mold growth. It is recommended to further evaluate the source of moisture and address any underlying issues to prevent further damage. A qualified contractor should be consulted to investigate and repair as needed.

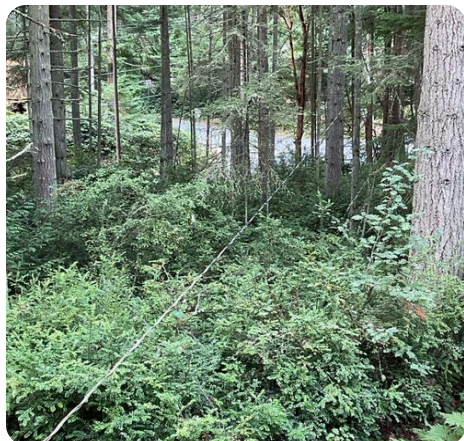
38 Trees In Contact With Overhead Utility Lines

Tree branches were noted to be in contact with the overhead electrical service wires. Trees may cause damage to the service entrance conductors presenting an electrical functionality and safety concern. The inspector recommends having the tree limbs trimmed away from the service lines by a qualified professional. The utility provider may or may not be responsible for keeping trees trimmed away from the service lines. Please contact your local utility provider for more information. This work should not be performed by the homeowner or an unqualified professional due to the safety hazard that exists.

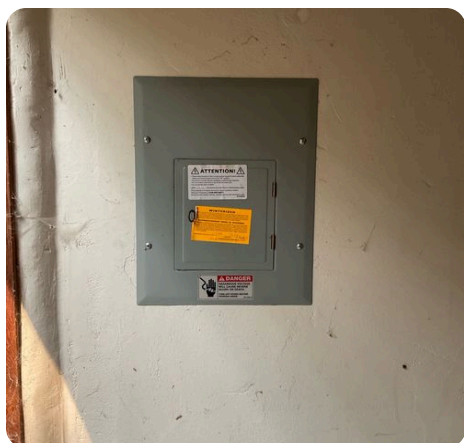
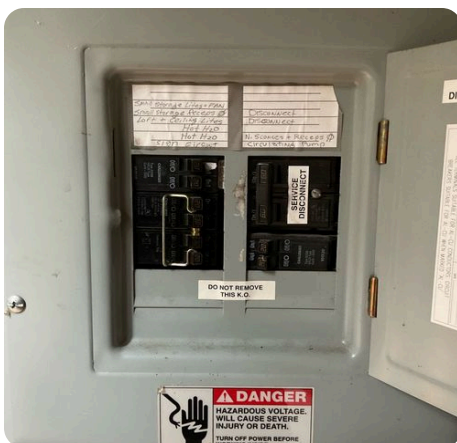
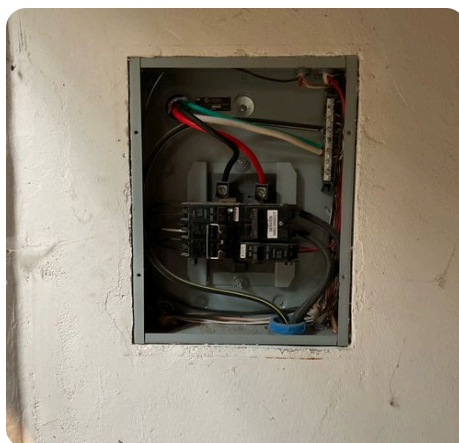
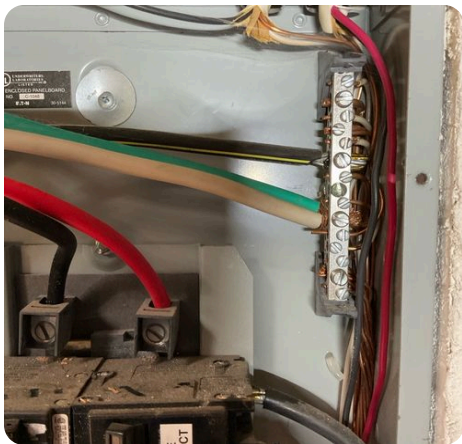
39 Shared Bus Bar For Grounds And Neutrals

📍 Location: Detached Studio

The subpanel has grounds and neutrals sharing the same bus bar, which is not up to current electrical code standards. This setup can lead to safety hazards, such as improper grounding and potential overloading. It is recommended to have a qualified electrician evaluate and repair this issue by separating the grounds and neutrals onto their respective bus bars to ensure proper functioning and safety of the electrical system.

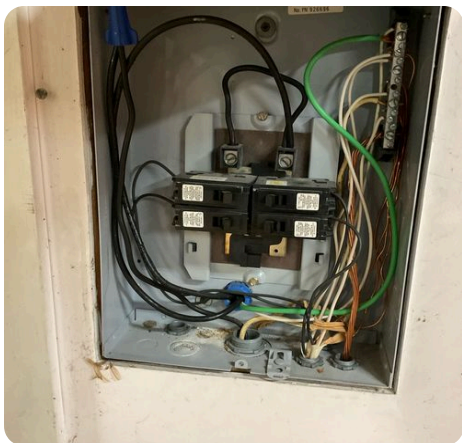
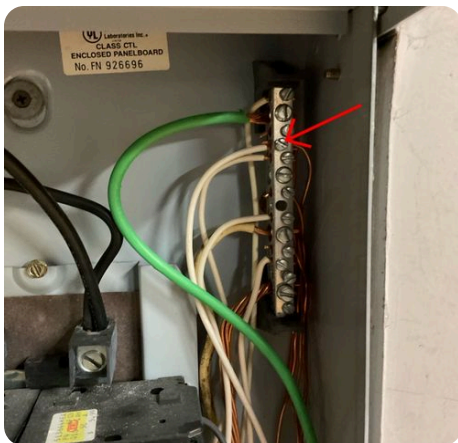
40 Double-Tapped Neutral

📍 Location: Detached Garage

Double-tapped neutral was observed at the sub-panel where two neutral wires are connected to a single terminal slot. This could result in poor connections, and overheating, and poses a potential fire hazard. It is advised to contact a qualified electrician to address this issue for the safety and optimal performance of the electrical system.

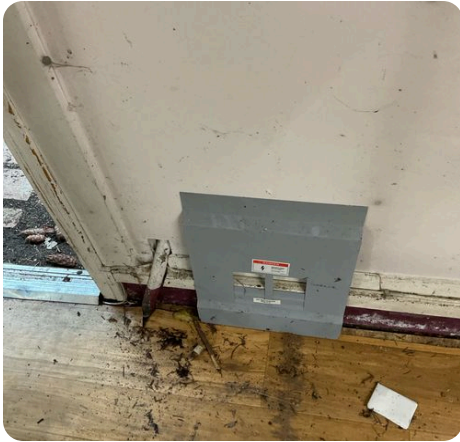
41 Face Plate Not Installed

📍 Location: Detached Garage

The face plate is not installed and is sitting on the ground. It is recommended to properly install the face plate to ensure safety and functionality of the electrical components. Securing the face plate in place will prevent dust accumulation and reduce the risk of accidental damage to the wiring.

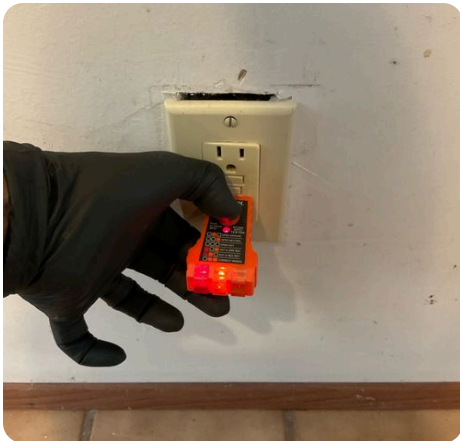
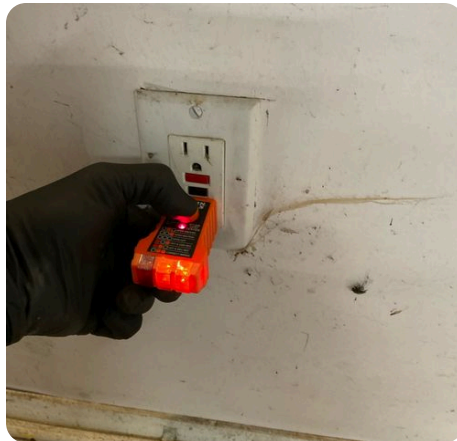
42 GFCI Receptacle Failed Test

Location: Main House, Multiple Locations, Detached Garage, Detached Studio

The GFCI receptacle did not operate properly or 'trip' when tested. GFCI receptacles are designed to protect against electrical shock and should be in proper working condition. It is recommended to have a qualified electrician evaluate and repair or replace the receptacle.

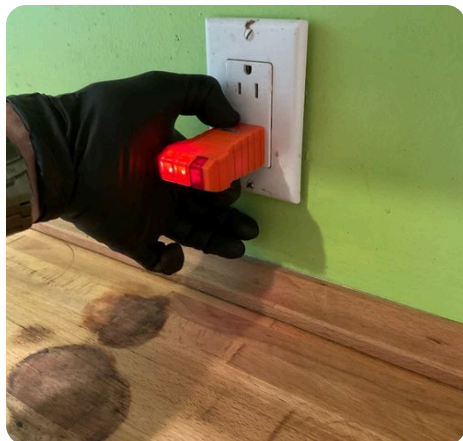
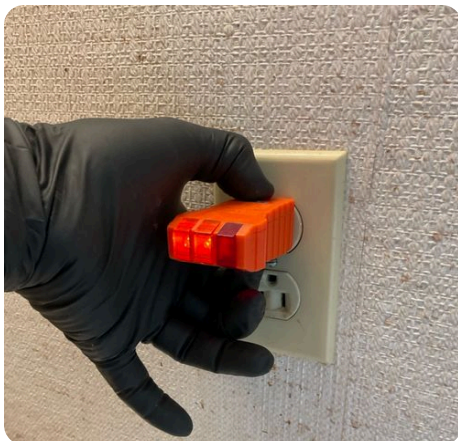
43 Missing GFCI Protection

Location: Main House, Bathrooms, Kitchen

Ground Fault Circuit Interrupter (GFCI) protection is missing in potential wet locations. GFCIs are crucial in these areas to protect against electric shocks. It is recommended to have a qualified electrician install GFCI outlets for safety.

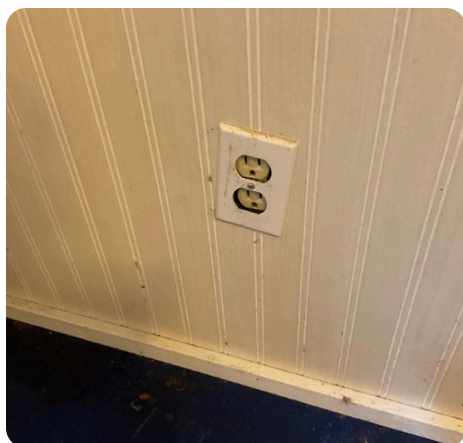
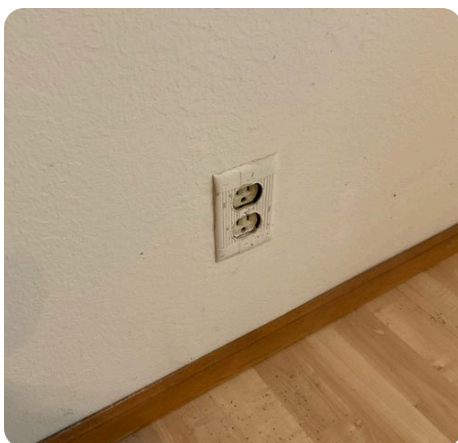
44 Gap Between Outlets And Covers

📍 Location: Main House, Multiple Locations

The presence of a gap between outlets and their covers can pose a safety hazard as it exposes electrical components. It is recommended to evaluate and repair these gaps promptly to prevent any risk of electric shock or damage. This can be addressed by installing proper-sized outlet covers or utilizing outlet spacers. If unsure, contacting a licensed electrician is advised for professional assistance.

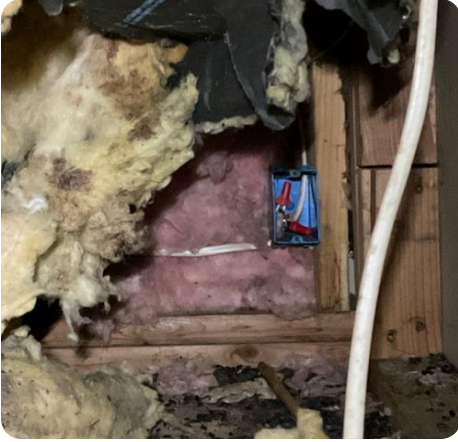
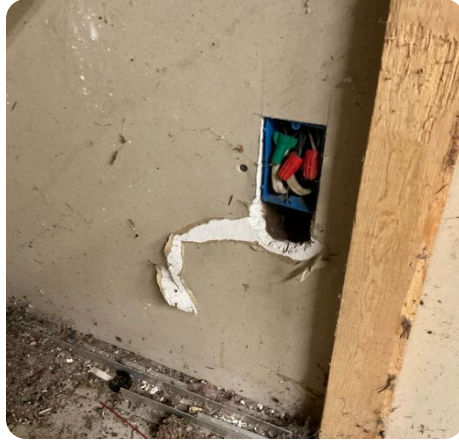
45 Missing Junction Box Covers

📍 Location: Attic, Main House, Detached Garage

Some junction boxes are missing covers. Installing covers is recommended for safety reasons.

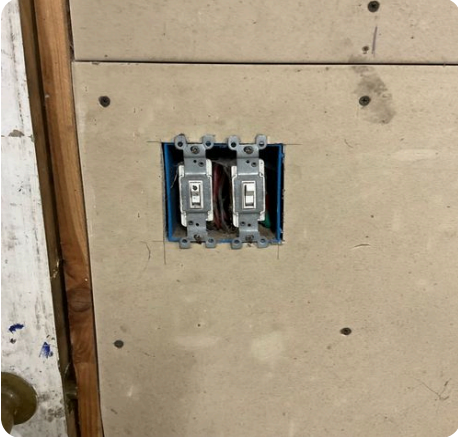
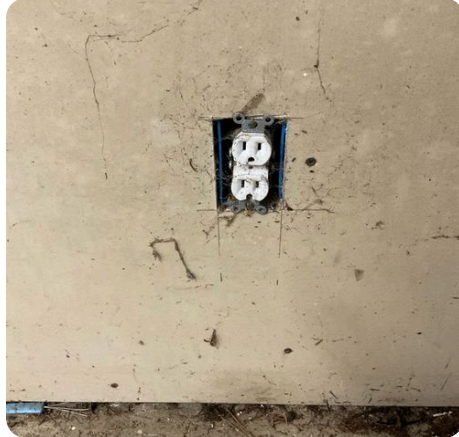
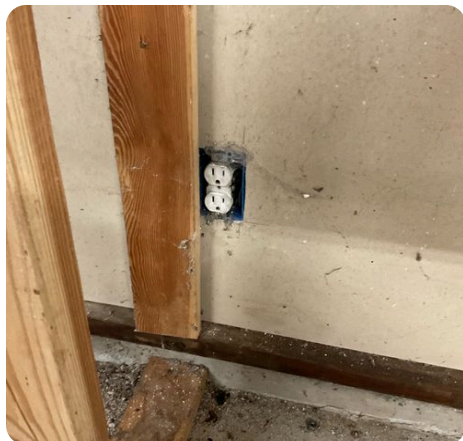
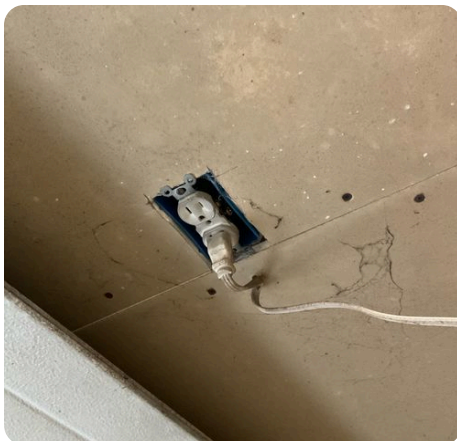
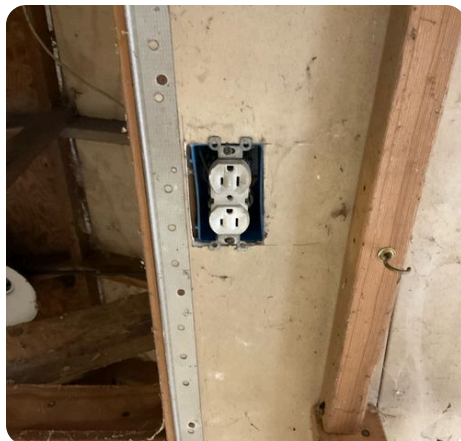
46 Missing Outlet And Switch Covers

Location: Detached Garage

The outlet and switch covers are missing in multiple areas. It is recommended to install outlet and switch covers to prevent electrical hazards and to ensure the safety of the occupants. You can easily purchase covers at a hardware store and install them yourself following the manufacturer's instructions.

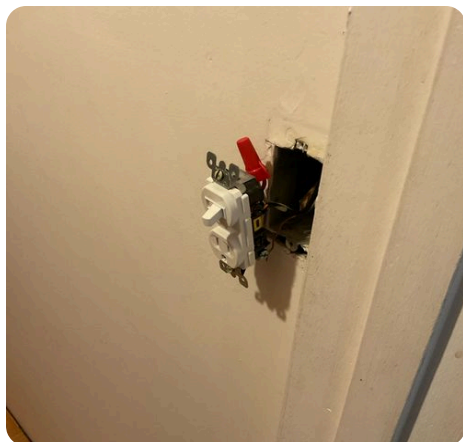
47 **Loose Switch**

📍 Location: Upstairs Closet, Main House

The switch was found to be loose during the inspection. A loose switch can be a safety hazard as it may cause electrical arcing or even a potential fire risk due to overheating. It is recommended to have a qualified electrician evaluate and repair this issue to ensure proper and safe operation.

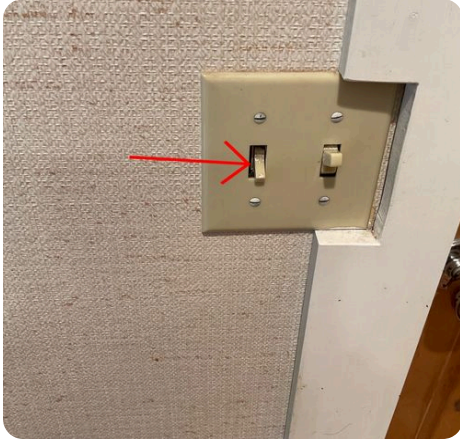
48 **Loose Switch Knob**

📍 Location: Lower Level Bathroom, Main House

The switch knob on one of the switches is loose. This can lead to difficulty in operating the switch and might pose a safety hazard. It is recommended to tighten or replace the switch knob to ensure proper functionality and safety. If unsure, consider hiring a qualified electrician to evaluate and repair as needed.

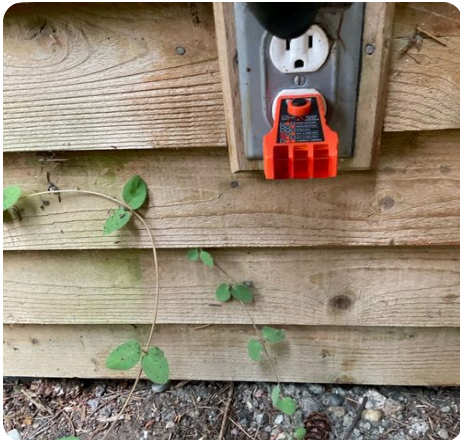
49 **Outlet Not Functioning**

📍 Location: Detached Studio

The inspector found one exterior outlet that did not have power. Contact an electrician for further evaluation and repair.

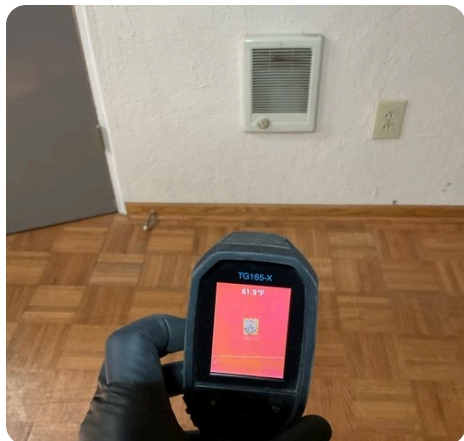
50 **Non-Functional Electric Wall Heater**

📍 Location: Upstairs Room, Main House

One of the electric wall heaters in the was not functional. We recommend evaluating and repairing the electric wall heater as needed. All other electric wall heaters were functional. Contact a licensed electrician to inspect and repair the electric wall heater as needed.

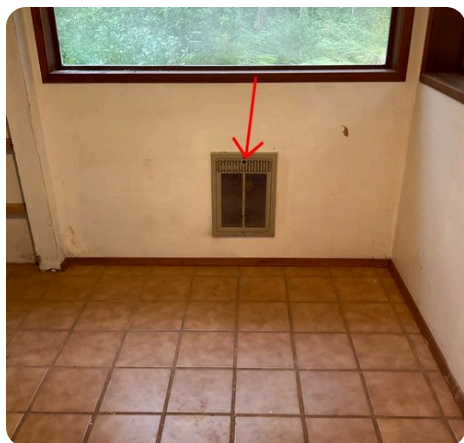
51 Missing Thermostat Control Knob

Location: Main House, Laundry Room

The thermostat in the HVAC system is missing a control knob. This can make it difficult to adjust the temperature settings accurately. It is recommended to replace the missing knob to ensure proper functionality and control of the HVAC system.

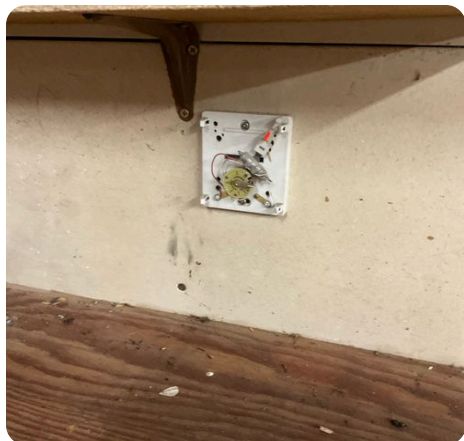
52 Thermostat Cover Missing

Location: Detached Garage

The thermostat cover is missing. It is recommended to have the thermostat cover in place to protect the internal components from dust and damage. Consider replacing the cover to ensure proper functioning of the thermostat.

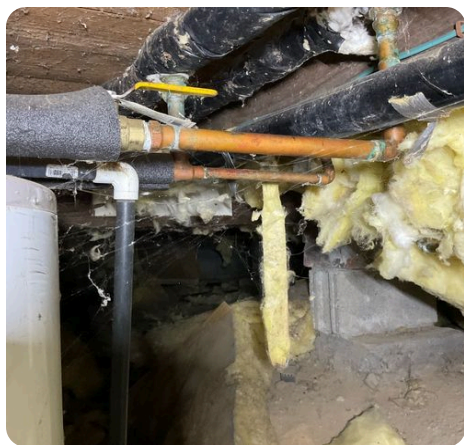
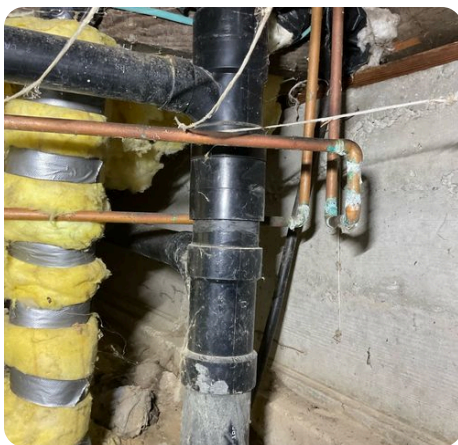
53 Insulation Needed For Water Pipes

📍 Location: Main House, Crawl Space

The water pipes in the home are uninsulated. It is recommended to insulate water pipes, especially in cold climates, to prevent freezing and potential bursting during winter months. Insulating water pipes can also help in conserving energy by reducing heat loss. A qualified plumber can evaluate the pipes and install appropriate insulation to prevent any issues in the future.

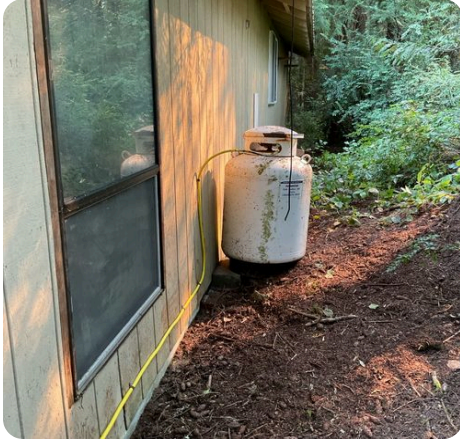
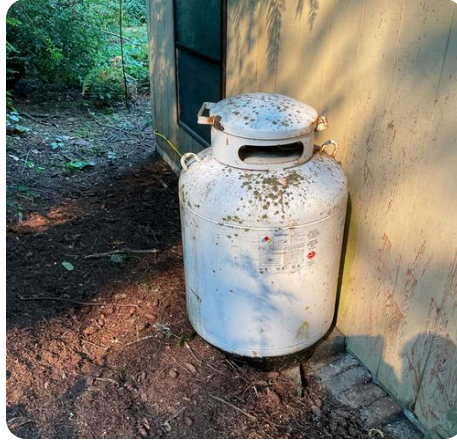
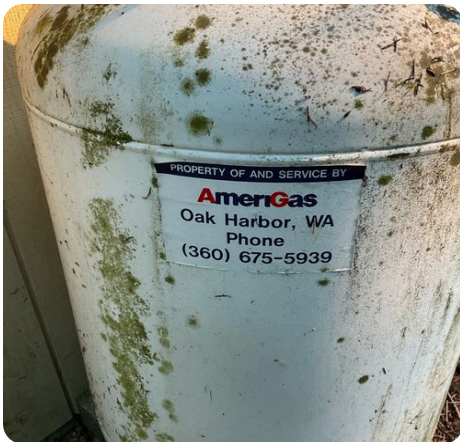
54 Propane Tanks Not Secured

📍 Location: Detached Garage

The propane tank(s) is/are not secured to prevent movement. Strapping the tank(s) to prevent it/them from tipping over is recommended. Contact a qualified professional to perform this maintenance.

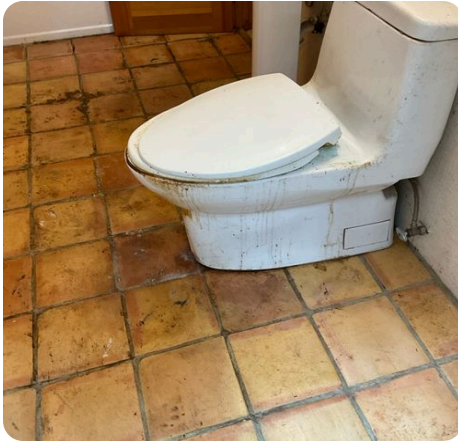
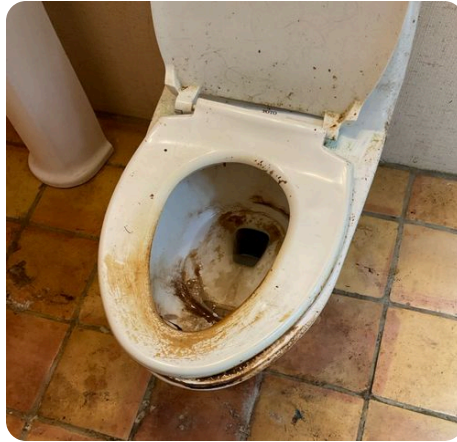
55 Stained Toilet With Broken Seat

📍 Location: Lower Level Bathroom, Main House

The stained toilet with a broken seat suggests that there may have been an overflow in the past, leading to potential water damage. It is recommended to evaluate the toilet for any underlying issues and repair or replace the broken seat to ensure proper functionality.

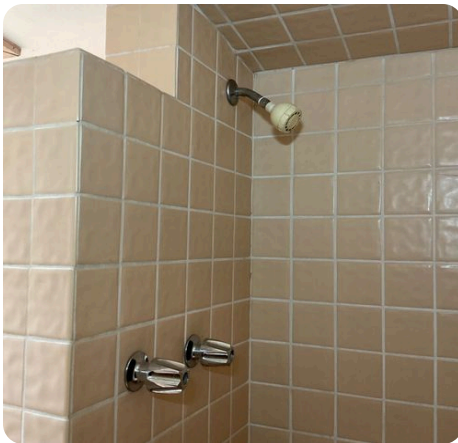
56 Non-Functioning Tub/Shower Faucet

📍 Location: Main House, Upstairs Bathroom, North Shower Head

The tub/shower faucet is not functioning properly. This issue can lead to inconvenience and affect the functionality of the tub/shower unit. It is recommended to have a licensed plumber evaluate and repair the faucet to ensure proper operation.

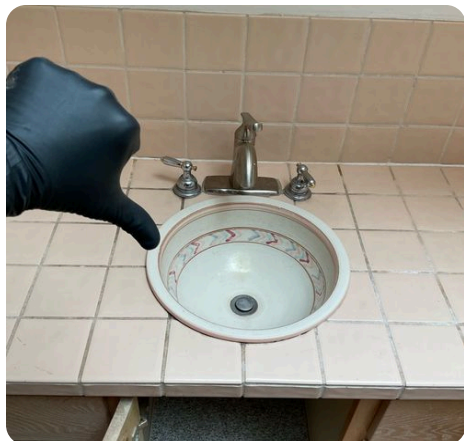
57 Non Functional Sink Faucet

📍 Location: Upstairs Bathroom

The sink faucet is not functioning properly. This can be due to a variety of issues such as a damaged internal mechanism or mineral build-up. It is recommended to have a qualified plumber evaluate and repair the faucet to ensure proper functionality. Regular maintenance, such as cleaning out debris and mineral deposits, can help prevent similar issues in the future.

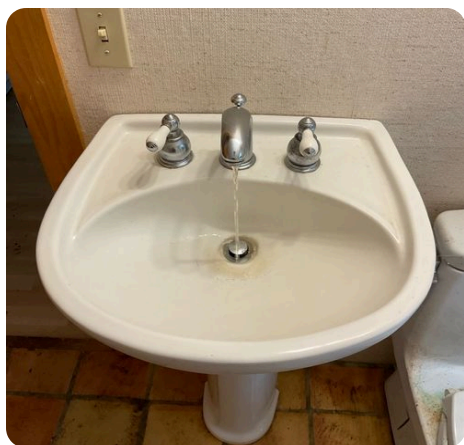
58 Low Water Flow When Other Fixtures Are In Use

📍 Location: **Lower Level Bathroom**

The water pressure in the sink appears to decrease when other fixtures are being used concurrently, indicating a potential issue with the plumbing system. It is recommended to have a licensed plumber evaluate the water pressure and make any necessary repairs to improve the flow rate. In some cases, installing a pressure-balancing valve or upgrading to a larger pipe size may help alleviate this issue.

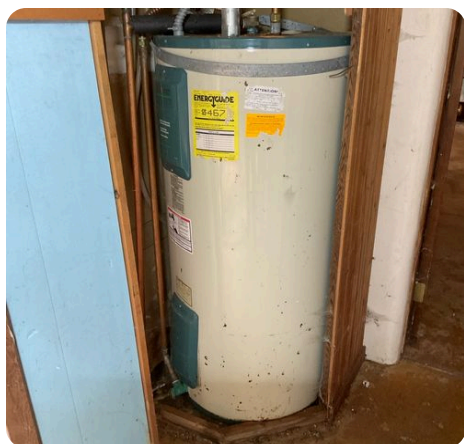
59 Missing Water Heater Straps

📍 Location: **Detached Studio**

The water heater is missing seismic straps for stability. It is recommended to have a qualified plumber install water heater earthquake straps to secure the unit and reduce the risk of tipping over during seismic activity.

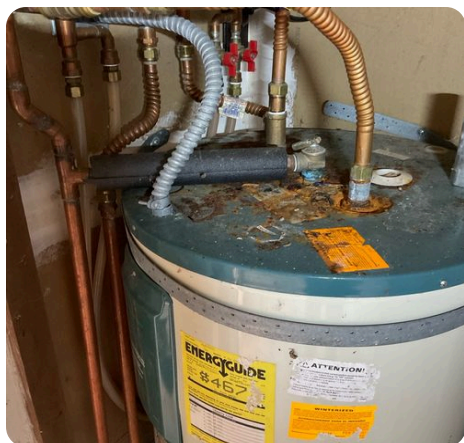
60 Rust At Water Heater

📍 Location: Detached Studio

The presence of rust on the water heater can indicate corrosion, which may lead to leaks or other water damage. It is recommended to have a qualified plumber evaluate the extent of corrosion and repair or replace any affected parts to prevent further deterioration.

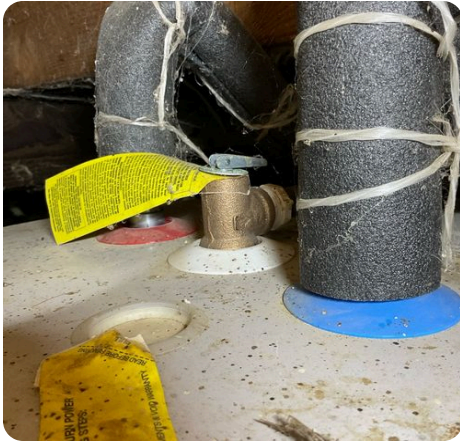
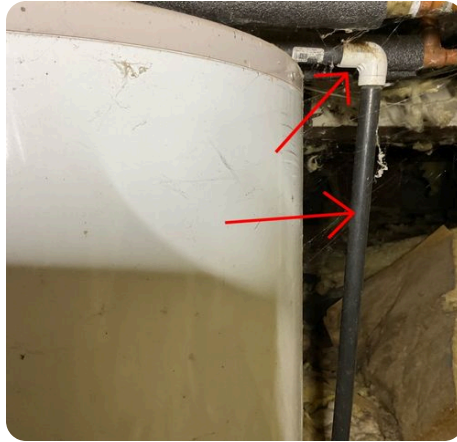
61 Improper Discharge Pipe Material

📍 Location: Main House

The discharge pipe material appears to be PVC, which is not heat-rated. The discharge pipe should be made of heat-resistant material, such as copper, PEX, or CPVC, to ensure it can withstand high temperatures in the event of a discharge. It is recommended to have a qualified plumber evaluate and repair this issue to ensure proper functionality of the TPR valve.

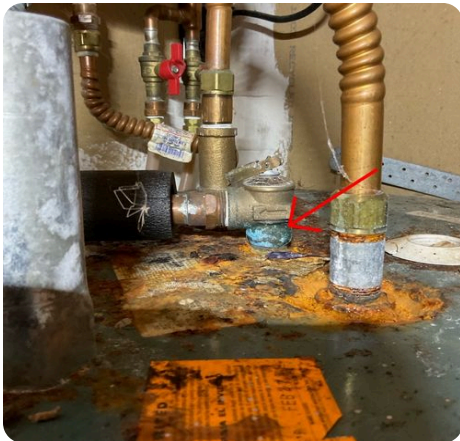
62 TPR Valve Encrustation Issue

📍 Location: Detached Studio

The TPR valve shows encrustation, which can hinder its proper functioning. It is recommended to evaluate the valve to ensure it opens smoothly in case of high temperature or pressure. A qualified plumber should be contacted to clean or replace the valve if necessary.

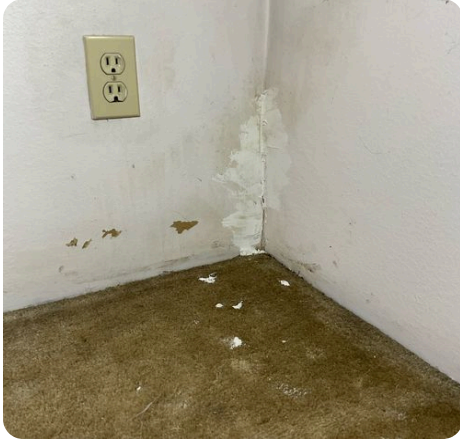
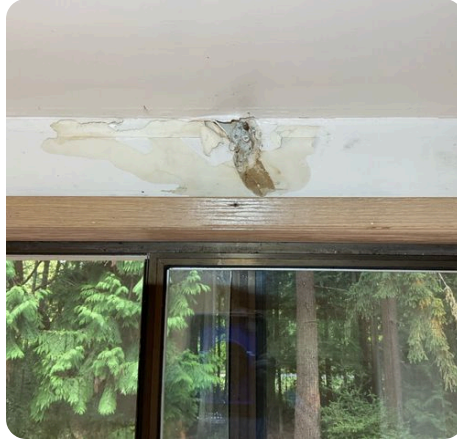
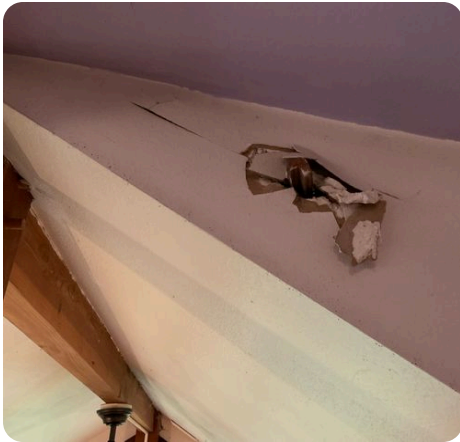
63 Damaged Drywall

📍 Location: Main House

Areas of damaged or cracked drywall were observed in the walls. Evaluating and repairing these issues is recommended as they can impact the aesthetic appeal of the home and may lead to further damage if not addressed. Contacting a qualified drywall contractor to assess the extent of necessary repairs and to ensure proper repairs are made is suggested.

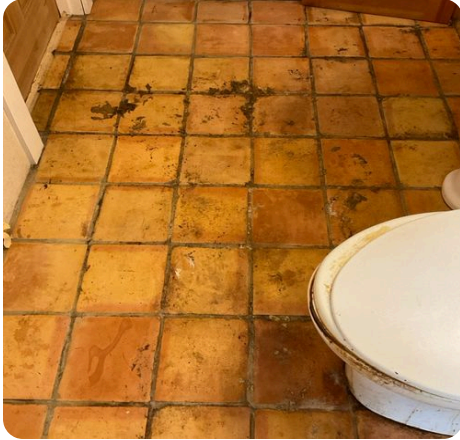
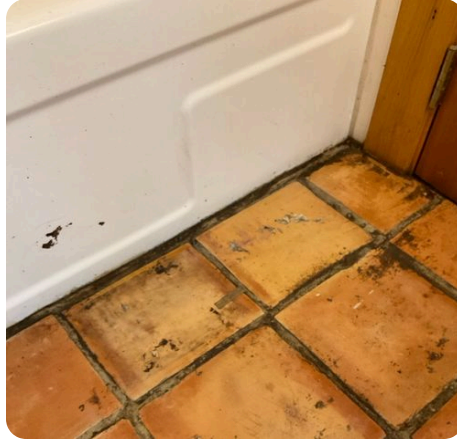
64 Effluence Staining Issue

📍 Location: Main House, Lower Level Bathroom

There is effluence staining on the bathroom floor, which indicates a potential plumbing leak. We recommend further evaluation and repair by a qualified plumber to address the issue and prevent any further damage.

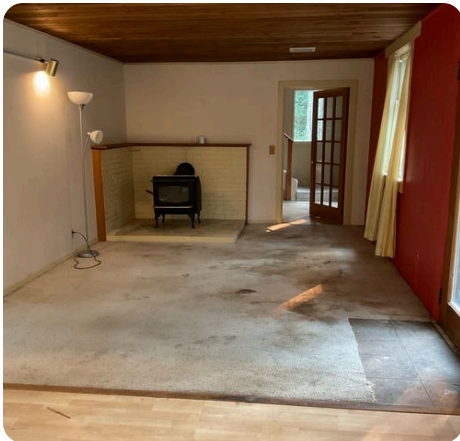
65 Carpet Condition

Location: Main House

The carpet in the property is heavily stained and damaged. This can not only be unsightly but also indicate a lack of maintenance. It is recommended to evaluate and repair the carpet by either deep cleaning or replacing it to improve the aesthetic appeal of the space.

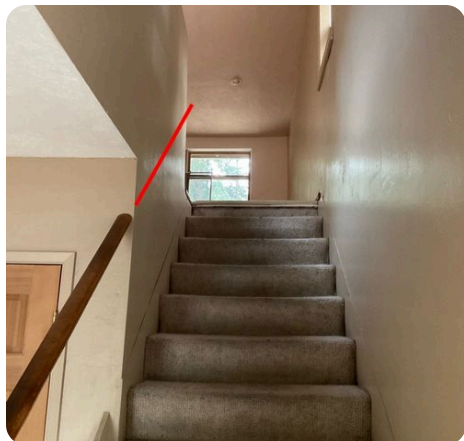
66 Missing Handrail

Location: Main House

The handrail/railing system is missing in the stairwell, posing a fall hazard if someone were to trip. It is recommended to have a qualified professional install handrail/railing systems as a preventive safety measure.

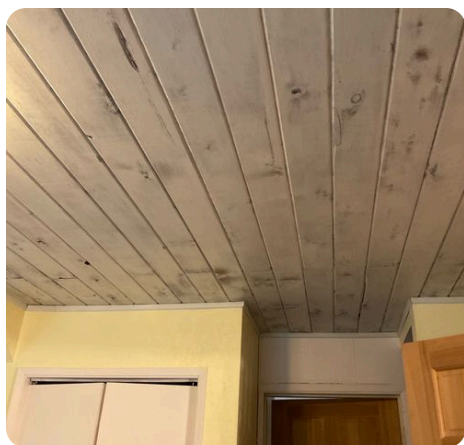
67 Smoke Alarm Missing

📍 Location: **Lower Level Bedroom, Main House**

There is a missing smoke alarm. Smoke alarms provide early warning in case of a fire, ensuring the safety of the occupants. A working smoke alarm should be installed in every bedroom and in the hallway outside sleeping areas. Installing a smoke alarm is recommended to ensure occupant safety. Regularly testing the alarms is also advised.

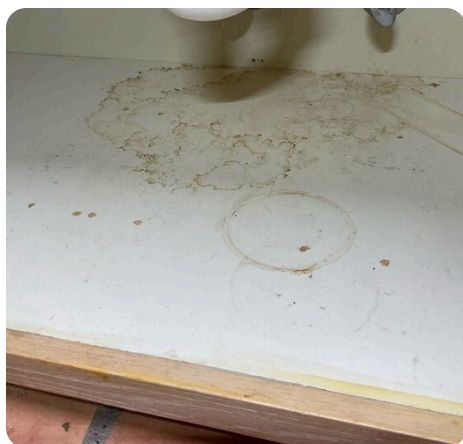
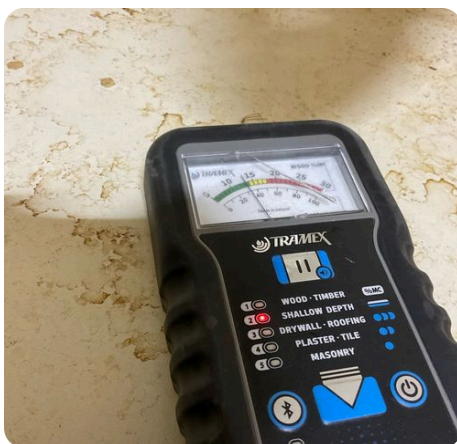
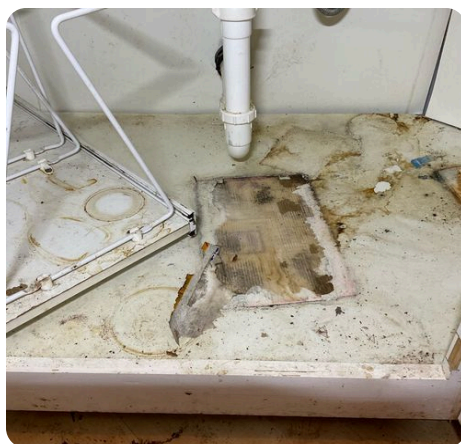
70 Past Moisture Damage In Cabinet

Location: **Upstairs Bathroom, Kitchen**

The cabinet shows signs of past moisture damage, which could indicate a previous leak or elevated moisture levels in the area. It is recommended to evaluate the extent of the damage and repair any affected areas to prevent further issues such as mold growth or structural deterioration. A qualified contractor can assess the damage and replace any compromised materials.

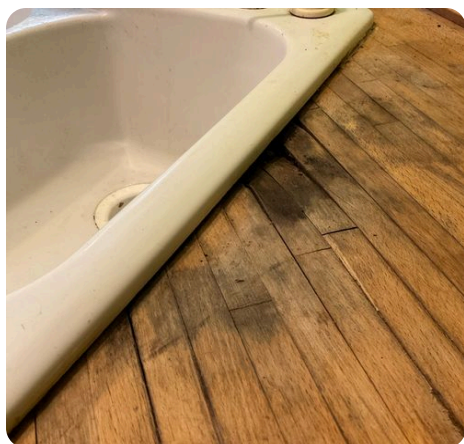
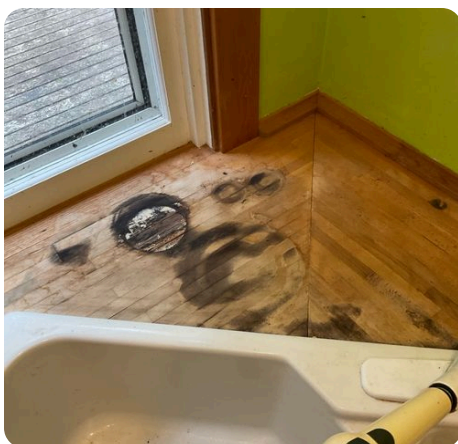
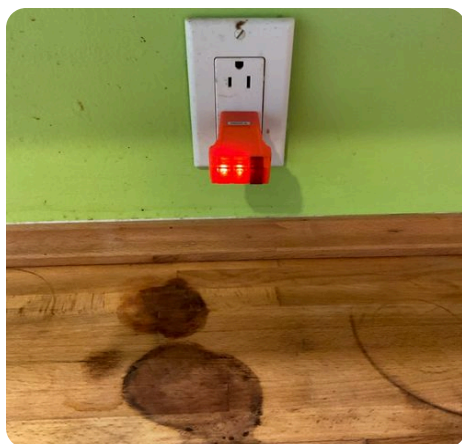
71 Damaged Countertops

Location: **Kitchen**

The countertops exhibit visible scratches, chips, or cracks on the surface, which can impact both the aesthetics and functionality of the area. It is important to address this issue by evaluating and repairing the damaged areas. Depending on the severity of the damage, contacting a qualified countertop professional may be necessary for repair or replacement.

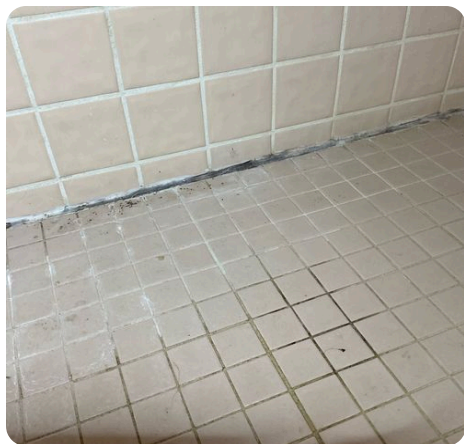
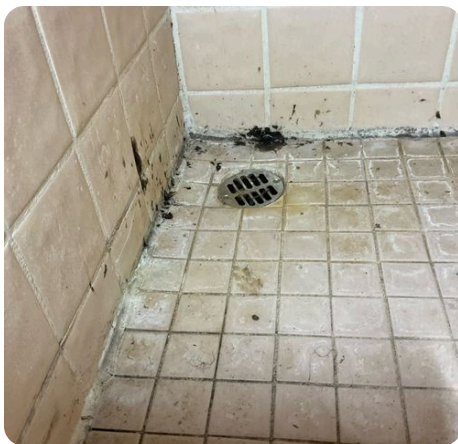
The presence of mildew in the grout can indicate excessive moisture levels in the area, which can lead to mold growth and potentially impact indoor air quality. It is recommended to evaluate and repair the grout by thoroughly cleaning it with a mixture of water and vinegar or a mildew cleaner, and ensuring proper ventilation to prevent future mildew growth.

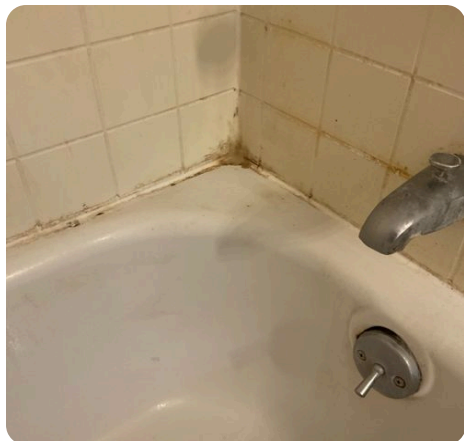
73 Shower Caulking Mildew Issue

The presence of mildew in the shower caulking should be addressed. Mildew not only looks unsightly, but can also indicate a damp environment which can lead to mold growth. It is recommended to evaluate the caulking, remove any mildew present, and recaulk the shower to prevent further issues. Ensure the shower area is well-ventilated after each use to discourage mildew growth in the future.

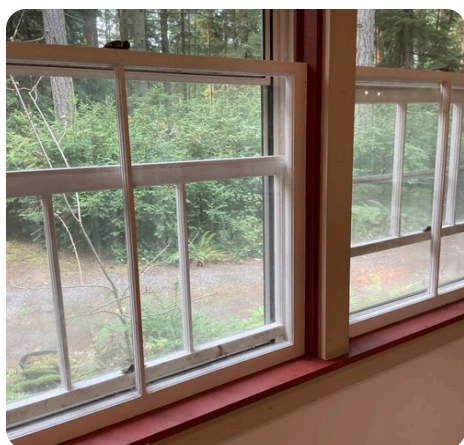
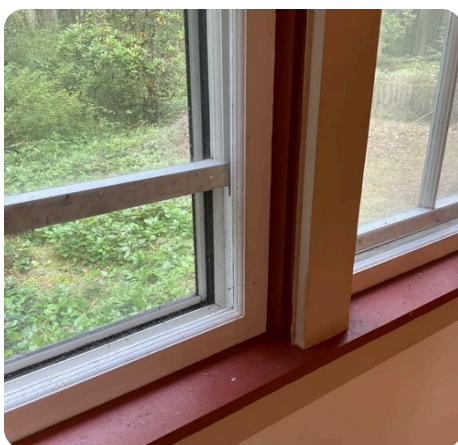
74 Painted Shut Window

The window is painted shut, which is common in older homes or windows that have not been opened for a long time. It is essential to be able to open windows for ventilation and emergencies. Having a qualified window contractor assess and fix the window is recommended to ensure smooth operation.

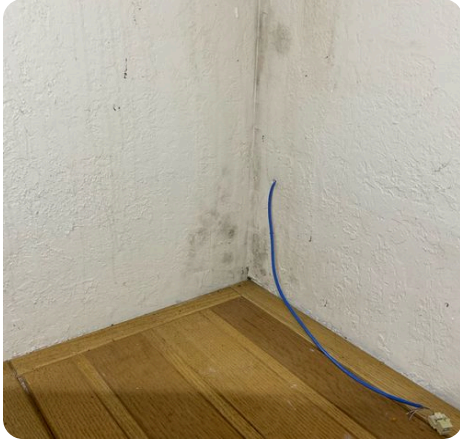
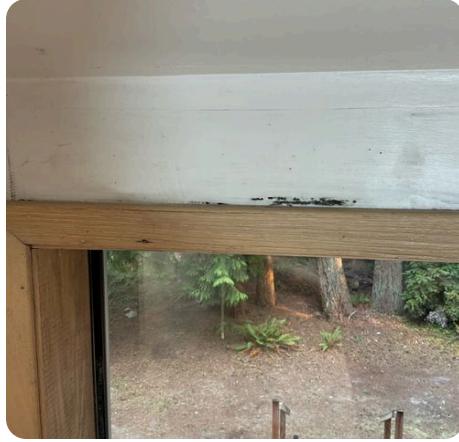
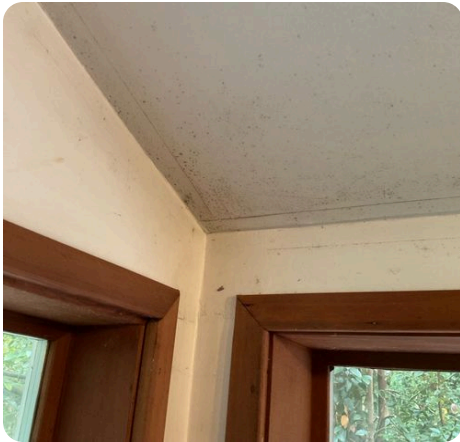
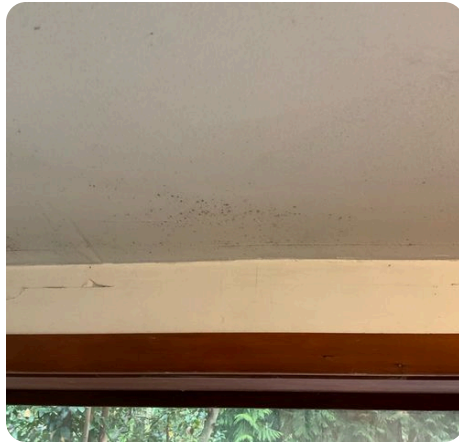
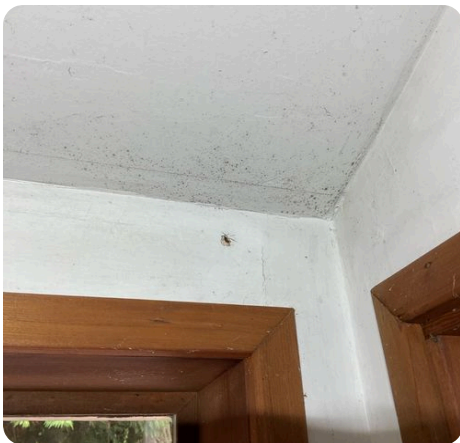
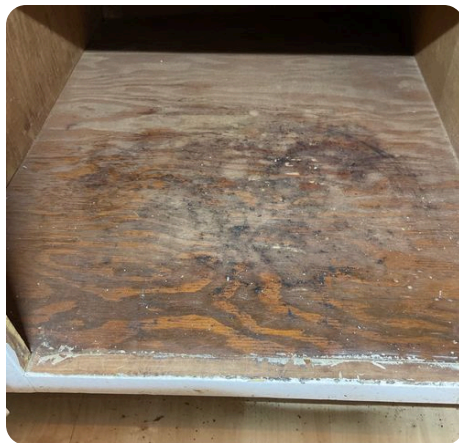
75 Mildew Presence Concerns

Mildew is present in multiple areas. It is recommended to address this issue promptly to prevent further growth and to maintain a healthy indoor environment. Evaluation and repair by a qualified mold remediation specialist may be necessary to effectively eliminate the mildew.

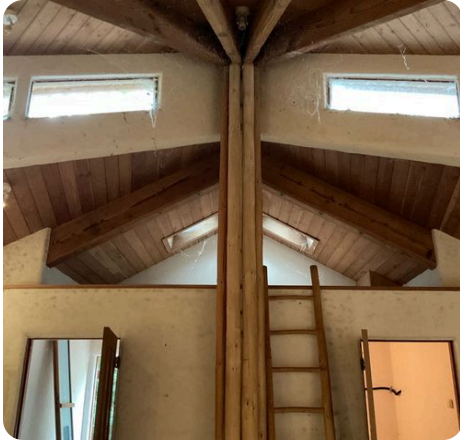
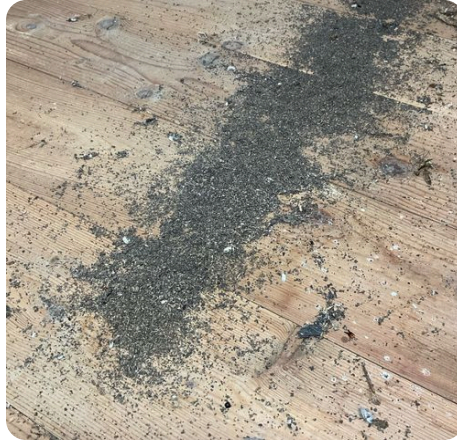
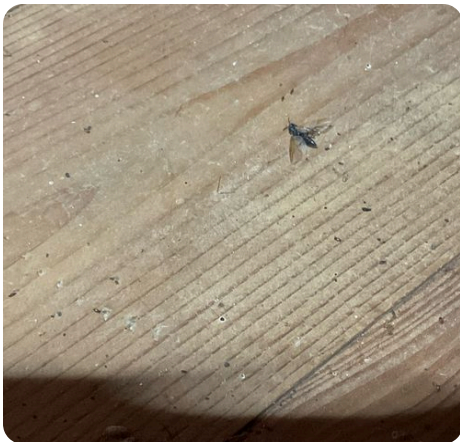
76 Carpenter Ant Frass And Carcasses

The presence of carpenter ant frass and carcasses indicates a possible infestation in the property. It is recommended to evaluate and address this issue promptly to prevent further damage to the structure. Hiring a licensed pest control professional can help in identifying the extent of the infestation and providing appropriate treatment to eliminate the ants.

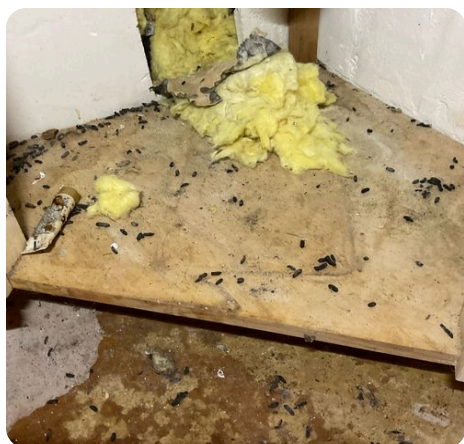
77 Evidence Of Rodents

The presence of rodent droppings in a property can lead to health hazards and damage. It is recommended to address this issue promptly to prevent further infestation. Contacting a licensed pest control professional for evaluation and extermination is advised.

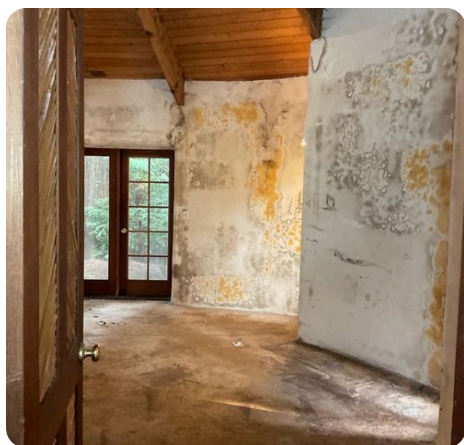
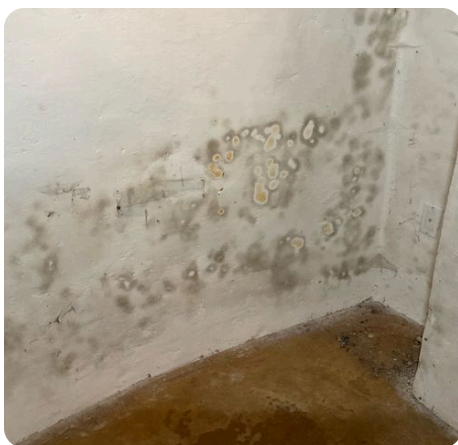
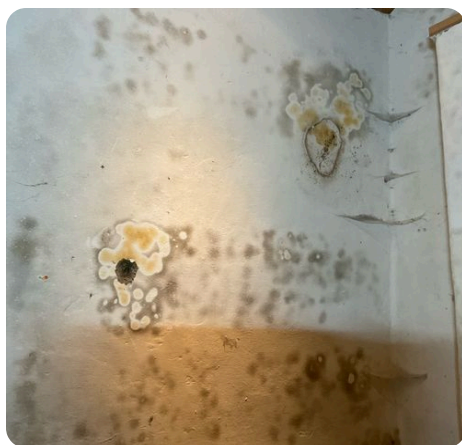
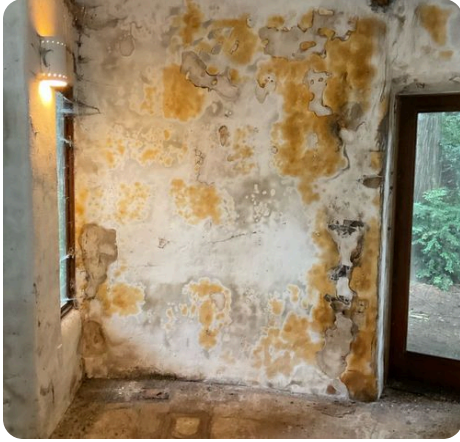
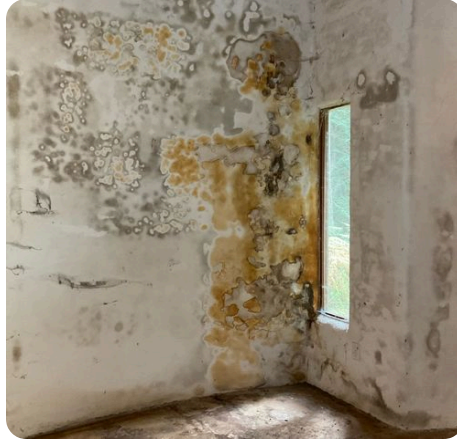
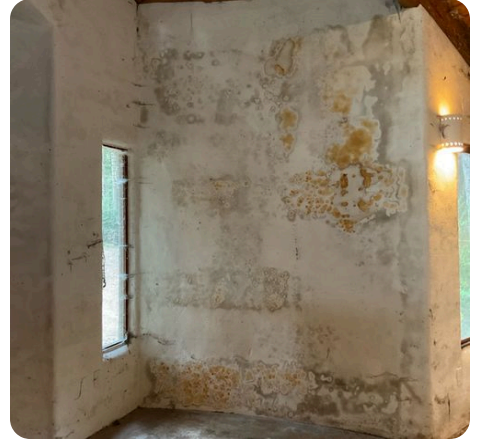
78 Mildew And Elevated Moisture Issue

The presence of mildew and elevated moisture on the walls is a sign of excessive moisture levels within the property. This can lead to mold growth and potential structural damage if not addressed. It is recommended to evaluate the ventilation in the affected area and repair any leaks or sources of moisture. A qualified contractor can help in identifying the root cause and providing solutions to prevent further moisture issues.

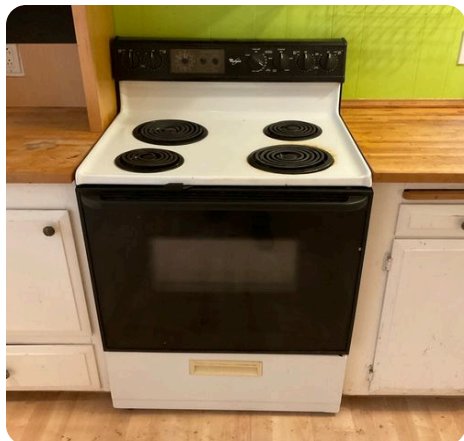
79 No Anti-Tip Bracket

There is no anti-tip bracket installed for the oven. This device prevents the oven from tipping forward in the event that something heavy is set on the open oven door. For added safety, the inspector recommends that a bracket be installed.

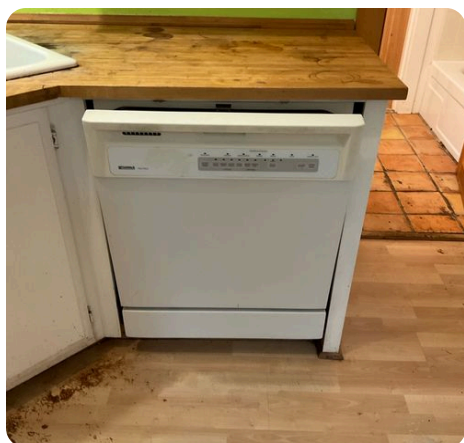
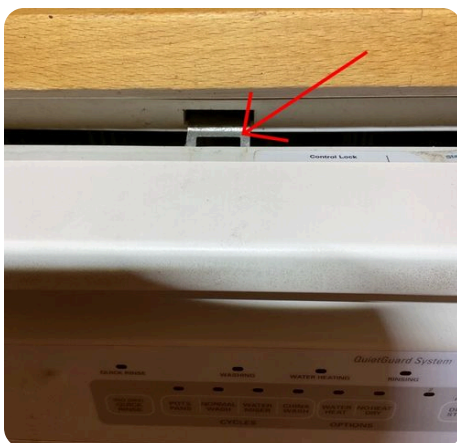
80 Door Not Closing

The dishwasher door is not closing properly. This issue can lead to water leakage during operation and may result in inefficient cleaning. Evaluate and repair the door latch or hinges as needed to ensure proper functionality. If the problem persists, consider contacting a qualified appliance repair technician for further assistance.

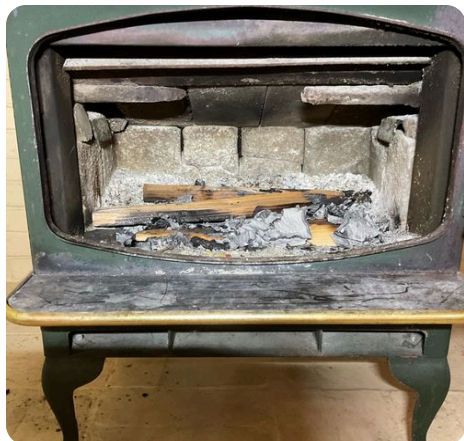
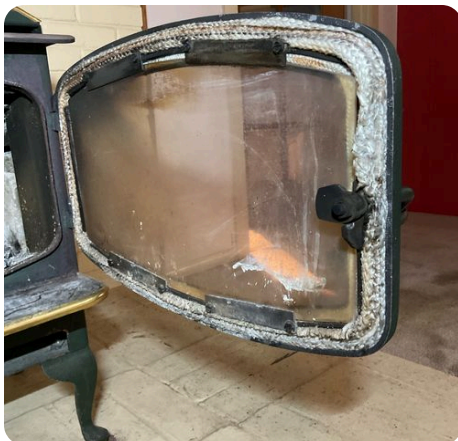
81 Wood Stove Cleaning Recommended

It is recommended to clean the wood stove to ensure proper functionality and prevent potential fire hazards. Soot and debris accumulation can restrict airflow and decrease efficiency. Consider hiring a professional chimney sweep for a thorough cleaning.
