Service: Pre-Listing Inspection

Prepared for: Amy Gulden

Aaron McBride

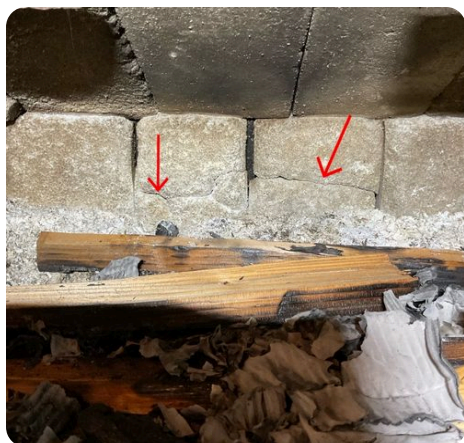
82 Cracked Fire Bricks In Firebox

The fire bricks at the backside of the firebox are cracked, which can lead to heat escaping and potential safety hazards. It is recommended to evaluate and repair the cracked fire bricks by a qualified mason or fireplace technician to ensure proper functionality and safety of the fireplace.

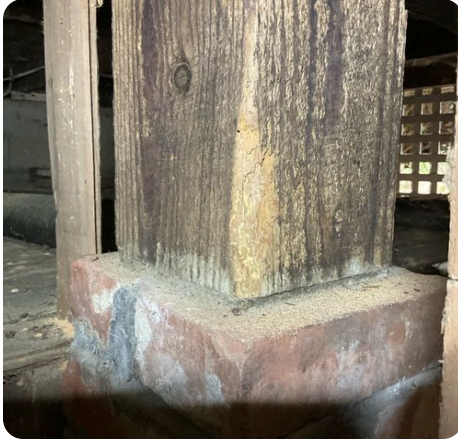
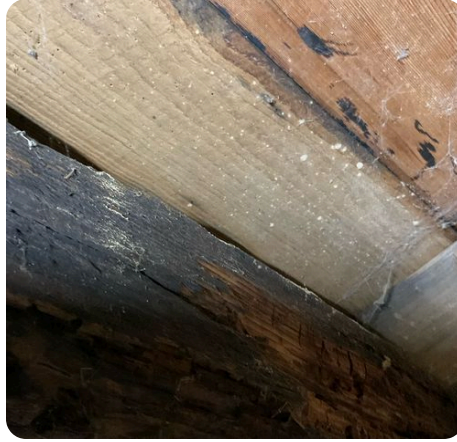
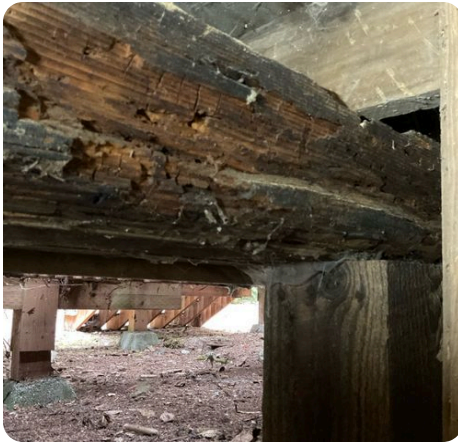
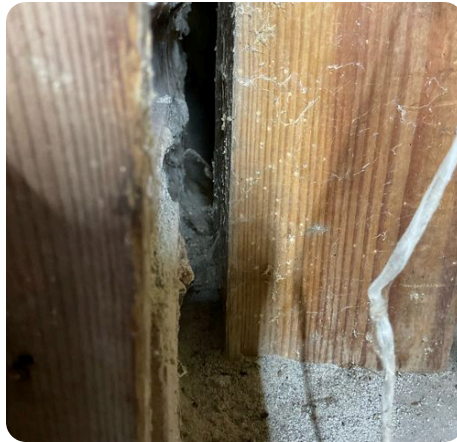
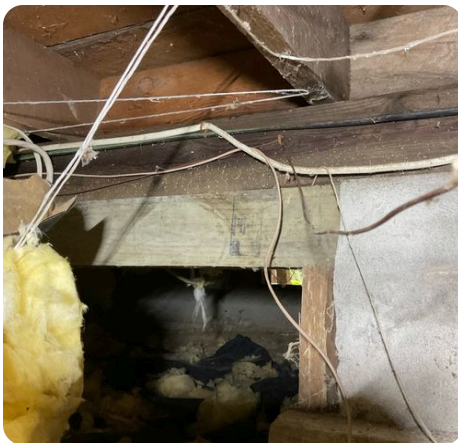
83 Insect Damage

The presence of insect damage in the structural components should be evaluated and repaired promptly. Insect damage can weaken the integrity of the beams, columns, or posts, potentially compromising the stability of the structure. It is recommended to consult with a licensed pest control professional to address the infestation and repair any damage to prevent further structural issues.

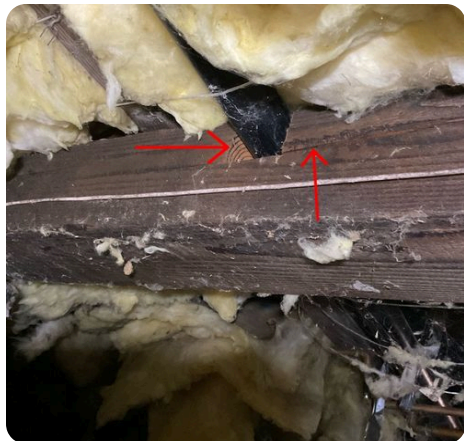
84 Improperly Notched Beam With Split

The beam in the property has been improperly notched, leading to a split. This issue compromises the structural integrity of the beam, which could affect the overall stability of the building. It is recommended to evaluate the extent of the damage and repair the beam promptly to prevent further deterioration. A qualified carpenter or structural engineer should be consulted for appropriate repairs to ensure the beam is properly reinforced.

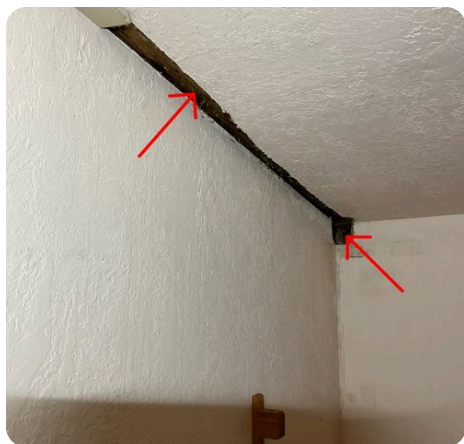
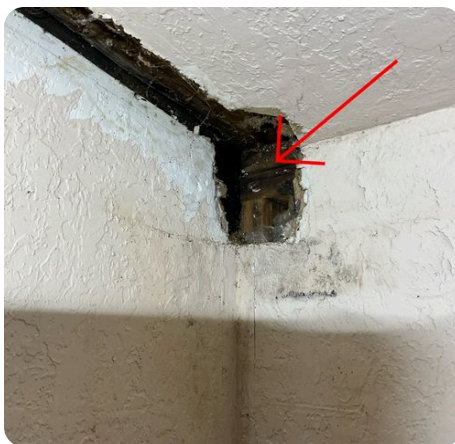
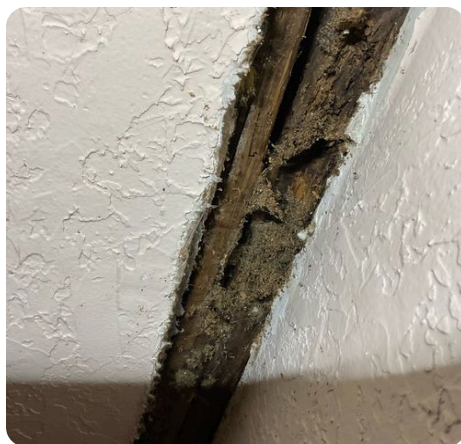
85 Deteriorated Rafter And Framing

The rafter and framing in the roof show signs of deterioration. This can compromise the structural integrity of the roof and may lead to further damage if not addressed. It is recommended to evaluate the extent of the deterioration and repair or replace the affected components as necessary. A qualified contractor should be consulted to ensure the repairs are done properly.

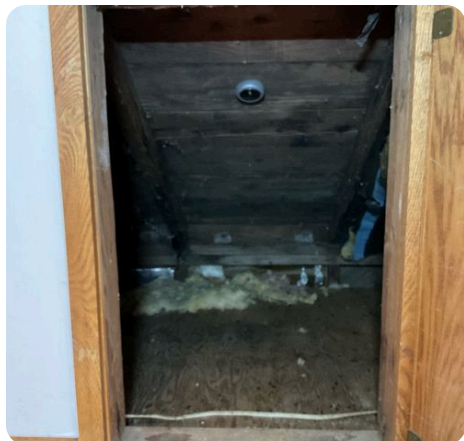
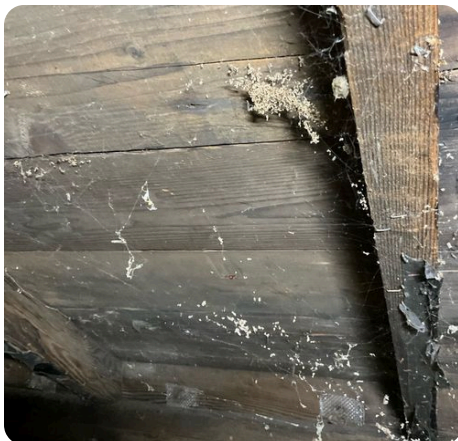
86 Insect Frass Issue

The presence of insect frass in the attic indicates a possible infestation. Insect frass, the excrement of wood-destroying insects like termites or carpenter ants, can lead to structural damage if left unchecked. It is recommended to contact a pest control specialist to evaluate the extent of the infestation and address it promptly to prevent further damage.

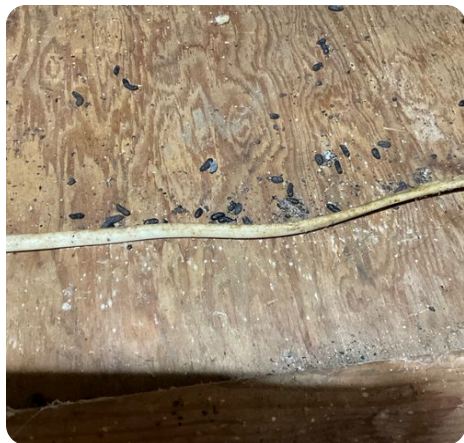
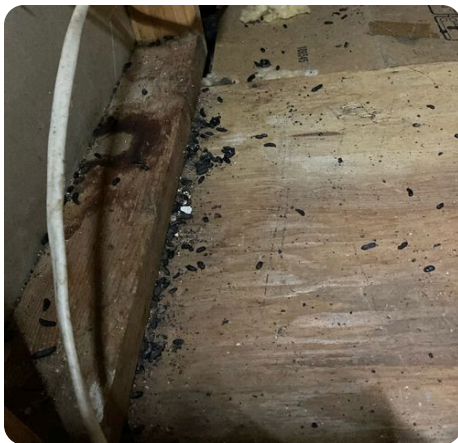
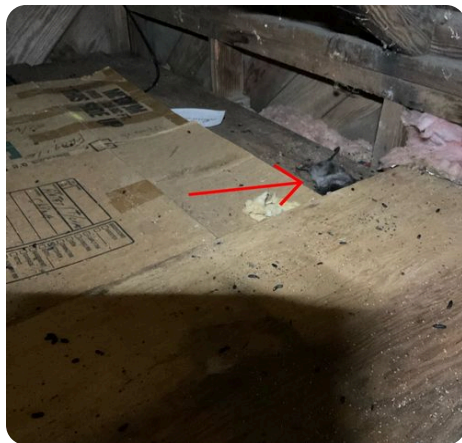
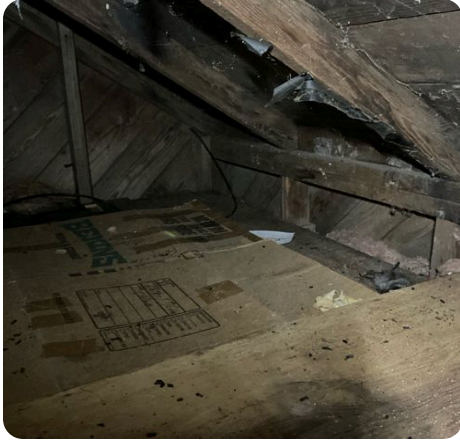
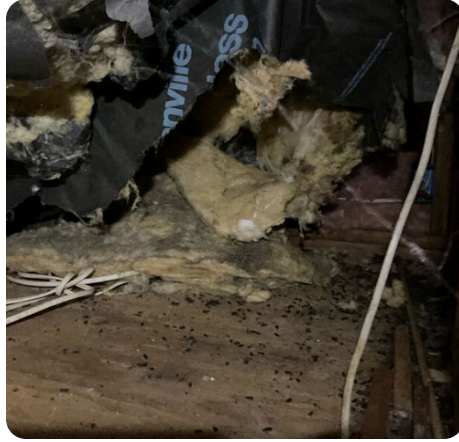
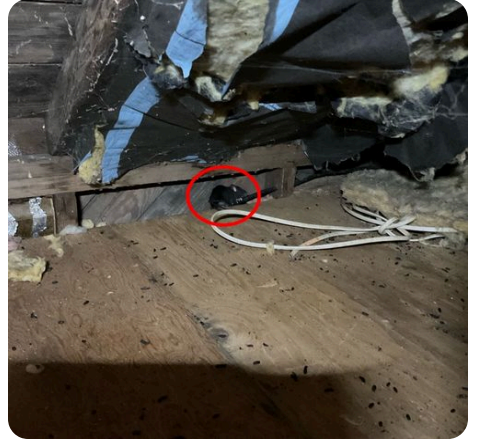
87 Rodent/Small Animal Activity

There was evidence of rodent/Small Animal activity in the insulation (visible droppings and/or trails). It could not be determined at the time of the inspection whether the activity was current, and no available access could be found. Extermination and control measures are recommended. Contact a qualified Pest Control Operator to evaluate and provide the appropriate control measures.

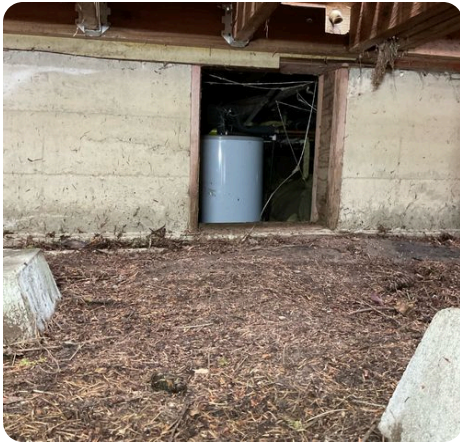
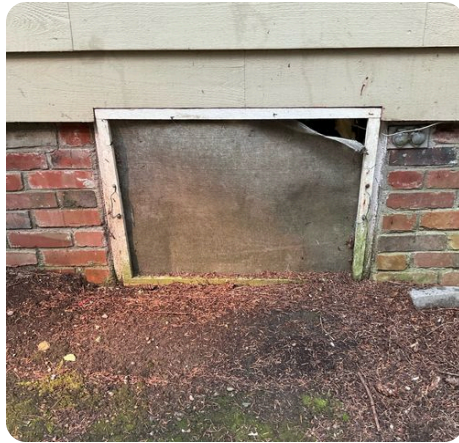
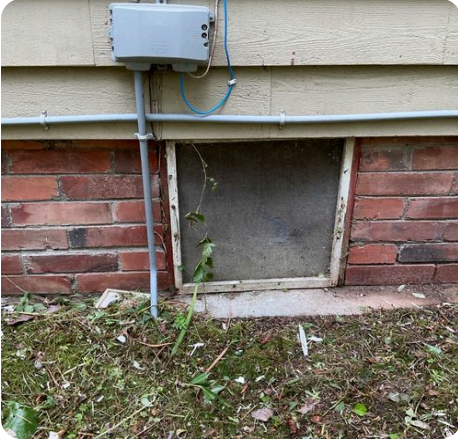
88 Insecure Crawlspace Access Covers

The Crawlspace access covers are not secure. This can lead to safety hazards, pest infestations, and energy inefficiency. It is recommended to secure the access covers properly to prevent these issues. You may consider installing locks or latches to ensure the covers are tightly sealed.

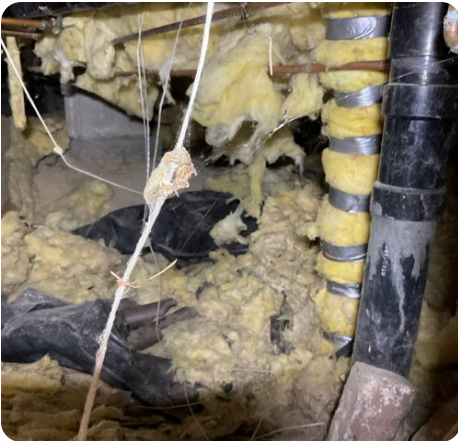
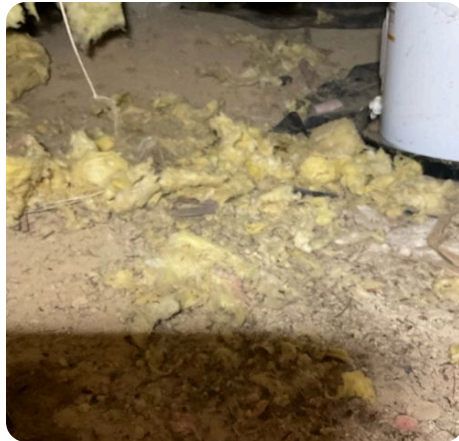
89 Rodent/Small Animal Intrusion

Evidence of rodent or small animal intrusion found in the crawl space. (Inspector visually saw raccoon in crawl space) This can lead to damage to insulation and potential health hazards. It is recommended to evaluate and repair any entry points or gaps in the crawl space to prevent further intrusion. Consider hiring a pest control professional to address the issue and ensure the crawl space is properly sealed to prevent future infestations.

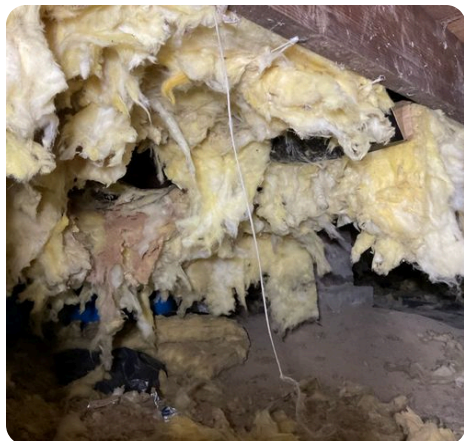
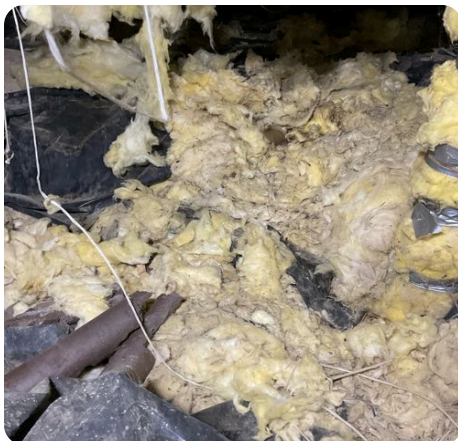
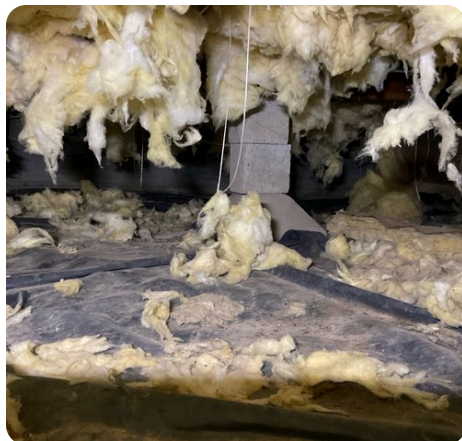
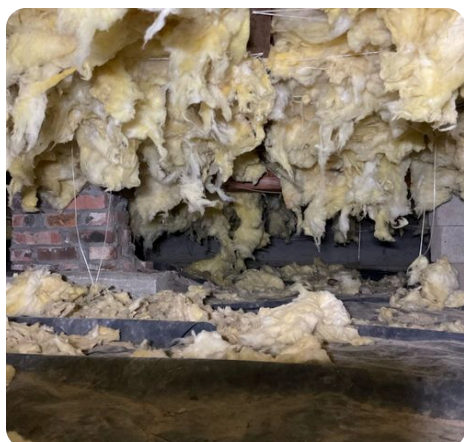
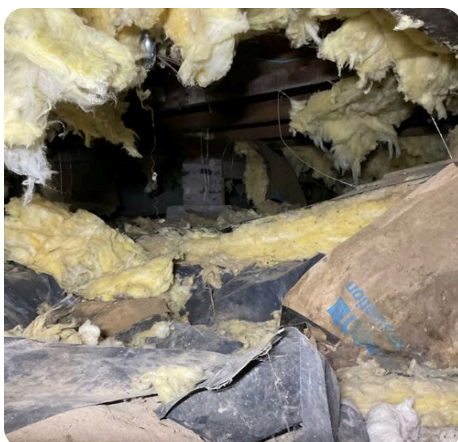
90 Old Vapor Barrier

The vapor barrier in the crawl space appears to be old. It is recommended to evaluate and replace the vapor barrier with 6 mil black vapor barrier to ensure proper moisture control and insulation effectiveness. Qualified professionals such as insulation contractors can assist with this replacement.

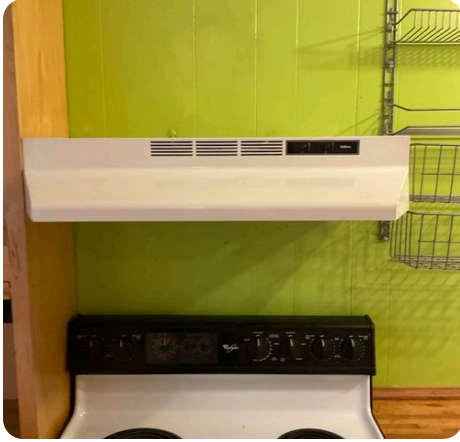
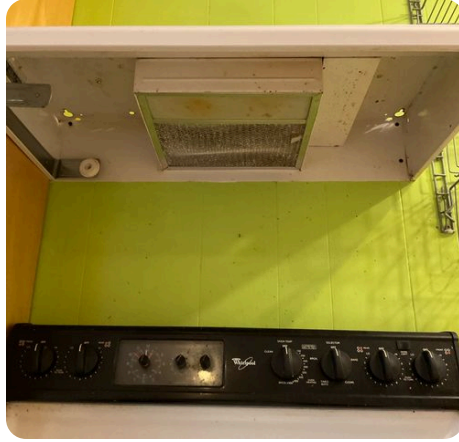
The vent fan should be properly vented to the outdoors to effectively remove cooking odors, moisture, and airborne grease. Recirculating the vent fan may not be as efficient in improving indoor air quality. It is recommended to evaluate the current setup and consider rerouting the vent to exhaust outside to enhance ventilation.

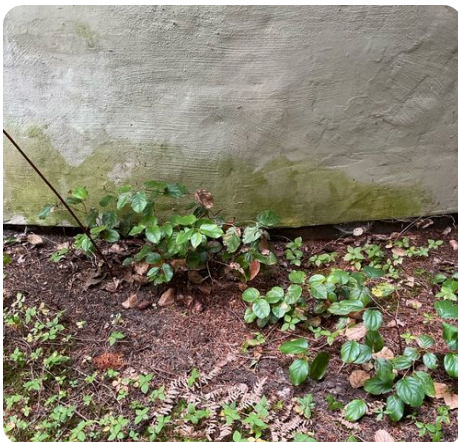
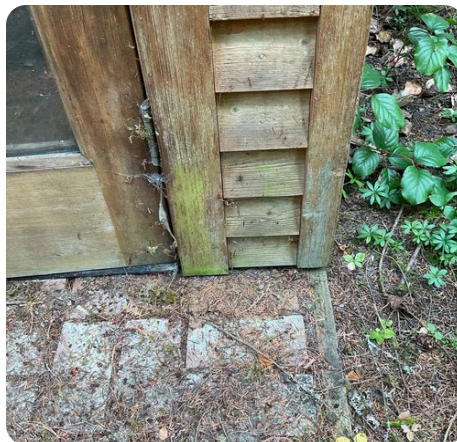
The presence of mildew and lichen on the siding can indicate excessive moisture levels, which may lead to degradation of the siding material over time. It is recommended to evaluate and address the moisture source to prevent further growth and potential damage. A qualified contractor can assist in properly cleaning and treating the affected areas to restore the exterior appearance of the property.

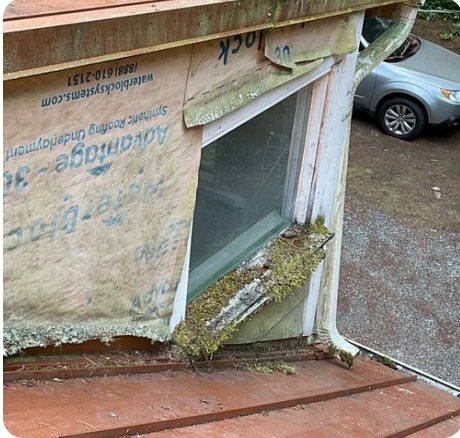
Unfinished Siding

The siding on the house appears to be unfinished. This can lead to moisture penetration, which may result in water damage and mold growth. It is recommended to evaluate and repair the unfinished siding to prevent further damage. A qualified siding contractor can help in completing the siding installation properly to ensure the protection of the exterior walls.

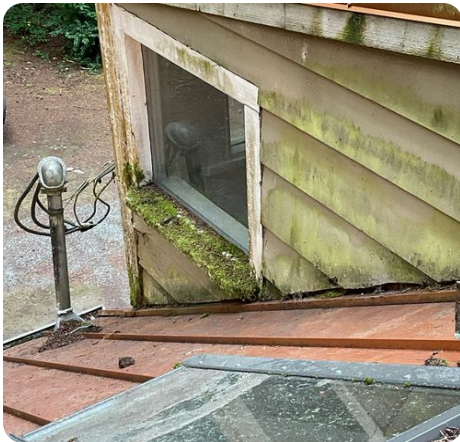
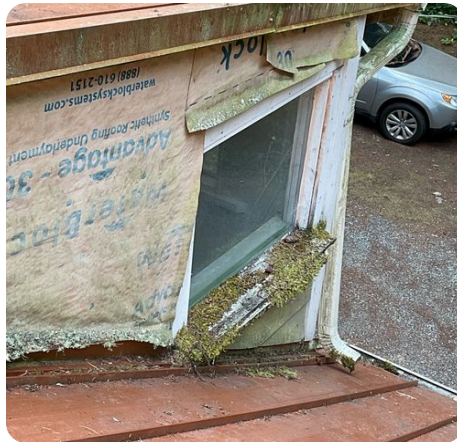
Trim With Moss Growth

The trim on the exterior of the property shows signs of deterioration and moss growth. It is recommended to address this issue promptly to prevent further damage and maintain the aesthetic appeal of the home. A qualified carpenter or general contractor can evaluate the extent of the damage and repair or replace the trim as needed. To prevent future moss growth, ensure proper drainage and sunlight exposure in the area.

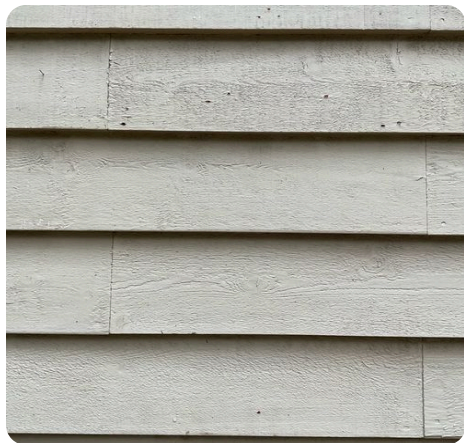
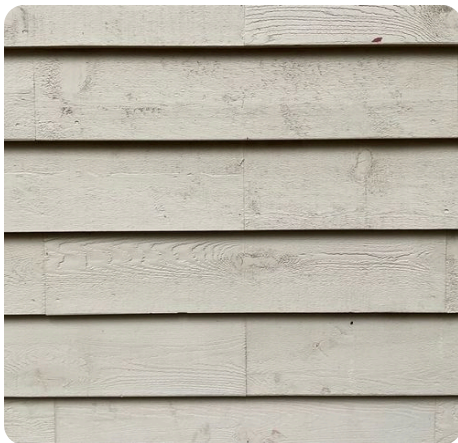
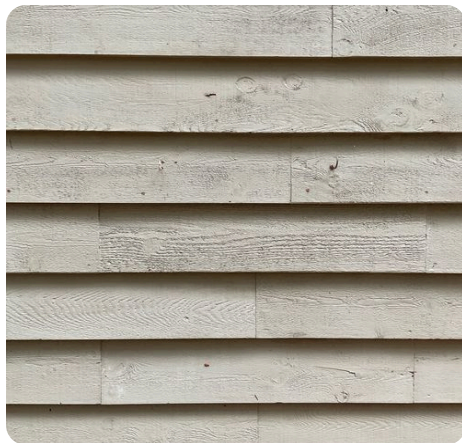
Siding Functional

The siding material appears to be in an overall functional condition. A program of regular/routine maintenance is recommended to maintain the integrity of the caulking around the windows, doors, nail holes, and gaps between the siding boards as well as periodic painting or surface refinishing to provide long-term protection. Note: This is a non-invasive inspection and the inspector cannot see conditions behind the siding material.

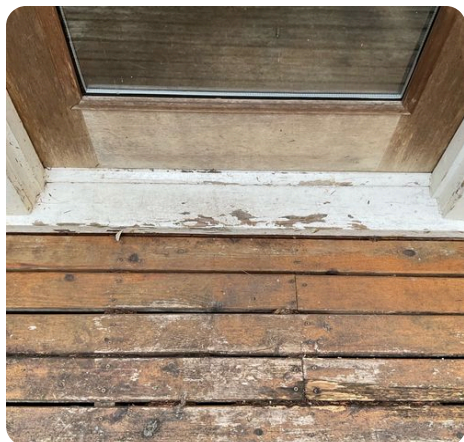
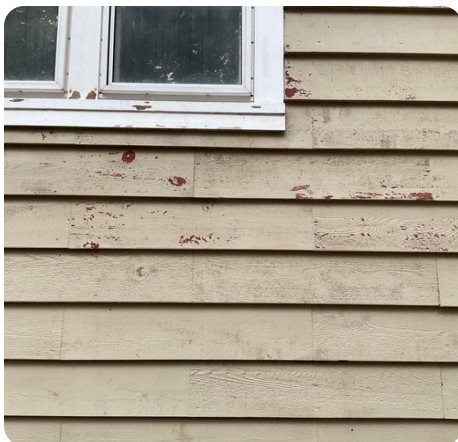
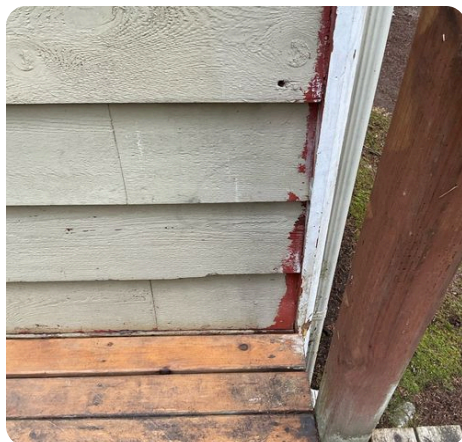
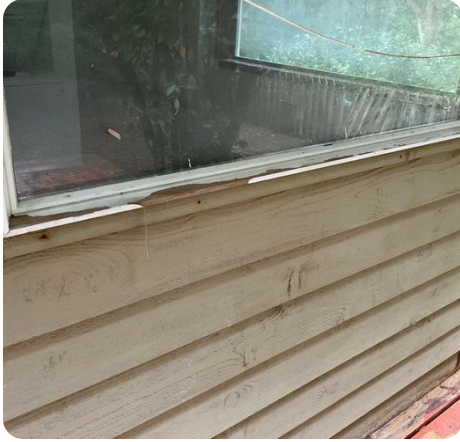
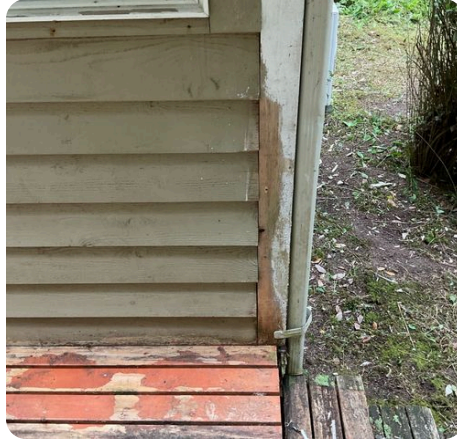
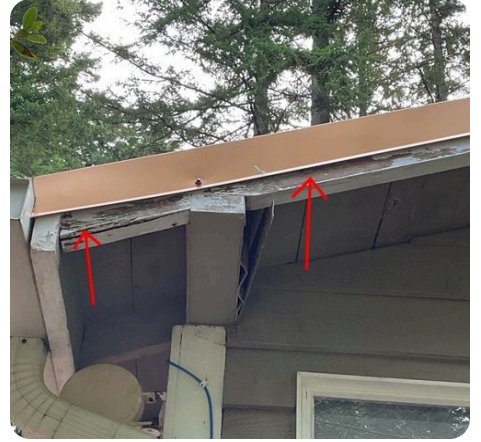
Exterior Touchup Paint

The exterior of the property shows signs of wear and tear with areas of chipped or faded paint observed. It is recommended to evaluate and repair the affected areas by touching up the paint to maintain the aesthetics and protect the surfaces from weather damage. Hiring a qualified painter for the paint touchup is advised for a professional finish.

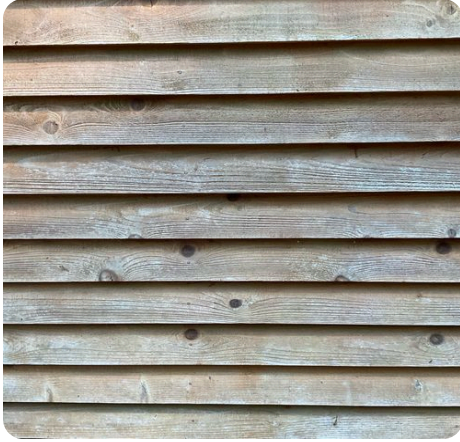
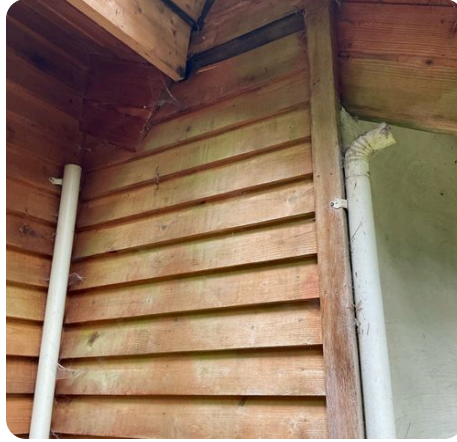
Location: Detached Studio

The exterior sealant on the surfaces is faded. This can lead to reduced protection against moisture intrusion and may result in damage to the underlying structure. It is recommended to evaluate the sealant and reapply as necessary to maintain the integrity and weather resistance of the surfaces. A qualified contractor can assist with this task.

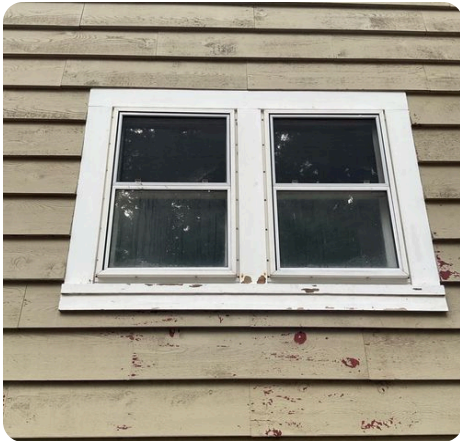
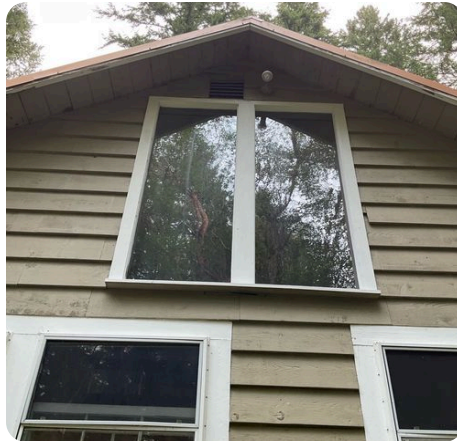
Location: Main House, Multiple Locations

Failed Seals On Storm Windows

The storm windows show signs of a failed seals. This can lead to decreased energy efficiency and potential water leaks. It is recommended to replace the seal or consider recaulking around the edges to prevent further damage.

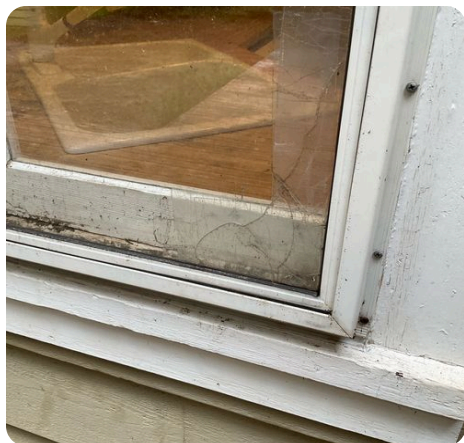
Location: Main House, Kitchen

Broken Glass Pane

There is a broken window pane at the structure. Replacing the glass pane is needed to provide proper security and for preventative safety measures. Repairs are recommended by a qualified glass company.

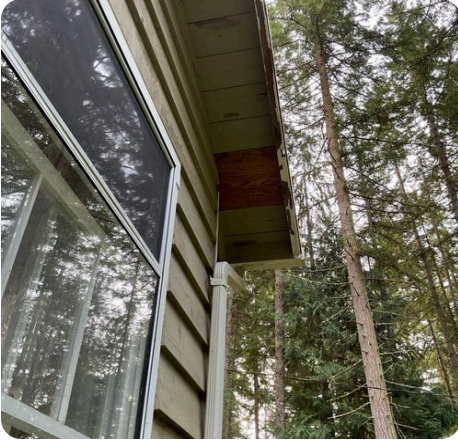
Location: Main House

Unfinished/Unpainted Soffits

The soffits were found to be unfinished. It is recommended to properly prep and paint these areas to protect the wood from weathering and prolong its lifespan. A qualified painter or carpenter can assist with evaluating and repairing these issues.

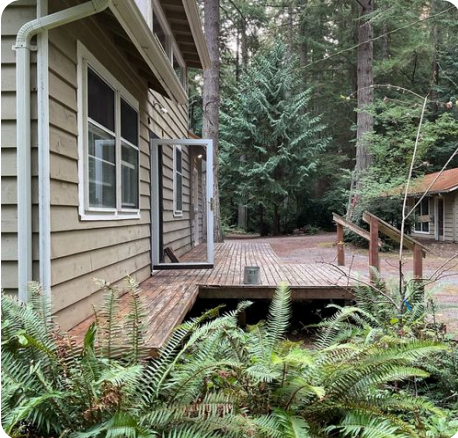
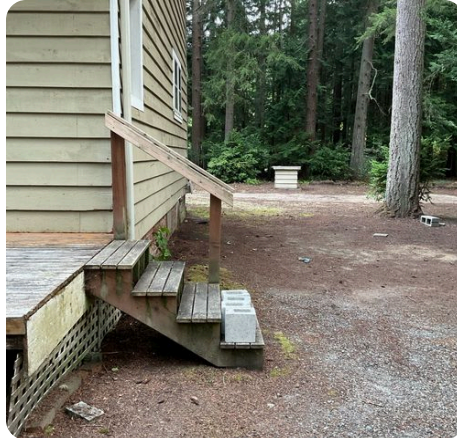
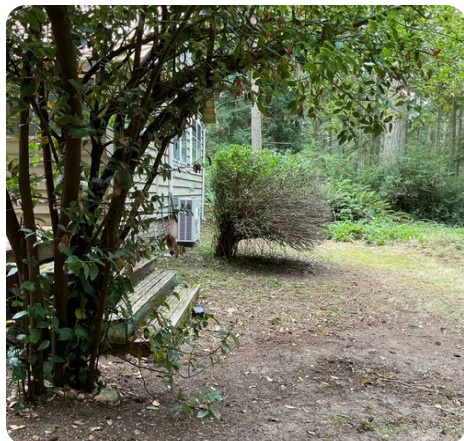
Grading Recommendations

The grading around the perimeter of the foundation should be maintained to adequately drain excessive surface and roof runoff water away from the structure. Due to the soil type and/or amount of water from surrounding areas, even flat lots may hold water. It is recommended that the grade slope away from the structure at least 6" for the first 6'-10' away from the foundation.

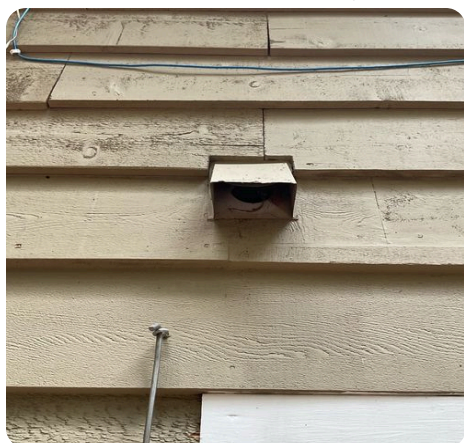
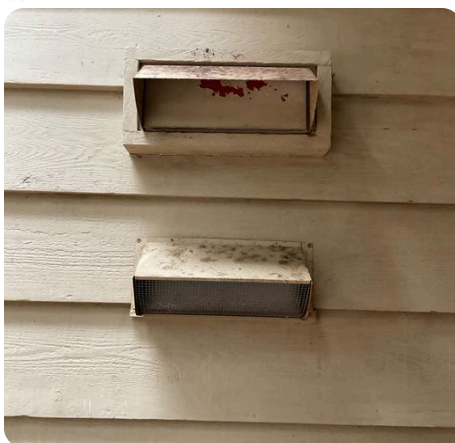
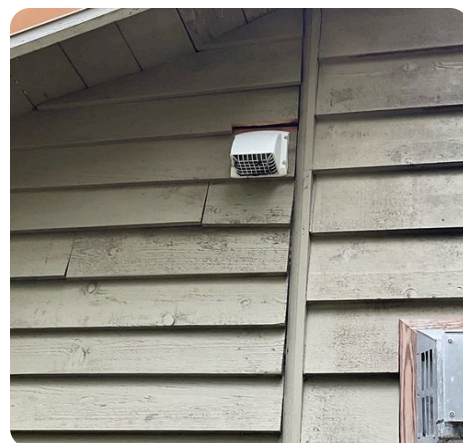
Location: Main House

The exhaust hoods, vents, and other penetrations appeared to be serviceable.

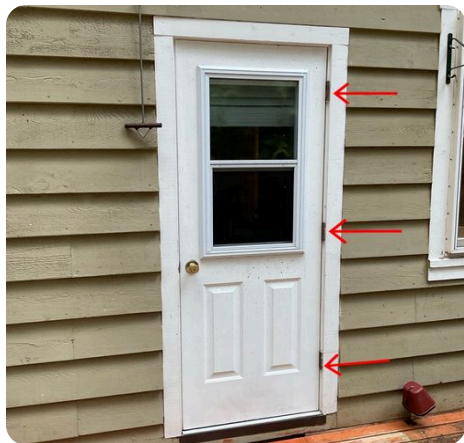
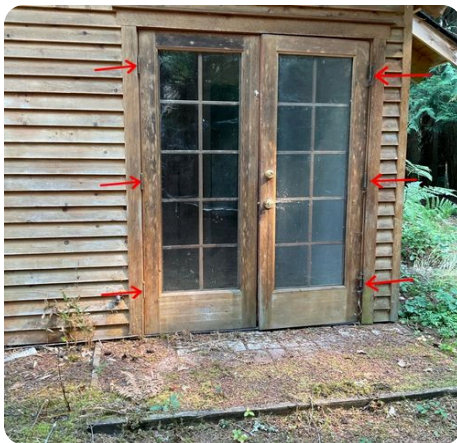
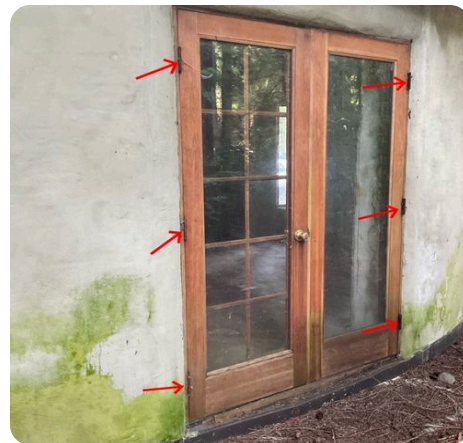
Door Hinge Pins Exposed

The exterior door(s) appear to be functional; however, further investigation may be needed to determine if the doors were properly installed. By having the hinges on the exterior of the door, removal of the pins could allow the doors to be pulled open and access be gained. Contact a qualified trade for evaluations.

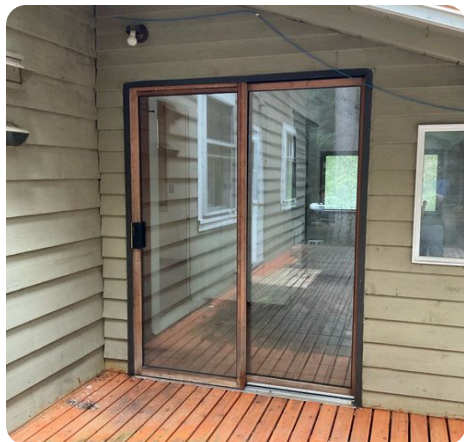
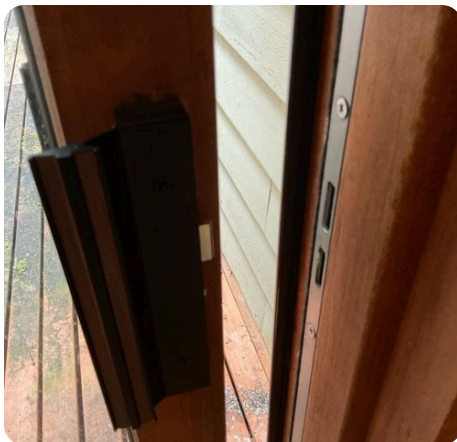
Location: Main House

Sliding Glass Door Lock Damage

The sliding glass door lock is damaged. Evaluate and repair the lock to ensure proper security and functionality. It is recommended to consult a qualified locksmith to repair or replace the damaged lock for optimal safety.

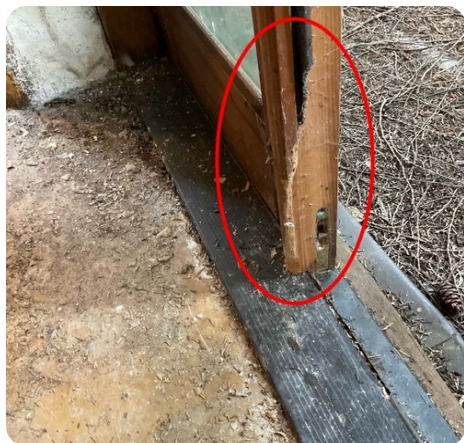
Location: Detached Studio

Damaged Weather Stripping

Damaged or missing weather stripping was noted at the exterior door. Having the affected weather stripping replaced is recommended to help prevent moisture penetration and heat loss.

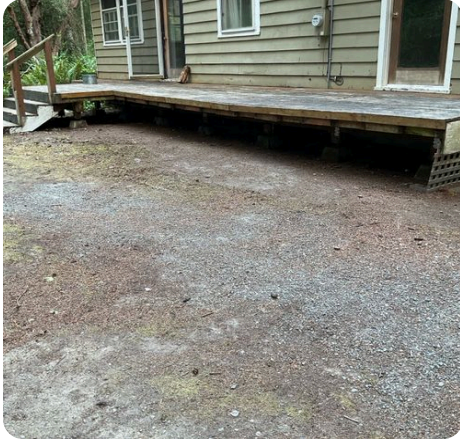
Location: Front Deck

Lag Bolts Not Present

The current structure does not appear to be lag bolted or positively anchored. Proper anchoring is essential for supporting both vertical and lateral loads, as nails or toe-nails are prone to withdrawal. It is recommended that all elevated structures be properly lag bolted as a preventative safety measure. Consult with your local jurisdiction department for current requirements and contact a qualified building contractor for repair estimates.

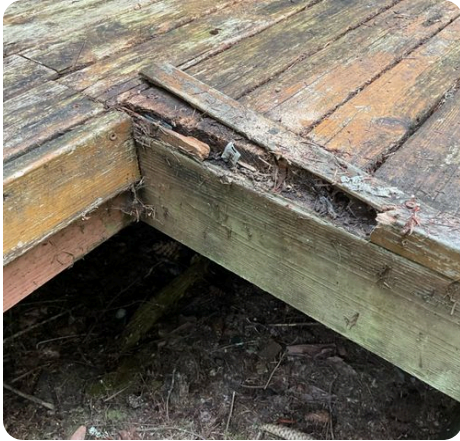
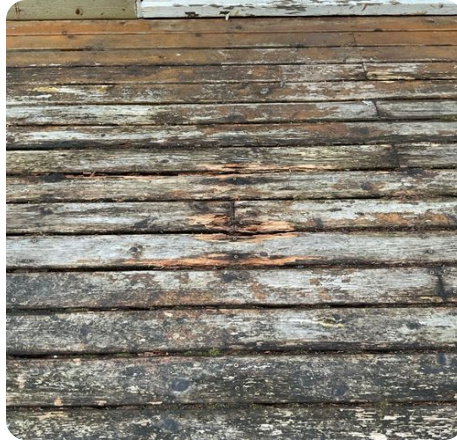
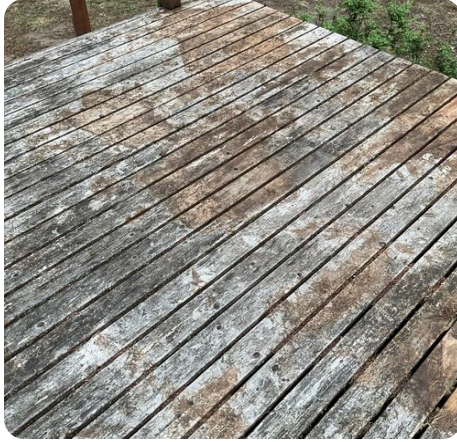
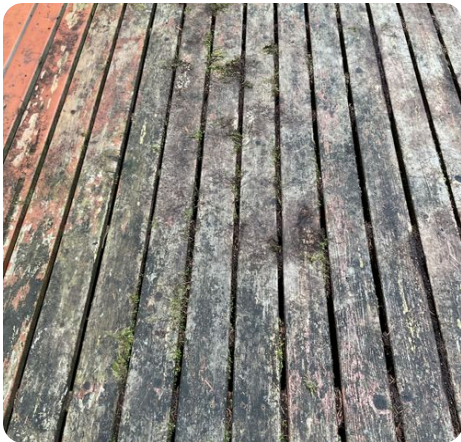
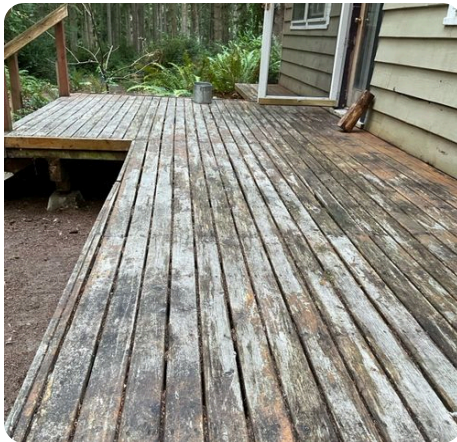
Location: Front Deck, Rear Deck

Deteriorated Deck Boards

The inspector noted that the surface is in need of repairs. There were some deteriorated boards noted. We recommend evaluating all of the decks and replacing the deteriorated boards to prevent any further issues. Any repairs should be completed by a qualified professional.

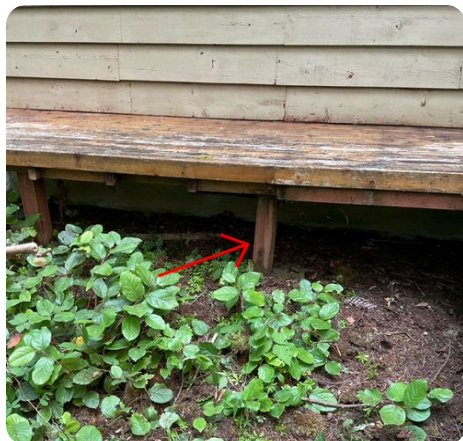
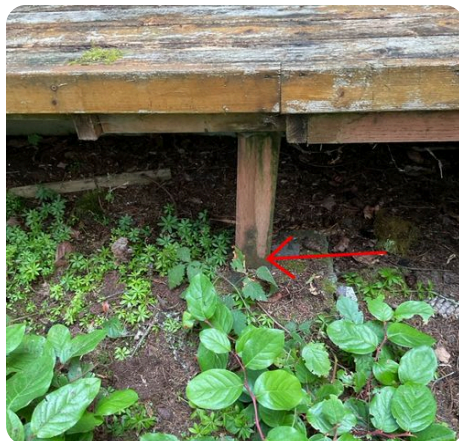
Location: **Front Deck**

Loose Post

The deck has a loose post. This issue can lead to structural instability and compromise the safety of the deck. It is recommended to evaluate and repair the post promptly to prevent any further damage or safety hazards. A qualified contractor should be hired to properly secure the post to ensure the stability of the deck.

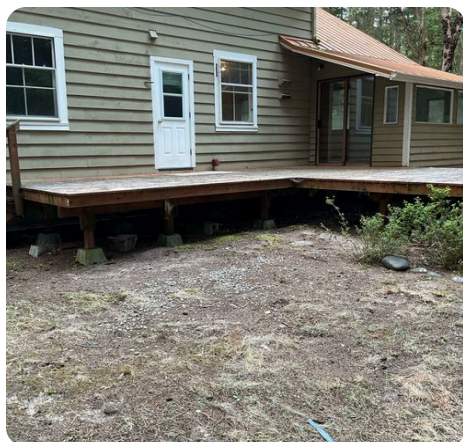
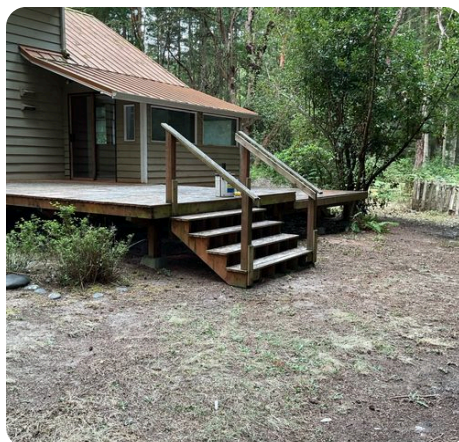
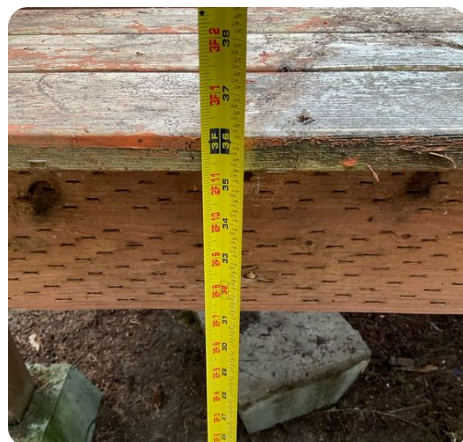
Location: Rear Deck

Railings Issue

The missing railings pose a safety hazard by not providing necessary support and fall protection. It is recommended to install railings in compliance with building codes to ensure the safety of occupants, especially in elevated areas. Evaluation and repair by a qualified contractor are advised to prevent accidents.

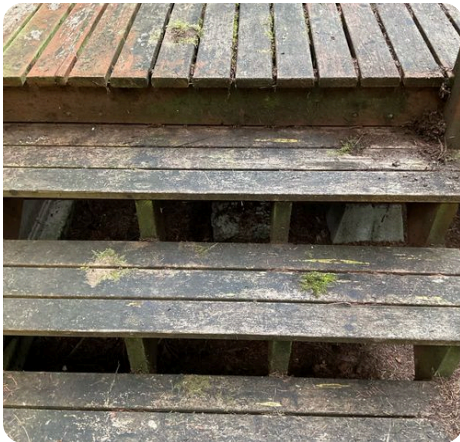
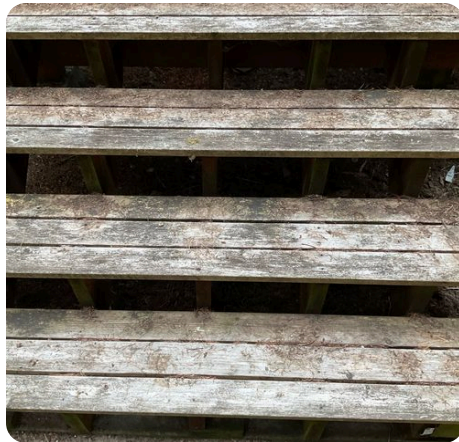
Location: Rear Deck, Front Deck

Damaged Steps

Damage to the steps was observed, which could present a safety hazard. It is important to have a qualified contractor evaluate and repair the damaged steps promptly to prevent accidents or further deterioration.

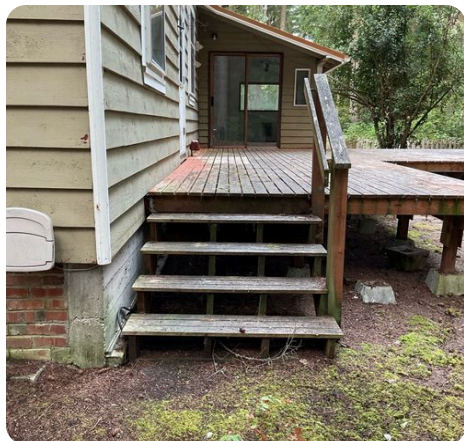
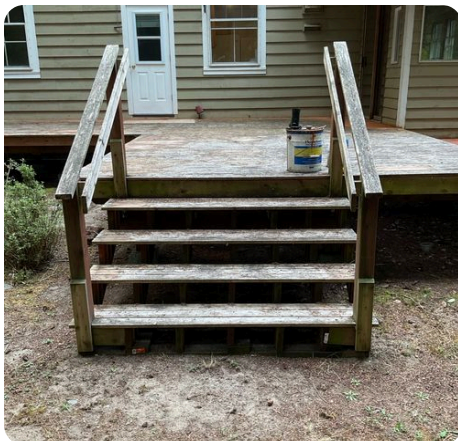
Location: Rear Deck

Weathered Steps Evaluation

The steps on the deck appear weathered, which can impact their structural integrity and safety over time. It is recommended to have a qualified carpenter evaluate the steps for any signs of rot or damage. Repairing or replacing the weathered steps will help ensure the safety of individuals using the deck.

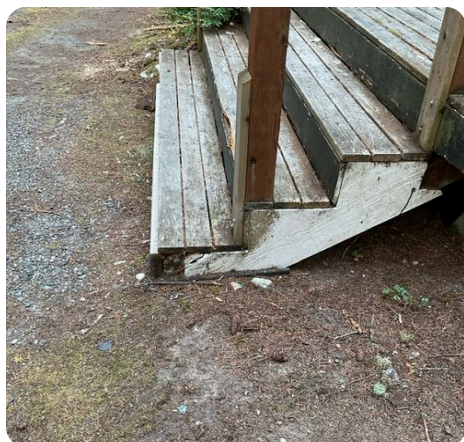
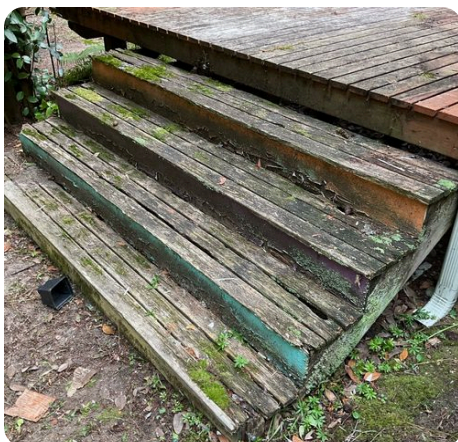
Wood/Ground Contact

The front and back deck steps are in contact with the ground beneath them. This is a conducive condition that can lead to pest infestation. There should generally be at least 4-6 inches of clearance between non-pressure treated wood and the ground to prevent moisture wicking and deterioration. No deterioration appeared to have occurred thus far; however, providing clearance would assist in preventing future deterioration.

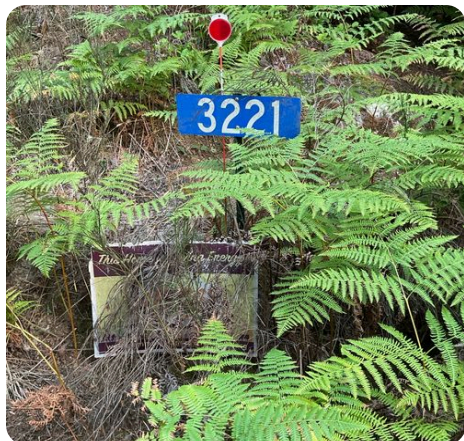
The address on the post is clearly visible from the street.

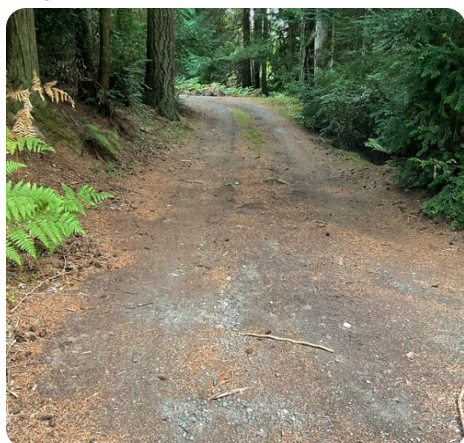
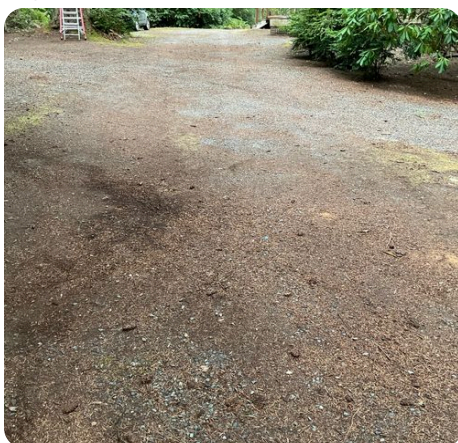
Gravel Driveway Inspection

The gravel driveway was serviceable at the time of inspection.

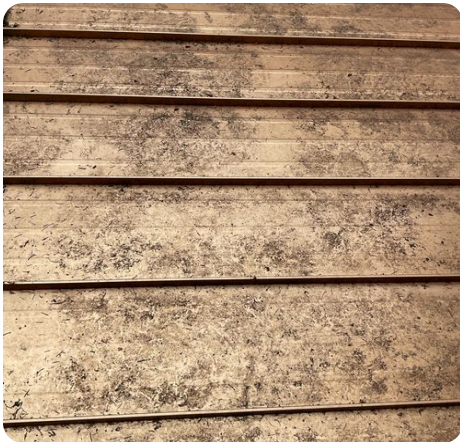
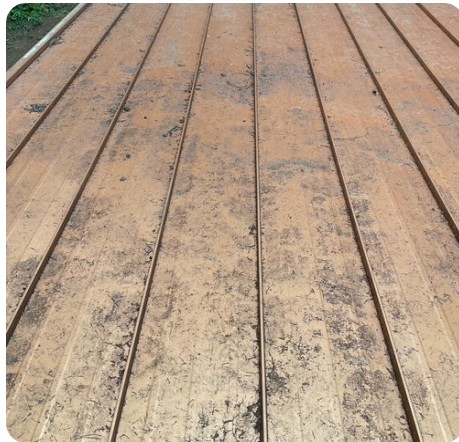
Location: Main House

Moss Growth Issue

The presence of moss growth on a metal roof can trap moisture, leading to potential water damage and corrosion. It is recommended to evaluate and remove the moss to prevent further deterioration of the roof surface. A qualified roofing contractor can address this issue by safely cleaning the moss and applying treatments to inhibit regrowth. Additionally, ensuring proper ventilation and sunlight exposure can help prevent future moss growth.

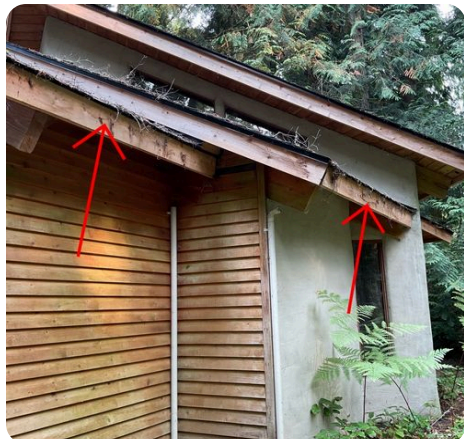
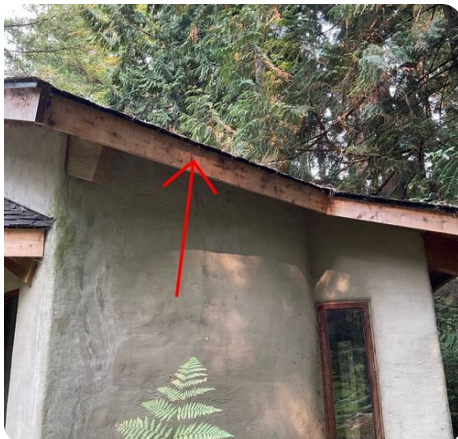
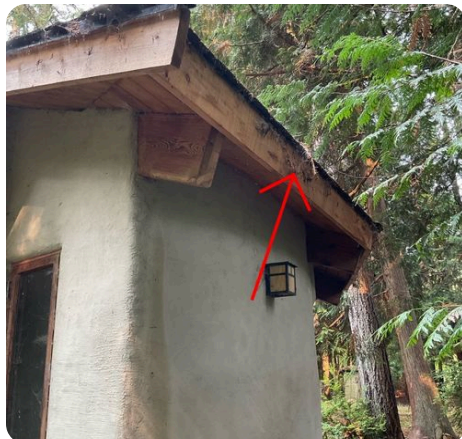
Location: Detached Garage, South Side

Missing Gutters

There are areas on the roof where gutters are missing. Gutters play a crucial role in directing water away from the foundation of the house, preventing potential damage. Evaluating and repairing these missing gutters is recommended to ensure proper drainage and prevent water issues. A qualified gutter specialist should be contacted for further evaluation and installation if needed.

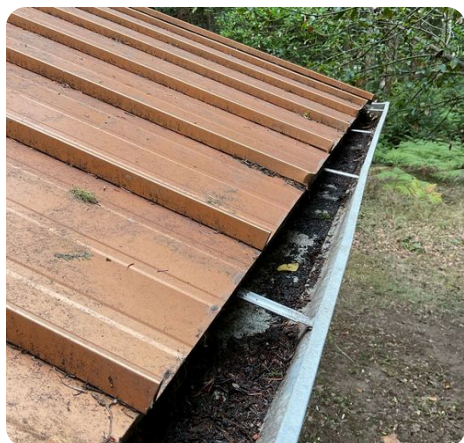
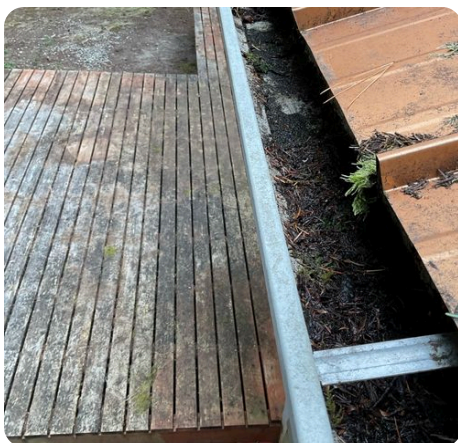
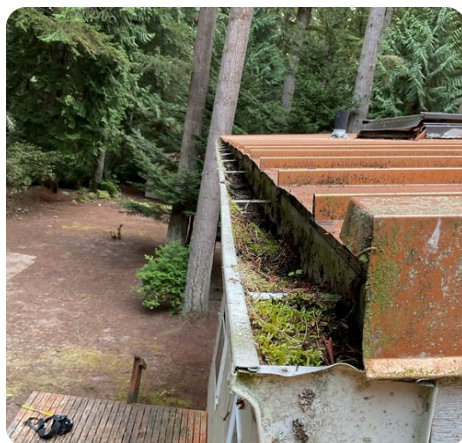
Location: **Detached Garage**

Loose Gutter

There is a loose gutter on the roof area, which may cause water overflow and potential damage to the surrounding areas. It is recommended to evaluate and repair the loose gutter to ensure proper functionality and prevent any future issues. A qualified gutter repair professional should be contacted for further assistance.

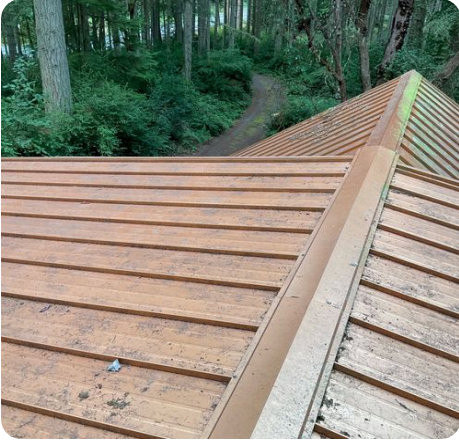
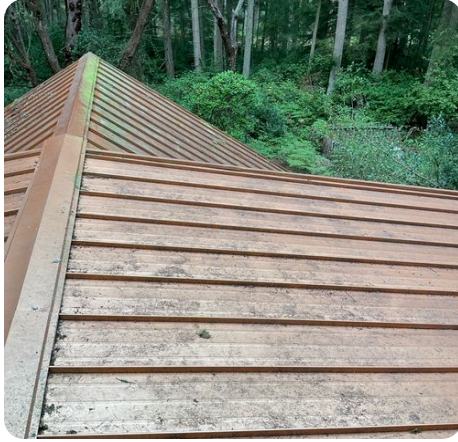
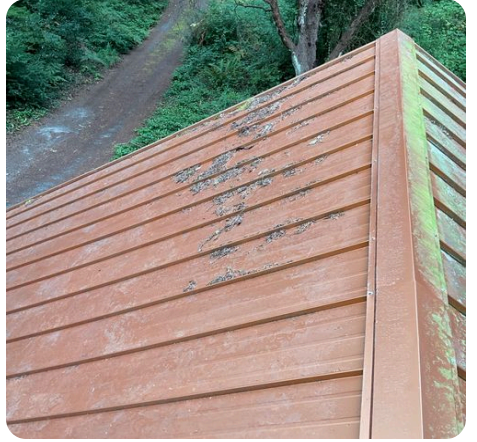
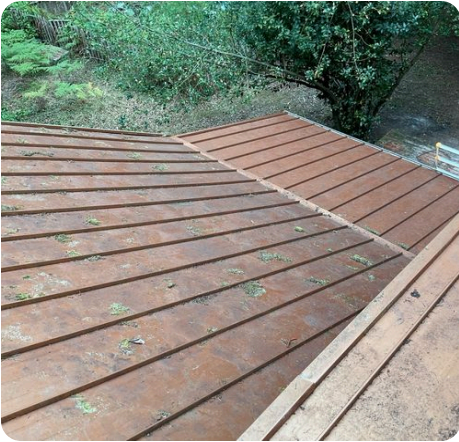
Location: Detached Garage

The roof cover was evaluated from the rooftop. It is recommended to periodically inspect the roof cover for any signs of damage or wear to ensure its functionality and prolong its lifespan.
