Service: Pre-Listing Inspection

Prepared for: Amy Gulden

Aaron McBride

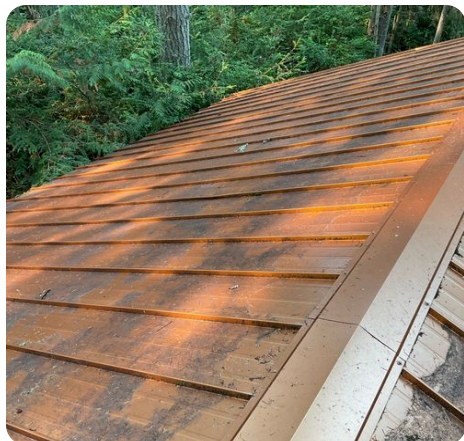
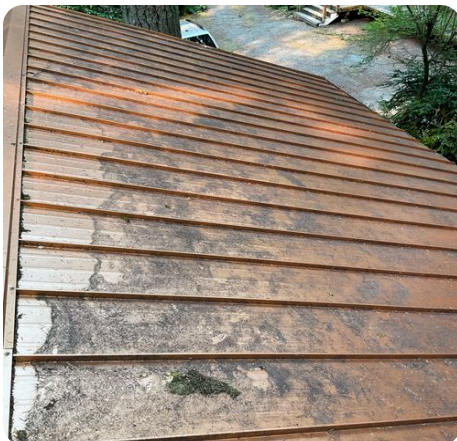
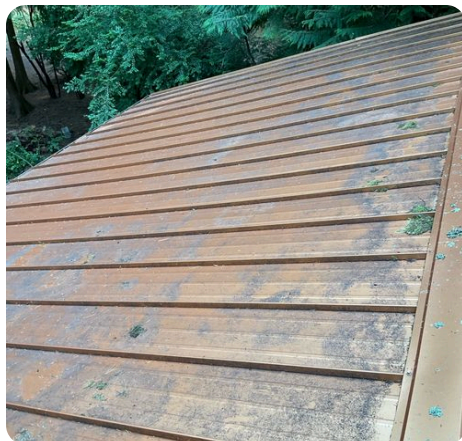
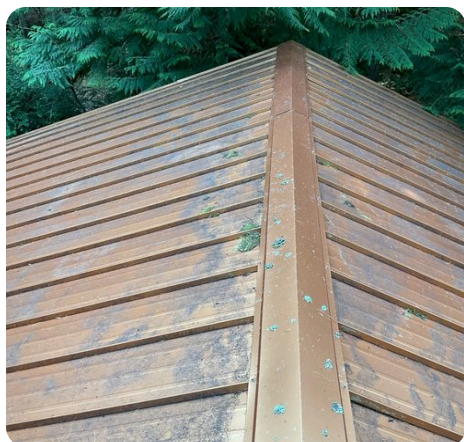
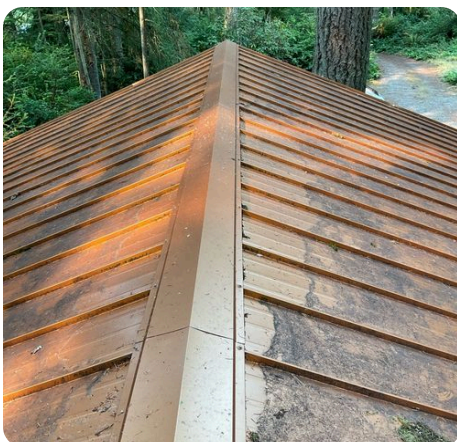
The roof cover was evaluated from the rooftop. It is recommended to periodically inspect the roof cover for any signs of damage or wear to ensure its functionality and prolong its lifespan.

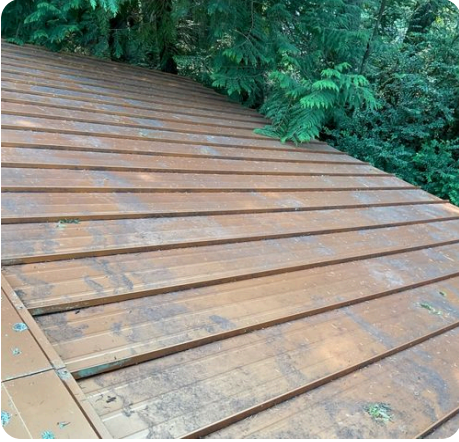
Location: Detached Garage

The overhanging branches in contact with the roofing surface can cause damage to the roof covering. It is recommended to trim back the branches to prevent potential issues such as moisture penetration, mold growth, and damage to the shingles. Evaluation and trimming by a qualified tree service professional is advised.

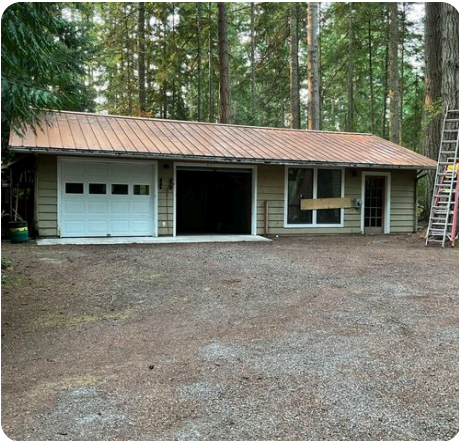
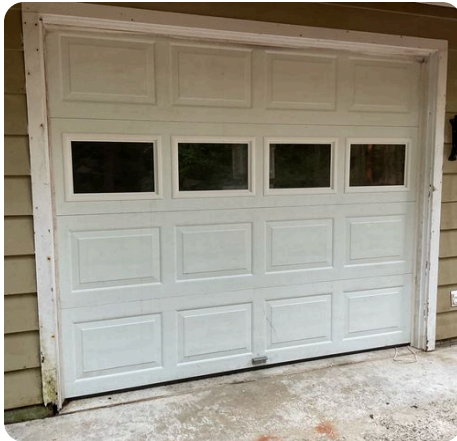
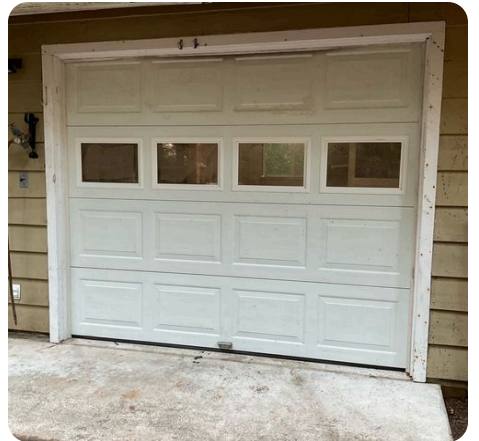
📍 Location: Detached Garage

The garage doors were evaluated and found to be in functional condition at this time.

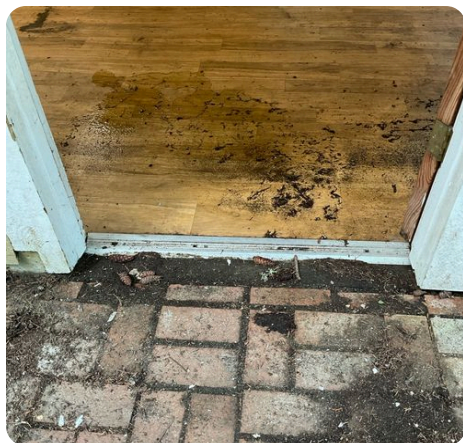
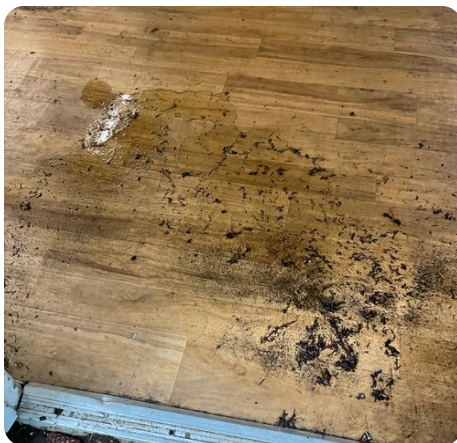
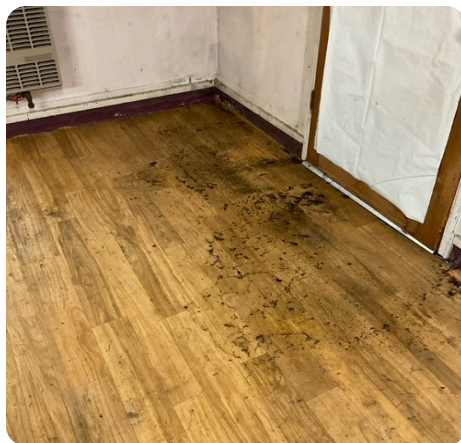
Moisture Issue On Garage Floor

The presence of moisture on the garage floor could indicate a potential water leakage issue. It is recommended to evaluate the source of moisture and repair it promptly to prevent further damage and potential mold growth. A qualified contractor can assess the situation and suggest appropriate solutions.

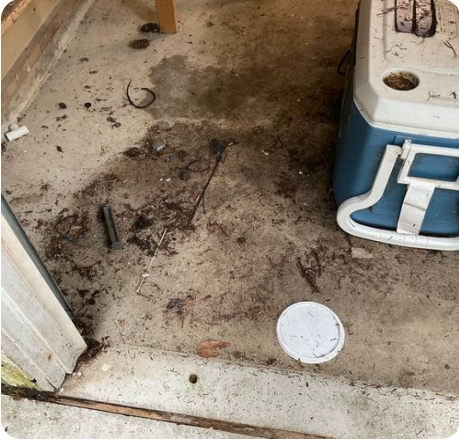
Not Visible

Due to the vinyl flooring in the West side of the garage at the time of the inspection, the inspector was unable to see all areas of the flooring.

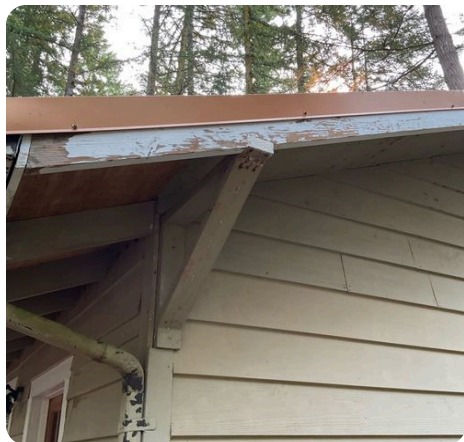
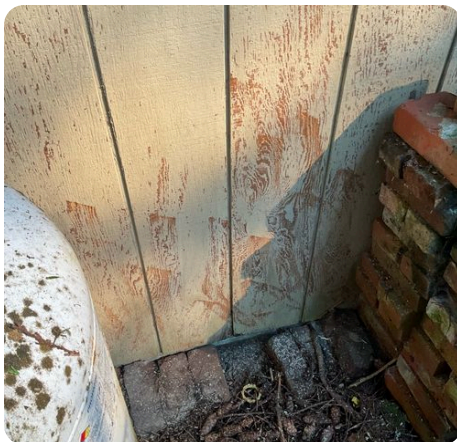
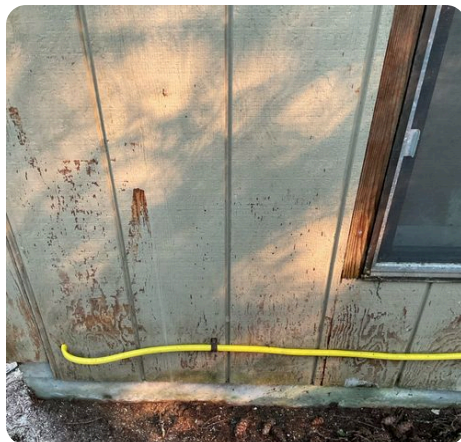
Exterior Paint Touch Up Required

The exterior of the detached garage shows signs of paint deterioration, with areas that require touch up to maintain protection against weather elements. It is recommended to evaluate the extent of the damage and hire a qualified painter to repair the affected areas to prevent further issues and ensure the aesthetics of the property.

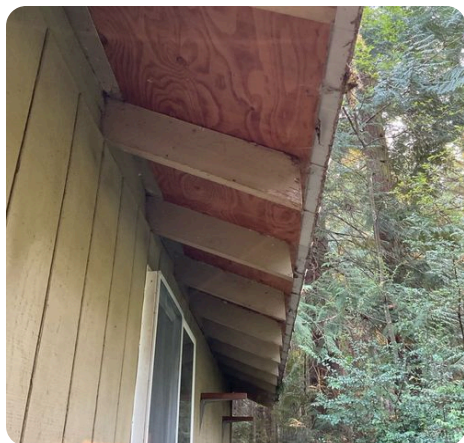
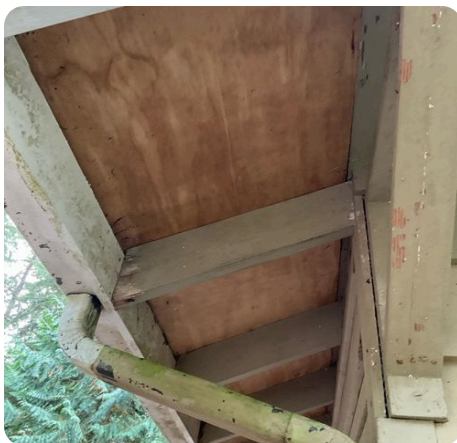
Unpainted Soffit Areas

The soffit areas in the garage are unpainted. It is recommended to paint the soffits to protect the wood from moisture damage and extend its lifespan. Painting the soffit areas also enhances the overall appearance of the garage interior. Consider evaluating and painting the unpainted soffit areas to maintain them in good condition.

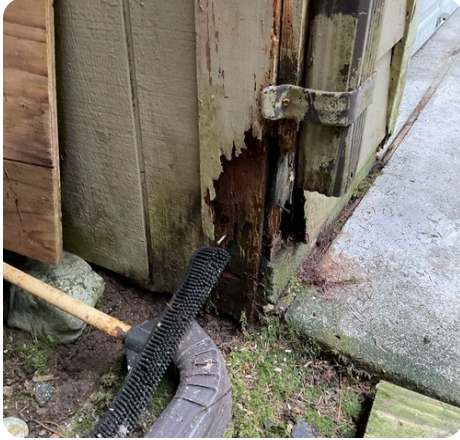
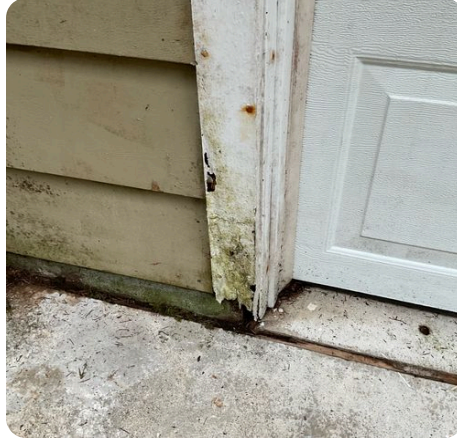
Deteriorated Trim/Siding Issue

The trim and siding on the corner of the garage and garage door trim are deteriorated. This can lead to further damage to the structure and should be evaluated and repaired by a qualified carpenter to prevent moisture intrusion and maintain the integrity of the garage.

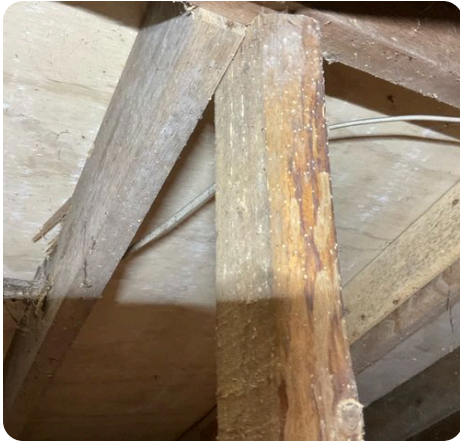
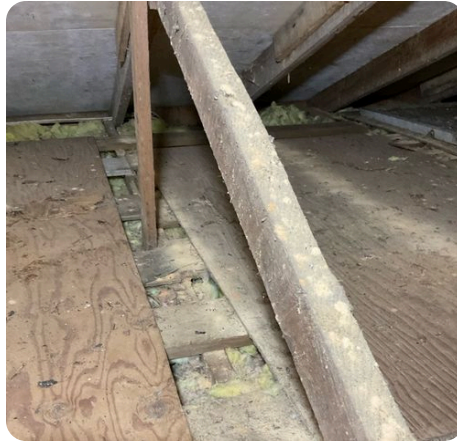
Insect Damage In Garage

The presence of insect damage is observed in the garage. It is recommended to evaluate and repair the affected areas to prevent further damage and infestation. Hiring a qualified pest control professional can help address the issue effectively.

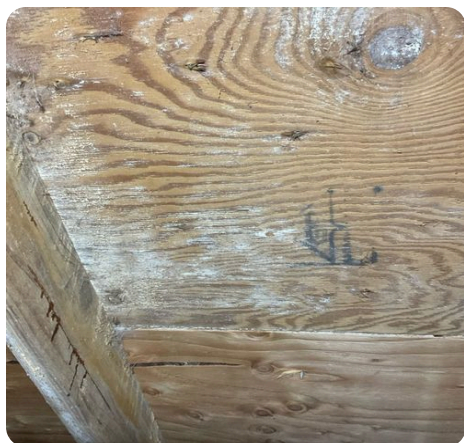
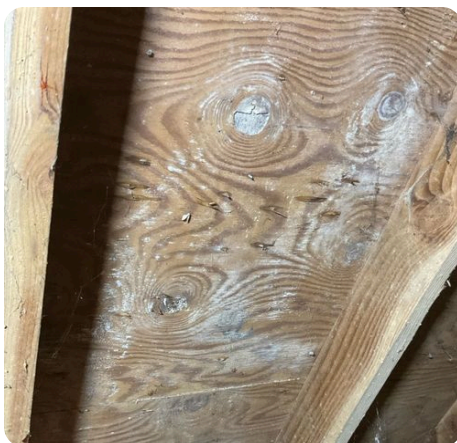
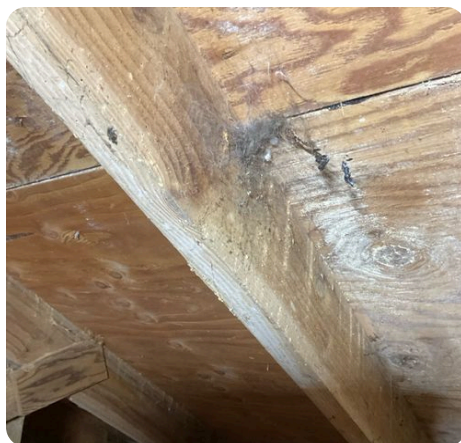
Location: Attic, Detached Garage

The presence of organic staining on the sheathing has been noted. This could be an indication of water intrusion or potential mold growth. It is recommended to further evaluate the source of moisture and address any underlying issues to prevent further damage. A qualified contractor should be consulted to investigate and repair as needed.

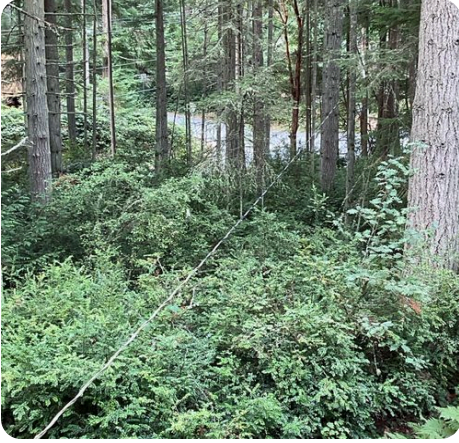
Tree branches were noted to be in contact with the overhead electrical service wires. Trees may cause damage to the service entrance conductors presenting an electrical functionality and safety concern. The inspector recommends having the tree limbs trimmed away from the service lines by a

qualified professional. The utility provider may or may not be responsible for keeping trees trimmed away from the service lines. Please contact your local utility provider for more information. This work should not be performed by the homeowner or an unqualified professional due to the safety hazard that exists.

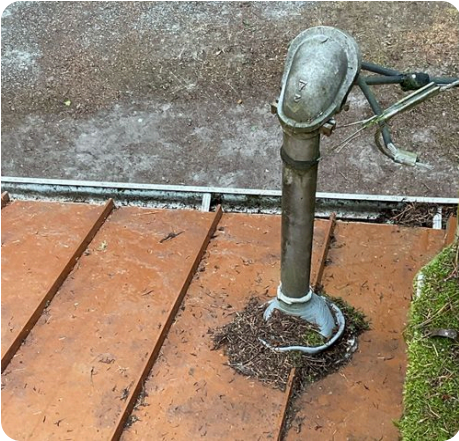
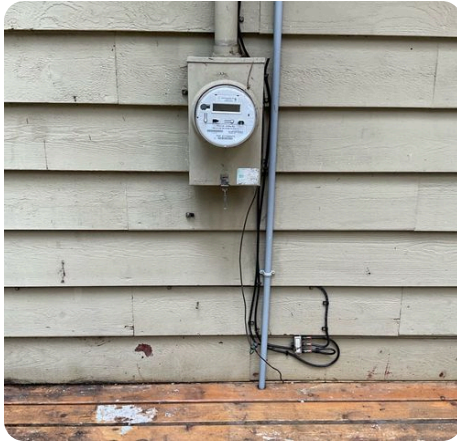
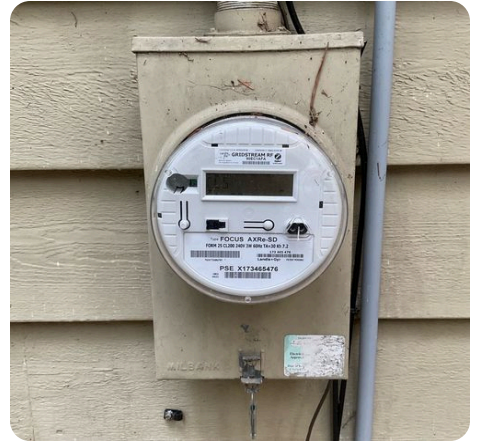
📍 Location: Main House

The service entrance components, electric meter, and grounding system were in serviceable condition at the time of inspection.

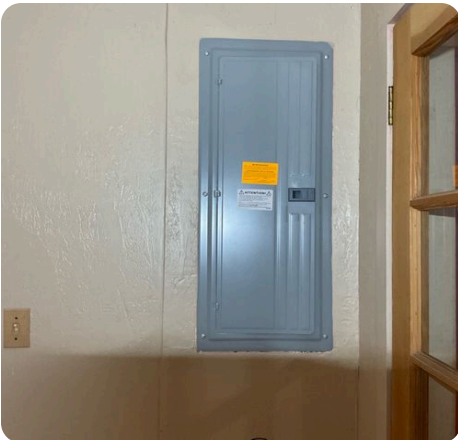
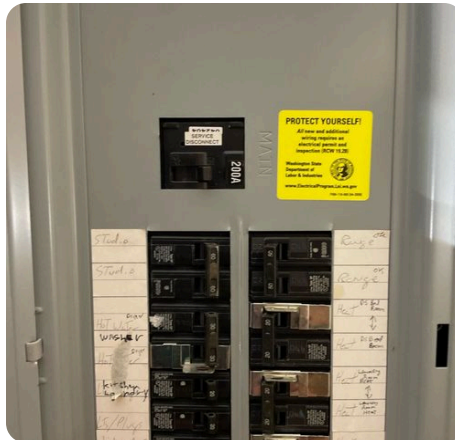
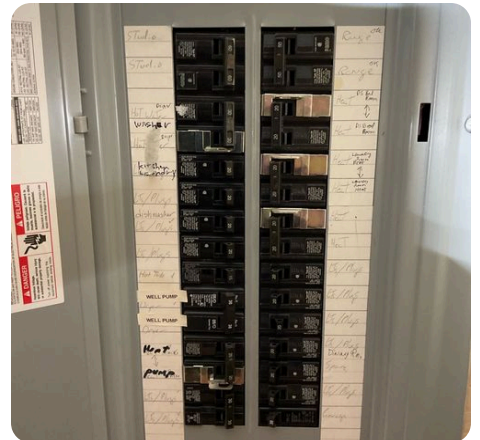
📍 Location: Main House

The service electrical panel, main disconnect and dead-front cover appeared to be in functional condition. The various circuit breakers were labeled on the panel door. Verifying the circuit breakers are correctly labeled is not within the scope of this inspection. Periodic evaluation is recommended for continued safe use.

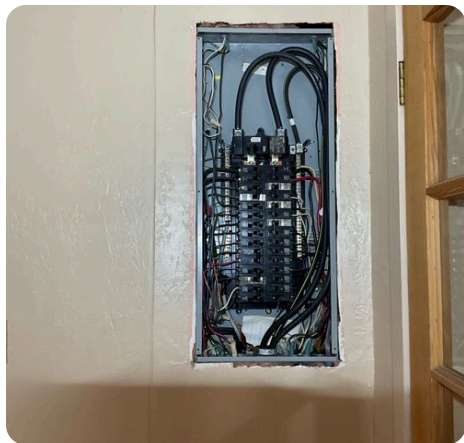
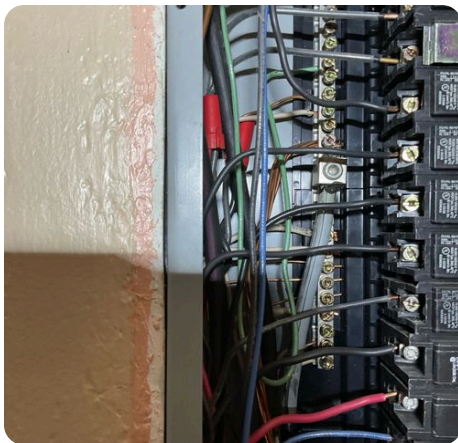
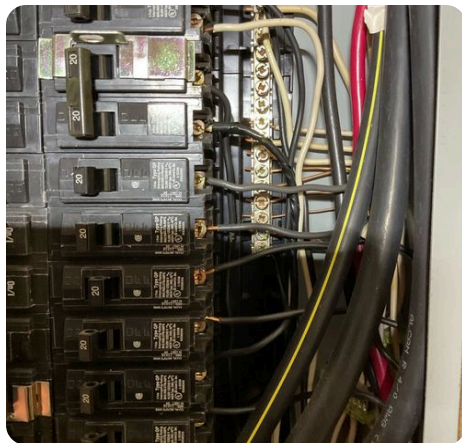
📍 Location: Main House

The interior components of the electrical panel were evaluated and were in satisfactory condition at the time of the inspection.

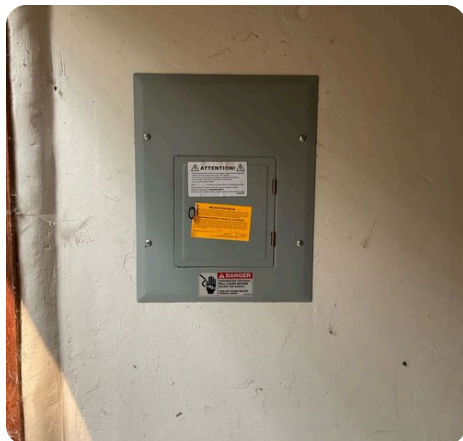
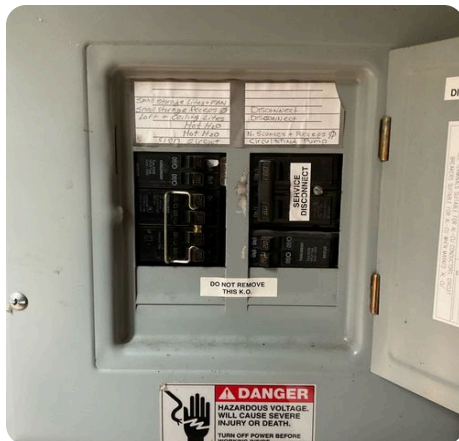
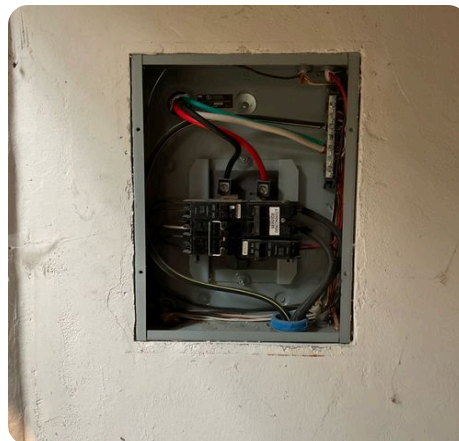
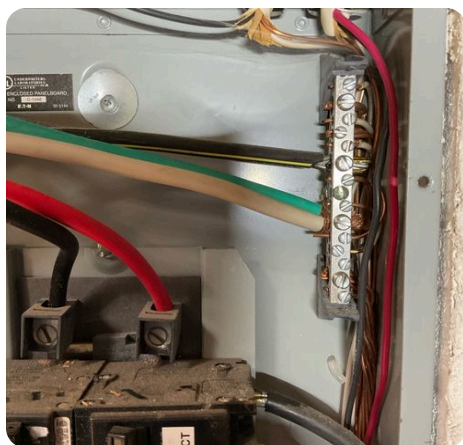
Location: Detached Studio

The subpanel has grounds and neutrals sharing the same bus bar, which is not up to current electrical code standards. This setup can lead to safety hazards, such as improper grounding and potential overloading. It is recommended to have a qualified electrician evaluate and repair this issue by separating the grounds and neutrals onto their respective bus bars to ensure proper functioning and safety of the electrical system.

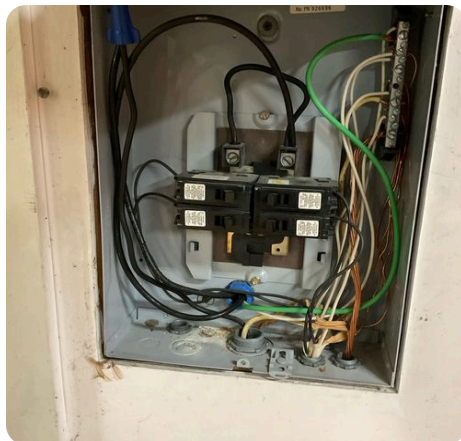
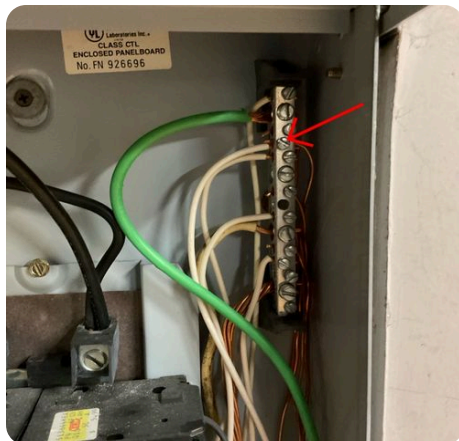
Location: Detached Garage

Double-Tapped Neutral

Double-tapped neutral was observed at the sub-panel where two neutral wires are connected to a single terminal slot. This could result in poor connections, and overheating, and poses a potential fire hazard. It is advised to contact a qualified electrician to address this issue for the safety and optimal performance of the electrical system.

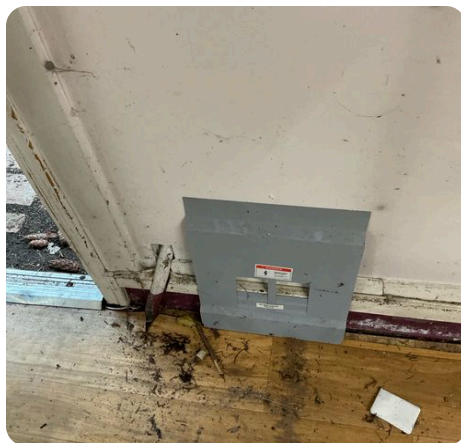
Location: Detached Garage

Face Plate Not Installed

The face plate is not installed and is sitting on the ground. It is recommended to properly install the face plate to ensure safety and functionality of the electrical components. Securing the face plate in place will prevent dust accumulation and reduce the risk of accidental damage to the wiring.

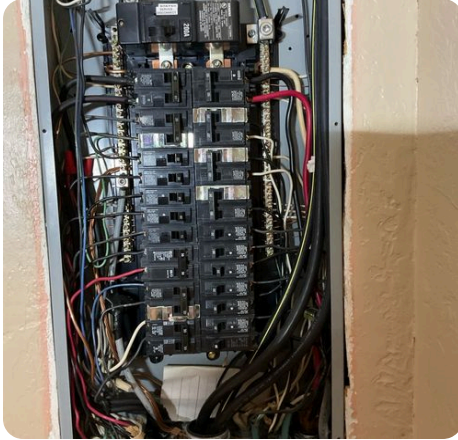
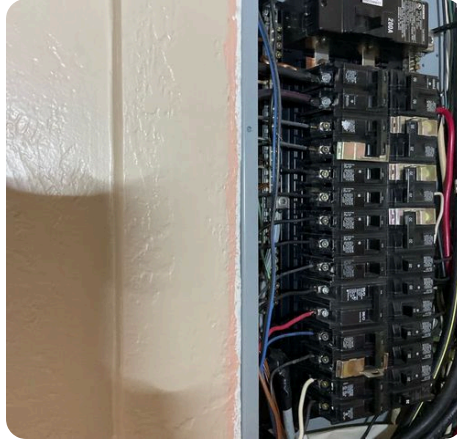
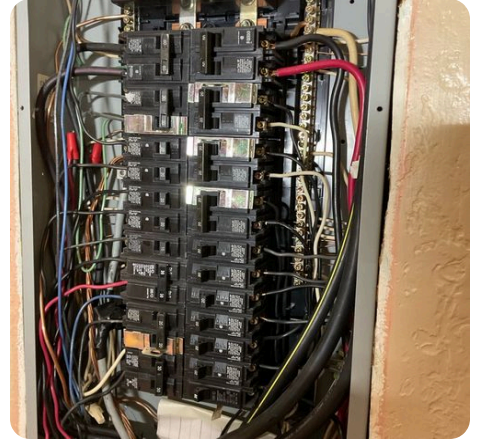
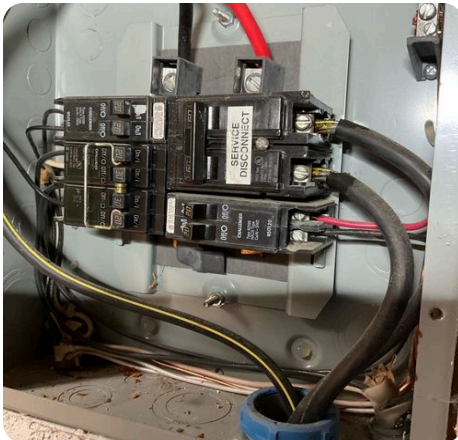
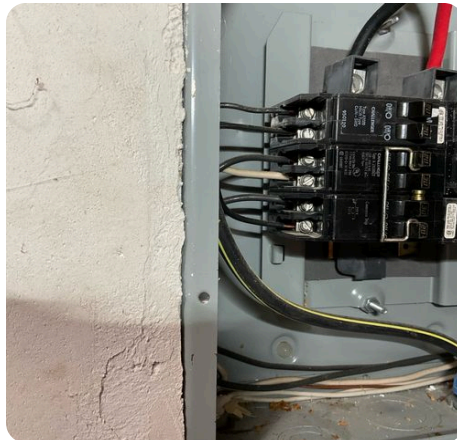
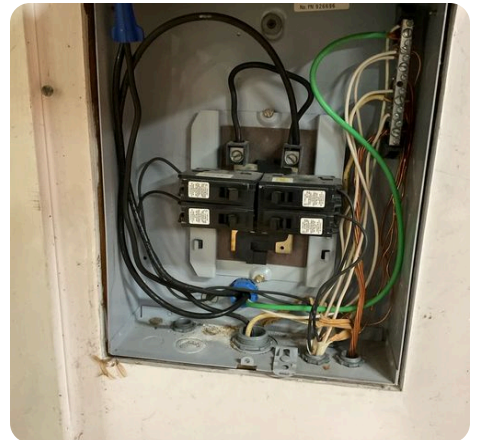
The overcurrent protection devices in the electrical system were evaluated. It is essential to ensure these devices are kept in good working condition to protect the electrical system from overloads and short circuits. Note: The inspector does not operate or physically test any of the breakers during this visual examination.

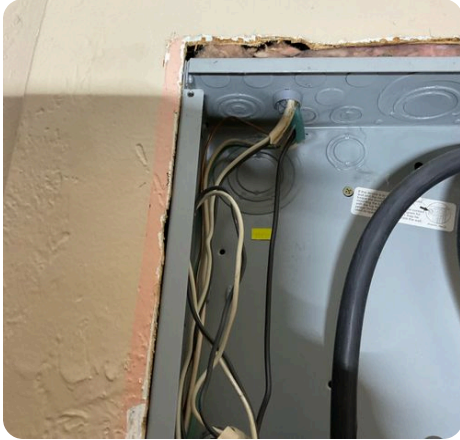
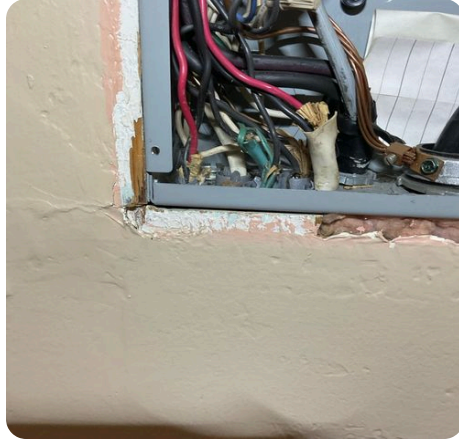
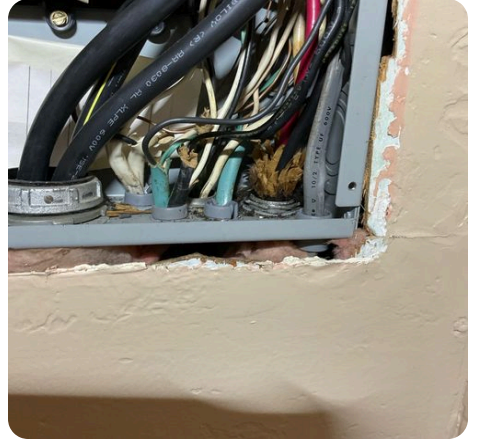
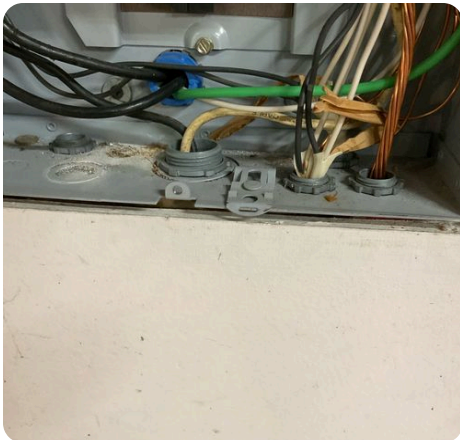
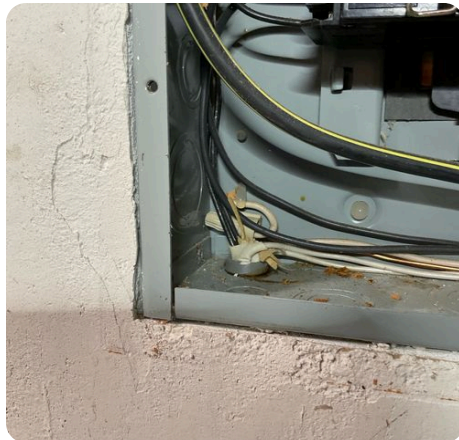
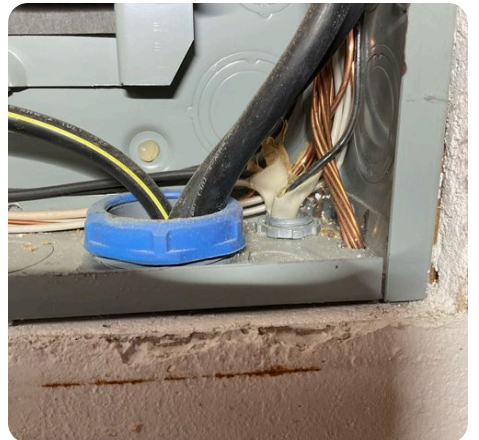
During the inspection, the visible wiring at the property was evaluated and found to be in functional condition.

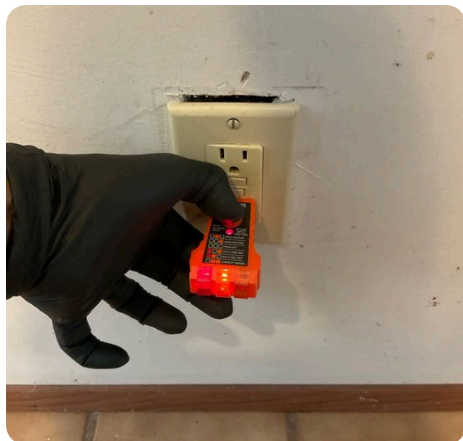
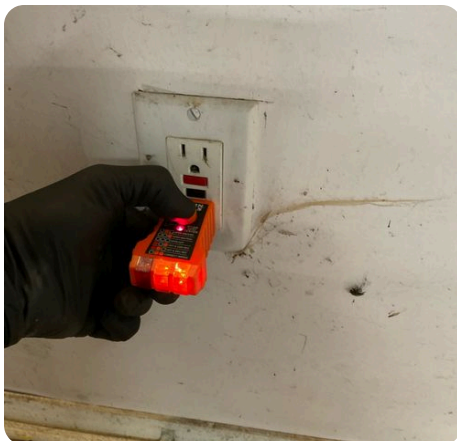
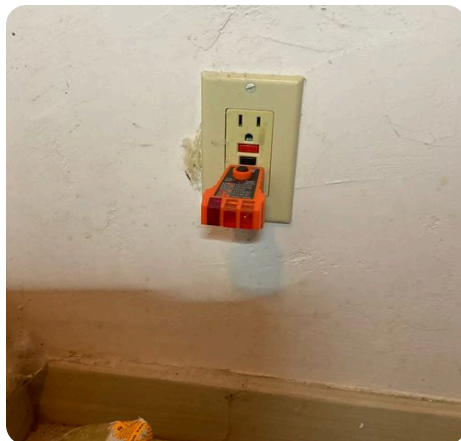
Location: Main House, Multiple Locations, Detached Garage, Detached Studio

GFCI Receptacle Failed Test

The GFCI receptacle did not operate properly or 'trip' when tested. GFCI receptacles are designed to protect against electrical shock and should be in proper working condition. It is recommended to have a qualified electrician evaluate and repair or replace the receptacle.

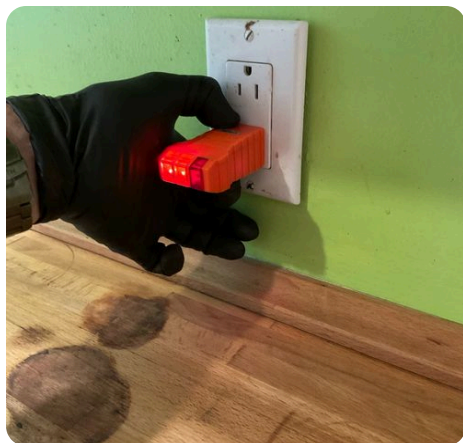
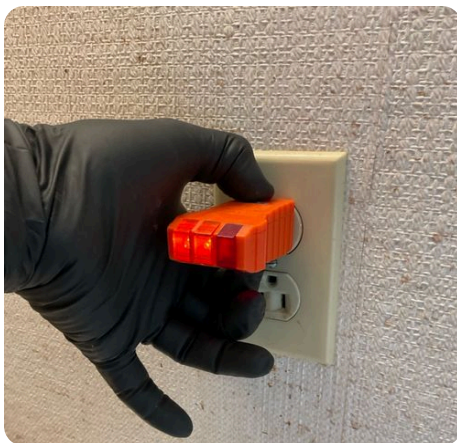
Location: Main House, Bathrooms, Kitchen

Missing GFCI Protection

Ground Fault Circuit Interrupter (GFCI) protection is missing in potential wet locations. GFCIs are crucial in these areas to protect against electric shocks. It is recommended to have a qualified electrician install GFCI outlets for safety.

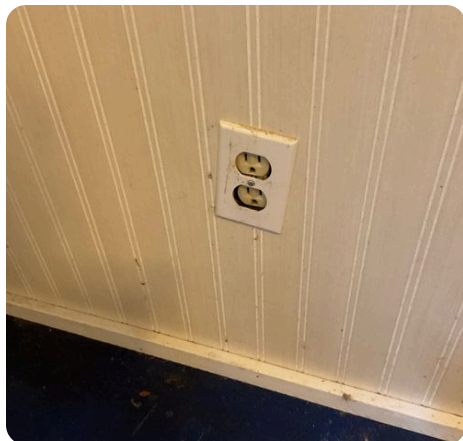
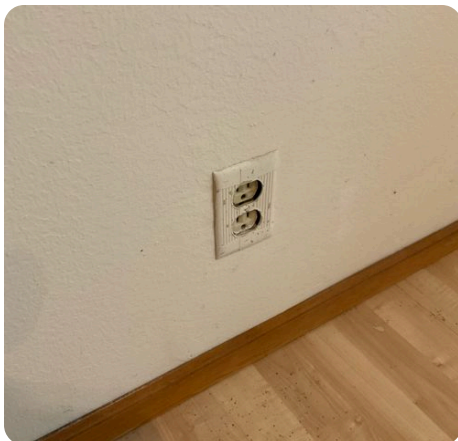
Location: Main House, Multiple Locations

Gap Between Outlets And Covers

The presence of a gap between outlets and their covers can pose a safety hazard as it exposes electrical components. It is recommended to evaluate and repair these gaps promptly to prevent any risk of electric shock or damage. This can be addressed by installing proper-sized outlet covers or utilizing outlet spacers. If unsure, contacting a licensed electrician is advised for professional assistance.

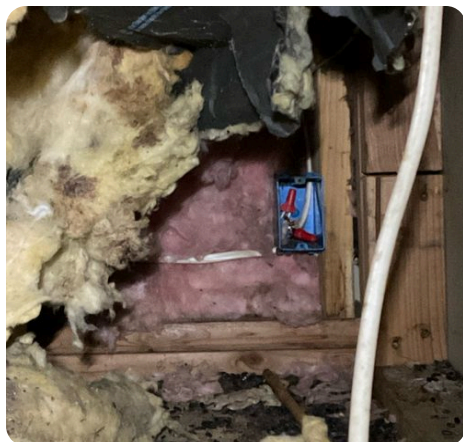
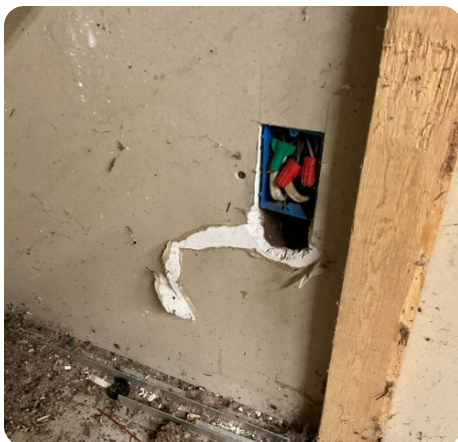
Location: Attic, Main House, Detached Garage

Missing Junction Box Covers

Some junction boxes are missing covers. Installing covers is recommended for safety reasons.

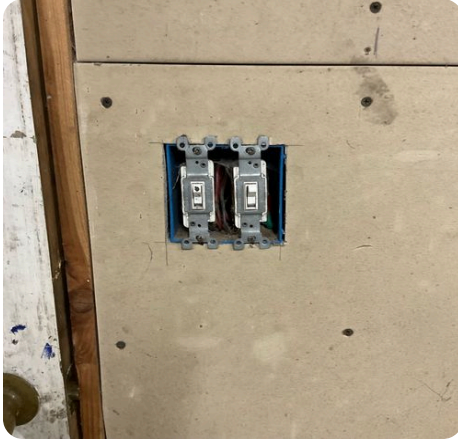
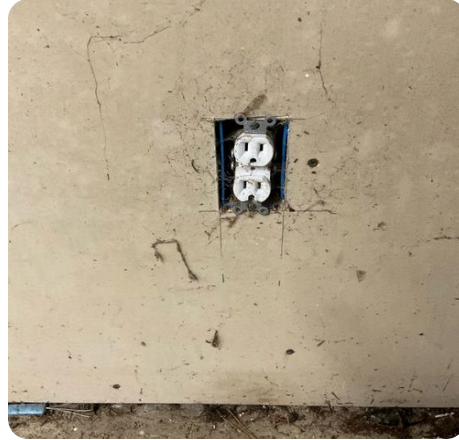
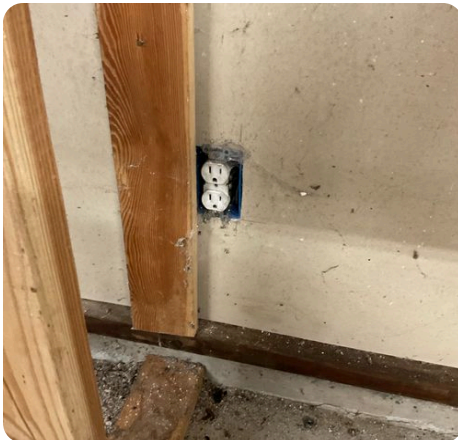
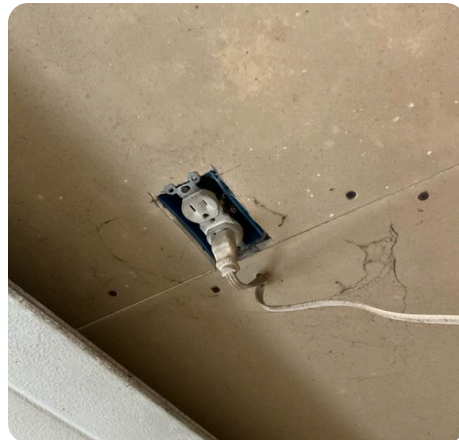
Location: Detached Garage

Missing Outlet And Switch Covers

The outlet and switch covers are missing in multiple areas. It is recommended to install outlet and switch covers to prevent electrical hazards and to ensure the safety of the occupants. You can easily purchase covers at a hardware store and install them yourself following the manufacturer's instructions.

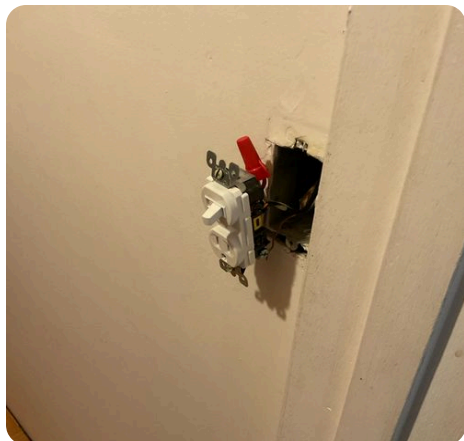
**Location:** Upstairs Closet, Main House

Loose Switch

The switch was found to be loose during the inspection. A loose switch can be a safety hazard as it may cause electrical arcing or even a potential fire risk due to overheating. It is recommended to have a qualified electrician evaluate and repair this issue to ensure proper and safe operation.

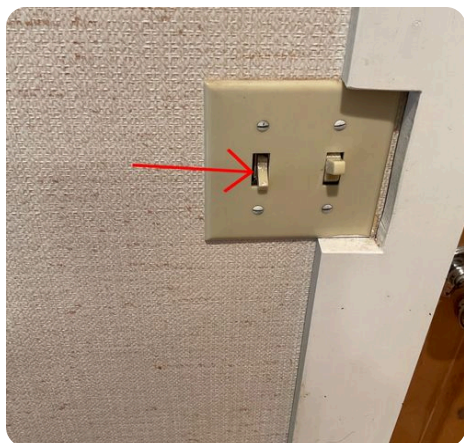
Location: Lower Level Bathroom, Main House

Loose Switch Knob

The switch knob on one of the switches is loose. This can lead to difficulty in operating the switch and might pose a safety hazard. It is recommended to tighten or replace the switch knob to ensure proper functionality and safety. If unsure, consider hiring a qualified electrician to evaluate and repair as needed.

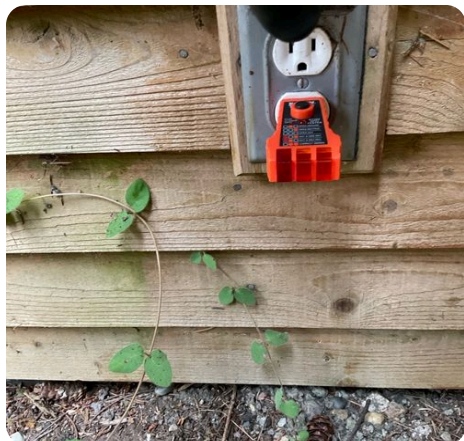
Location: Detached Studio

Outlet Not Functioning

The inspector found one exterior outlet that did not have power. Contact an electrician for further evaluation and repair.

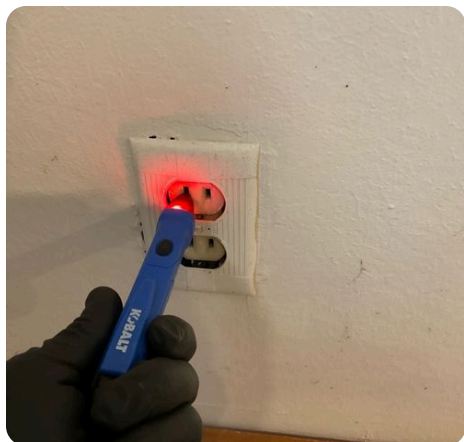
Location: Living Room, Main House

Two-Prong Outlet Issue

The two-prong outlets in the property may not be grounded, which can pose a safety hazard. It is recommended to consider upgrading these outlets to three-prong outlets to ensure proper grounding. A licensed electrician should evaluate and replace the outlets to meet current safety standards.

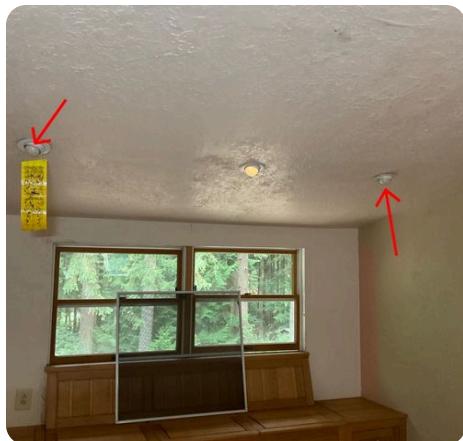
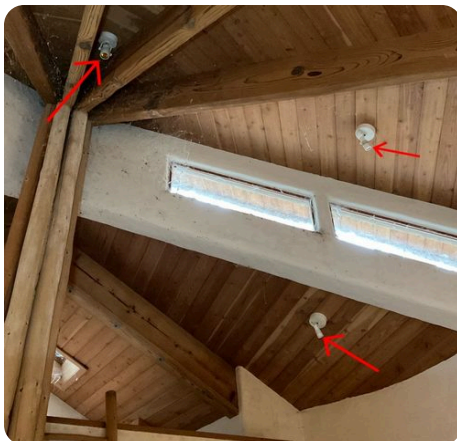
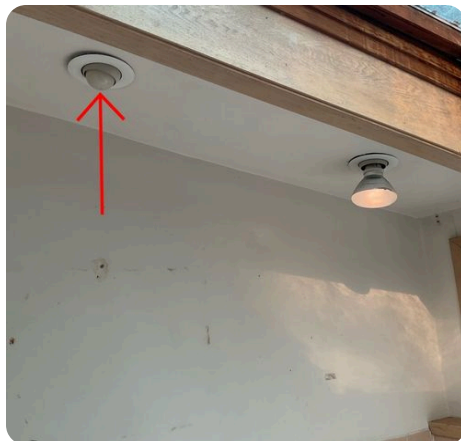
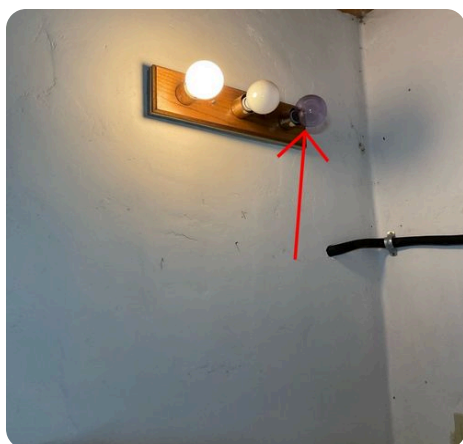
Location: Main House, Detached Studio

Non-Functional Lights And Bulbs

The home inspection revealed non-functional lights and bulbs throughout the property, impacting the overall functionality and safety of the lighting system. It is recommended to evaluate and repair or replace the non-functional lights and ensure that all areas have the appropriate bulbs for proper illumination. Consider hiring a qualified electrician to address any underlying issues with the lighting fixtures.

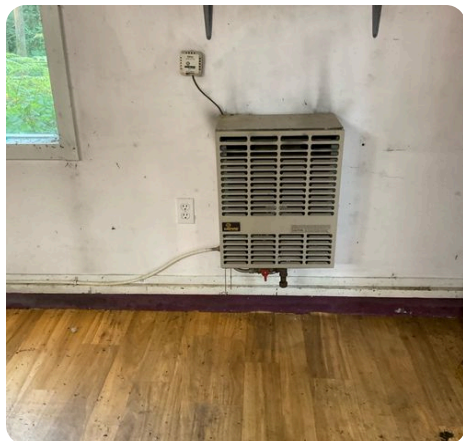
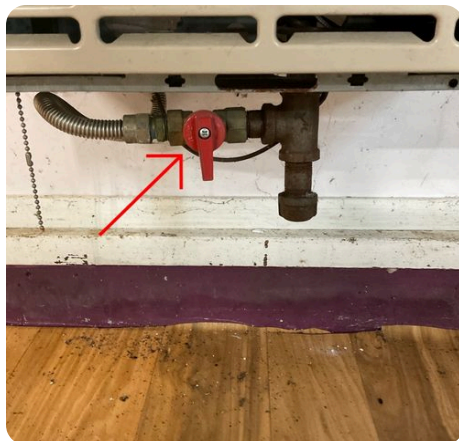
Location: Detached Garage

The gas wall heater in the detached garage was not tested. The gas line was in the off position. The inspector is not authorized to turn any gas valves on for safety reasons. Recommend testing ater valve is turned on prior to listing.

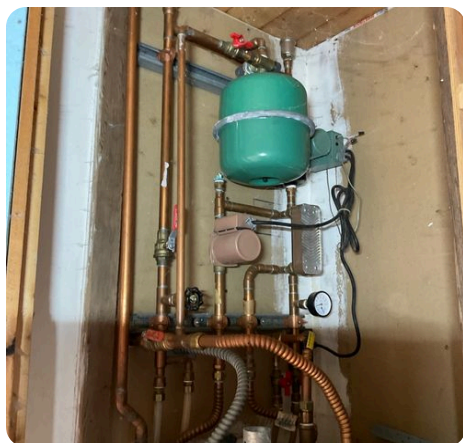
Location: Detached Studio

The radiant heat in the property is not functioning. This can result in uneven heating throughout the space, leading to discomfort and inefficient energy use. We recommend contacting a qualified HVAC technician to evaluate and repair the radiant heating system.

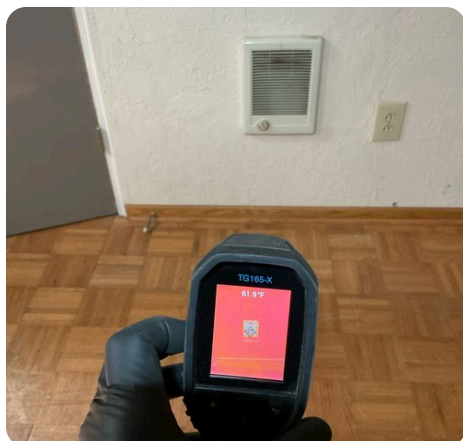
Location: Upstairs Room, Main House

One of the electric wall heaters in the was not functional. We recommend evaluating and repairing the electric wall heater as needed. All other electric wall heaters were functional. Contact a licensed electrician to inspect and repair the electric wall heater as needed.

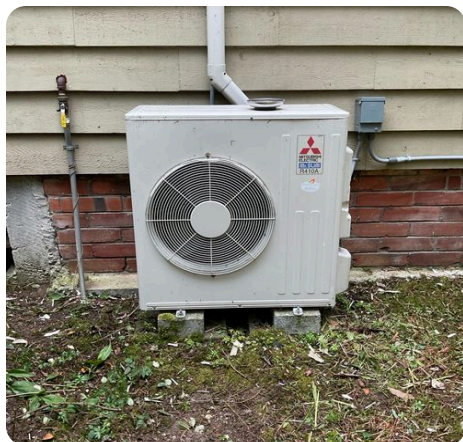
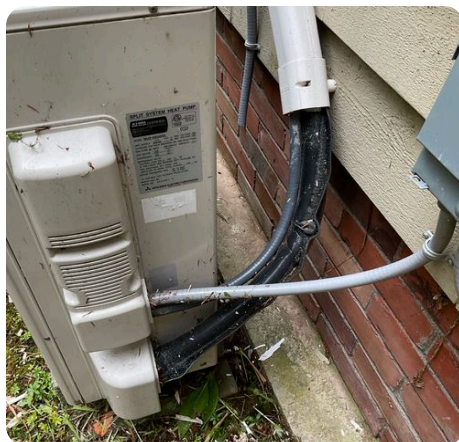
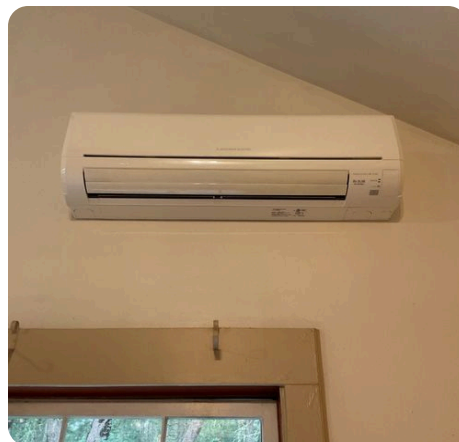
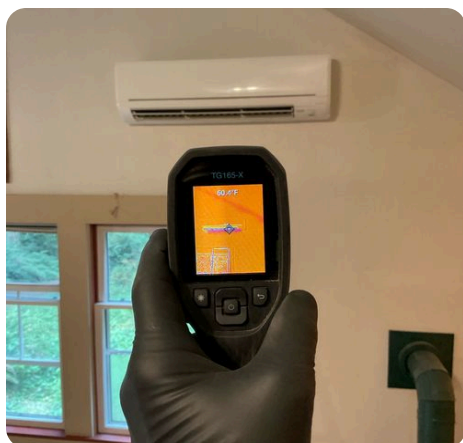
Location: Living Room, Main House

The cooling function of the mini-split system was tested during the inspection. However, it is important to note that the remote for the system was not found, limiting the complete evaluation of its functionality. We recommend locating the remote to ensure all features can be properly assessed for optimal performance.

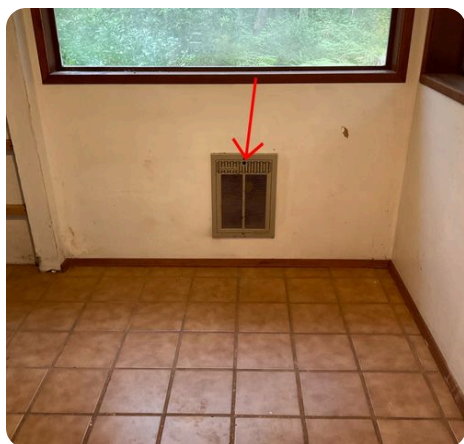
Location: Main House, Laundry Room

Missing Thermostat Control Knob

The thermostat in the HVAC system is missing a control knob. This can make it difficult to adjust the temperature settings accurately. It is recommended to replace the missing knob to ensure proper functionality and control of the HVAC system.

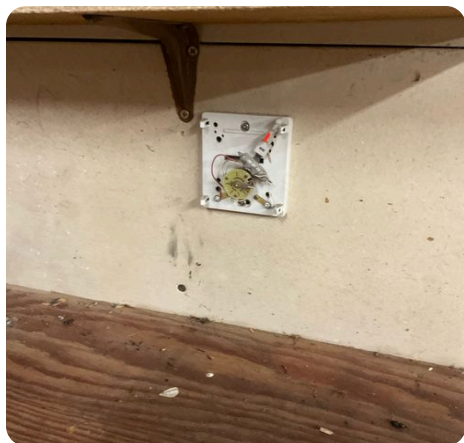
Location: Detached Garage

Thermostat Cover Missing

The thermostat cover is missing. It is recommended to have the thermostat cover in place to protect the internal components from dust and damage. Consider replacing the cover to ensure proper functioning of the thermostat.

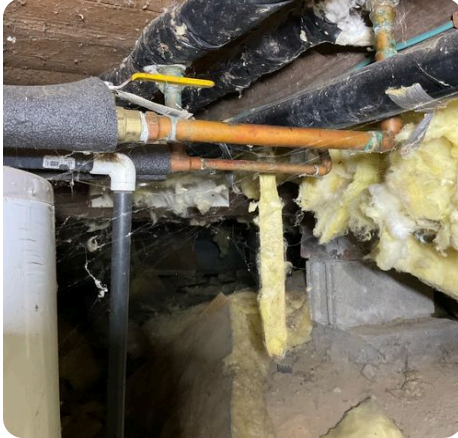
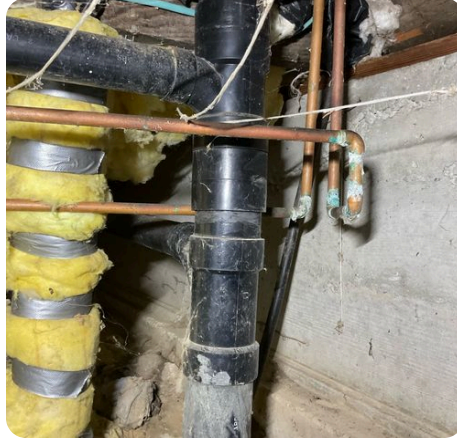
📍 Location: Main House, Crawl Space

The water pipes in the home are uninsulated. It is recommended to insulate water pipes, especially in cold climates, to prevent freezing and potential bursting during winter months. Insulating water pipes can also help in conserving energy by reducing heat loss. A qualified plumber can evaluate the pipes and install appropriate insulation to prevent any issues in the future.

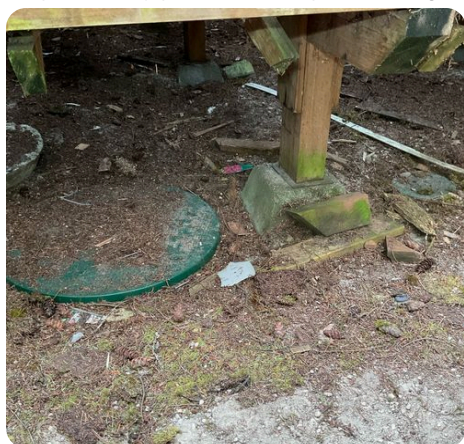
📍 Location: Under Rear Deck

The septic system is outside the scope of a home inspection and should be evaluated by a qualified septic professional to ensure proper functionality and prevent any potential issues prior to listing.

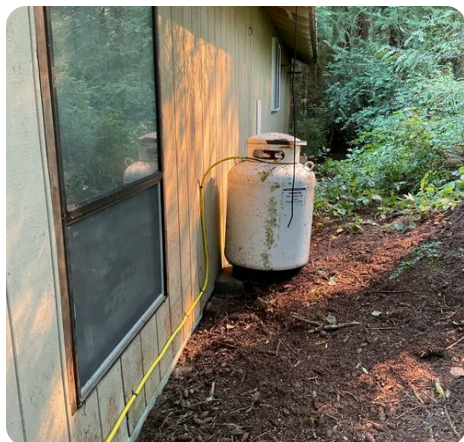
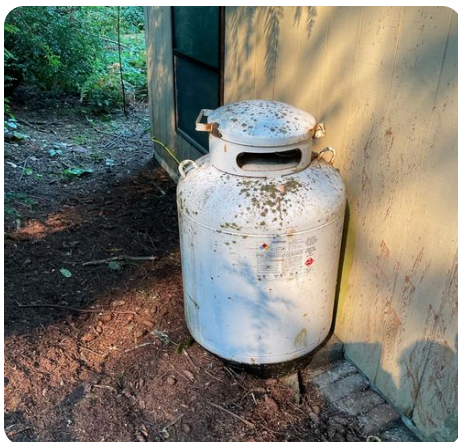
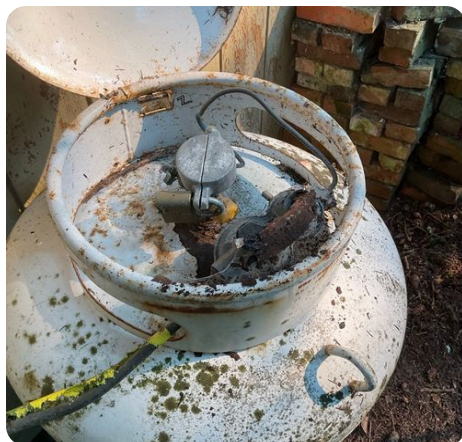
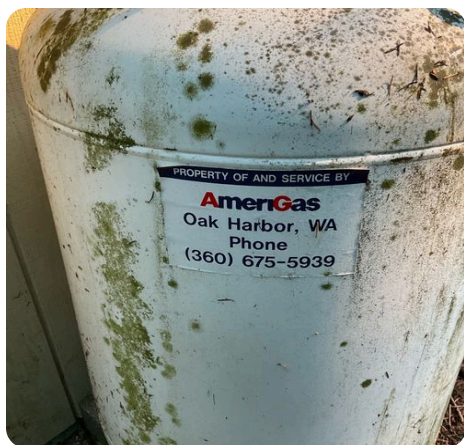
Location: Detached Garage

The propane tank(s) is/are not secured to prevent movement. Strapping the tank(s) to prevent it/them from tipping over is recommended. Contact a qualified professional to perform this maintenance.

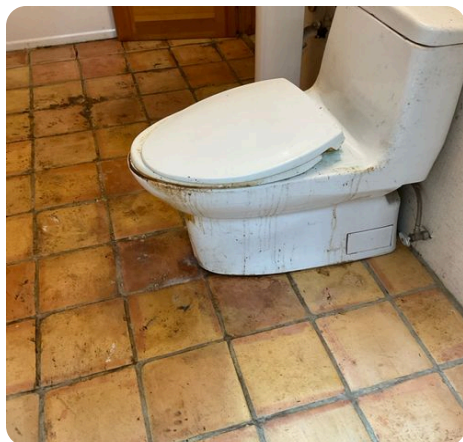
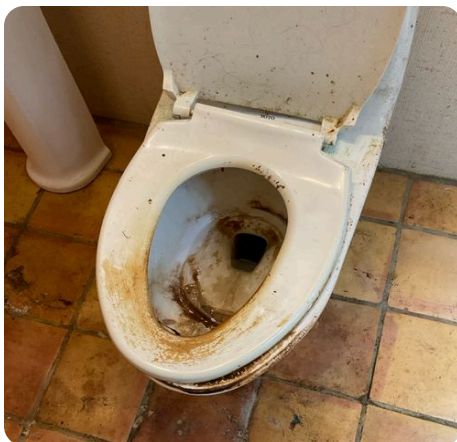
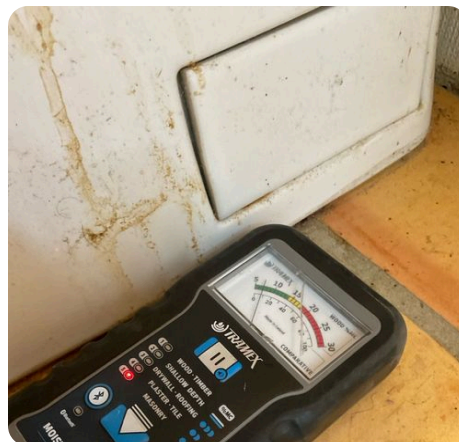
Location: Lower Level Bathroom, Main House

Stained Toilet With Broken Seat

The stained toilet with a broken seat suggests that there may have been an overflow in the past, leading to potential water damage. It is recommended to evaluate the toilet for any underlying issues and repair or replace the broken seat to ensure proper functionality.
