Service: Pre-Listing Inspection

Prepared for: Amy Gulden

Aaron McBride

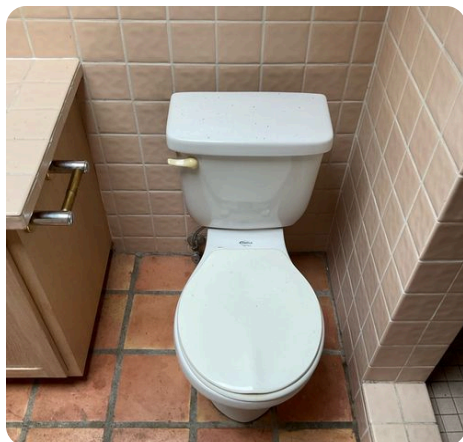
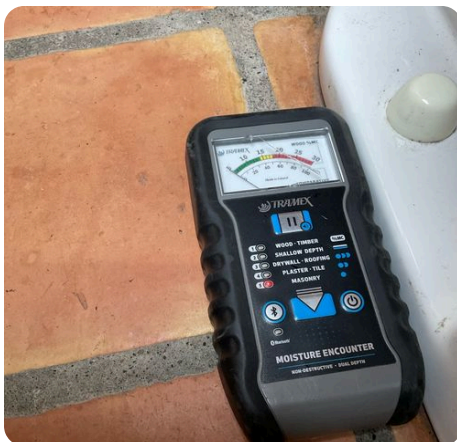
Location: Main House, Upstairs Bathroom

Toilet Tested And Inspected

The toilet was tested and appeared to be in functional condition at the time of the inspection. Regular evaluation, such as checking for leaks, mounting issues and ensuring proper flushing mechanisms are recommended to keep the toilet functioning smoothly.

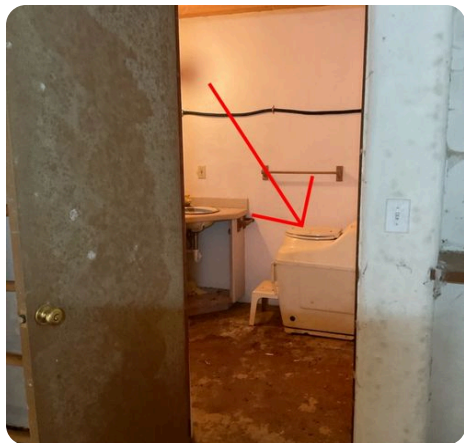
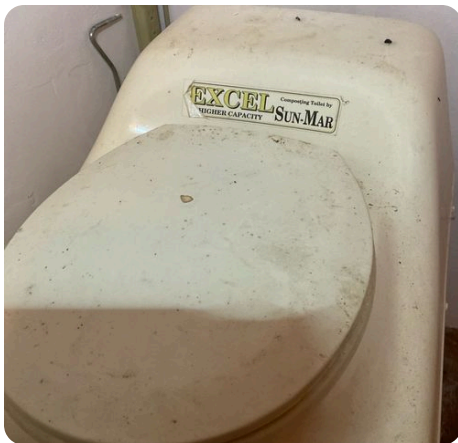
Location: Detached Studio

Non-Standard Toilet Type Identified

The presence of a composting toilet was noted during the inspection. Composting toilets are not a standard plumbing fixture and may require special maintenance procedures. It is recommended to familiarize yourself with the specific maintenance requirements of a composting toilet for optimal performance.

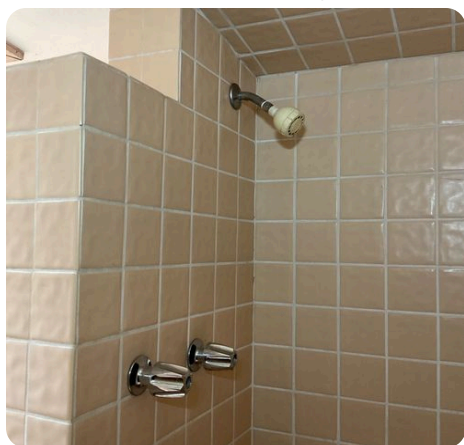
Location: Main House, Upstairs Bathroom, North Shower Head

Non-Functioning Tub/Shower Faucet

The tub/shower faucet is not functioning properly. This issue can lead to inconvenience and affect the functionality of the tub/shower unit. It is recommended to have a licensed plumber evaluate and repair the faucet to ensure proper operation.

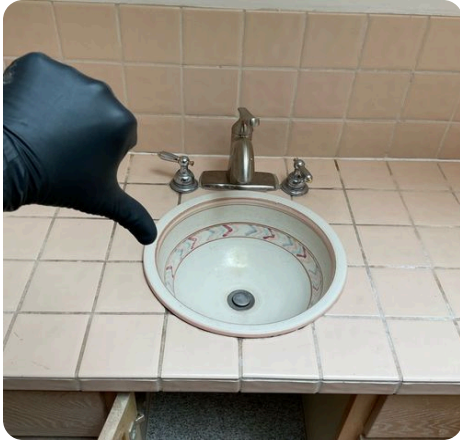
Non Functional Sink Faucet

The sink faucet is not functioning properly. This can be due to a variety of issues such as a damaged internal mechanism or mineral build-up. It is recommended to have a qualified plumber evaluate and repair the faucet to ensure proper functionality. Regular maintenance, such as cleaning out

debris and mineral deposits, can help prevent similar issues in the future.

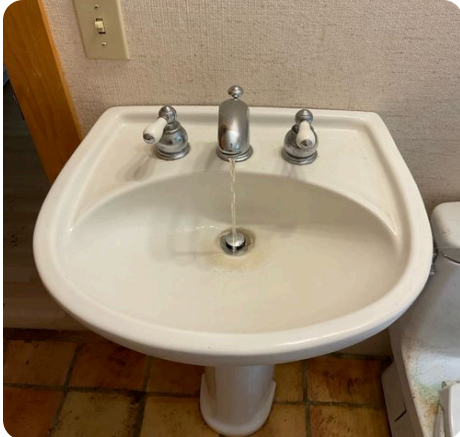
Location: **Lower Level Bathroom**

Low Water Flow When Other Fixtures Are In Use

The water pressure in the sink appears to decrease when other fixtures are being used concurrently, indicating a potential issue with the plumbing system. It is recommended to have a licensed plumber evaluate the water pressure and make any necessary repairs to improve the flow rate. In some cases, installing a pressure-balancing valve or upgrading to a larger pipe size may help alleviate this issue.

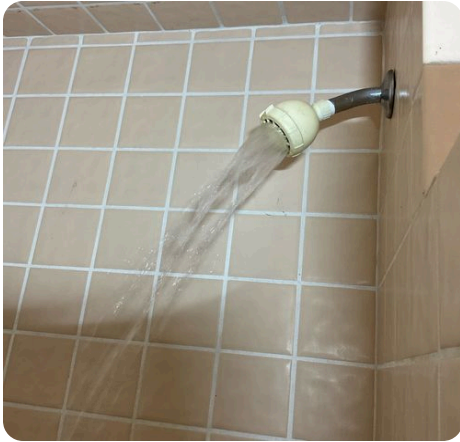
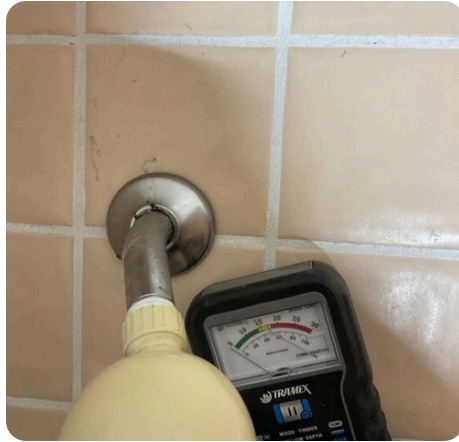
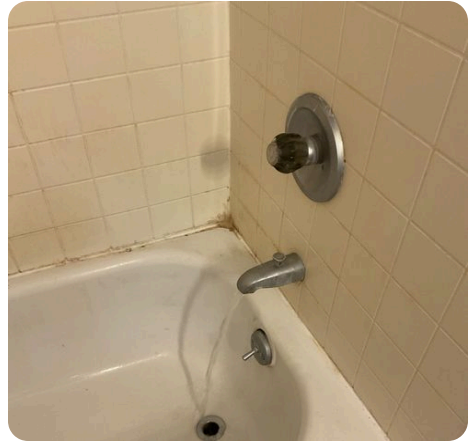
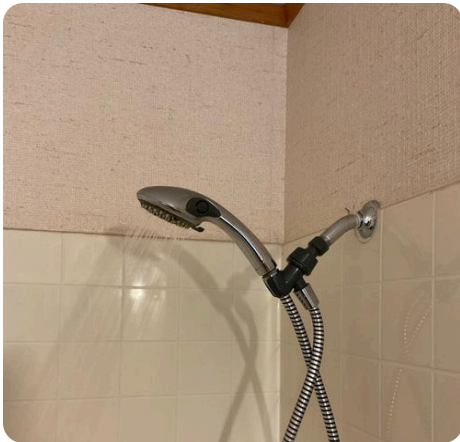
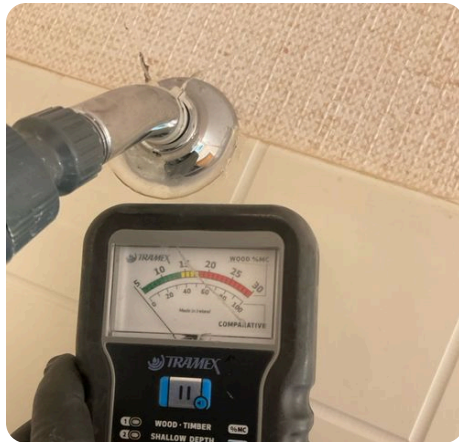
Location: **Main House**

Generally Serviceable

The inspector ran water in each tub and shower to identify concerns. All fixtures appear to be serviceable unless noted elsewhere in this report.

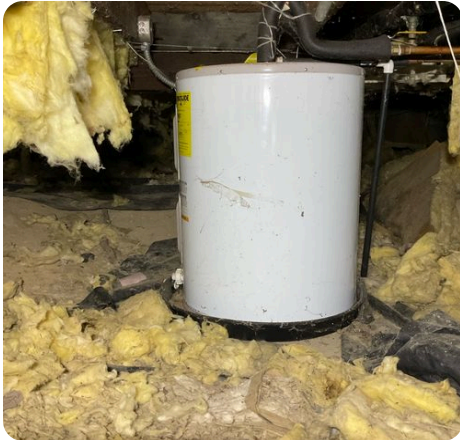
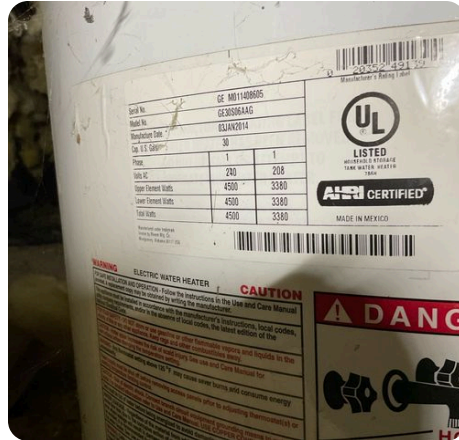
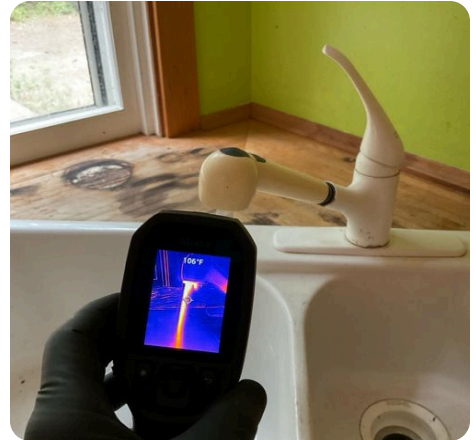
The water heater was visually inspected. The life expectancy of a water heater is typically 8-12 years from the date of installation, although there are exceptions on both sides. As a preventative maintenance recommendation, the water heater should be drained periodically to remove sediment buildup in the tank. The recommended setting for a residential water heater is under 120 degrees Fahrenheit. For safety.

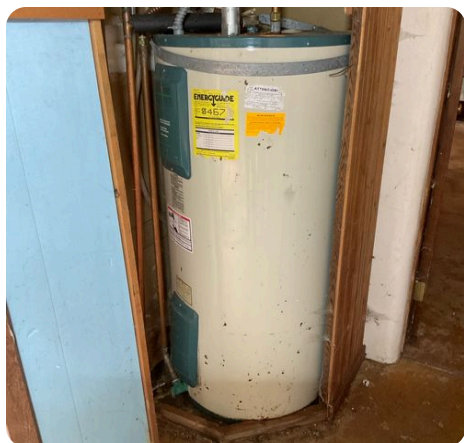
Location: Detached Studio

Missing Water Heater Straps

The water heater is missing seismic straps for stability. It is recommended to have a qualified plumber install water heater earthquake straps to secure the unit and reduce the risk of tipping over during seismic activity.

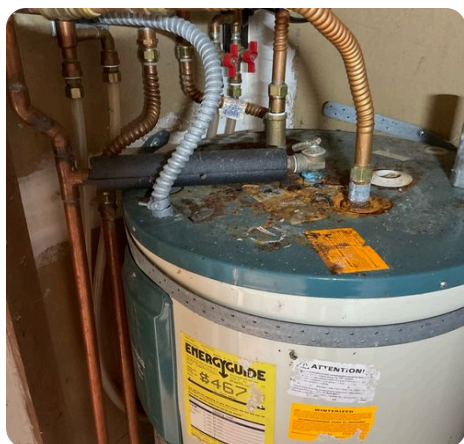
Location: Detached Studio

Rust At Water Heater

The presence of rust on the water heater can indicate corrosion, which may lead to leaks or other water damage. It is recommended to have a qualified plumber evaluate the extent of corrosion and repair or replace any affected parts to prevent further deterioration.

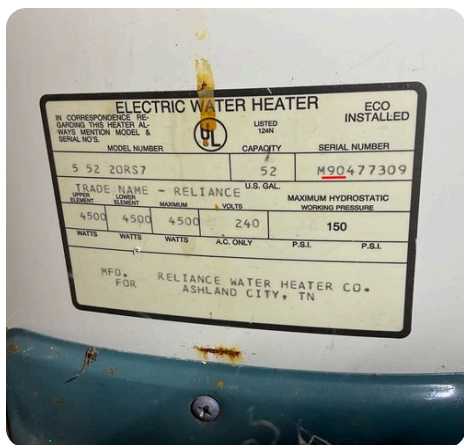
Location: Detached Studio

Water Heater Age

The water heater is 35 years old. It is recommended to consider replacing the water heater due to its age as older units may become less efficient and more prone to malfunctions. A licensed plumber should evaluate the condition and advise on a suitable replacement. Budget for a replacement in the future.

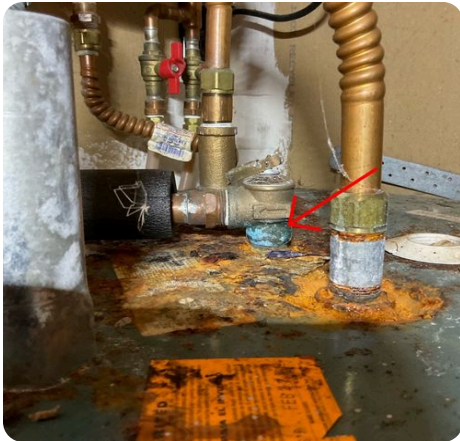
Location: Detached Studio

The TPR valve shows encrustation, which can hinder its proper functioning. It is recommended to evaluate the valve to ensure it opens smoothly in case of high temperature or pressure. A qualified plumber should be contacted to clean or replace the valve if necessary.

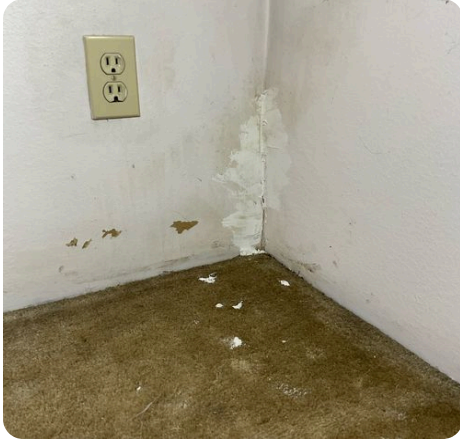
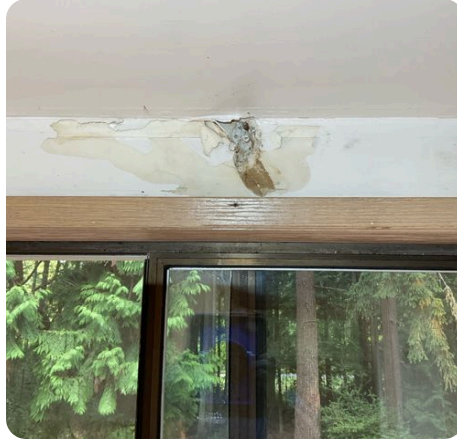
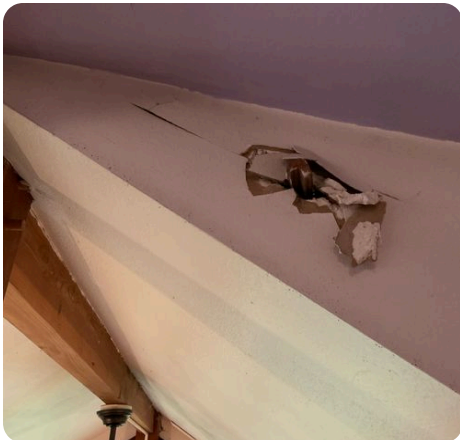
Location: Main House

Damaged Drywall

Areas of damaged or cracked drywall were observed in the walls. Evaluating and repairing these issues is recommended as they can impact the aesthetic appeal of the home and may lead to further damage if not addressed. Contacting a qualified drywall contractor to assess the extent of necessary repairs and to ensure proper repairs are made is suggested.

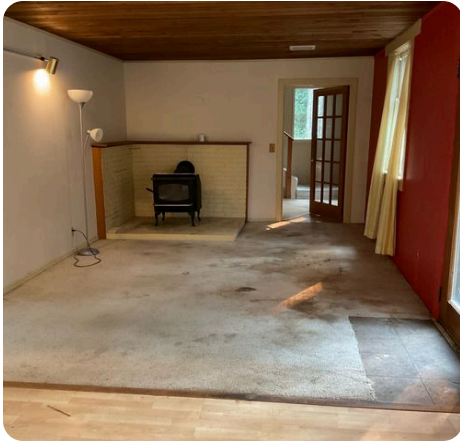
Location: Main House

Carpet Condition

The carpet in the property is heavily stained and damaged. This can not only be unsightly but also indicate a lack of maintenance. It is recommended to evaluate and repair the carpet by either deep cleaning or replacing it to improve the aesthetic appeal of the space.

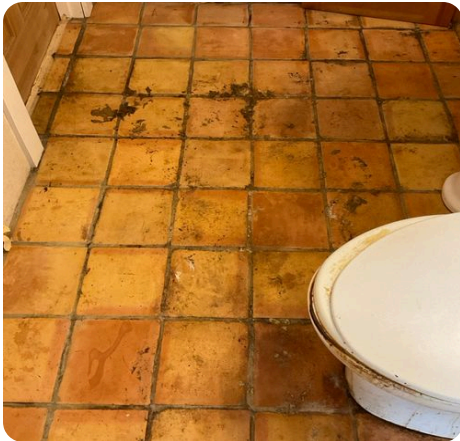
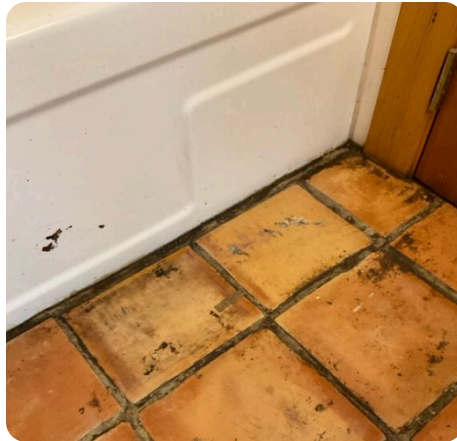
Location: Main House, Lower Level Bathroom

Effluence Staining Issue

There is effluence staining on the bathroom floor, which indicates a potential plumbing leak. We recommend further evaluation and repair by a qualified plumber to address the issue and prevent any further damage.

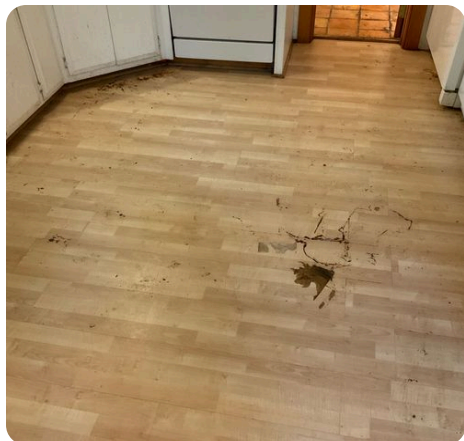
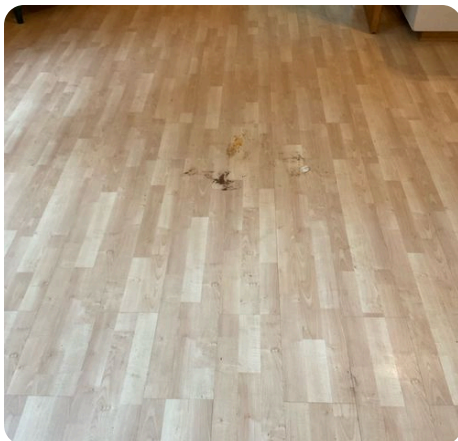
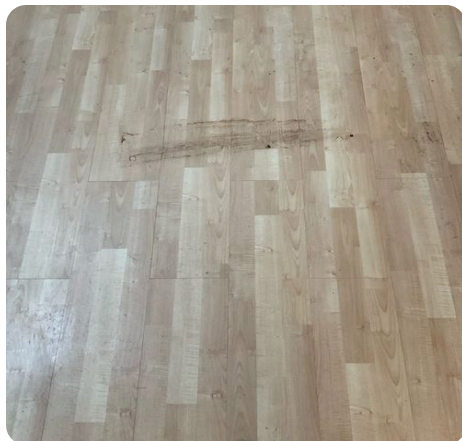
Location: Main House

Flooring Damage

Flooring damage was noted. Having the damaged flooring repaired or replaced by a qualified flooring contractor may be desired.

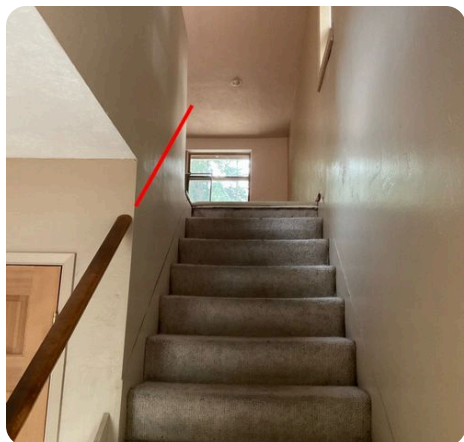
Location: Main House

Missing Handrail

The handrail/railing system is missing in the stairwell, posing a fall hazard if someone were to trip. It is recommended to have a qualified professional install handrail/railing systems as a preventive safety measure.

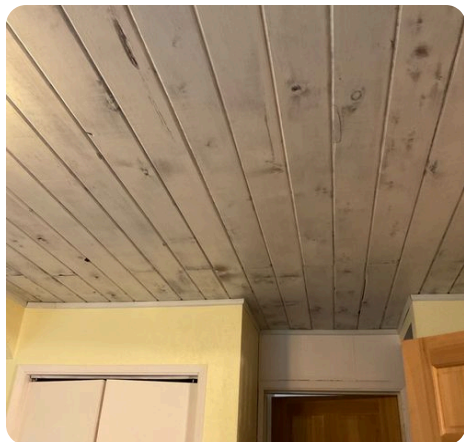
Location: Lower Level Bedroom, Main House

Smoke Alarm Missing

There is a missing smoke alarm. Smoke alarms provide early warning in case of a fire, ensuring the safety of the occupants. A working smoke alarm should be installed in every bedroom and in the hallway outside sleeping areas. Installing a smoke alarm is recommended to ensure occupant safety. Regularly testing the alarms is also advised.

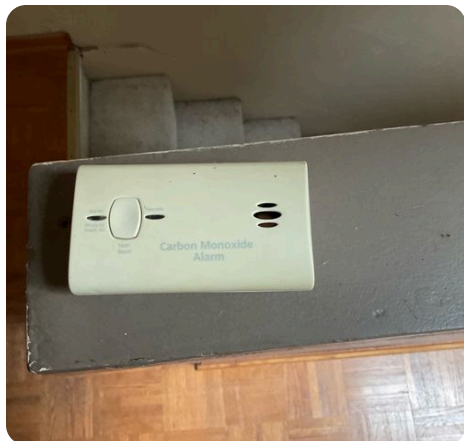
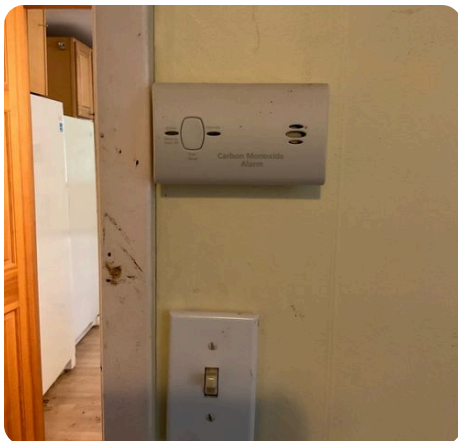
Location: Main House

Carbon Monoxide Alarms Noted

Carbon monoxide (CO) alarms were located in the home. The inspector does not test these alarms; however, verifies that they are installed near sleeping areas and on each level of the home. For continued protection, regular manual testing and battery maintenance are recommended.

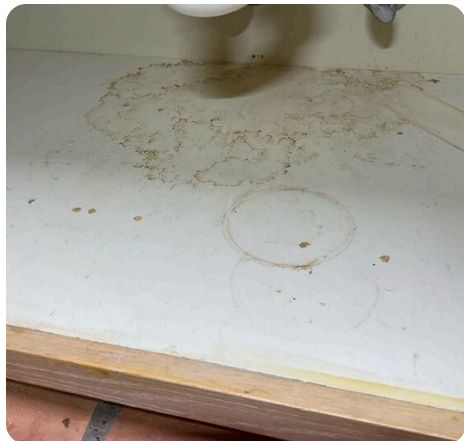
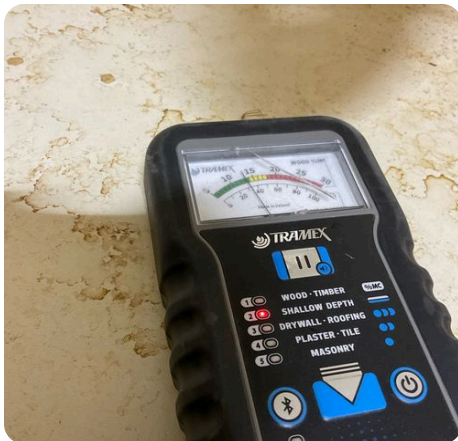
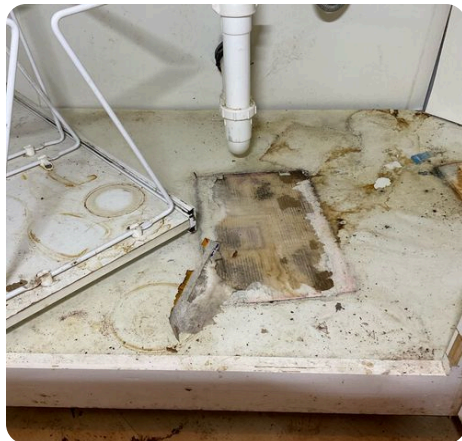
Location: Upstairs Bathroom, Kitchen

Past Moisture Damage In Cabinet

The cabinet shows signs of past moisture damage, which could indicate a previous leak or elevated moisture levels in the area. It is recommended to evaluate the extent of the damage and repair any affected areas to prevent further issues such as mold growth or structural deterioration. A qualified contractor can assess the damage and replace any compromised materials.

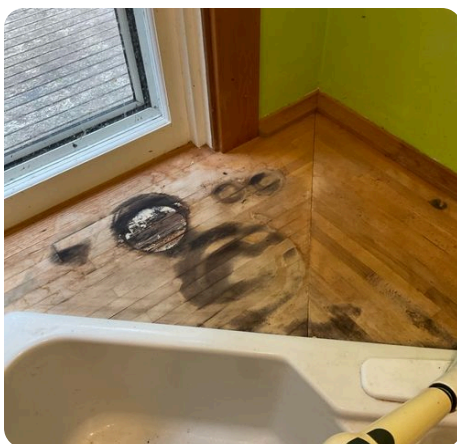
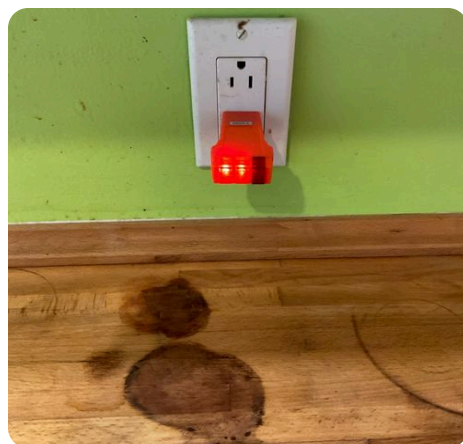
Location: Kitchen

Damaged Countertops

The countertops exhibit visible scratches, chips, or cracks on the surface, which can impact both the aesthetics and functionality of the area. It is important to address this issue by evaluating and repairing the damaged areas. Depending on the severity of the damage, contacting a qualified countertop professional may be necessary for repair or replacement.

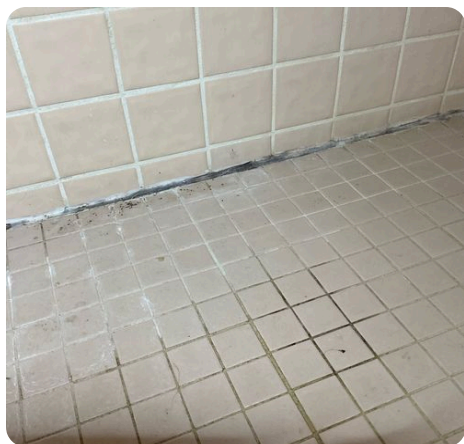
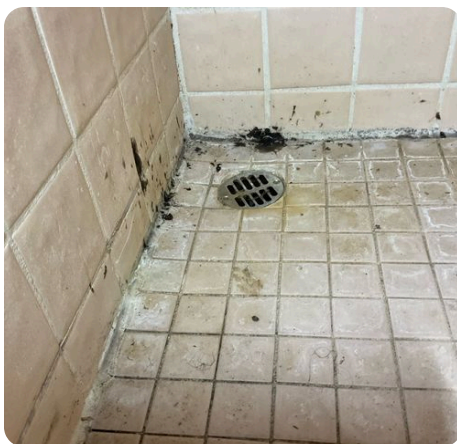
Mildew In Grout

The presence of mildew in the grout can indicate excessive moisture levels in the area, which can lead to mold growth and potentially impact indoor air quality. It is recommended to evaluate and repair the grout by thoroughly cleaning it with a mixture of water and vinegar or a mildew cleaner, and ensuring proper ventilation to prevent future mildew growth.

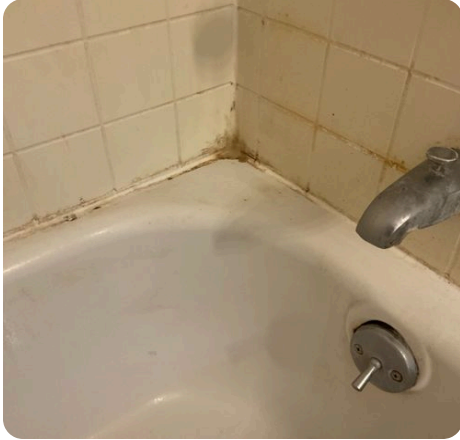
Shower Caulking Mildew Issue

The presence of mildew in the shower caulking should be addressed. Mildew not only looks unsightly, but can also indicate a damp environment which can lead to mold growth. It is recommended to evaluate the caulking, remove any mildew present, and recaulk the shower to prevent further issues. Ensure the shower area is well-ventilated after each use to discourage mildew growth in the future.

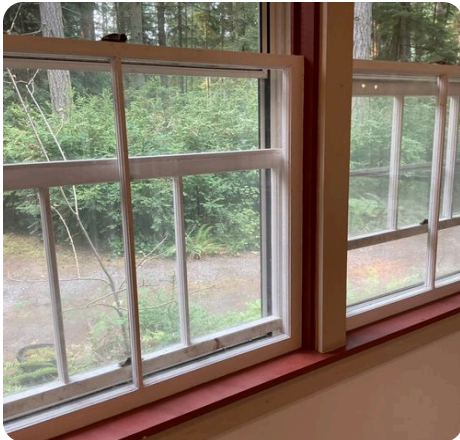
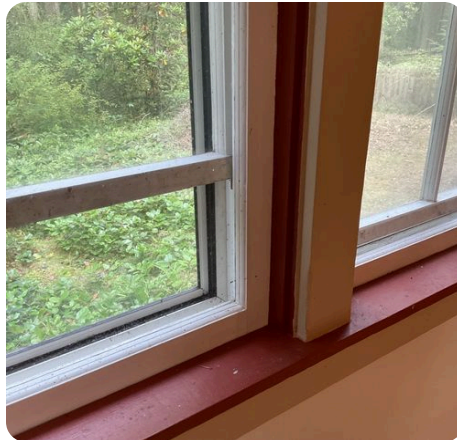
Location: Main House, Multiple Locations

Painted Shut Window

The window is painted shut, which is common in older homes or windows that have not been opened for a long time. It is essential to be able to open windows for ventilation and emergencies. Having a qualified window contractor assess and fix the window is recommended to ensure smooth operation.

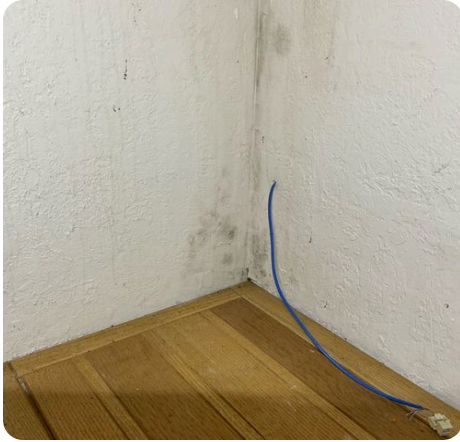
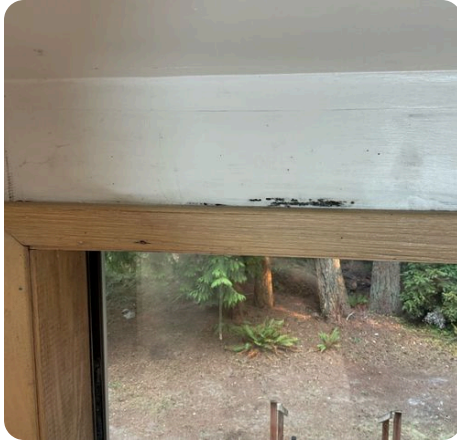
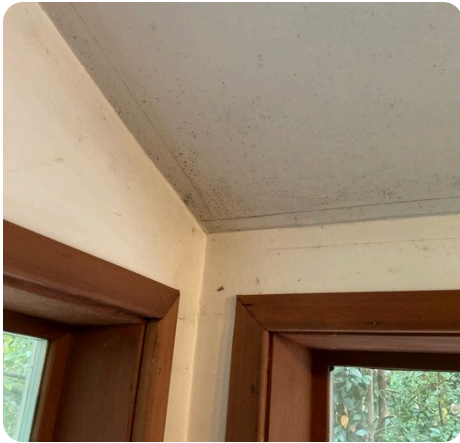
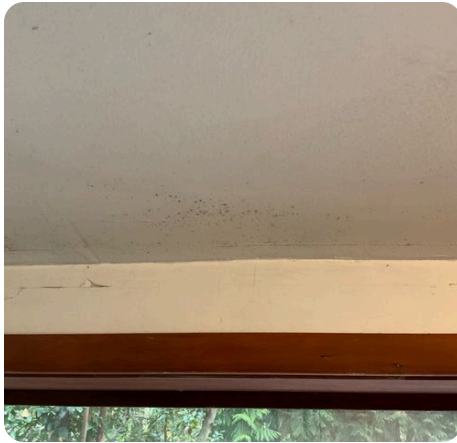
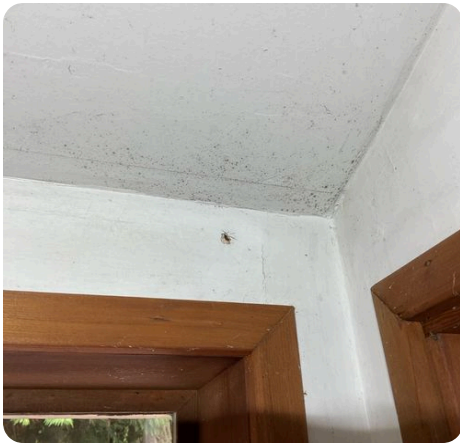
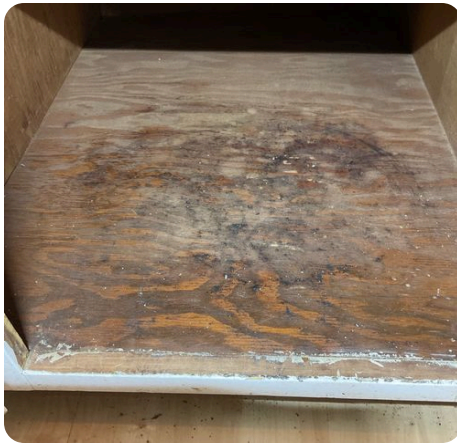
Mildew Presence Concerns

Mildew is present in multiple areas. It is recommended to address this issue promptly to prevent further growth and to maintain a healthy indoor environment. Evaluation and repair by a qualified mold remediation specialist may be necessary to effectively eliminate the mildew.

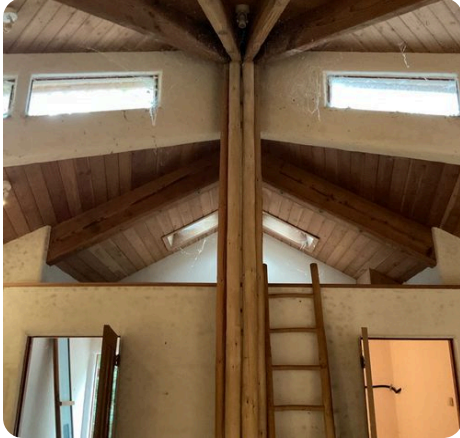
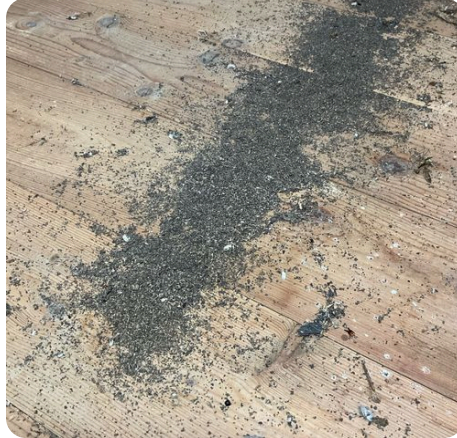
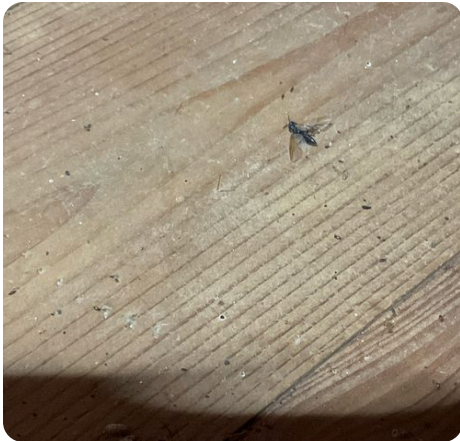
Location: Loft, Detached Studio

Carpenter Ant Frass And Carcasses

The presence of carpenter ant frass and carcasses indicates a possible infestation in the property. It is recommended to evaluate and address this issue promptly to prevent further damage to the structure. Hiring a licensed pest control professional can help in identifying the extent of the infestation and providing appropriate treatment to eliminate the ants.

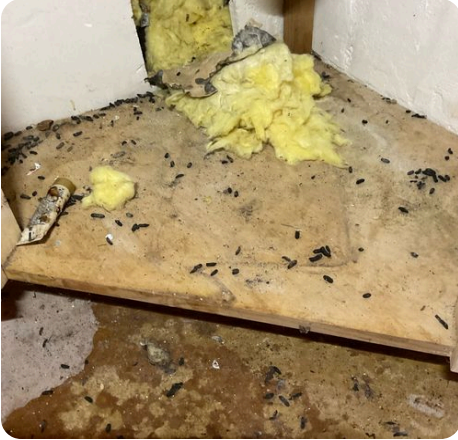
Location: Detached Studio

Evidence Of Rodents

The presence of rodent droppings in a property can lead to health hazards and damage. It is recommended to address this issue promptly to prevent further infestation. Contacting a licensed pest control professional for evaluation and extermination is advised.

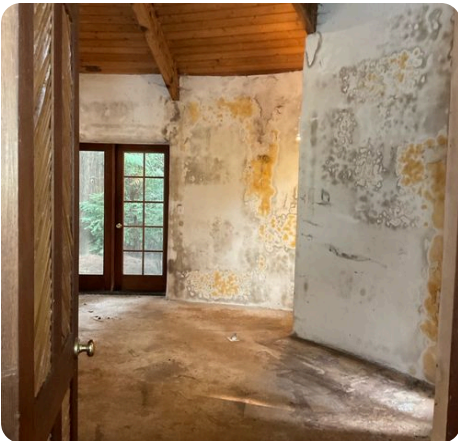
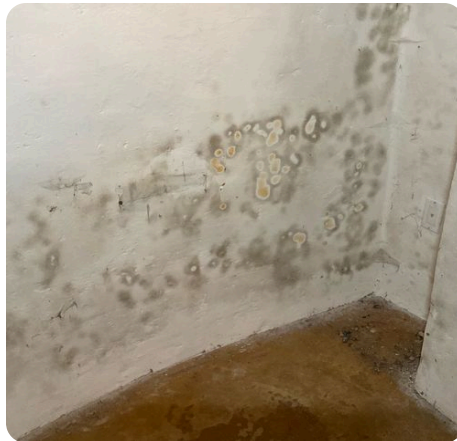
Location: Detached Studio

Mildew And Elevated Moisture Issue

The presence of mildew and elevated moisture on the walls is a sign of excessive moisture levels within the property. This can lead to mold growth and potential structural damage if not addressed. It is recommended to evaluate the ventilation in the affected area and repair any leaks or sources of moisture. A qualified contractor can help in identifying the root cause and providing solutions to prevent further moisture issues.

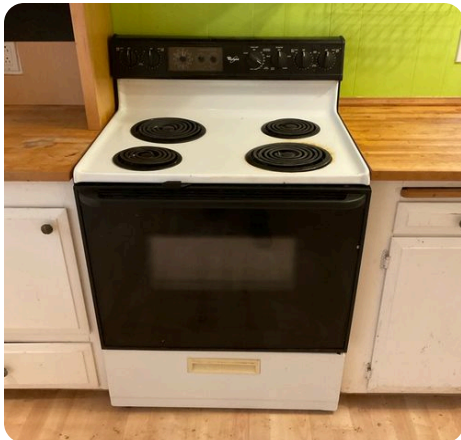
📍 Location: Kitchen

There is no anti-tip bracket installed for the oven. This device prevents the oven from tipping forward in the event that something heavy is set on the open oven door. For added safety, the inspector recommends that a bracket be installed.

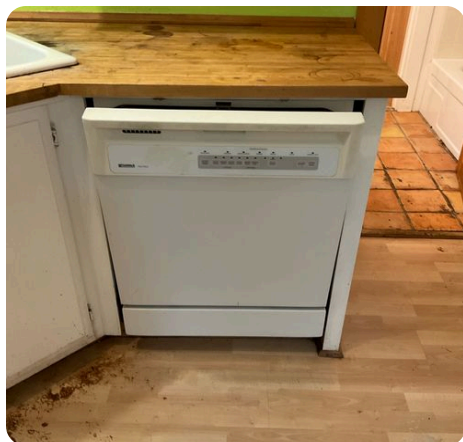
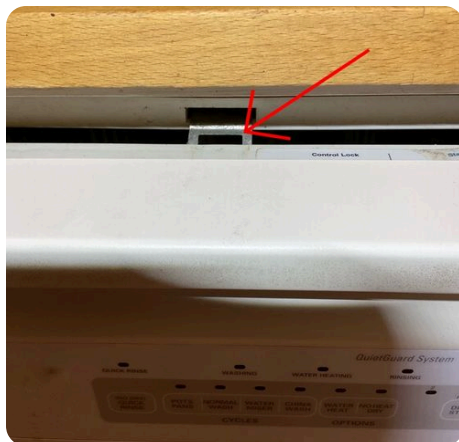
Location: Kitchen

Door Not Closing

The dishwasher door is not closing properly. This issue can lead to water leakage during operation and may result in inefficient cleaning. Evaluate and repair the door latch or hinges as needed to ensure proper functionality. If the problem persists, consider contacting a qualified appliance repair technician for further assistance.

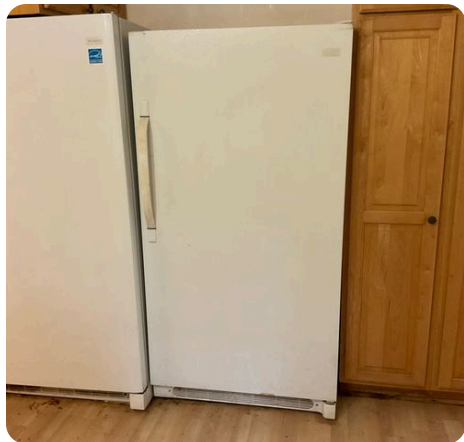
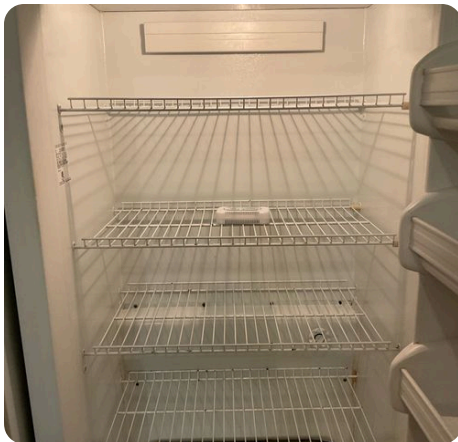
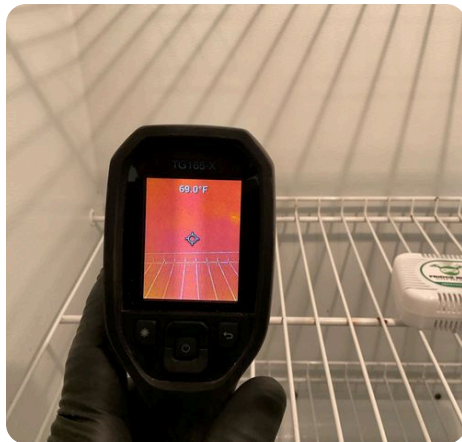
Location: Kitchen

Refrigerator Cooling Issue

The refrigerator was not cooling properly during the inspection due to the power being off upon arrival. It is recommended to allow the refrigerator ample time to cool once power is restored before evaluating its cooling performance. If the issue persists, have a licensed appliance technician evaluate and repair as needed.

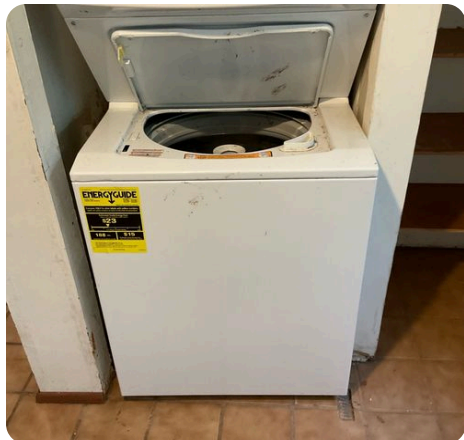
📍 Location: Laundry Room

An rinse cycle was performed on the washing machine, which appeared to be in functional condition at the time of the inspection. There were no visible water leaks at the washing machine hook-up valves or drain during testing. This inspection does not cover the full range of washing machine settings or the ability to wash clothes.

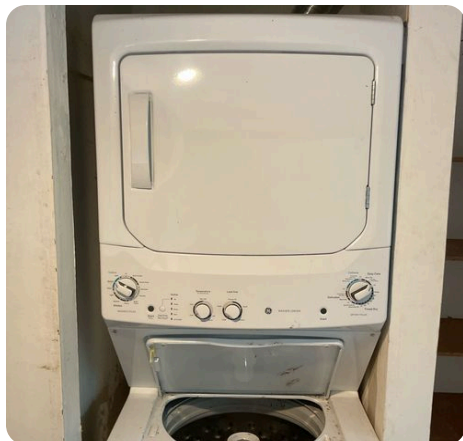
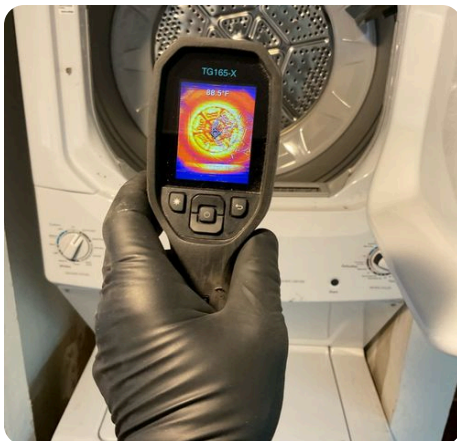
📍 Location: Laundry Room

An on/off test was performed on the clothes dryer. The interior temperature of the dryer responded to the controls. The inspector is not able to dry clothes or conduct a full test of all the settings.

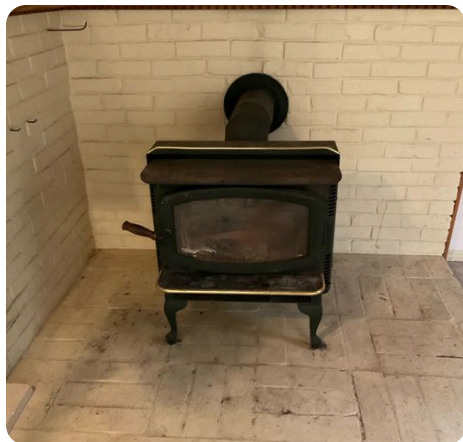
Wood Stove Present

There is a wood stove installed in the structure which appears to be in satisfactory condition. The inspector does not test or ignite the system; therefore, you should verify or further investigate the current condition and operation of the unit. This type of unit is required to be installed per UL listing and manufactures recommendations. Recommend you contact a certified chimney inspection service for further evaluations of the system.

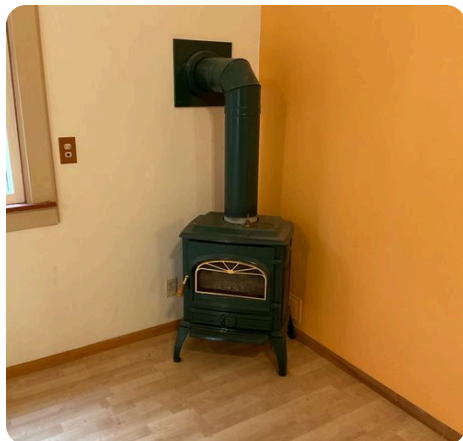
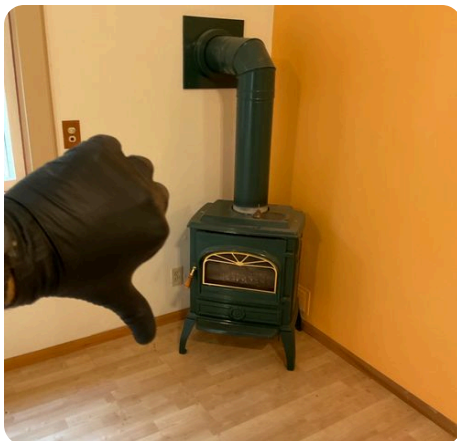
Gas Fireplace/Stove - No Fuel

The gas fireplace/stove was not tested due to no fuel supply present. It is recommended to verify the functionality of the fireplace/stove prior to closing.

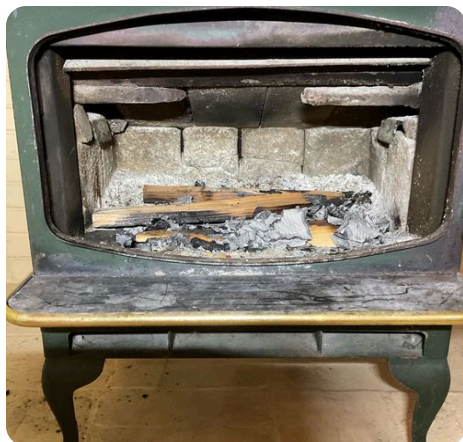
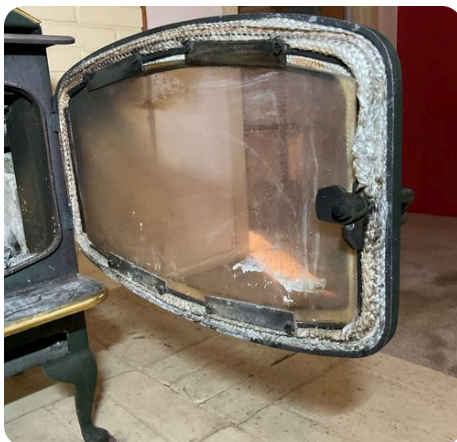
Wood Stove Cleaning Recommended

It is recommended to clean the wood stove to ensure proper functionality and prevent potential fire hazards. Soot and debris accumulation can restrict airflow and decrease efficiency. Consider hiring a professional chimney sweep for a thorough cleaning.

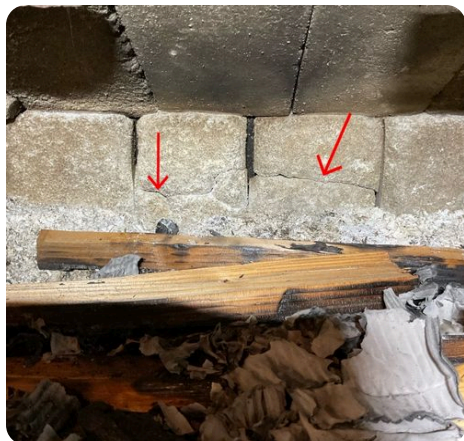
Cracked Fire Bricks In Firebox

The fire bricks at the backside of the firebox are cracked, which can lead to heat escaping and potential safety hazards. It is recommended to evaluate and repair the cracked fire bricks by a qualified mason or fireplace technician to ensure proper functionality and safety of the fireplace.

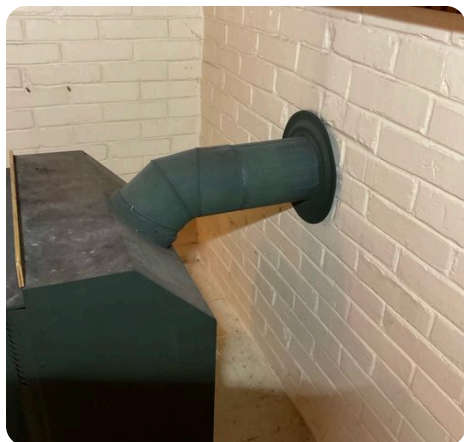
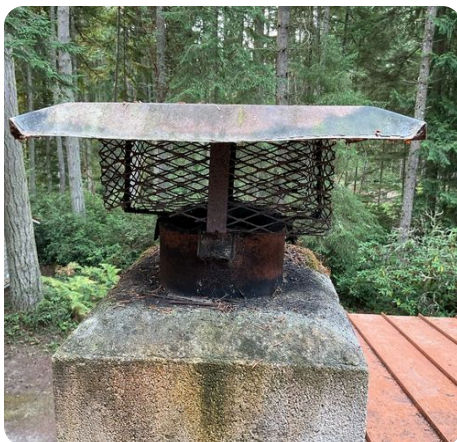
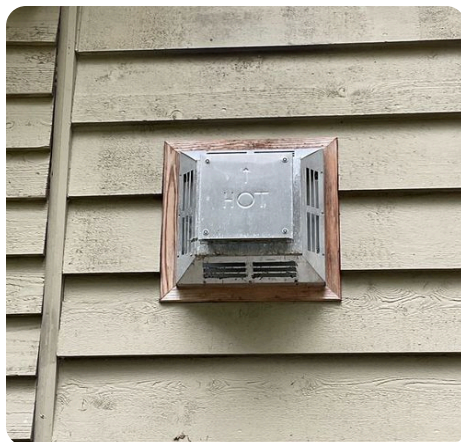
Flue Not Visible

The flue conditions were not fully visible during the inspection. If the chimney has not been cleaned or inspected in the last 1–2 years, contacting a chimney inspection company for service is advised. Note: If the fireplace is used heavily, having them professionally cleaned and inspected every 1–2 years is suggested as a preventive maintenance measure.

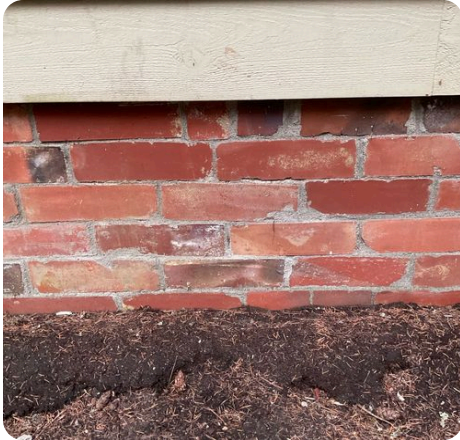
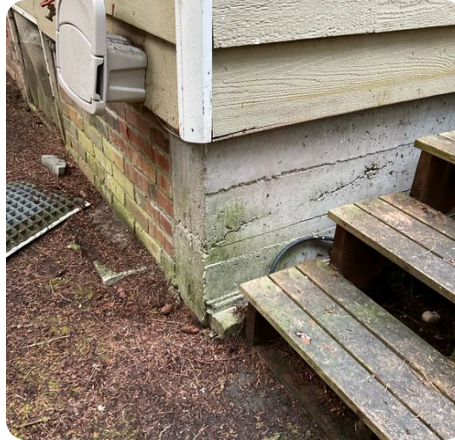
Foundation/Slab Evaluated

The foundation/slab was visually assessed during the inspection and appeared to be in functional condition with no immediate concerns noted. As part of routine maintenance, we recommend regularly monitoring the foundation for any signs of cracks, shifting, or water intrusion to address potential issues promptly and ensure long-term structural integrity.

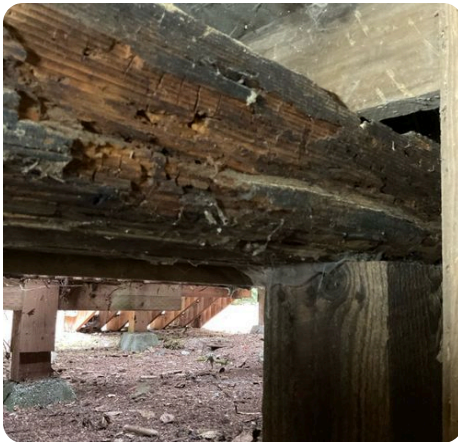
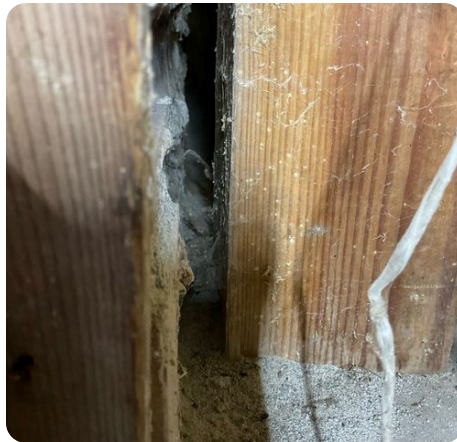
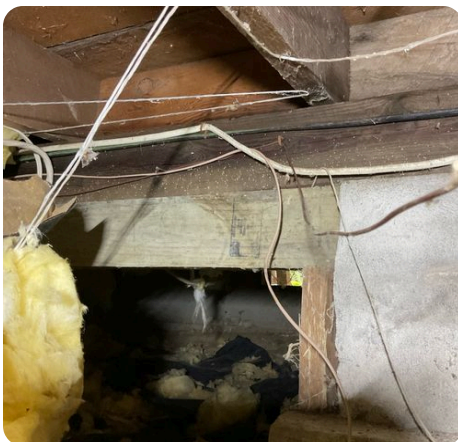
Insect Damage

The presence of insect damage in the structural components should be evaluated and repaired promptly. Insect damage can weaken the integrity of the beams, columns, or posts, potentially compromising the stability of the structure. It is recommended to consult with a licensed pest control professional to address the infestation and repair any damage to prevent further structural issues.

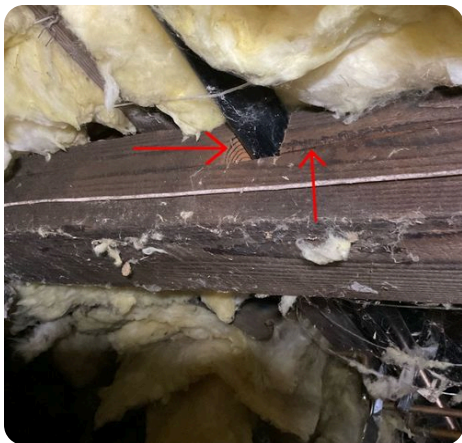
Improperly Notched Beam With Split

The beam in the property has been improperly notched, leading to a split. This issue compromises the structural integrity of the beam, which could affect the overall stability of the building. It is recommended to evaluate the extent of the damage and repair the beam promptly to prevent further deterioration. A qualified carpenter or structural engineer should be consulted for appropriate repairs to ensure the beam is properly reinforced.

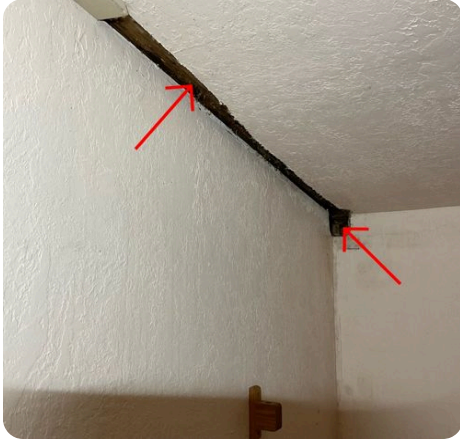
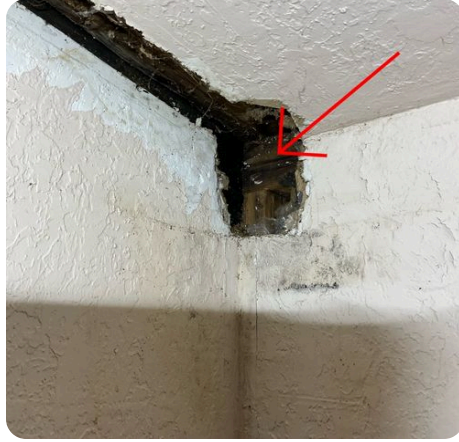
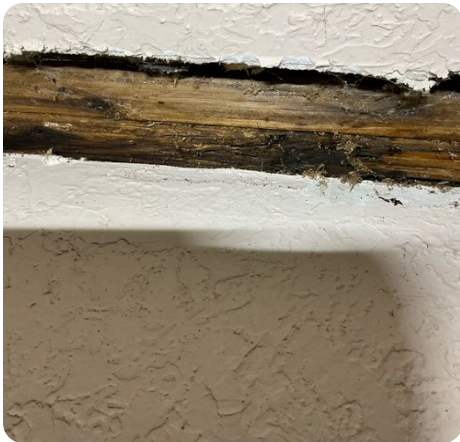
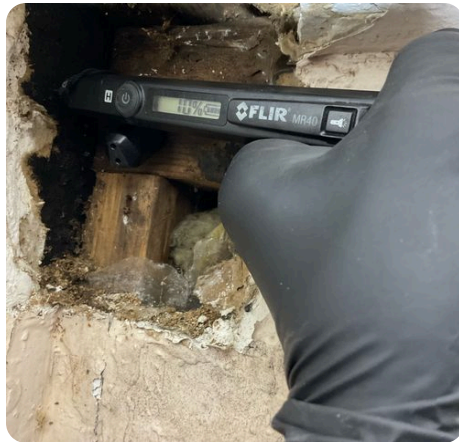
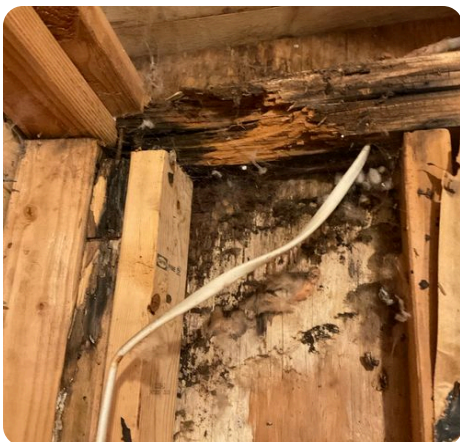
Deteriorated Rafter And Framing

The rafter and framing in the roof show signs of deterioration. This can compromise the structural integrity of the roof and may lead to further damage if not addressed. It is recommended to evaluate the extent of the deterioration and repair or replace the affected components as necessary. A qualified contractor should be consulted to ensure the repairs are done properly.

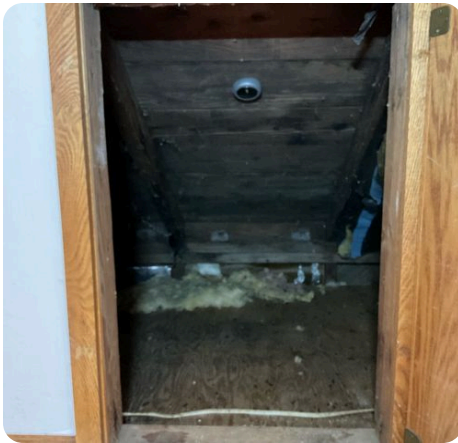
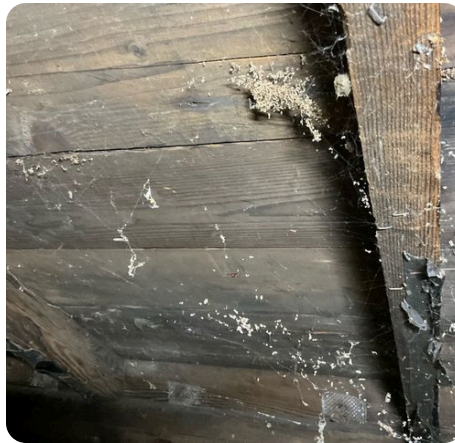
The presence of insect frass in the attic indicates a possible infestation. Insect frass, the excrement of wood-destroying insects like termites or carpenter ants, can lead to structural damage if left unchecked. It is recommended to contact a pest control specialist to evaluate the extent of the infestation and address it promptly to prevent further damage.

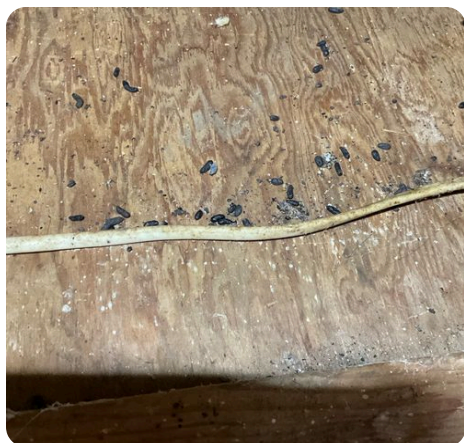
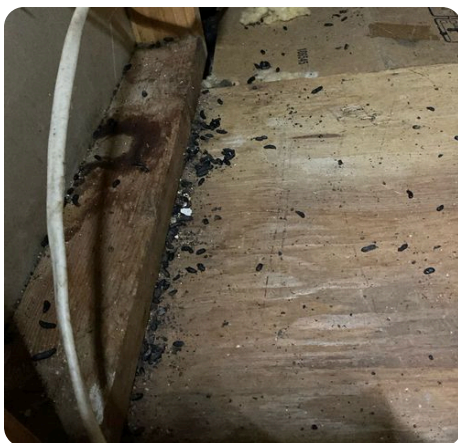
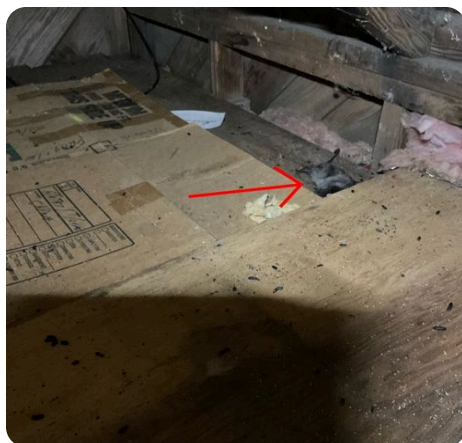
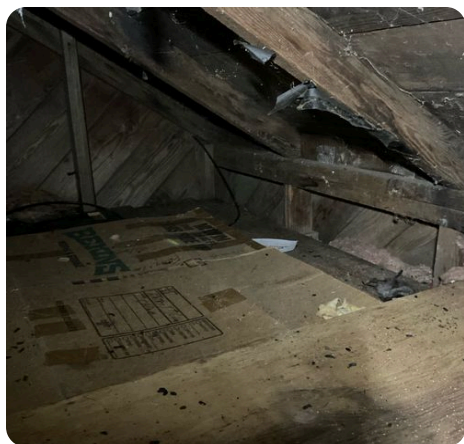
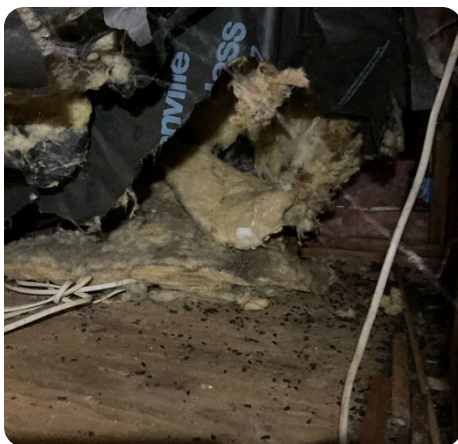
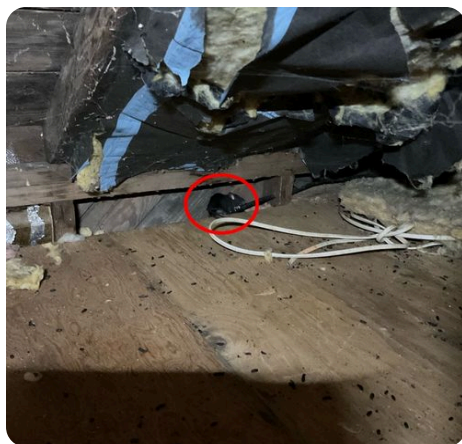
There was evidence of rodent/Small Animal activity in the insulation (visible droppings and/or trails). It could not be determined at the time of the inspection whether the activity was current, and no available access could be found. Extermination and control measures are recommended. Contact a qualified Pest Control Operator to evaluate and provide the appropriate control measures.
