Service: Pre-Listing Inspection

Prepared for: Amy Gulden

Aaron McBride

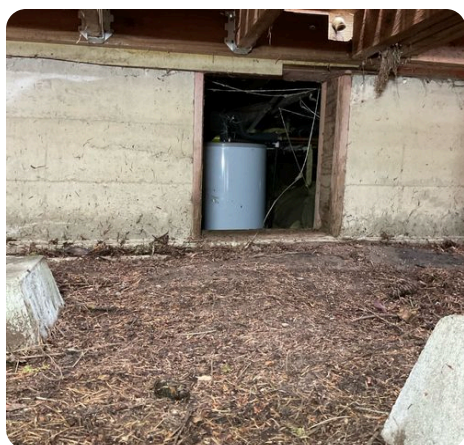
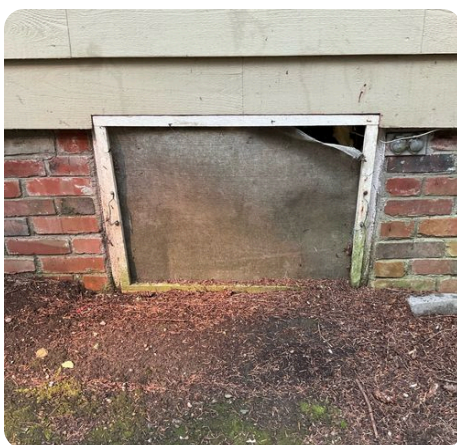
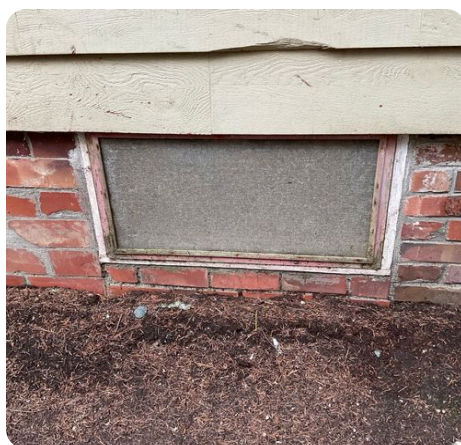
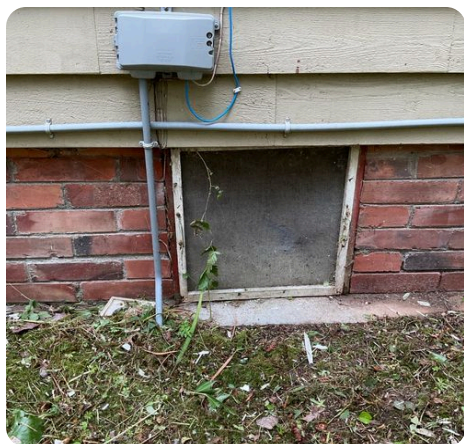
Location: Main House

The Crawlspace access covers are not secure. This can lead to safety hazards, pest infestations, and energy inefficiency. It is recommended to secure the access covers properly to prevent these issues. You may consider installing locks or latches to ensure the covers are tightly sealed.

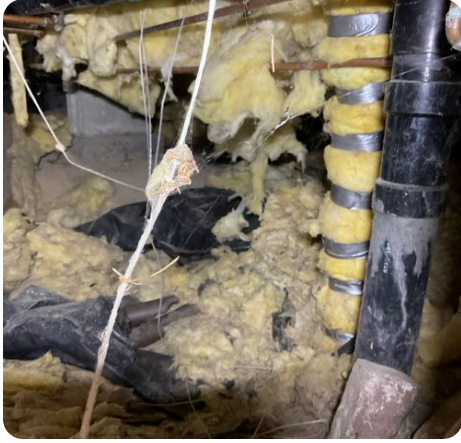
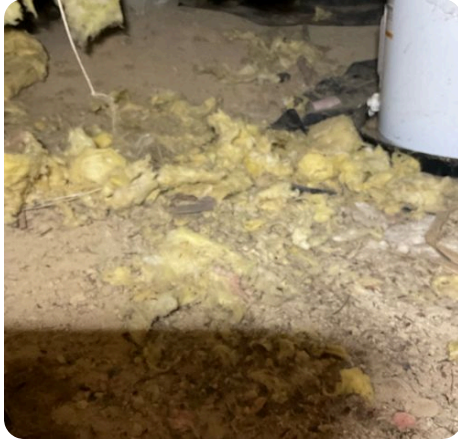
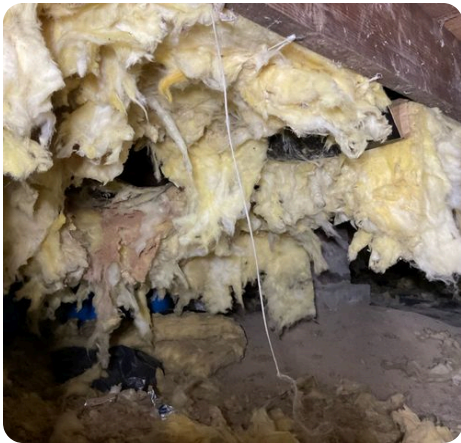
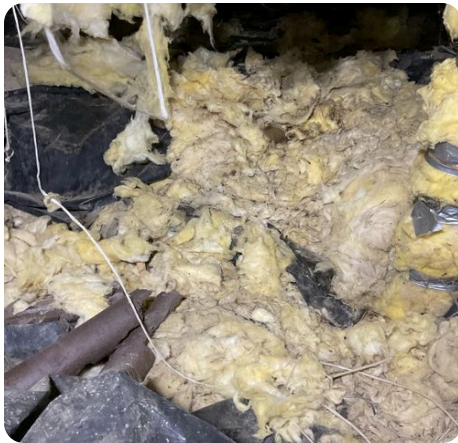
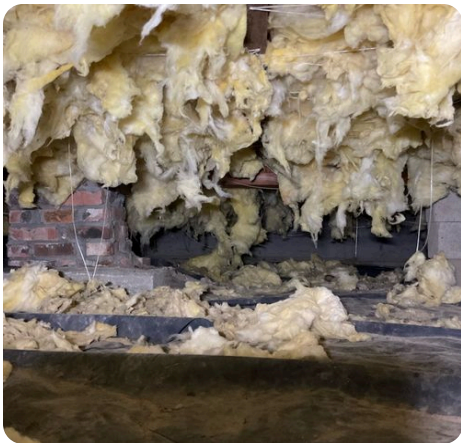
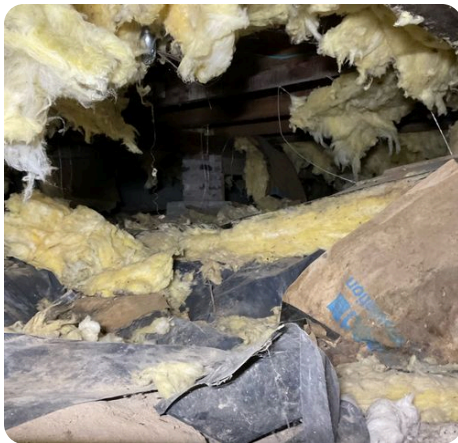
Rodent/Small Animal Intrusion

Evidence of rodent or small animal intrusion found in the crawl space. (Inspector visually saw raccoon in crawl space) This can lead to damage to insulation and potential health hazards. It is recommended to evaluate and repair any entry points or gaps in the crawl space to prevent further intrusion. Consider hiring a pest control professional to address the issue and ensure the crawl space is properly sealed to prevent future infestations.

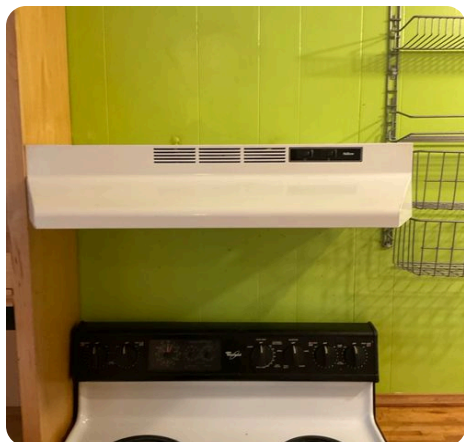
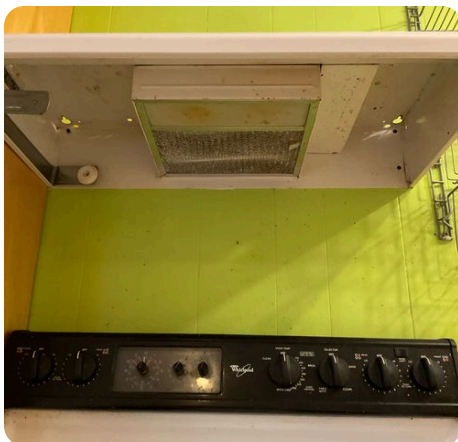
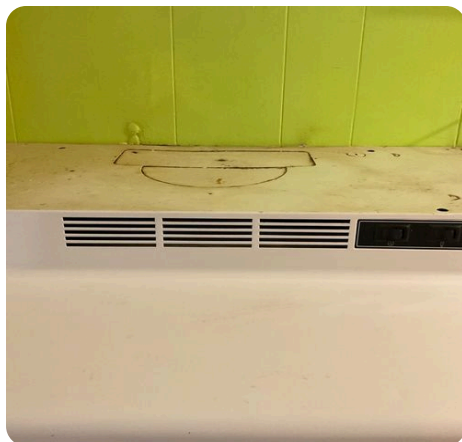
Location: Main House

The vent fan should be properly vented to the outdoors to effectively remove cooking odors, moisture, and airborne grease. Recirculating the vent fan may not be as efficient in improving indoor air quality. It is recommended to evaluate the current setup and consider rerouting the vent to exhaust outside to enhance ventilation.
