# Inspection Report

## Property Address:

535 Courtney Lane

Callao, VA

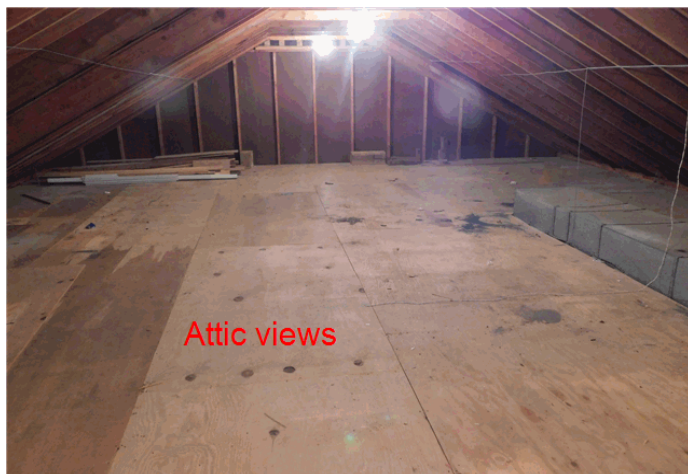
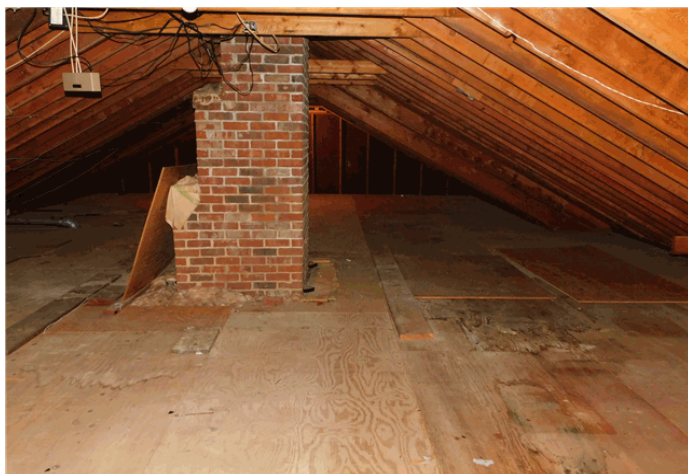
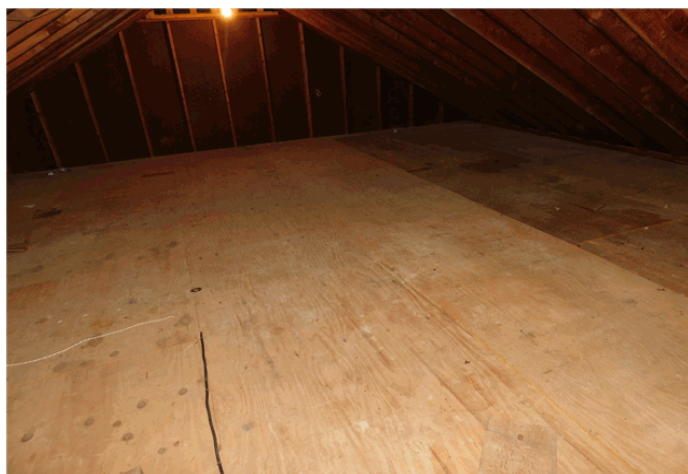
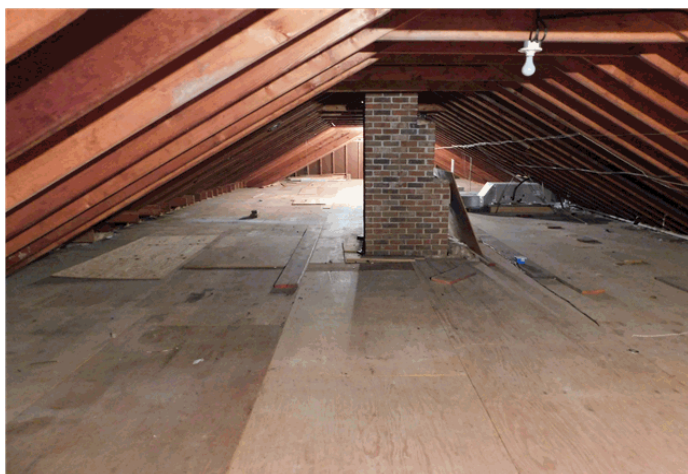
**AS** = Appears Serviceable**R** = Repair**S** = Safety**NI** = Not Inspected**17) Attic Conditions****AS**

The visible and accessible portions of the attic appeared to be in serviceable condition at the time of the inspection.

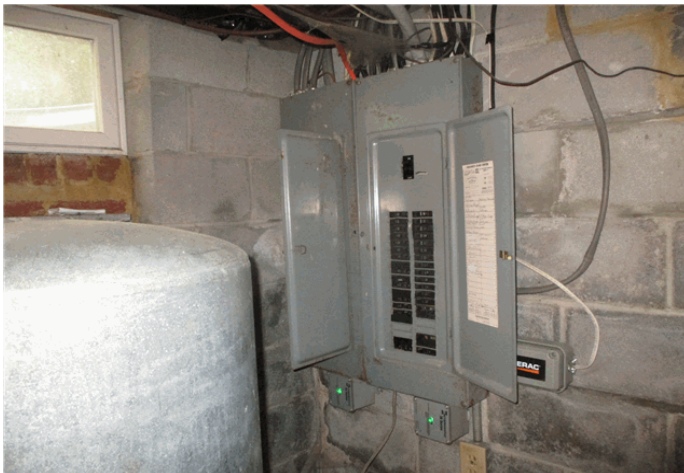
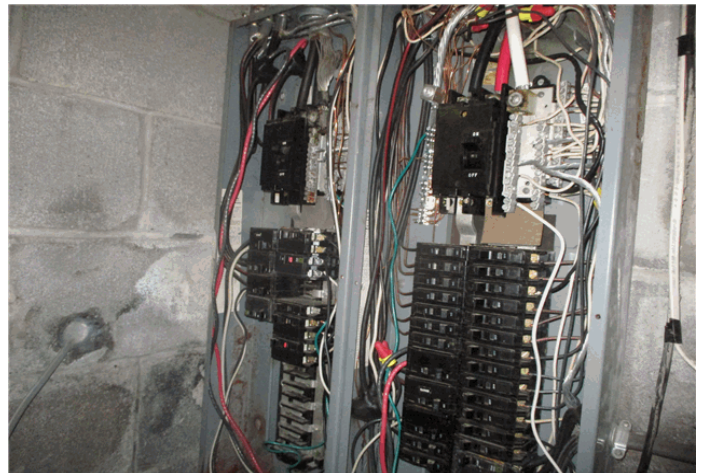
**24) Electrical Panel Conditions****AS**

The main panels appeared to be in serviceable condition at the time of the inspection.

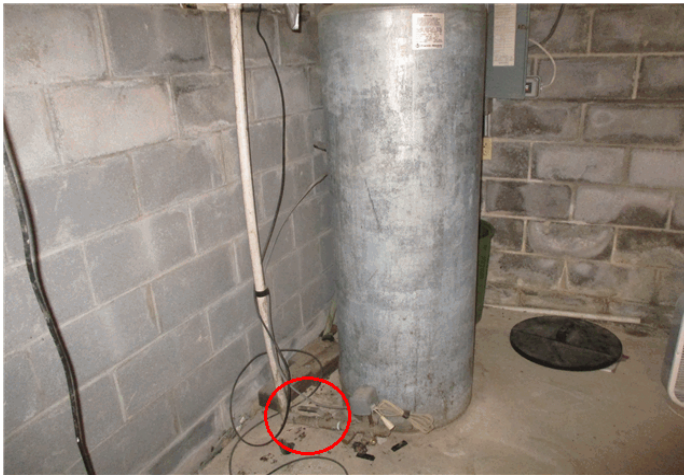
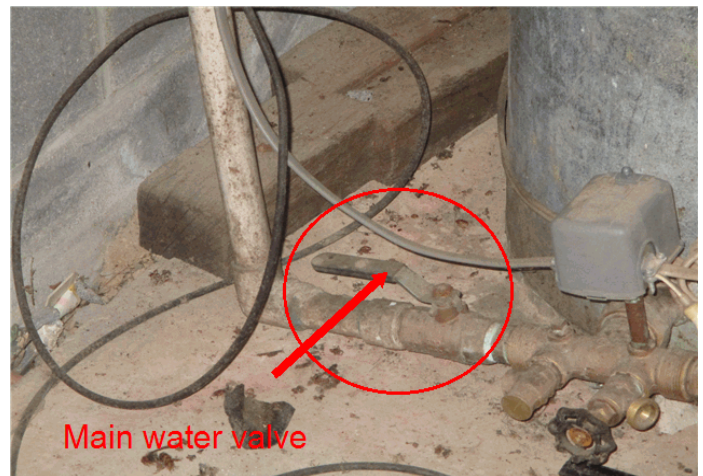
The visible portion of the main pipe and valve appeared to be in serviceable condition at the time of the inspection.

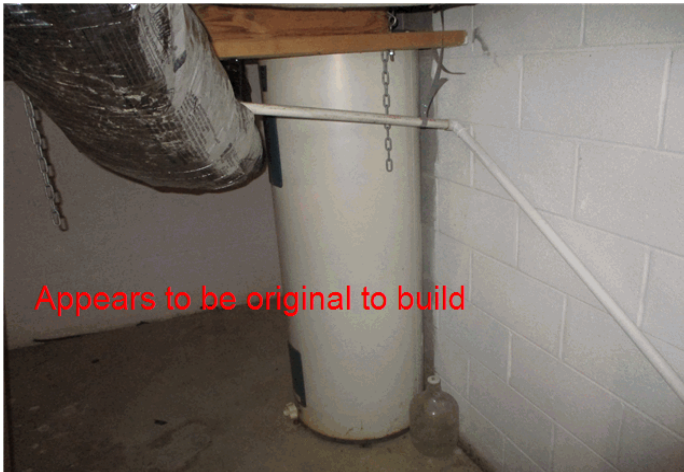
**AS = Appears Serviceable****R = Repair****S = Safety****NI = Not Inspected****Water Heater Type** Electric**Water Heater Location** Basement**Water Heater Capacity** 50 Gallon**29) Water Heater Conditions****AS**

The water heater was operable at the time of inspection. This does not however guarantee future performance, operation, or condition.

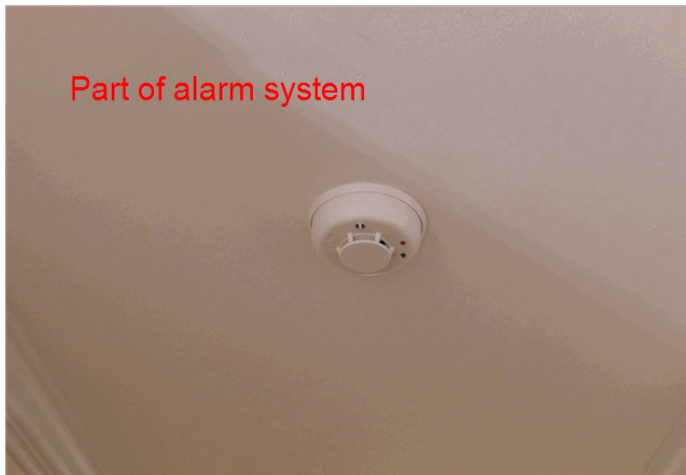
The smoke detector may be part of an alarm. The smoke detector was not tested. Smoke detectors have a useful lifespan of about 10 years, it is recommended to replace all units after this time period.
