# A Buyer's Choice **Home Inspections**

## PROPERTY INSPECTION REPORT

660 32nd Ave SE Apt 20, Albany, OR 97322

Date of Inspection: 11/1/2025 Time: 8:00 AM

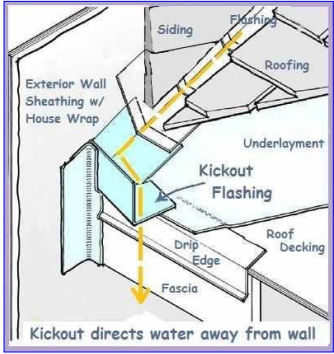
| Roof | | |
|---|---|---|
| Undersized diverter flashing | Undersized diverter flashing | Proper diverter flashing example* |

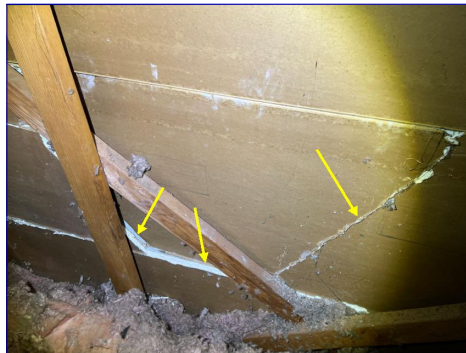
| Page 13 Item: 1 | Attic Observations | • Fire separation wall between units is damaged. Recommend review by a qualified, licensed contractor for repairs as necessary for safety. |

Fire separation between units is compromised

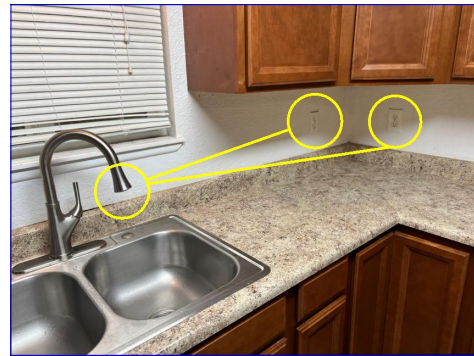
| Page 17 Item: 2 | 120 / 240 VAC Branch Circuits | • Electrical receptacle within six feet of a water source is not <b>GFCI</b> protected. Recommend having a licensed electrical contractor repair for safety. |

Not **GFCI** protected (kitchen)**Plumbing System**

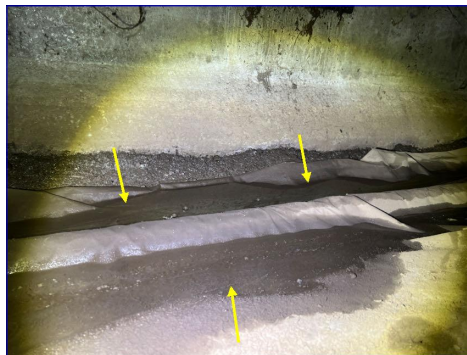
- Sitting water observed in the crawlspace at the main **DWV** waste disposal line. The inspector was unable to determine the cause of the water at the time of inspection. It is possible that there is or was a waste disposal line leak. Recommend referring to sellers disclosure and/or having a licensed and qualified plumber evaluate to determine the cause and prevent any further issues.

Sitting water

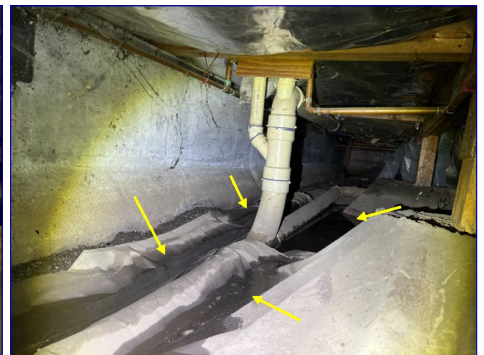
Sitting water

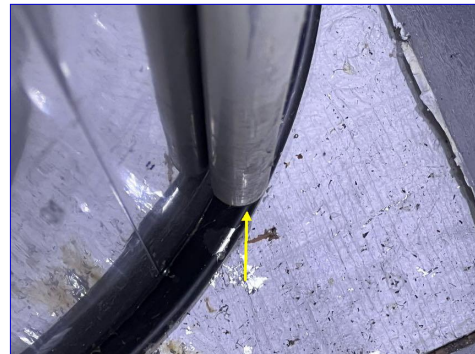
| Page 23 Item: 5 | TPR Valve | <ul style="list-style-type: none"> <li>• <b>TPR valve</b> / piping should be constructed of an approved material, such as CPVC, copper, polyethylene, galvanized steel, polypropylene, or stainless steel. <b>PVC</b> and other non-approved plastics should not be used since they can easily melt.</li> <li>• TPR discharge pipe was observed to be misaligned with the drip pan. In the event the unit needs to utilize the Temperature Pressure Relief (TPR) valve, the water will most likely spray to the surrounding areas. Recommend having a licensed contractor replace the discharge pipe with proper material and realign with drip pan.</li> </ul> |

Discharge pipe not aligned with drip pan

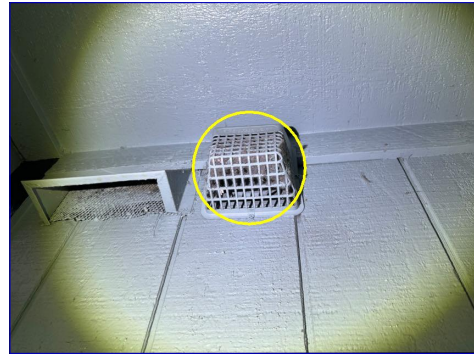
| Page 28 Item: 4 | Dryer Supply & Vent | <ul style="list-style-type: none"> <li>• Dryer vents shall terminate not less than 3 feet in any direction from openings into buildings.</li> <li>• Dryer exhaust vents should not terminate with a screen, as this can lead to lint accumulation and restrict airflow. Recommend removing the screen and cleaning the dryer exhaust to help reduce the risk of a potential fire hazard.</li> </ul> |

Screen on dryer exhaust vent termination

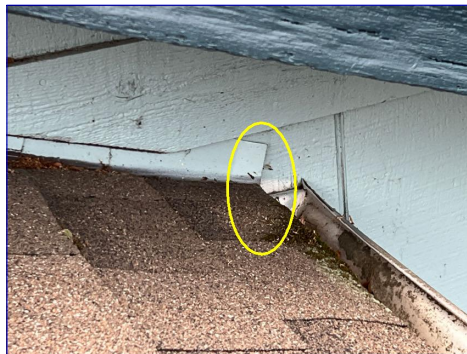
| Roof | | |
|---|---|---|
| Page 10 Item: 3 | Roof Flashing | <ul style="list-style-type: none"><li>Undersized kickout flashing (also called diverter flashing) noted. Kickout flashing should be present anywhere a roof and exterior wall intersect, where the wall continues past the lower roof-edge and gutter or where gutters terminate at the side of a chimney.</li></ul> |

Undersized diverter flashing

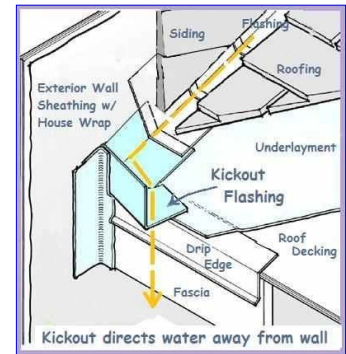
Proper diverter flashing example\*

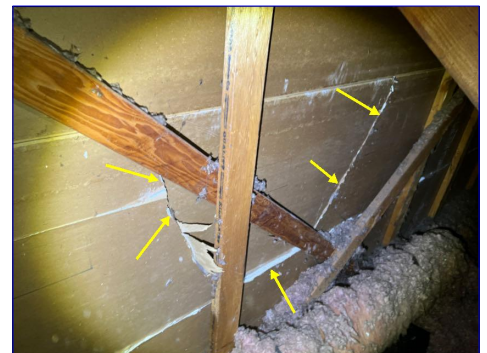
Fire separation between units is compromised

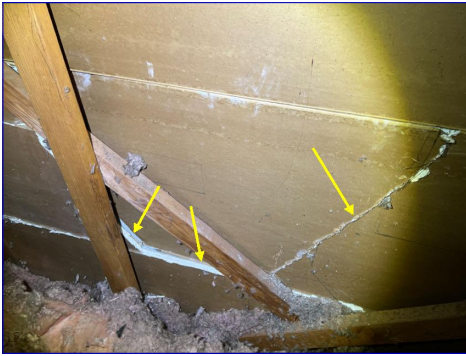
Fire separation between units is compromised

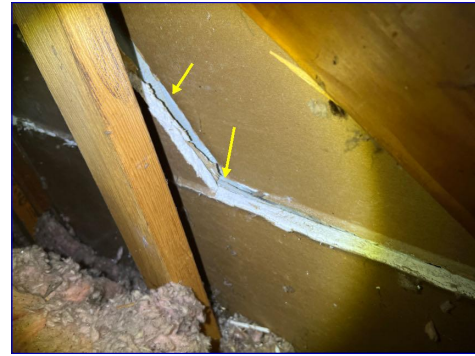
Fire separation between units is compromised

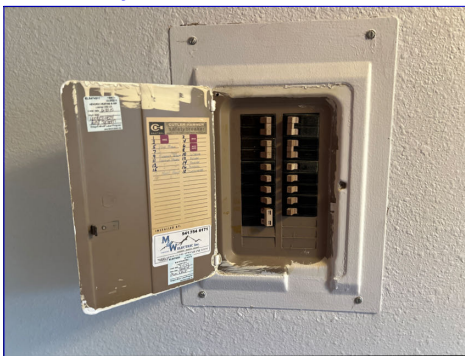
Main electric panel

- Thermal anomaly observed at connection of breaker which may be indicative of a loose, corroded or damaged connection. Recommend further evaluation of electrical system by a qualified electrical contractor and repair as necessary.

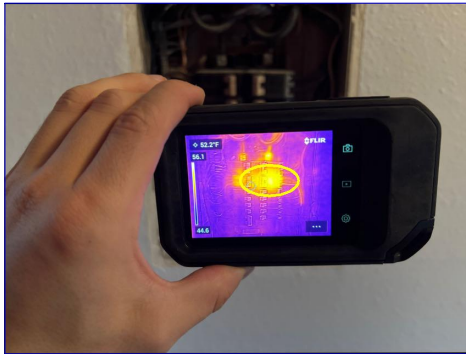
Thermal anomaly

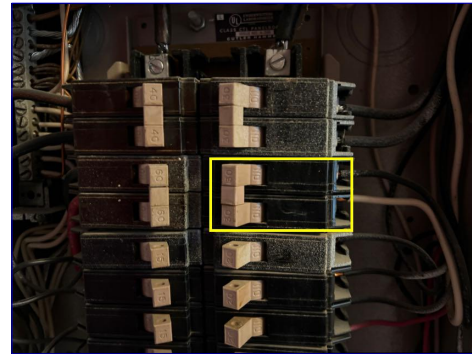
Thermal anomaly breaker

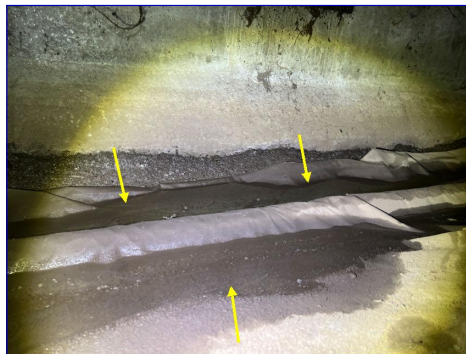
- Sitting water observed in the crawlspace at the main DWV waste disposal line. The inspector was unable to determine the cause of the water at the time of inspection. It is possible that there is or was a waste disposal line leak. Recommend referring to sellers disclosure and/or having a licensed and qualified plumber evaluate to determine the cause and prevent any further issues.

Sitting water

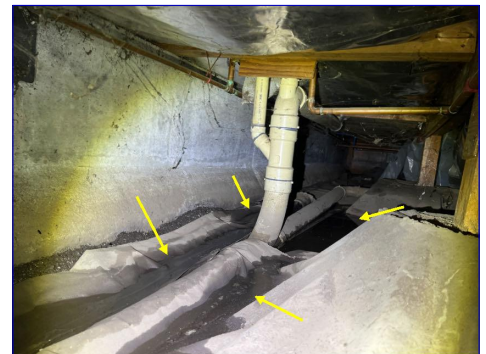
Sitting water

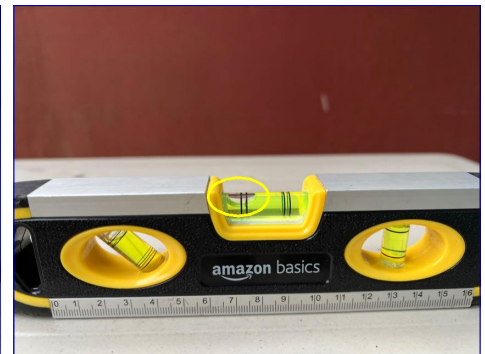
• Condenser is tilted, excessive uneven settlement can cause fractures in refrigerant line fittings and loss of refrigerant as well as shorten the life of the compressor. Unit should be leveled.

Unit is not level

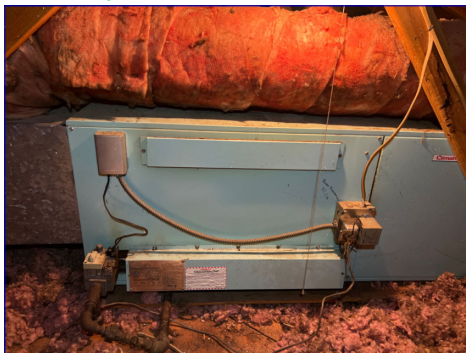
- Not inspected. System is shut down. Please confer with seller regarding start up procedure for this system

System is shut down

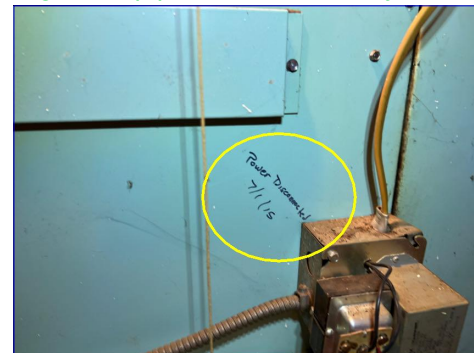
Power was disconnected

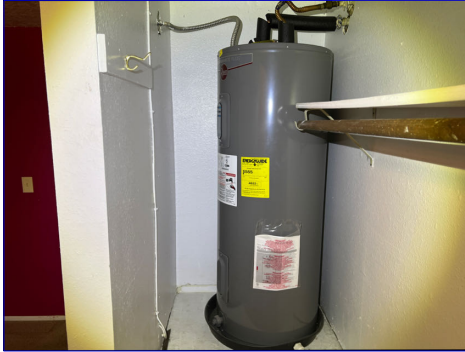
- The water heater was observed leaning and is not equipped with the required seismic strapping. Current standards require water heaters to be properly secured with seismic straps to prevent movement or tipping during an earthquake. Recommend correction and securing of the unit by a qualified plumber or contractor.

Water heater

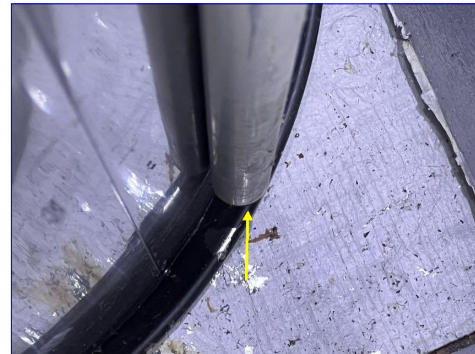
- **TPR valve** and extension/discharge pipe present.
- **TPR valve** / piping should be constructed of an approved material, such as CPVC, copper, polyethylene, galvanized steel, polypropylene, or stainless steel. **PVC** and other non-approved plastics should not be used since they can easily melt.
- TPR discharge pipe was observed to be misaligned with the drip pan. In the event the unit needs to utilize the Temperature Pressure Relief (TPR) valve, the water will most likely spray to the surrounding areas. Recommend having a licensed contractor replace the discharge pipe with proper material and realign with drip pan.

Discharge pipe not aligned with drip pan

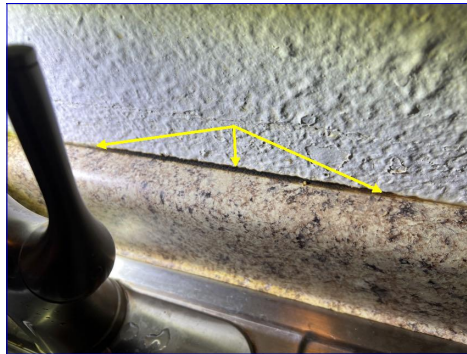
- Caulk needed along edge of counter and wall

Caulking needed

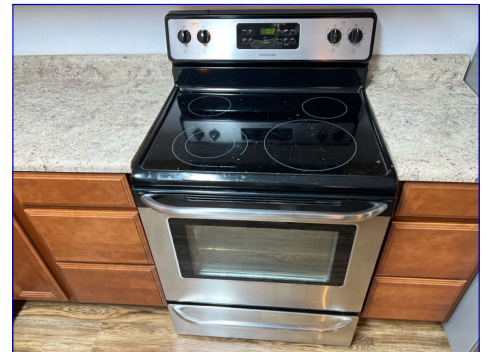
- Operated normal at the time of inspection.
- Range tips which is a safety hazard. Recommend installing anti-tip device for safety.

Range tips

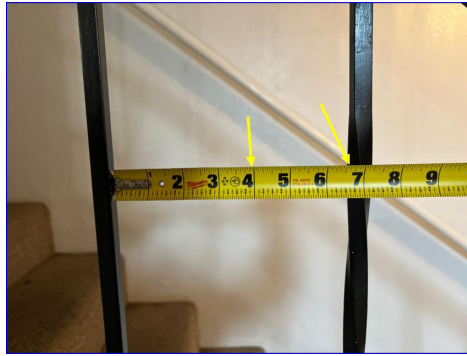
- Baluster opening between vertical members should not exceed 4 inches apart to keep children and pets from falling through or getting stuck in the railing.

Balusters exceeded 4"

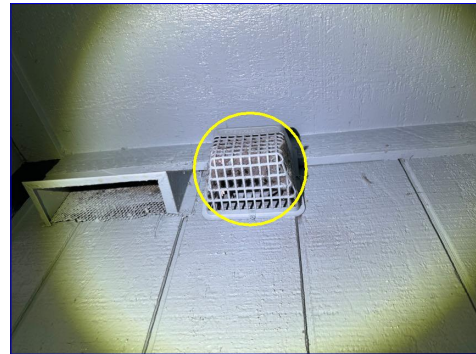
- Dryer vents shall terminate not less than 3 feet in any direction from openings into buildings.
- Dryer exhaust vents should not terminate with a screen, as this can lead to lint accumulation and restrict airflow. Recommend removing the screen and cleaning the dryer exhaust to help reduce the risk of a potential fire hazard.

Screen on dryer exhaust vent termination

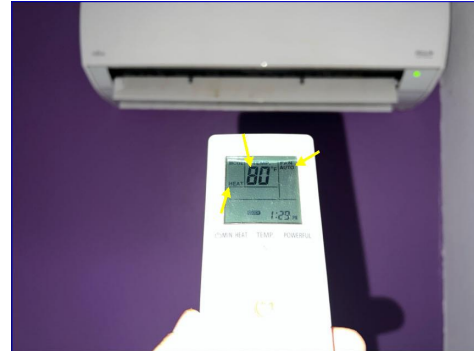
- Mini split system would not produce heat at the set temperature at the time of inspection. Recommend having a licensed and qualified contractor evaluate and make any necessary repairs.

Mini split not heating
