Home Inspection Report

PROPERTY INSPECTED:
**4001 South Elliott Prairie Road
Woodburn, OR 97071**

Date of Inspection: 01/16/2026

Inspection No. 44631-2-5828

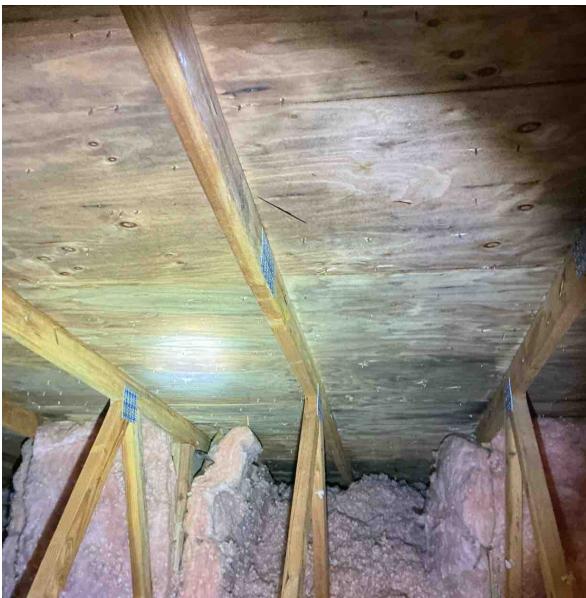
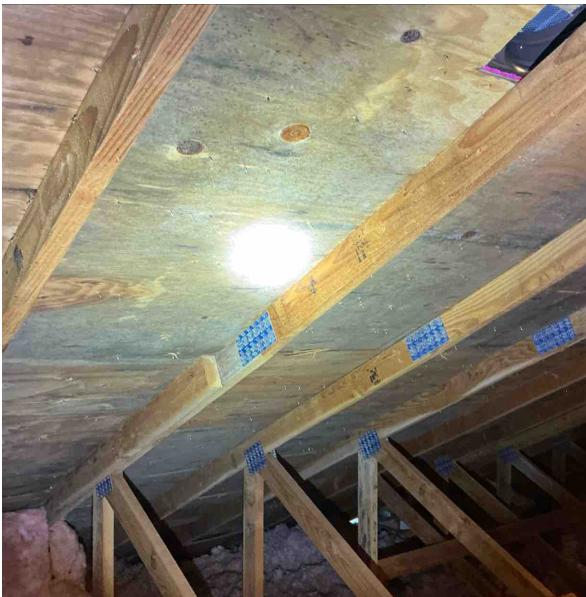
5.6.1 Mildew growth was noted on the interior roof sheathing in the attic, which is often times caused by a lack of proper ventilation throughout the attic. Have the ventilation checked by a qualified and licensed contractor, and the necessary corrections made to reduce the chance of further/future mildew growth or other ventilation related problems. The existing mildew growth should be treated and removed, post ventilation corrections, for health reasons. (The roof itself does appear to be newer, which may have corrected the ventilation issue.)

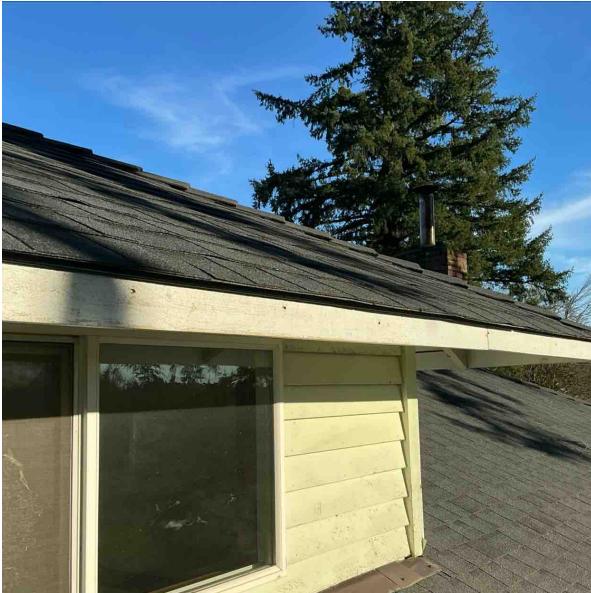
3.3 Wall Surface Wood siding

3.3.1 Minor chipping/flaking paint was observed in various locations throughout the exterior, as well as minor cracked caulking and trim damage. Additionally, there were a number of trim nails that have not been sealed. Recommend caulking and paint touchup as needed to ensure exterior components are well sealed.

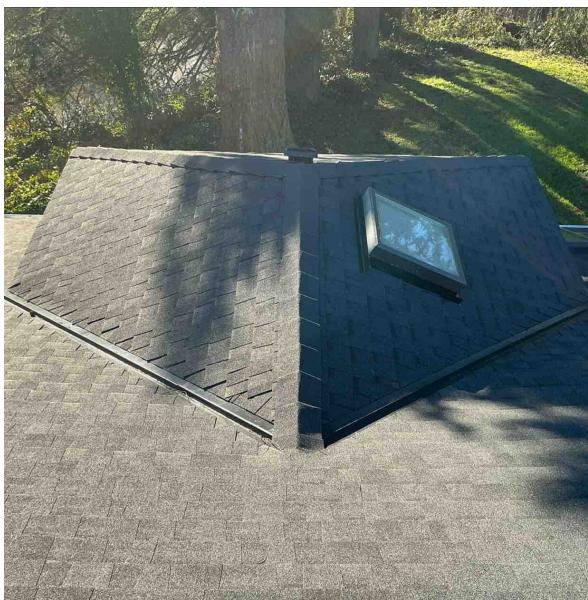
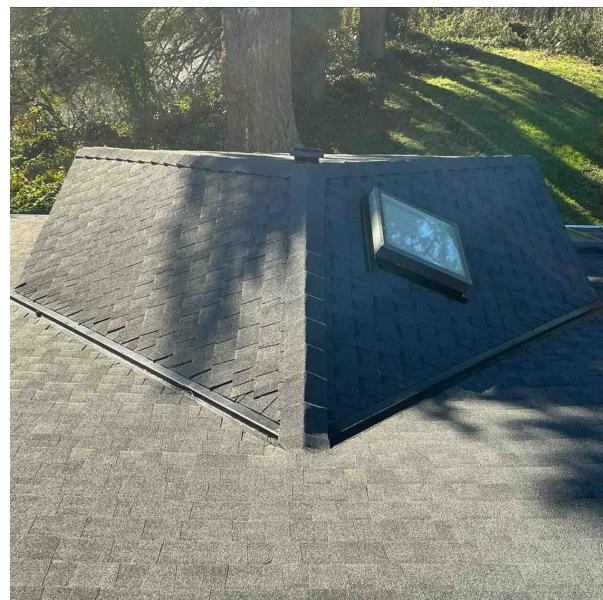
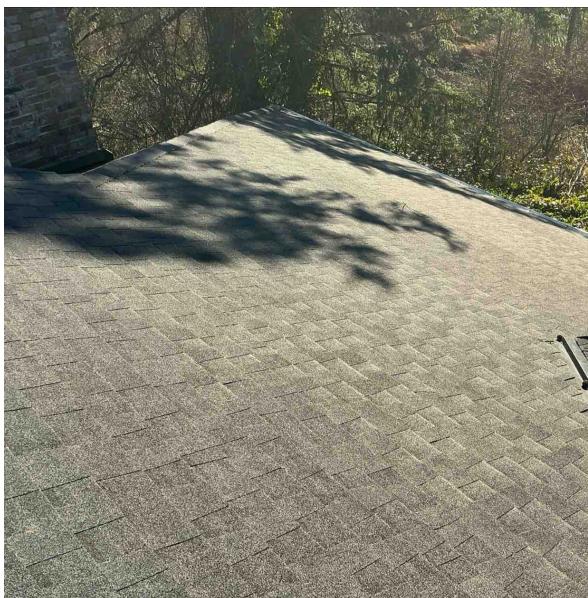
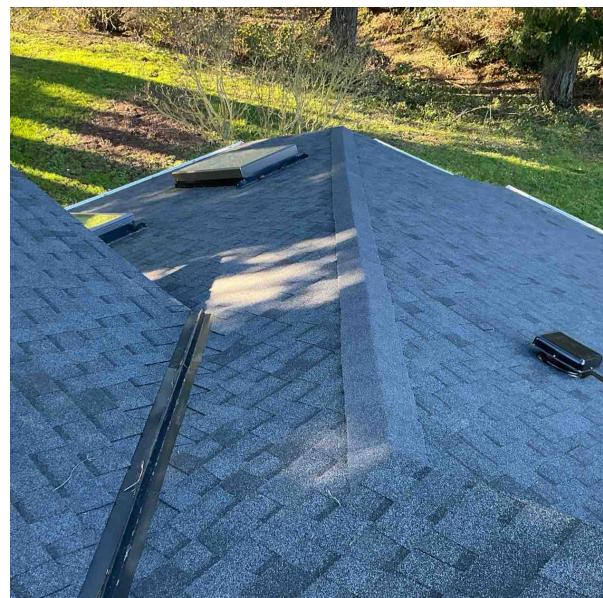
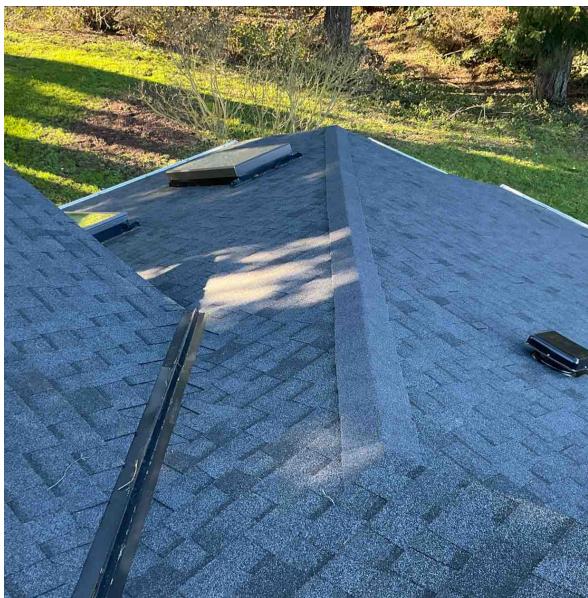
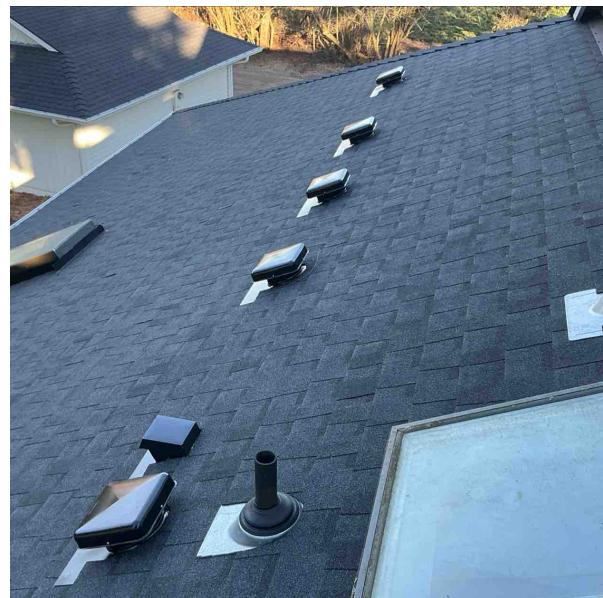
4.1.2 Roof was inspected and in overall good working order. Recommend routine maintenance be done to reduce the risk of premature deterioration, failure, and leaks.

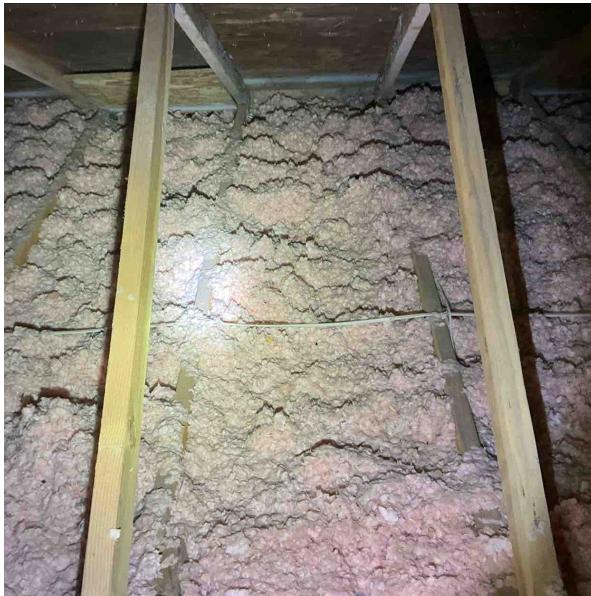
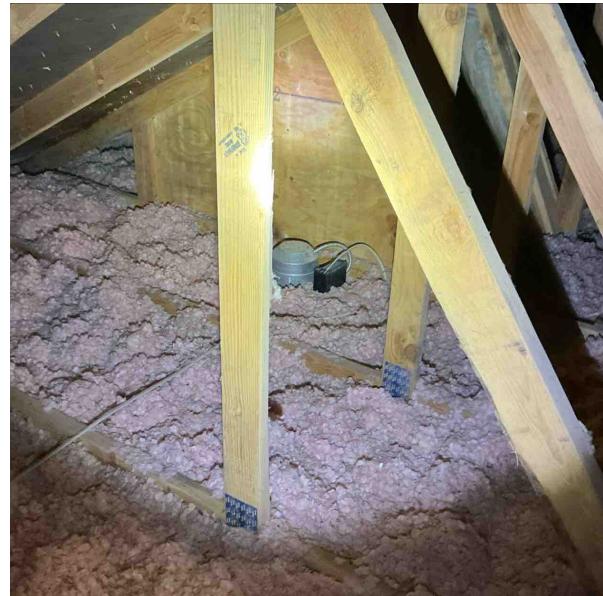
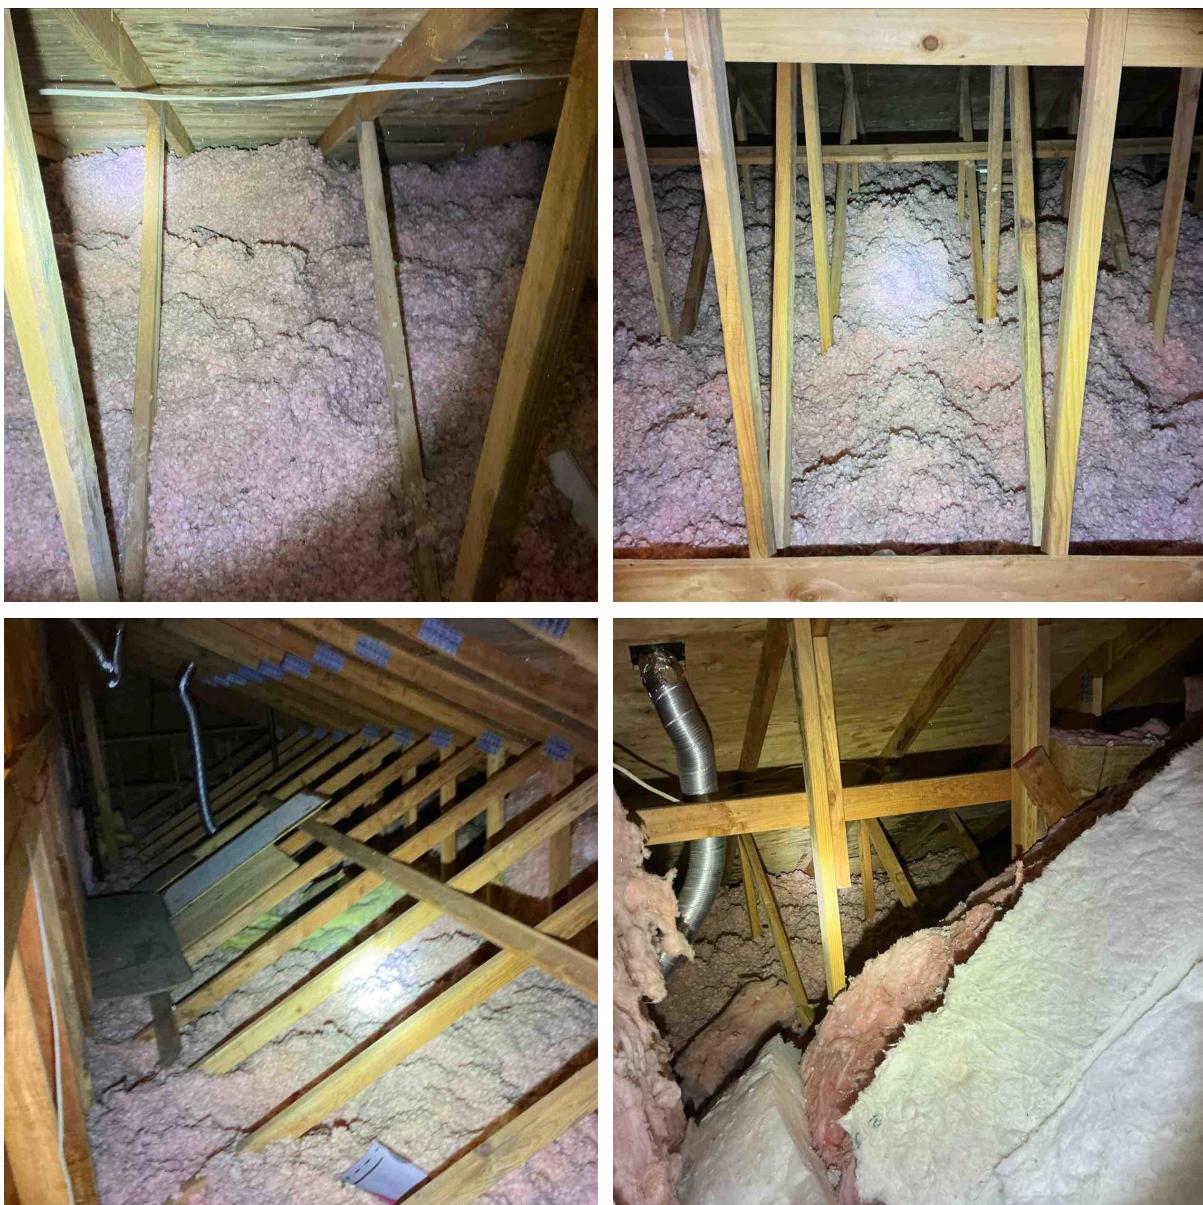
5.3 Insulation

5.3.1 Insulation level is low by today's standards, and is compacted in several locations.. Home could benefit from an upgrade.

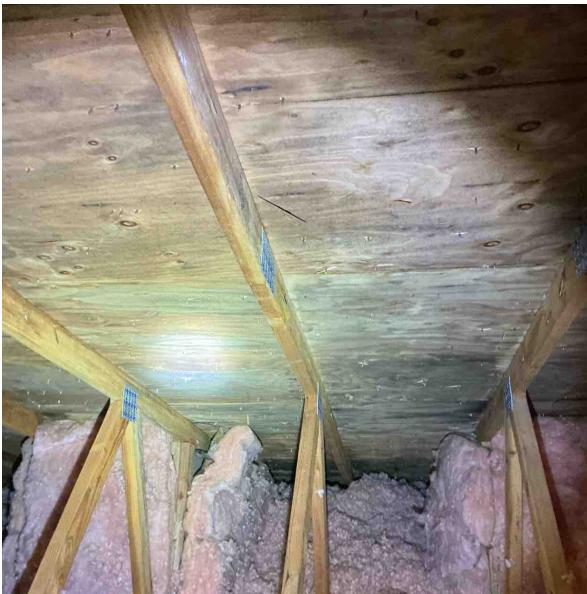
5.6 Sheathing

5.6.1 Mildew growth was noted on the interior roof sheathing in the attic, which is often times caused by a lack of proper ventilation throughout the attic. Have the ventilation checked by a qualified and licensed contractor, and the necessary corrections made to reduce the chance of further/future mildew growth or other ventilation related problems. The existing mildew growth should be treated and removed, post ventilation corrections, for health reasons. (The roof itself does appear to be newer, which may have corrected the ventilation issue.)

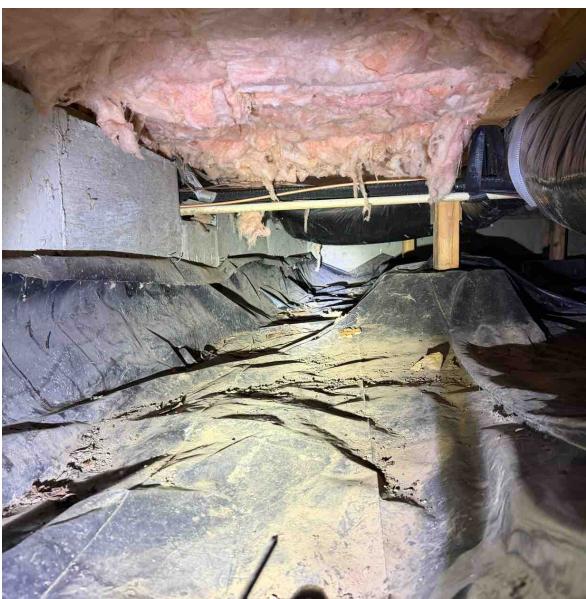
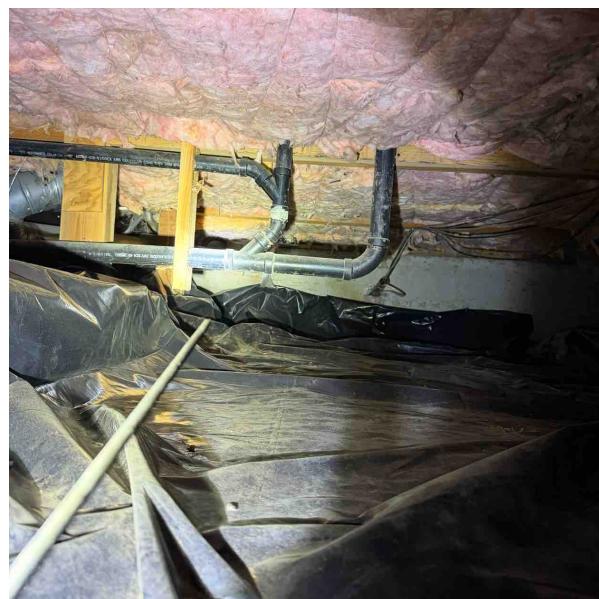
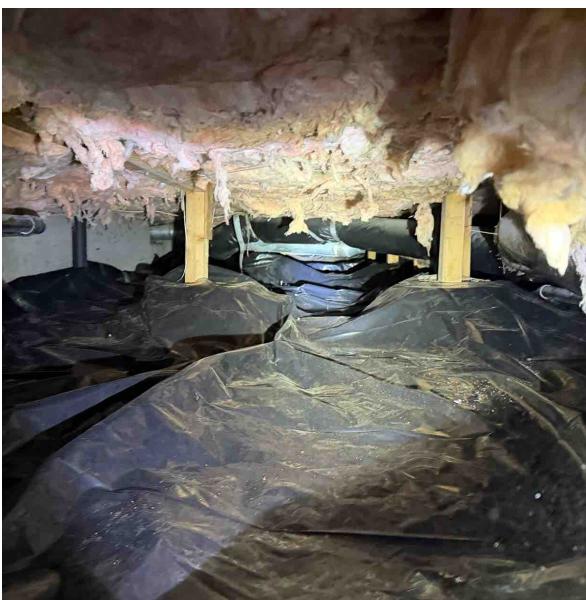
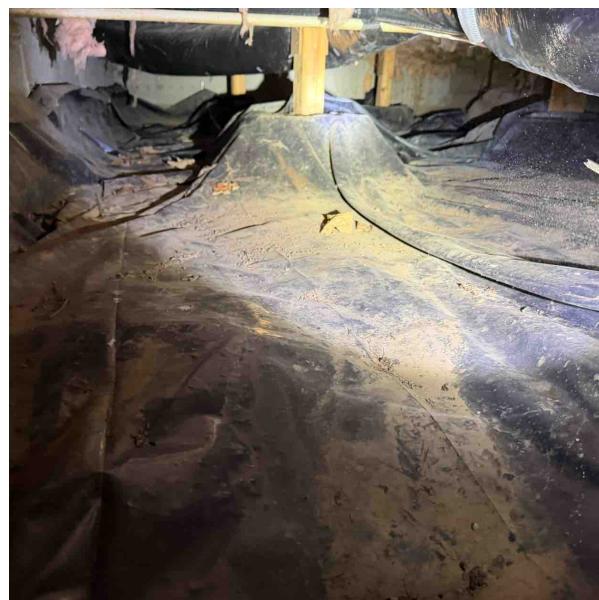
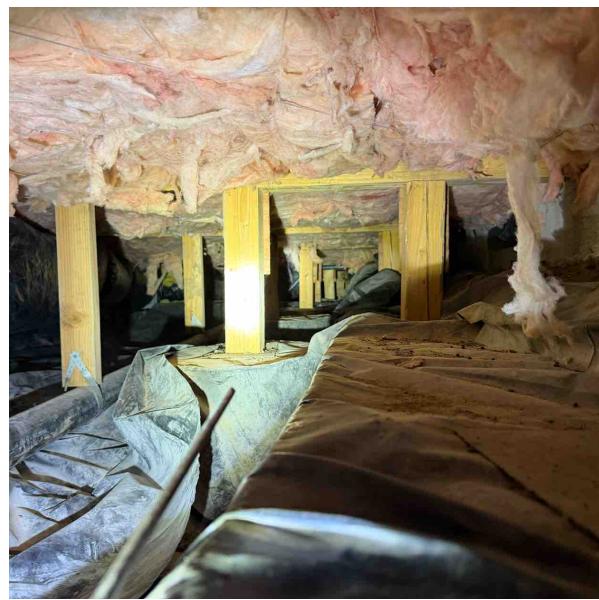
6.1.2 Crawlspace was inspected and in good working order. Evidence of past water noted (staining on the vapor barrier) but unable to determine where it came from or if it happens regularly. Monitor regularly and take any steps necessary to achieve a dry crawlspace.

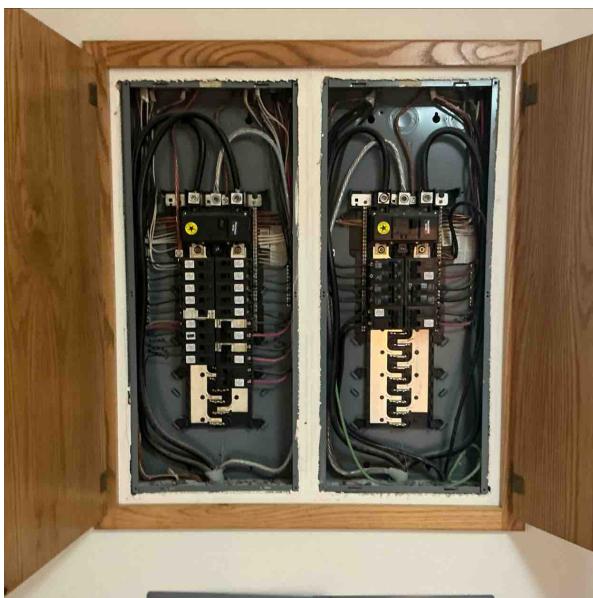
7.5 Distribution Panel(s)

7.5.1 Electrical panels were inspected and in good working order.

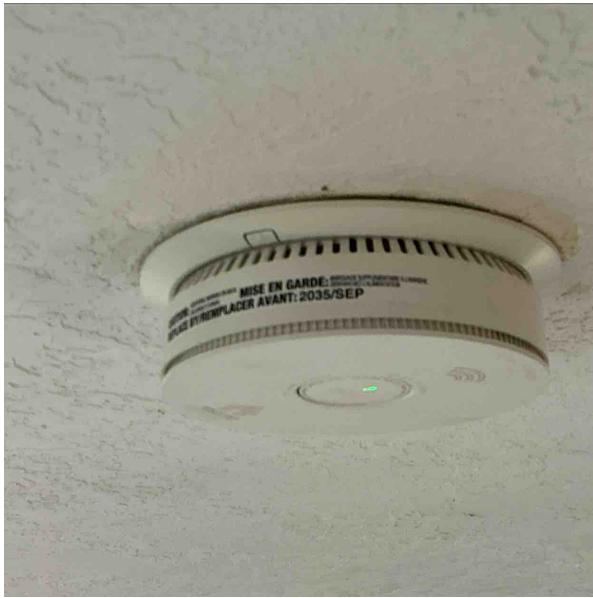
7.10 Smoke Alarms

7.10.1 Current smoke alarms meet todays standards. Correction is not required.

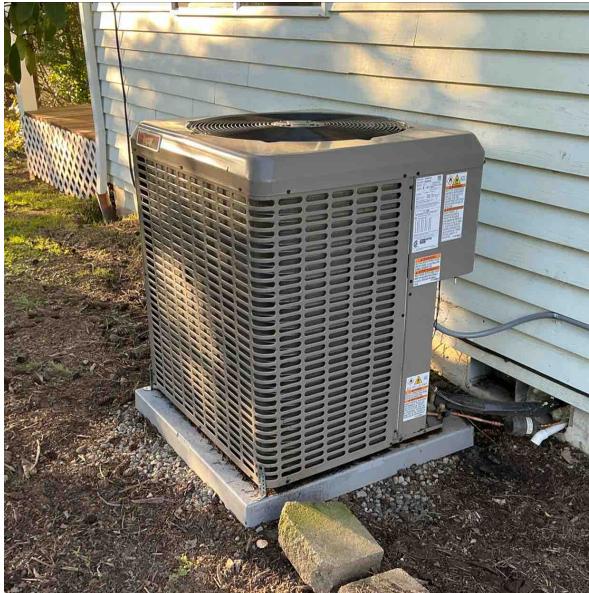
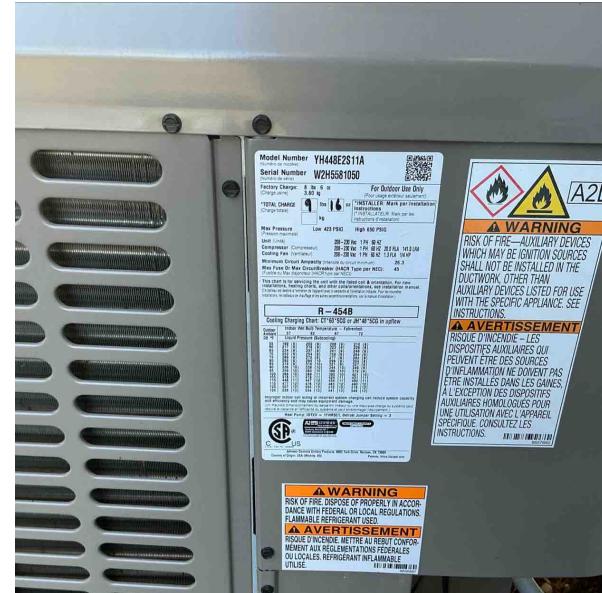
- Air Conditioning System

8.4.1 A/C unit is 1 years old (typical life of a A/C unit is approximately 15 years), A/C unit could not be tested at this time due to outside temperature of less than 60°. Operating an AC unit under 60° may cause damage. Recommend having serviced on an annual basis by a licensed HVAC professional, and budget for repair/maintenance in the future.

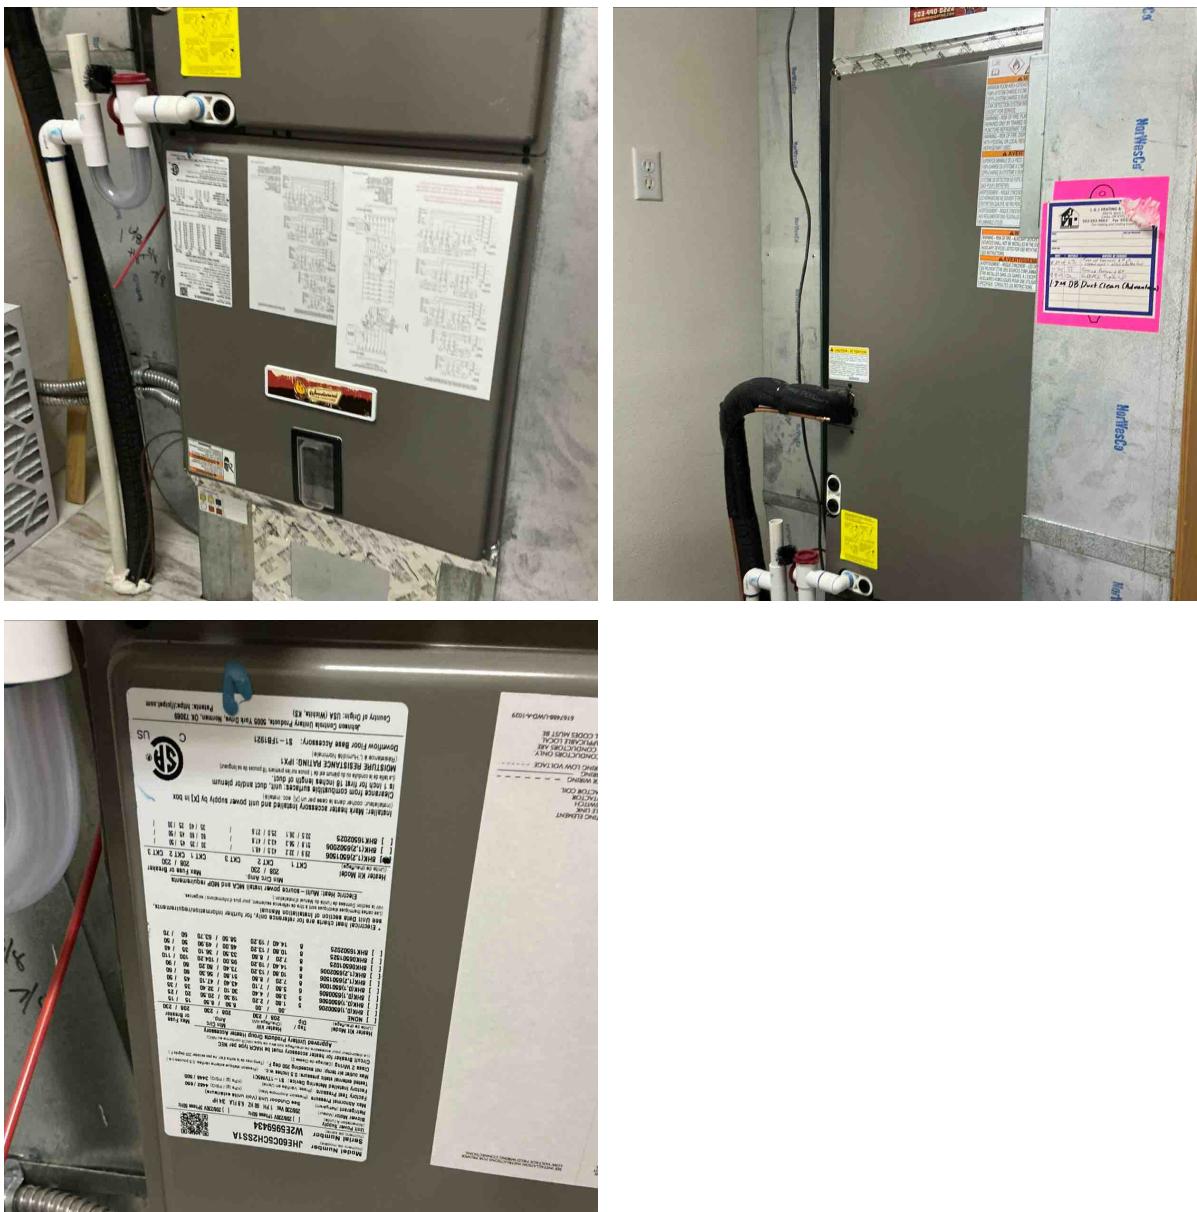
8.5 Heat Pump(s)

8.5.1 Heat Pump is 1 years old (typical life expectancy is 20 years). Recommend having the unit serviced by a licensed HVAC technician annually, and budgeting for repair/maintenance in the future. **(Utility)**

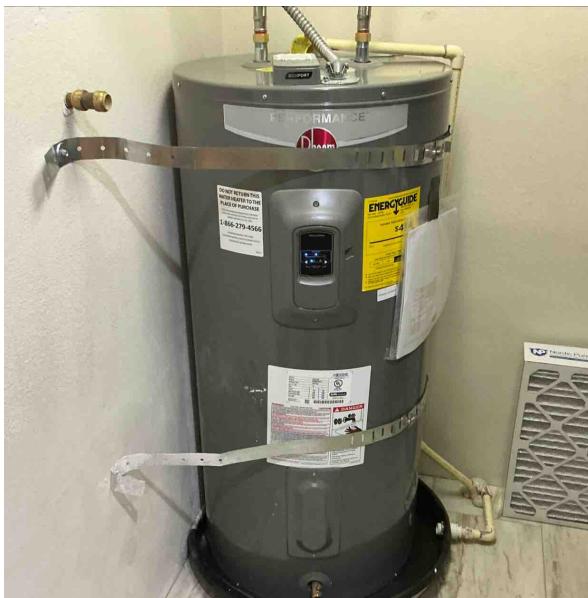
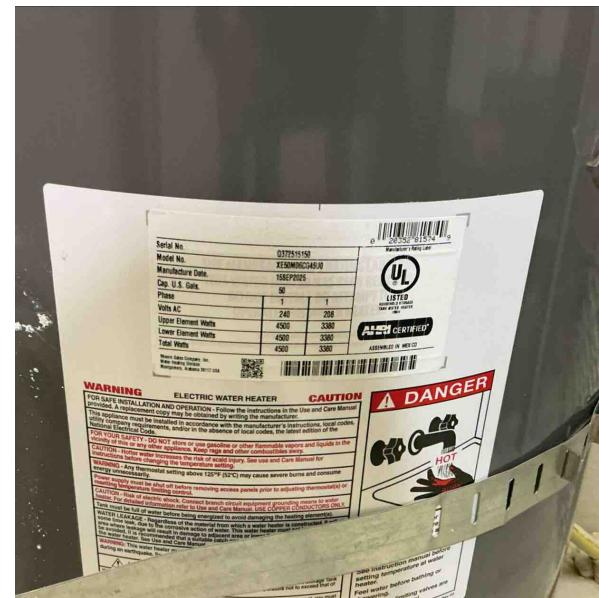
9.5.1 Water heater is 1 years old (typical life is 10-12 years). Water heater was functional at the time of inspection. **(Utility)**

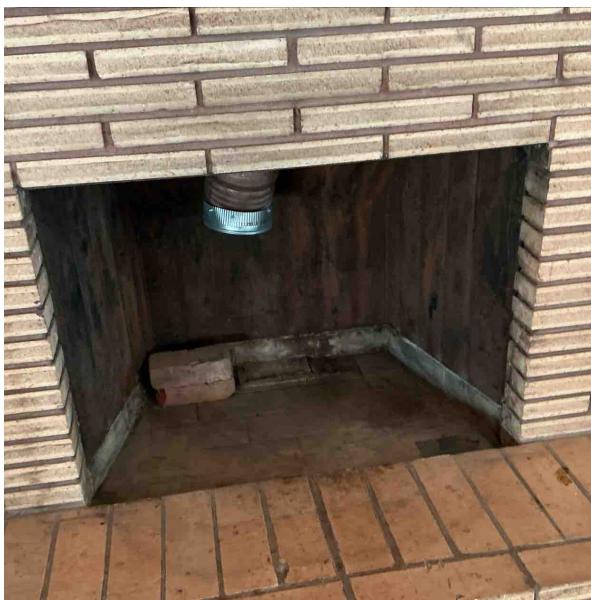
11.1 Fireplace General Comments

11.1.1 The fireplace has been converted to accommodate a stove. Corrections and upgrades may be required if the fireplace is to be used. **(Family Room)**
