Inspection Report

**James Christopher Balderson
Carolyn Reiner
15460 Kings Hwy
Montross VA 22520**

**Shannon Lewis
PO Box 244
Lively, VA 22507
(804) 724-4468**

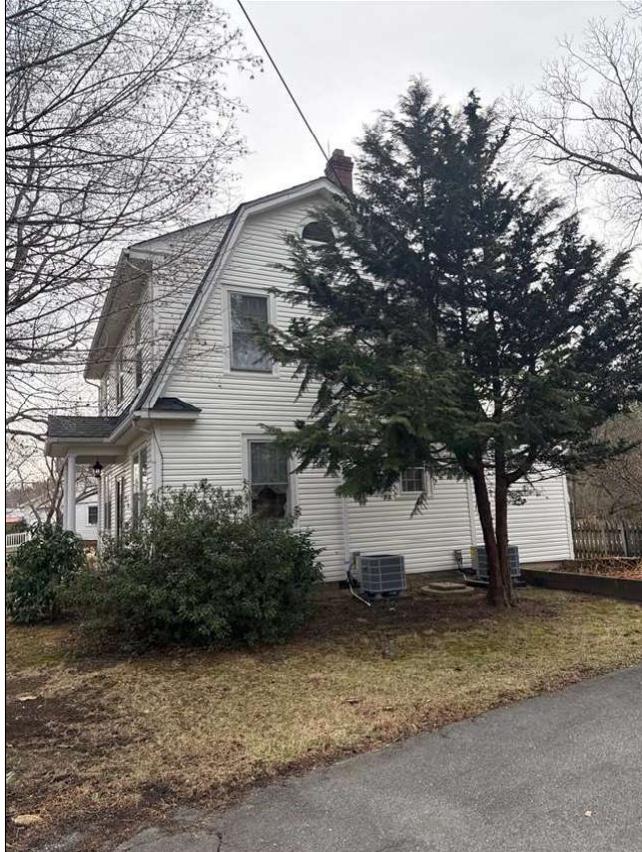
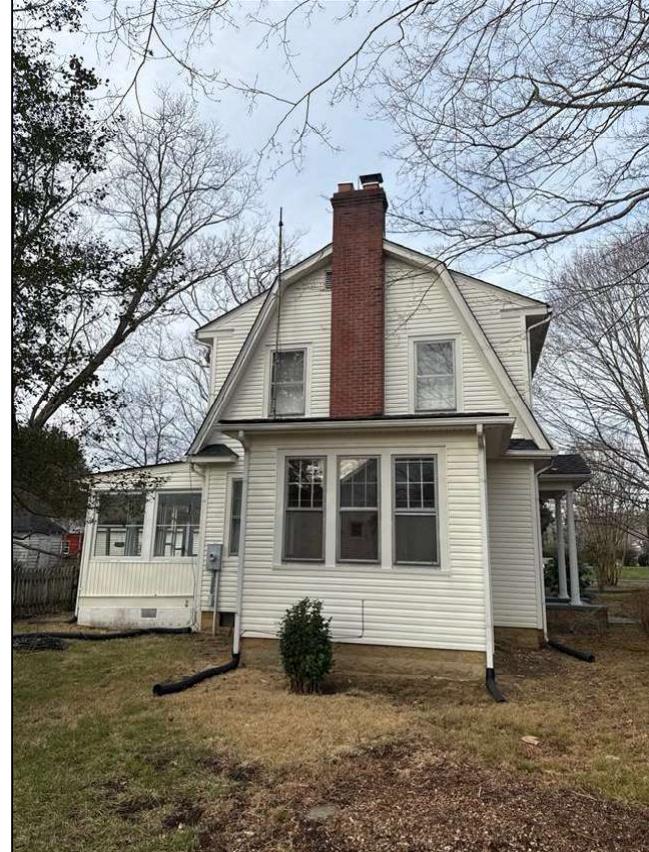
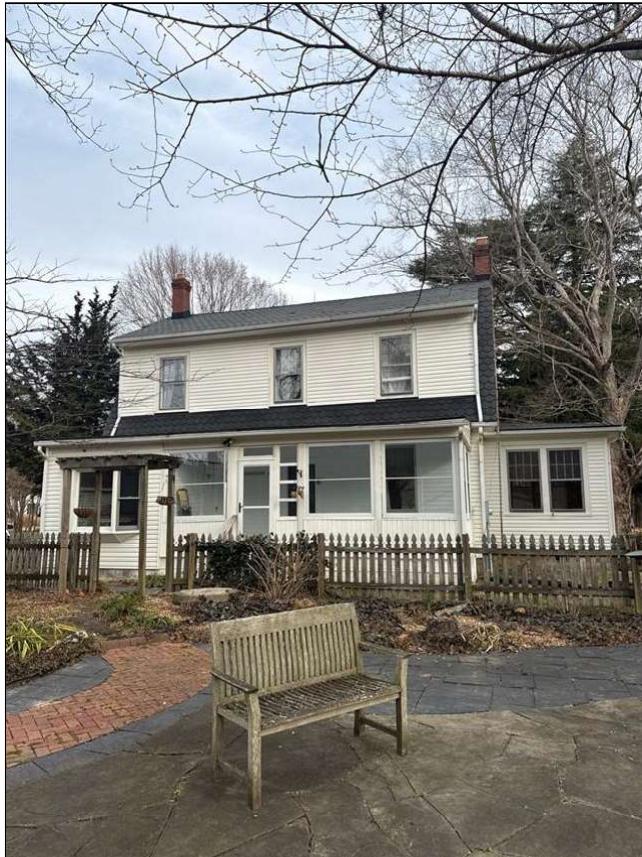
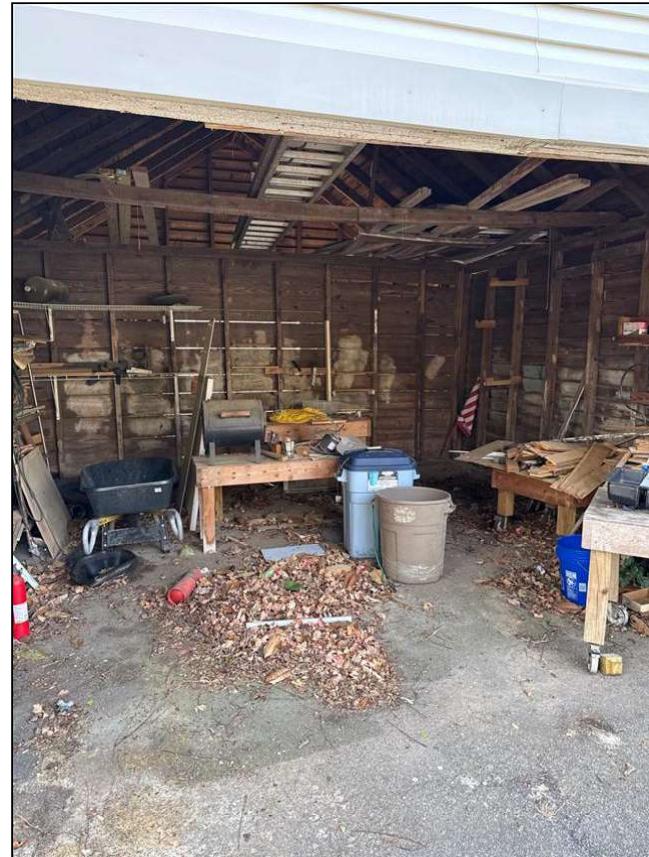
2.0 (1) The windows at the rear sun porch were improperly flashed. Flashing tape was exposed to the elements and was peeling away, exposing the wood wall sheathing. This could lead to wood rot. Further evaluation by a qualified carpenter is recommended.

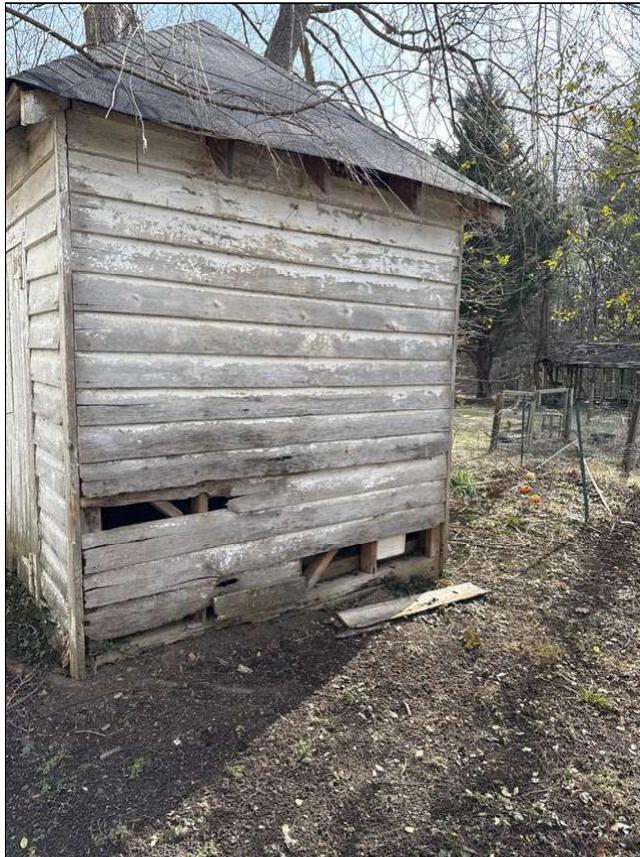
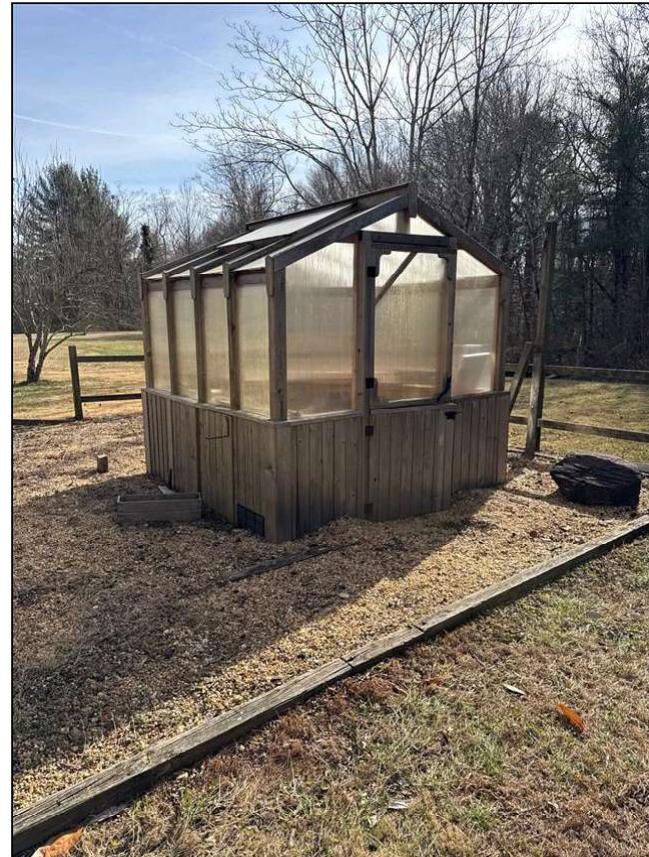
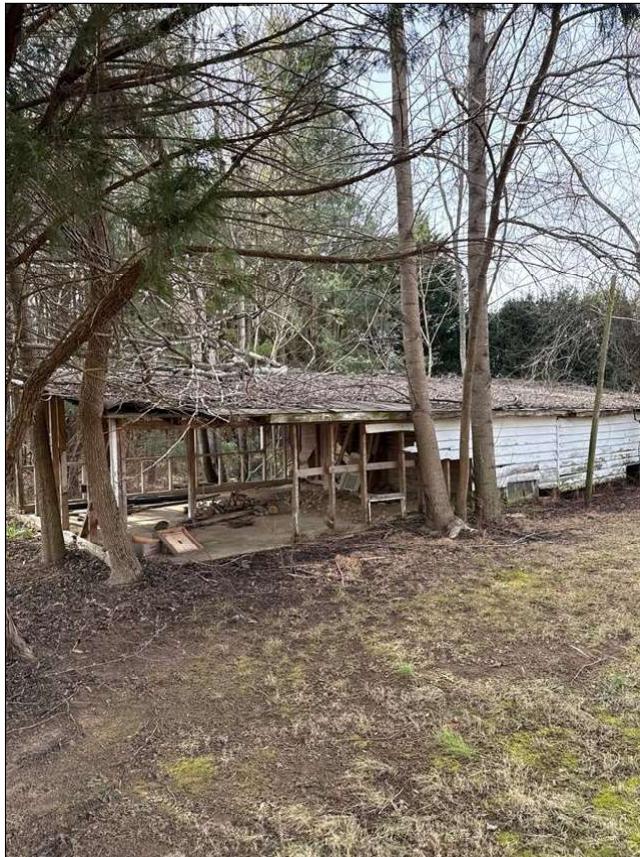
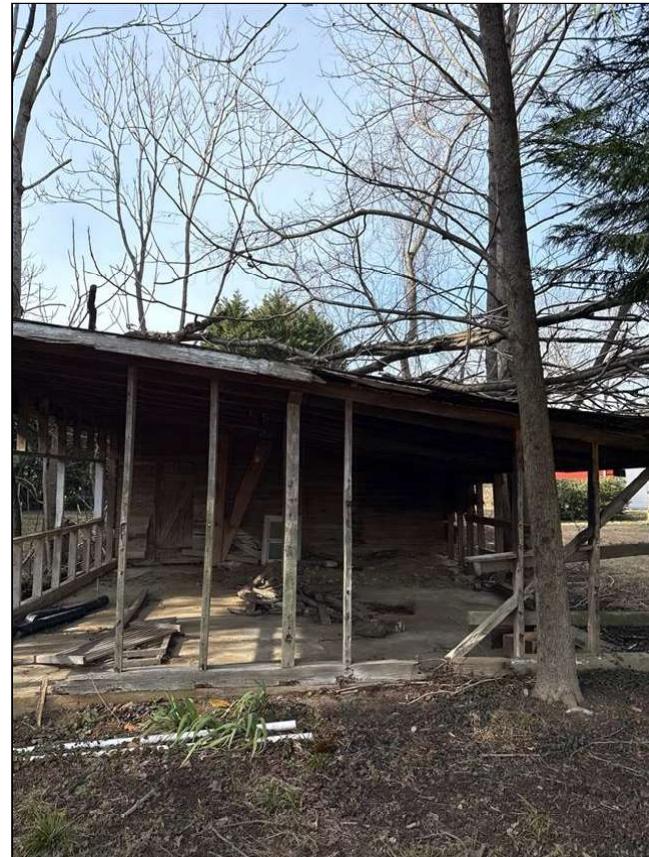
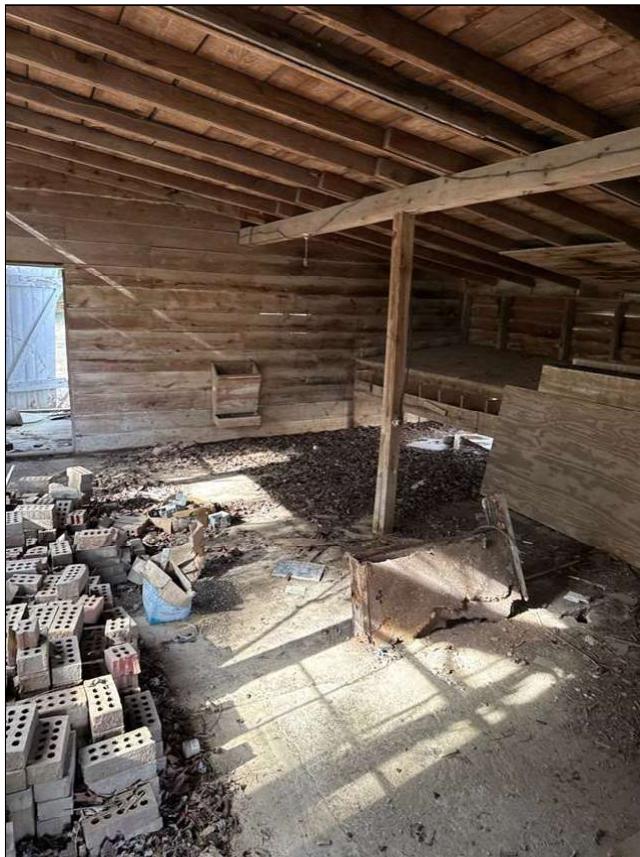
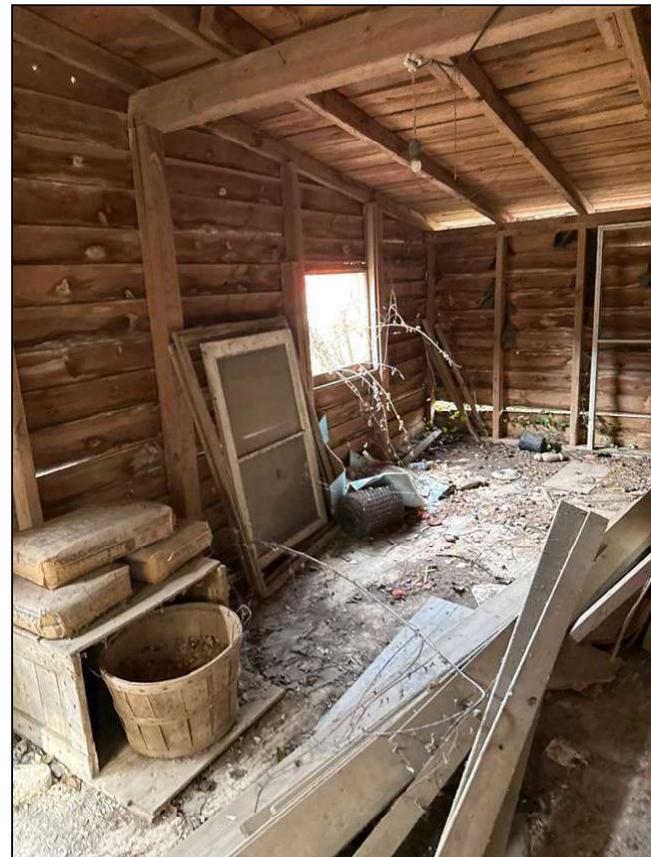
2.0 (3) The numerous outbuildings were beyond the scope of the home inspection, but were in overall poor, dilapidated condition. This could lead to significant expense to preserve, restore or demolish, depending on owner's desires. See general photos at the beginning of this section. Further evaluation by a qualified contractor is recommended.

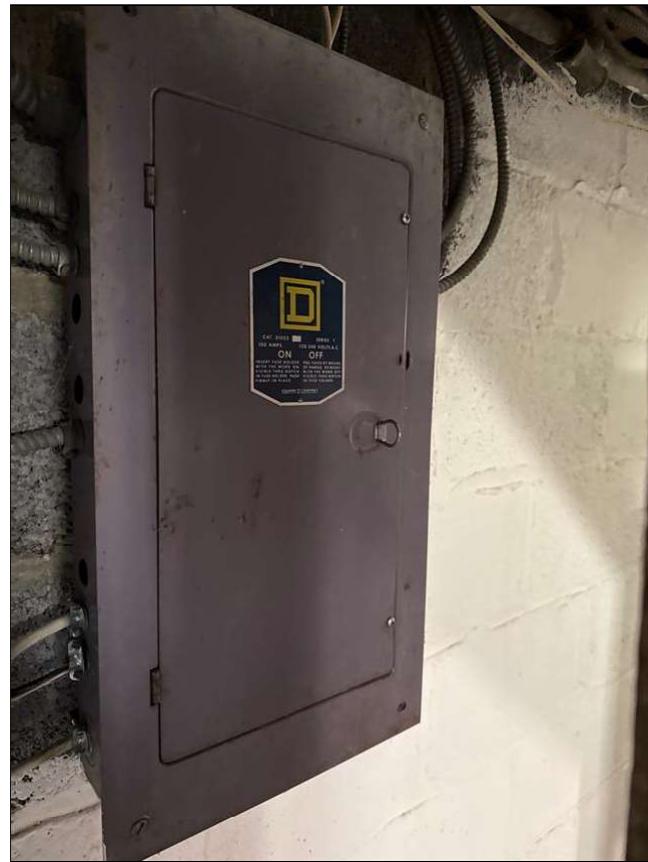
Open knockouts were observed at the junction box/former service panel in the basement. This could allow pest intrusion and was a shock hazard due to internal components being accessible. Installation of knockout cover blanks is recommended.

Former panel, serving as a sealed junction box

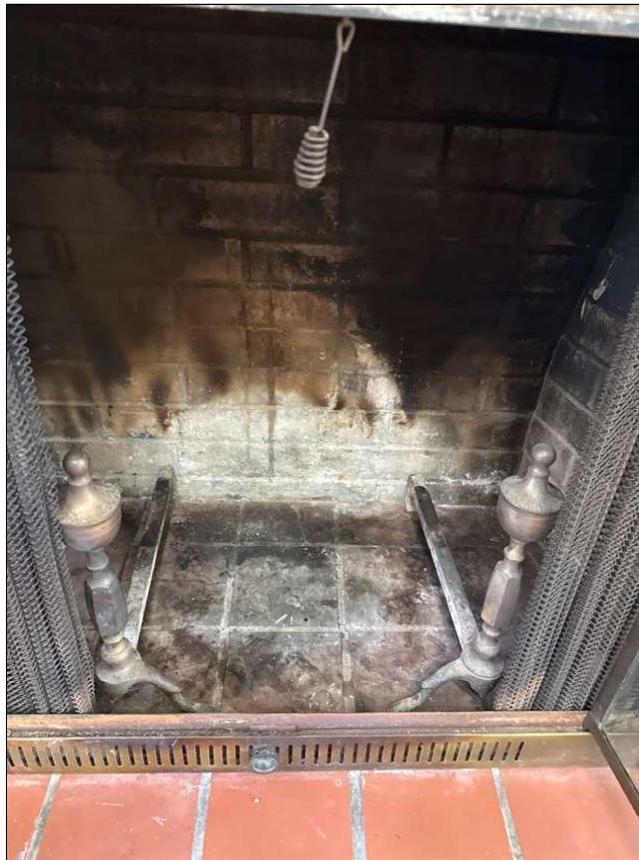
Wood-burning fireplace

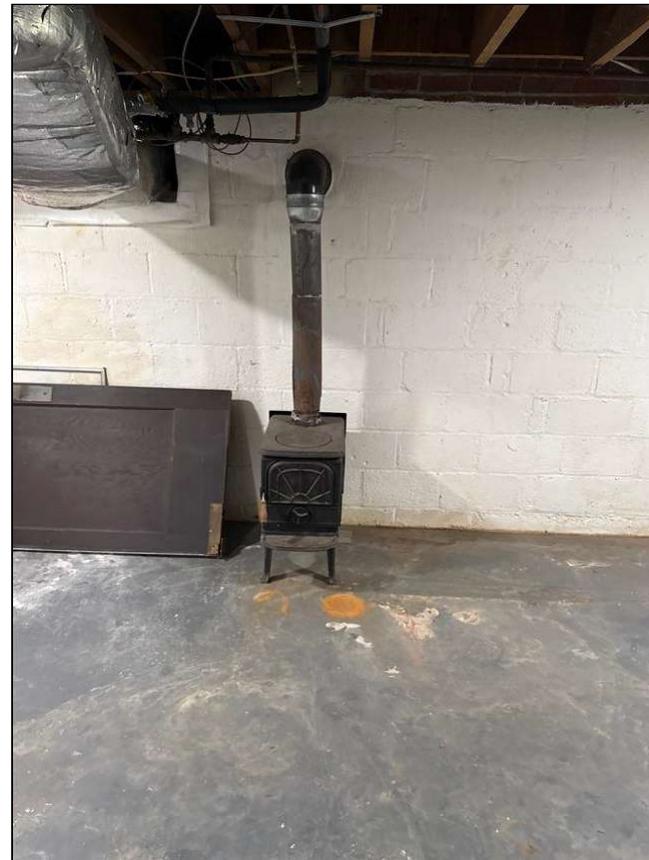
Wood stove, in basement
