# A Buyer's Choice Home Inspections

## PROPERTY INSPECTION REPORT

29460 Peoria Rd, Halsey, OR 97348  
Inspection prepared for: Andaman Rosse  
Real Estate Agent: -

Date of Inspection: 3/14/2026 Time: 8:00 AM  
Age of Home: 1971 Size: 1485  
Order ID: 225

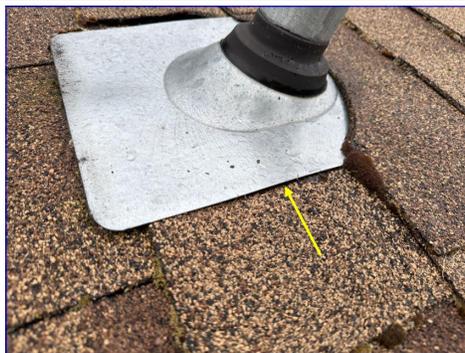
Page 12 Item: 3	Roof Flashing	<ul style="list-style-type: none"> <li>• The flashing around the electrical service entrance mast appears to be installed improperly. The sides of the flashing are installed on top of the shingles rather than beneath them. Flashing should be installed in a shingle-style manner so water is directed over the roofing materials and away from the penetration. This condition may allow water to enter beneath the roofing materials and increase the risk of moisture intrusion. Evaluation and correction by a qualified roofing contractor is recommended.</li> </ul>
-----------------	---------------	--

Flashing installed incorrectly

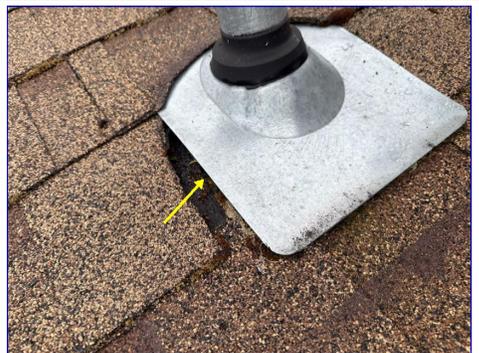
Flashing installed incorrectly

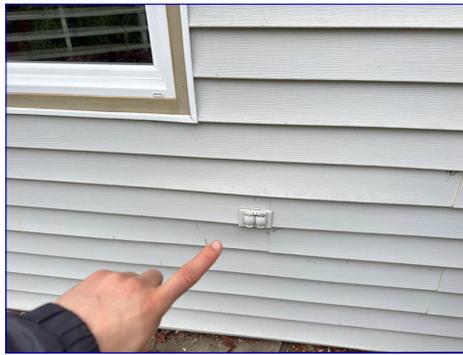
- Exterior electrical receptacles are not **GFCI** protected. Recommend installing **GFCI** receptacles for safety.
- Exposed electrical wiring observed in kitchen underneath the sink. This is a "Safety Concern" as it is used where it could be subject to "Physical Damage". Exposed electrical wires are normally encased in conduit to ensure safety. Recommend further evaluation of electrical system by a licensed electrical contractor for repair to ensure safety.
- Missing light switch cover observed in laundry room, garage and Primary bathroom. This is a shock hazard. Recommend installing covers for safety.
- Electrical receptacle within six feet of a water source is not **GFCI** protected. Recommend having a licensed electrical contractor repair for safety.

Not **GFCI** protected

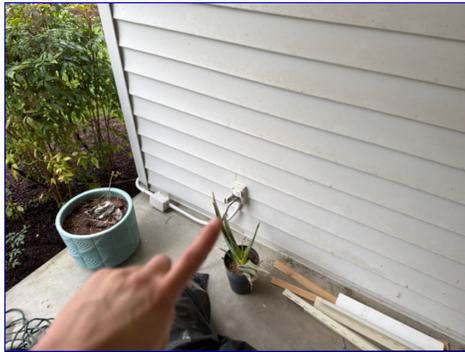
Not **GFCI** protected

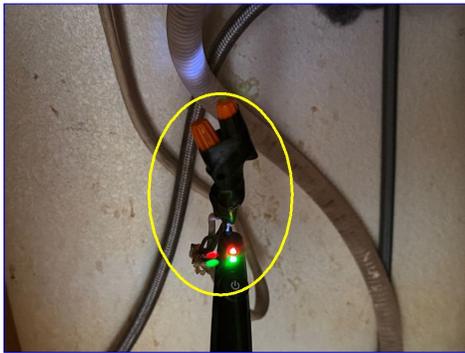
Exposed live wires

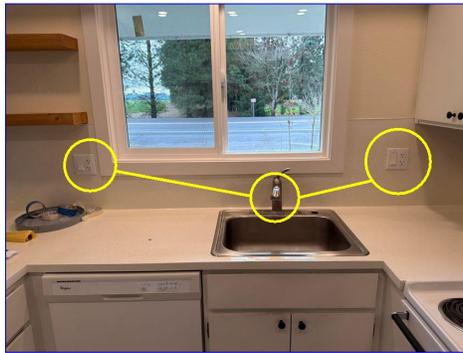
Receptacles within 6' of a water source are not **GFCI** protected

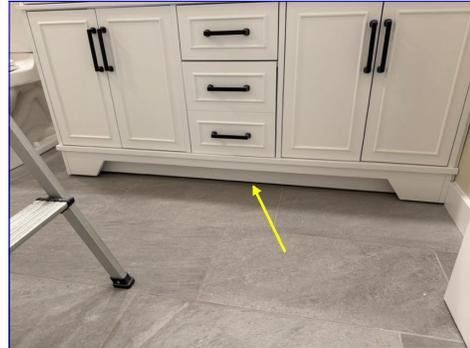
Page 30 Item: 7	Distribution/Ducting/Registers	<ul style="list-style-type: none"> <li>• The HVAC supply register in the primary bathroom is located beneath the vanity and is obstructed, which restricts proper airflow into the room. Recommend modifying the installation so the register is unobstructed to allow adequate air distribution.</li> </ul>
-----------------	--------------------------------	--

Register is blocked

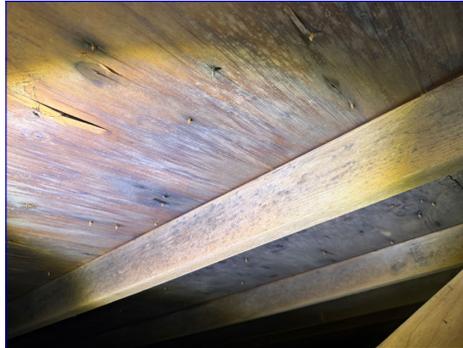
• Microbial growth or possible mold growth observed in several areas of the attic at the sheathing. Mold can only be confirmed with laboratory testing. Recommend having a qualified, contractor perform mold spore air testing and tape/swab sample of observed growth.

Microbial growth

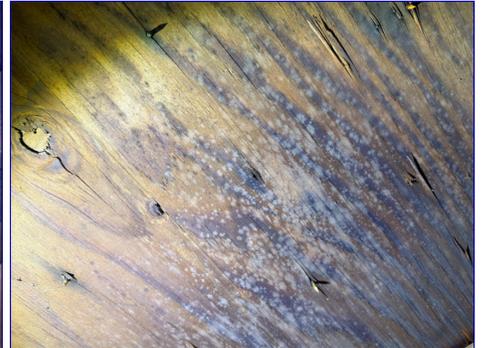
Microbial growth

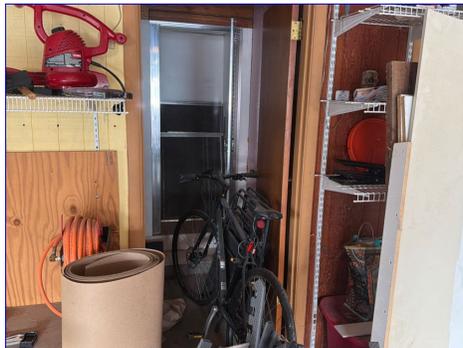
- Garage bathroom is being used for storage at the time of inspection. Unable to test the plumbing fixtures and other components in the bathroom.

Garage bathroom

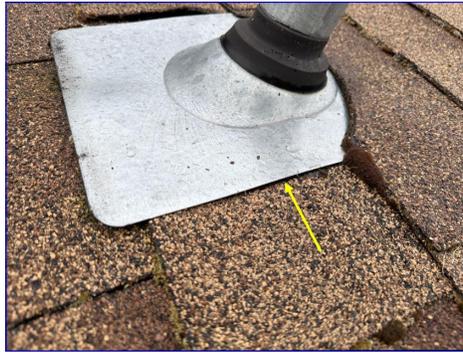
Flashing installed incorrectly

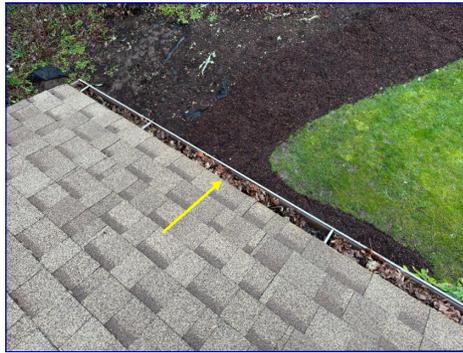
Suggest cleaning gutters

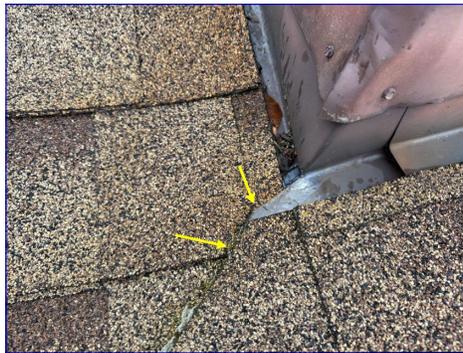
Possibly incorrect flashing installation

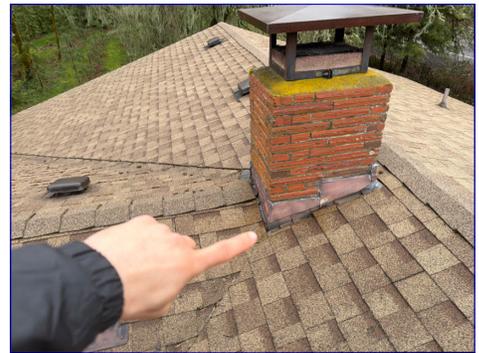
Possibly incorrect flashing installation

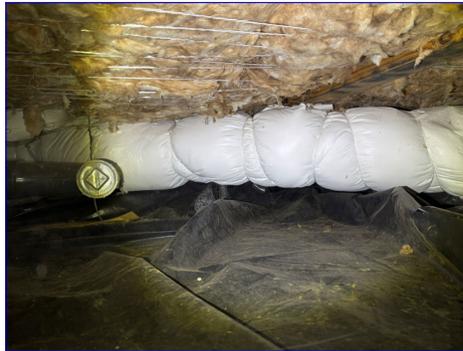
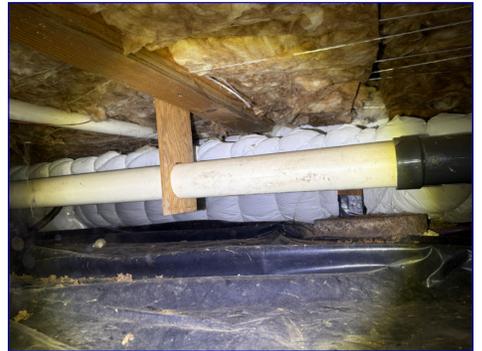
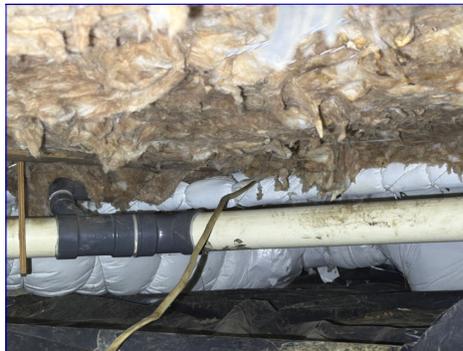
- Ductwork prevents further access into the remainder of the Crawlspace. The inspector made an attempt to crawl under the ductwork but due to the natural low headroom it was unsuccessful.

Ductwork prevents further access

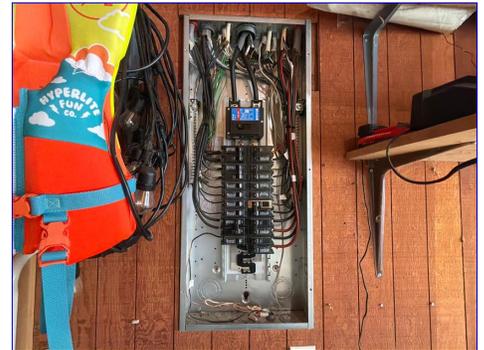
Main electric panel interior

- Combination Service Entrance Device (CSED) with Main Breaker
- The main service disconnect is approximately 200 amps, 240 volts.
- Service entrance cables are aluminum.
- Branch circuit wiring is a mix of copper and aluminum wiring. Buyer is advised that periodic maintenance of aluminum wiring is recommended to prevent "creeping" at electrical connections.
- **AFC** protection in bedroom branch circuits not present in this house. Although **AFC** protection may not have been required when this house was built, recommend consider upgrading all living space circuits by a licensed electrical contractor for safety.
- No thermal anomalies were observed.

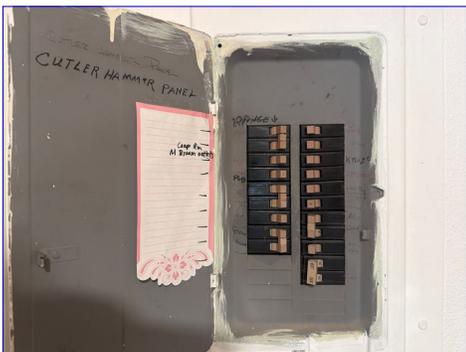
Subpanel

- **AFC** protection in bedroom branch circuits not present in this house. Although **AFC** protection may not have been required when this house was built, recommend consider upgrading all living space circuits by a licensed electrical contractor for safety.
- **Unable to inspect panel interior. Panel cover is stuck, painted shut or otherwise sealed and inaccessible.**
- Legend is missing, incomplete, inaccurate or illegible. Recommend further evaluation of electrical system by a licensed electrical contractor.

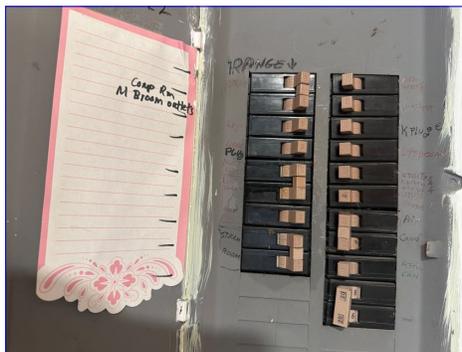
Incomplete legend

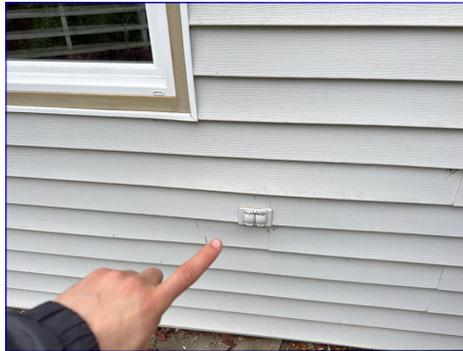
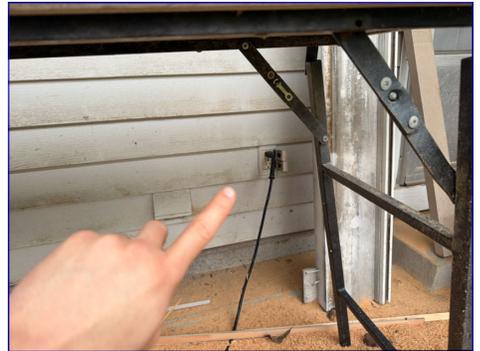
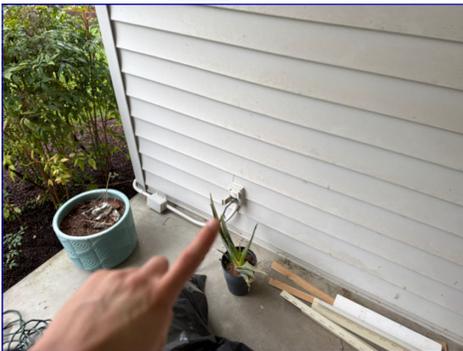
- Garage receptacles should all be **GFCI** protected.
- Exterior electrical receptacles are not **GFCI** protected. Recommend installing **GFCI** receptacles for safety.
- Exposed electrical wiring observed in kitchen underneath the sink. This is a "Safety Concern" as it is used where it could be subject to "Physical Damage". Exposed electrical wires are normally encased in conduit to ensure safety. Recommend further evaluation of electrical system by a licensed electrical contractor for repair to ensure safety.
- Missing light switch cover observed in laundry room, garage and Primary bathroom. This is a shock hazard. Recommend installing covers for safety.
- Electrical receptacle within six feet of a water source is not **GFCI** protected. Recommend having a licensed electrical contractor repair for safety.

Not **GFCI** protected

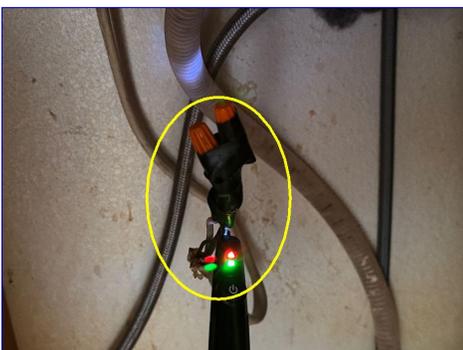
Exposed live wires

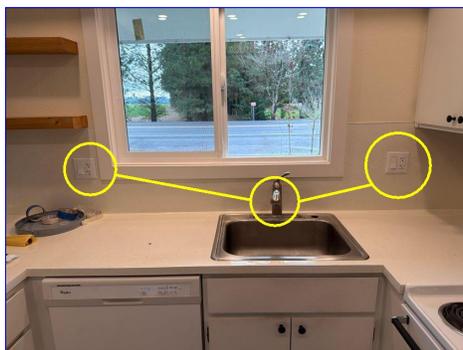
Receptacles within 6' of a water source are not **GFCI** protected

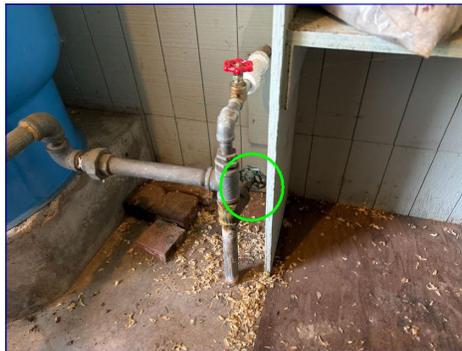
Main water shut off

• Galvanized main supply observed. Galvanized pipe corrodes and restricted water flow may be experienced. Some insurance companies will not insure galvanized main supply.

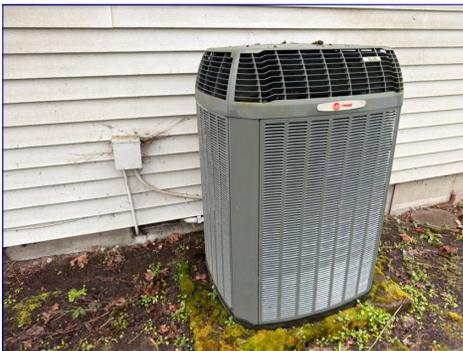
- As most manufacturers warn against operating air conditioning units when the outside temperature is below 65 degrees, this unit was not tested. Recommend referring to the Sellers Disclosure Statement regarding the condition of this unit.

Condenser unit

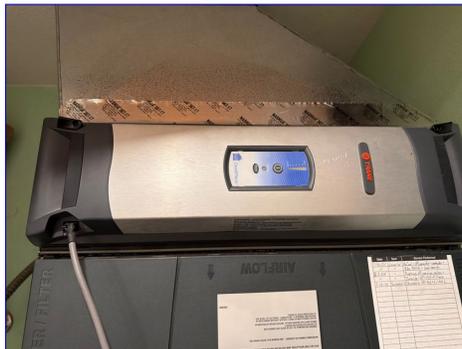
- Electronic air filters are beyond the scope of a home inspection.

Electronic air filter

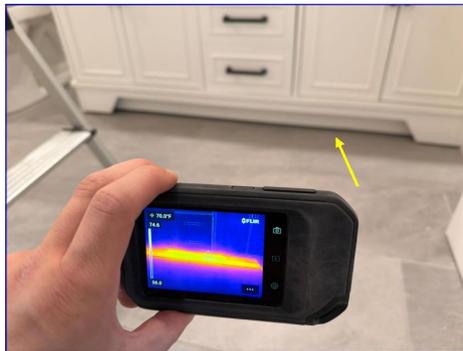
- A representative number of registers were tested and generally appeared to be in serviceable condition.
- The HVAC supply register in the primary bathroom is located beneath the vanity and is obstructed, which restricts proper airflow into the room. Recommend modifying the installation so the register is unobstructed to allow adequate air distribution.

Register is blocked

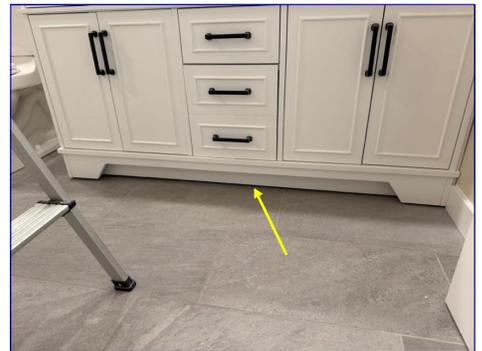
Register is blocked

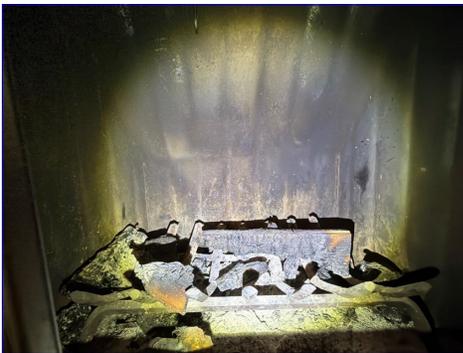
- All fireplaces, fuel burning stoves and chimneys should be inspected by a certified chimney sweep prior to use and no less than annually. Recommend further review and cleaning by a certified chimney sweep.
- Carbon Monoxide detector required in the same room as fireplace / fire-burning appliance.
- Smoke detectors required in the same room as fireplace / fire-burning appliance.

Fireplace

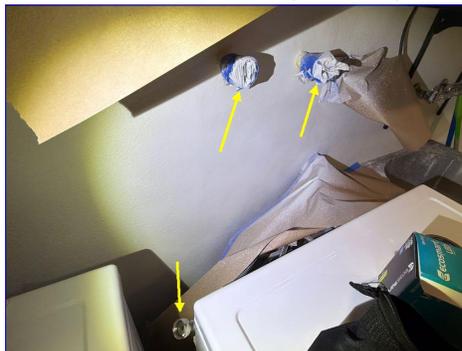
• Unit was not plugged in and/or water was off - due to possibility of leaking, unit was not plugged in and tested. Please refer to Standard of Practice. Recommend verification of units operation prior to closing.

Unit is not plugged in/hooked up

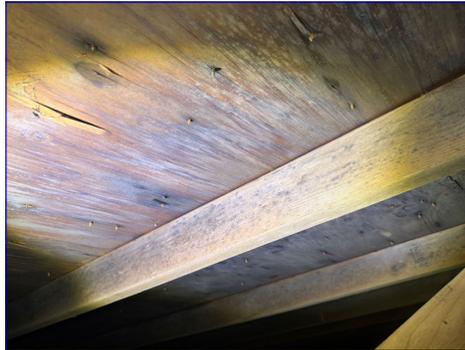
- Microbial growth or possible mold growth observed in several areas of the attic at the sheathing. Mold can only be confirmed with laboratory testing. Recommend having a qualified, contractor perform mold spore air testing and tape/swab sample of observed growth.

Microbial growth

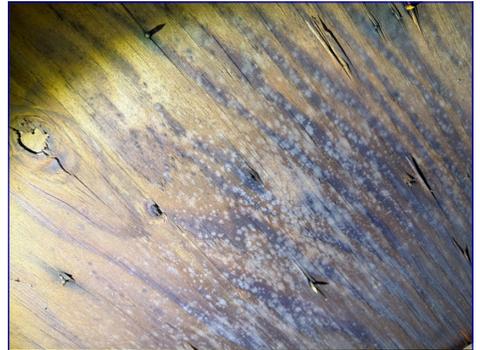
Microbial growth
