# A Buyer's Choice Home Inspections

## PROPERTY INSPECTION REPORT

859 Mule Deer Pl NW, Salem, OR 97304  
Inspection prepared for: Andaman Rosse  
Real Estate Agent: -

Date of Inspection: 1/27/2026 Time: 8:00 AM  
Age of Home: 2002 Size: 2474  
Order ID: 212

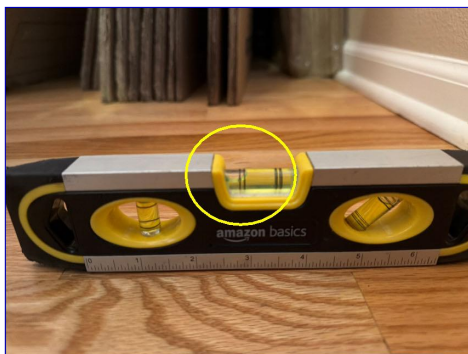
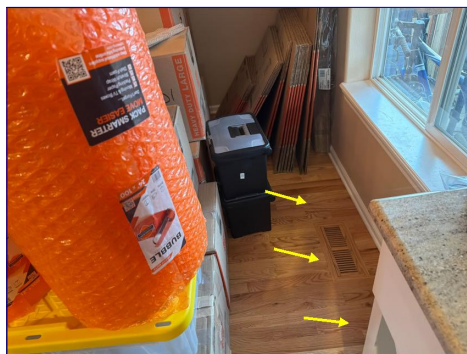
Page 31 Item: 2	Floors	<ul style="list-style-type: none"> <li>Floor is not level in west side of dining area. Suggest further evaluation by a licensed contractor.</li> </ul>
-----------------	--------	--------------------------------------------------------------------------------------------------------------------------------------------------------

Floor is not level

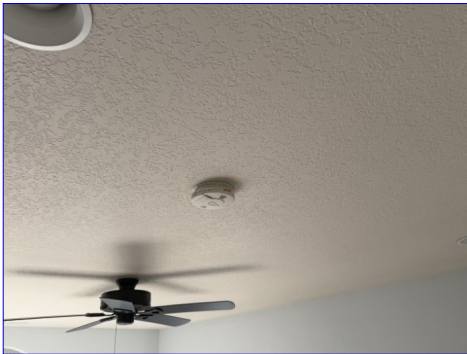
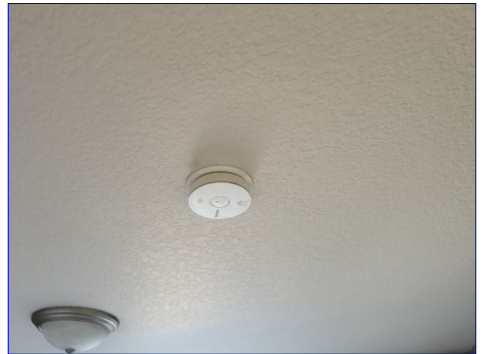
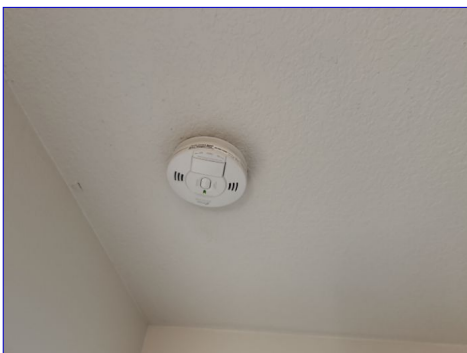
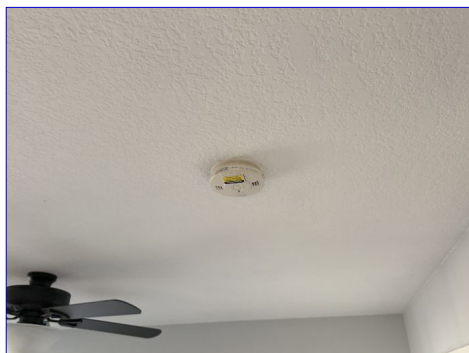
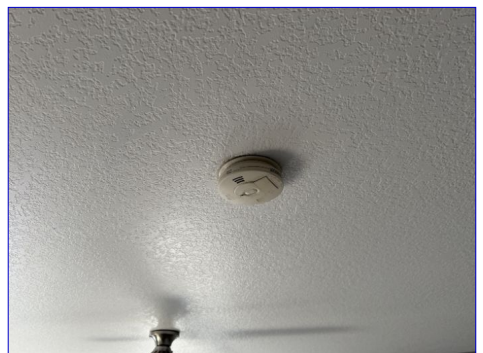
Smoke and CO alarm

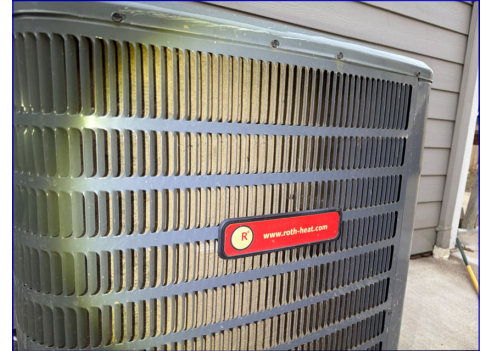
Condenser fins are dirty

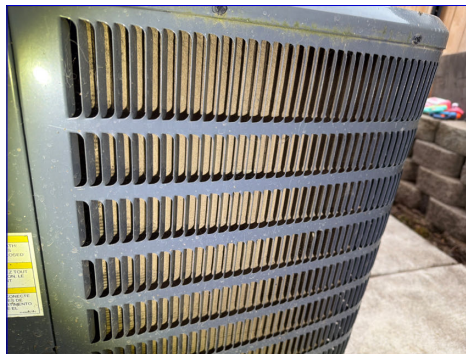
Condenser fins are dirty

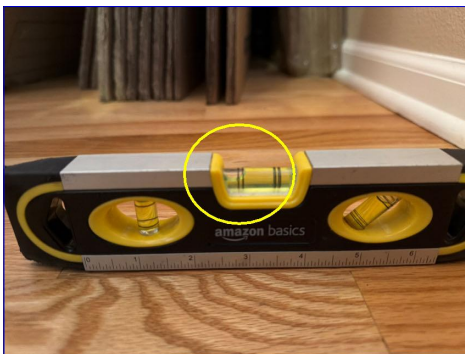
• Floor is not level in west side of dining area. Suggest further evaluation by a licensed contractor.

Floor is not level
