# A Buyer's Choice Home Inspections

## PROPERTY INSPECTION REPORT

3077 NW Lisa Pl, Corvallis, OR 97330  
Inspection prepared for: Andaman Rosse  
Real Estate Agent: Andaman Rosse -

Date of Inspection: 5/7/2026 Time: 9:00 AM  
Age of Home: 1976 Size: 3360  
Order ID: 275

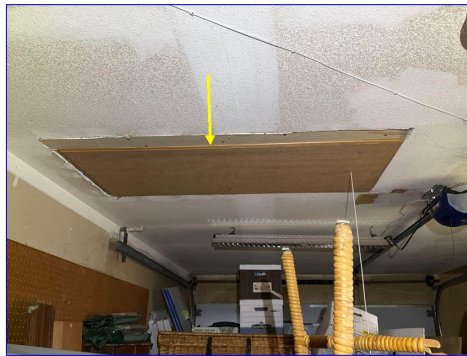
| Exterior | | |
|---|---|---|
| Page 17 Item: 4 | Fire Separation Wall | <ul style="list-style-type: none"> <li>• Attic access panel/hatch cover is plywood which is flammable. Recommend replacing access panel with a fire rated panel for safety.</li> <li>• Holes observed, suggest sealing to restore fire rating.</li> </ul> |

Attic access is flammable

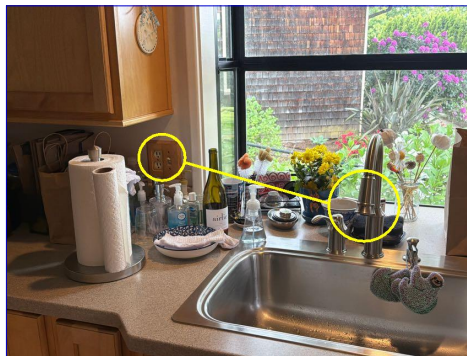
• Electrical receptacle within six feet of a water source is not **GFC** protected. Recommend having a licensed electrical contractor repair for safety.

Receptacle within 6' of water source is not **GFC** protected

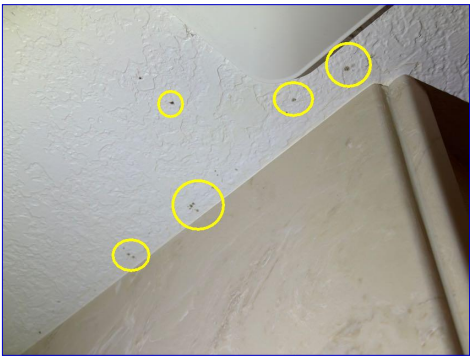
• Microbial growth or possible mold growth observed in the areas noted. Mold can only be confirmed with laboratory testing. Recommend having a qualified, contractor perform mold spore air testing and tape/swab sample of observed growth.

Possible microbial growth (hall bathroom)

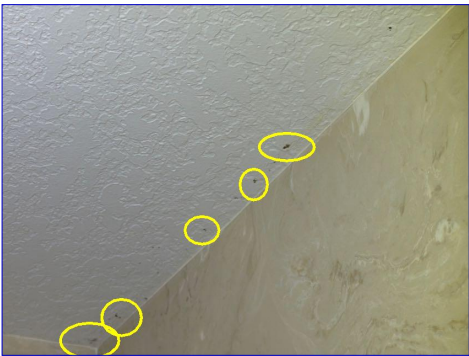
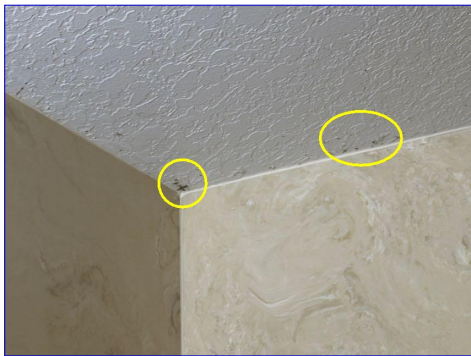
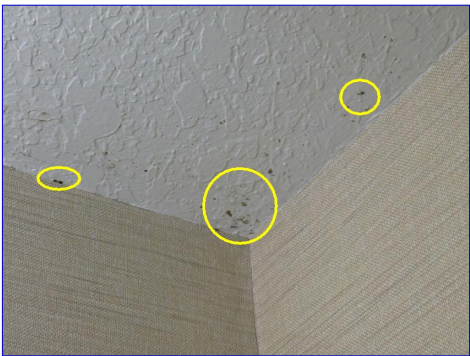
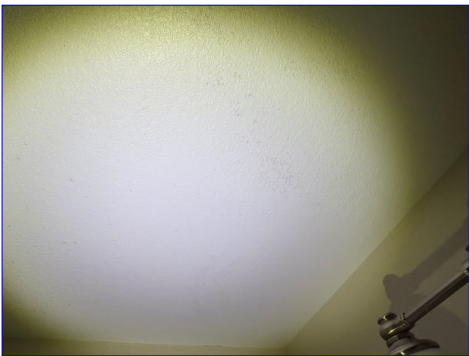
Possible microbial growth (hall bathroom)

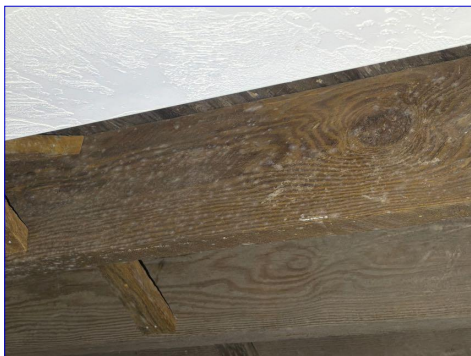
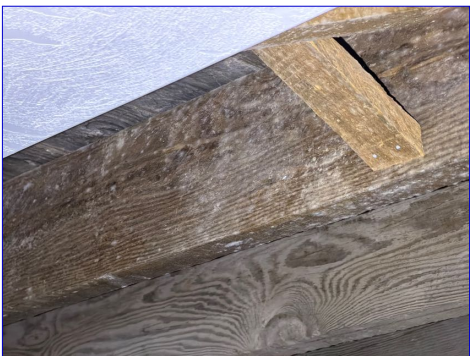
Possible microbial growth (basement closet)

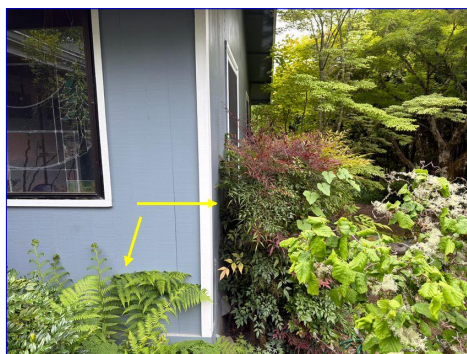
Vegetation is in contact with wall cladding

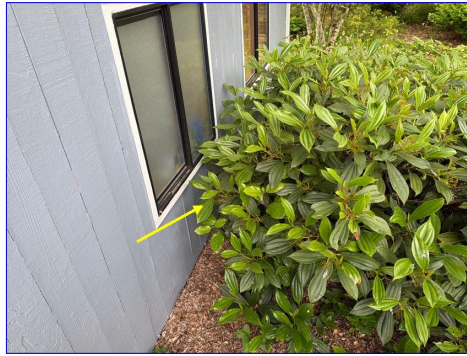
Vegetation is in contact with wall cladding

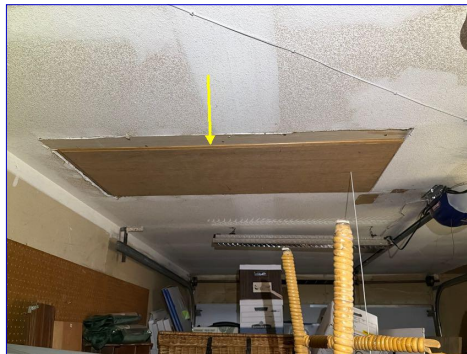
- Present
- Attic access panel/hatch cover is plywood which is flammable. Recommend replacing access panel with a fire rated panel for safety.
- Holes observed, suggest sealing to restore fire rating.

Attic acces is flammable

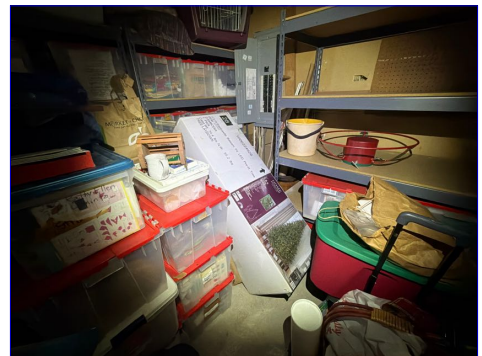
Pathway blocked to panel

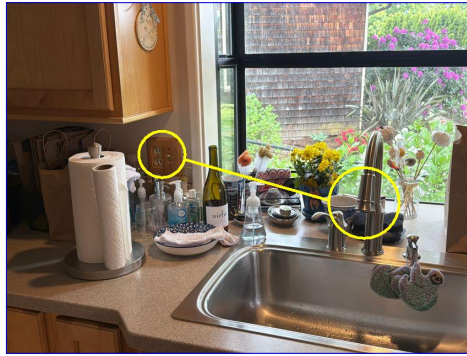
- Electrical receptacle in areas noted are loose and should be secured.
- Light(s)/light fixture(s) located in Basement is/are inoperable. Unable to determine if bulb(s) burnt out or if faulty fixture(s). Suggest client verify proper operation prior to closing.
- Basement and Garage receptacles should all be **GFCI** protected.
- The washing machine receptacle was not **GFCI** protected at the time of inspection. Although this condition may have been permitted at the time the home was constructed, current safety standards recommend **GFCI** protection in garage areas to reduce the risk of electrical shock. Upgrading is recommended for improved safety.
- Electrical receptacle within six feet of a water source is not **GFCI** protected. Recommend having a licensed electrical contractor repair for safety.

Receptacle within 6' of water source is not **GFCI** protected

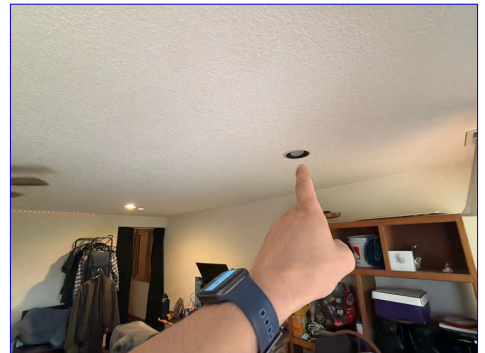
Inoperable light (Basement)

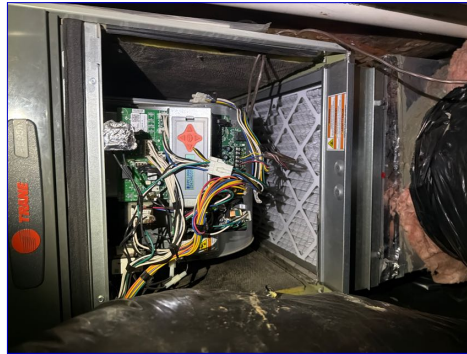
HVAC unit interior

- The interior of the HVAC unit could only partially be inspected as one of the panel covers is difficult to remove, and the inspector was unable to pull it off.

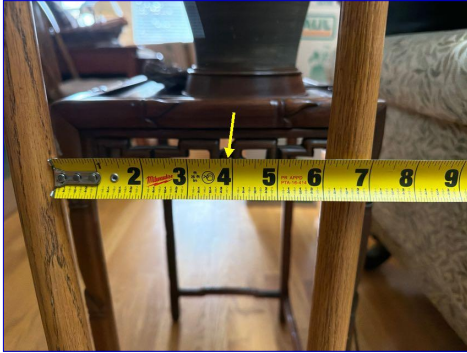
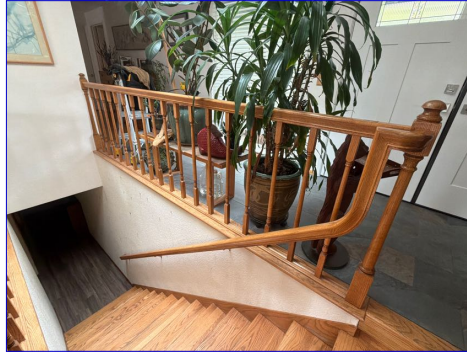
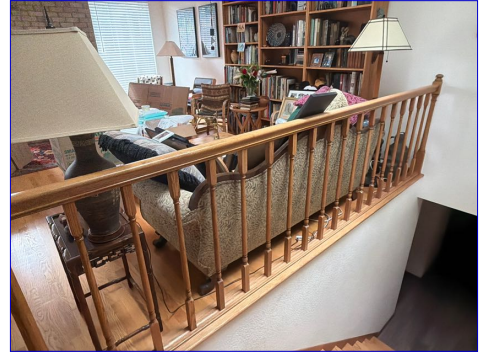
- Baluster opening between vertical members should not exceed 4 inches apart to keep children and pets from falling through or getting stuck in the railing.

Balusters spacing exceeds 4"

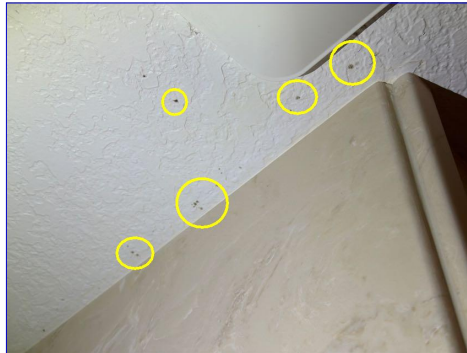
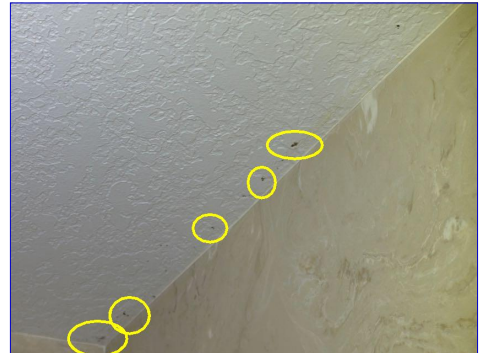
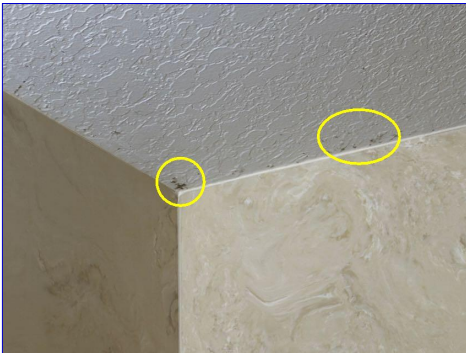
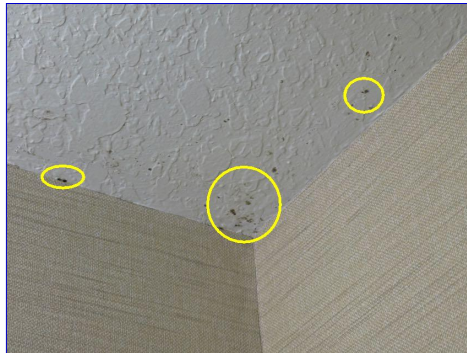
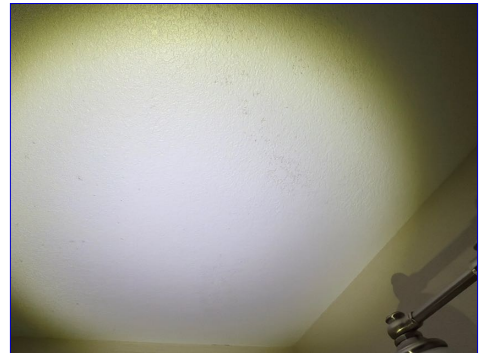
- Microbial growth or possible mold growth observed in the areas noted. Mold can only be confirmed with laboratory testing. Recommend having a qualified, contractor perform mold spore air testing and tape/swab sample of observed growth.

Possible microbial growth (hall bathroom)

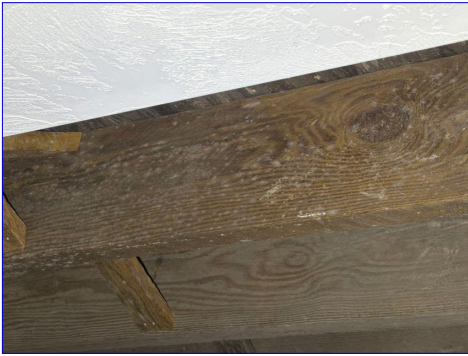
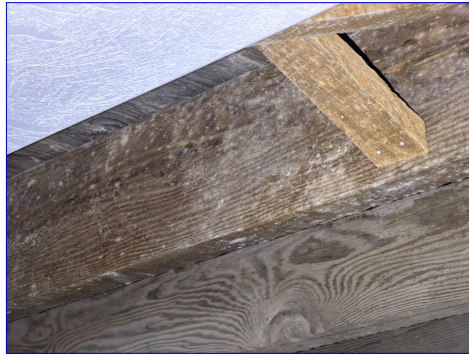
Possible microbial growth (basement closet)
