## **Property Inspection Report**

***630 E Cook St, Santa Maria, CA 93454***

***Date of Inspection: 7/15/2026 Time: 1:00 PM***

***Inspector: Greg Hines***

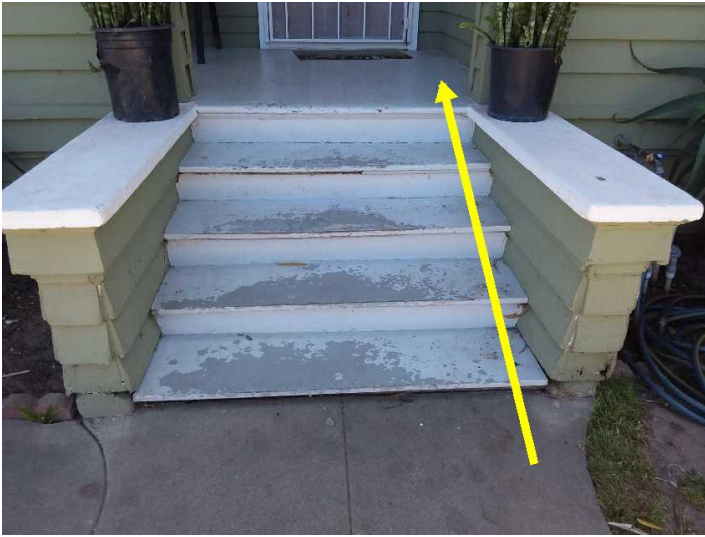
8.4. Current building standards require handrails to be installed on steps which have 4 or more risers, and particularly if children or the elderly visit or occupy this property.

Current building standards require handrails to be installed on steps which have 4 or more risers, and particularly if children or the elderly visit or occupy this property.

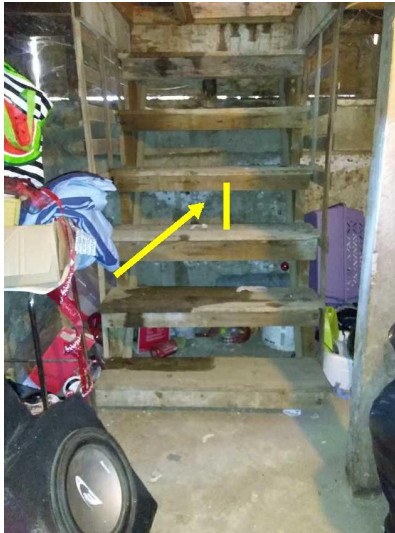
8.3. The openings in the stair risers are more than 4 inches apart and does not meet current standards. You may want this condition serviced to meet current standards.

The openings in the stair risers are more than 4 inches apart and does not meet current standards. You may want this condition serviced to meet current standards.

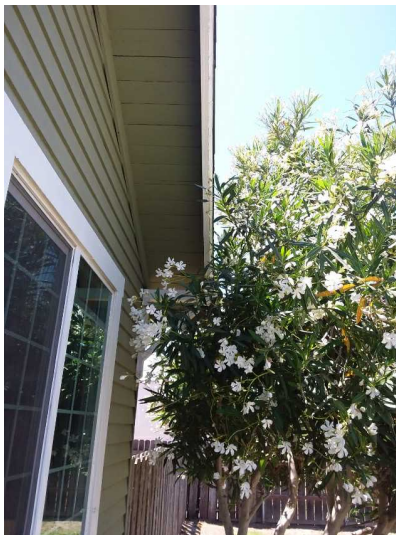
10.2. There are tree limbs over growing the residence that should be trimmed or monitored to insure that they do not impact or damage the roof or its components.

There are tree limbs over growing the residence that should be trimmed or monitored to insure that they do not impact or damage the roof or its components.

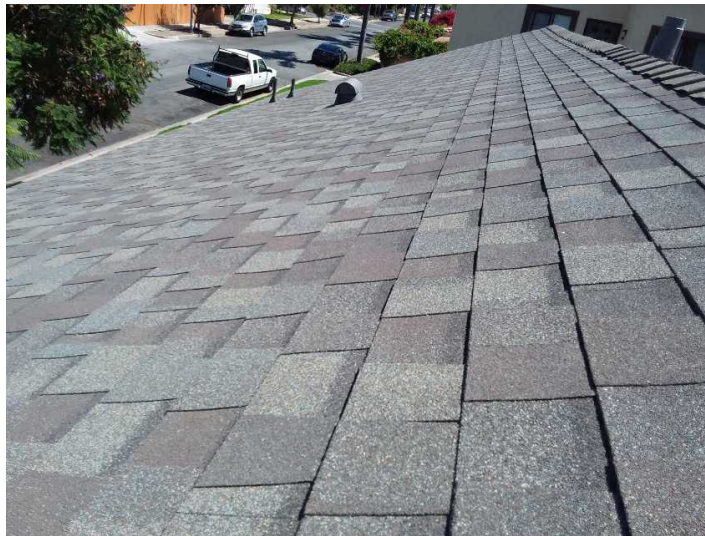
The composition shingle roof is in acceptable condition, but it will need to be kept clean and should be inspected annually. However, our service does not include any guarantee against leaks. For a guarantee, a roofing company would have to perform a water-test and issue a roof certification.

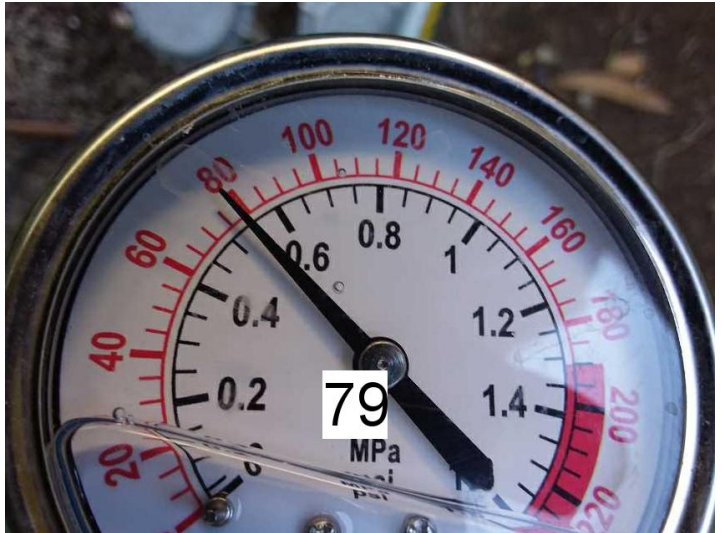
1.4. The pressure inside the residence is at or exceeds 80psi, which is too strong and will stress components of the system, and a regulator should be installed. Most regulators come factory pre-set at 60psi.

The pressure inside the residence is at or exceeds 80psi, which is too strong and will stress components of the system, and a regulator should be installed. Most regulators come factory pre-set at 60psi.

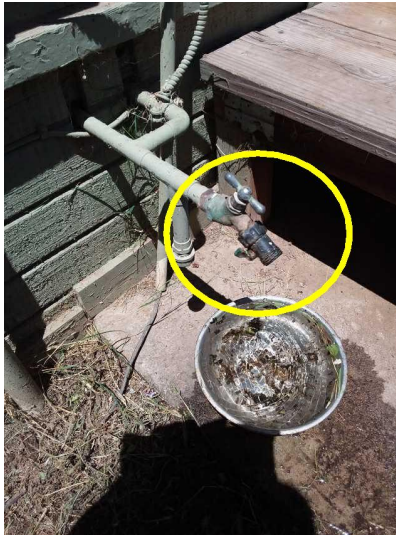
| Page 21 Item: 3 | Irrigation and Hose Bibb Information | 3.3. A hose bib at the rear leaks and should be serviced. |

3.3. A hose bib at the rear leaks and should be serviced.

A hose bib at the rear leaks and should be serviced.

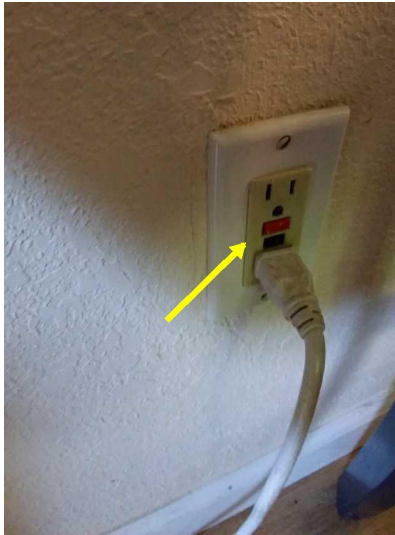
A GFCI outlet does not trip on test which should be evaluated and serviced.

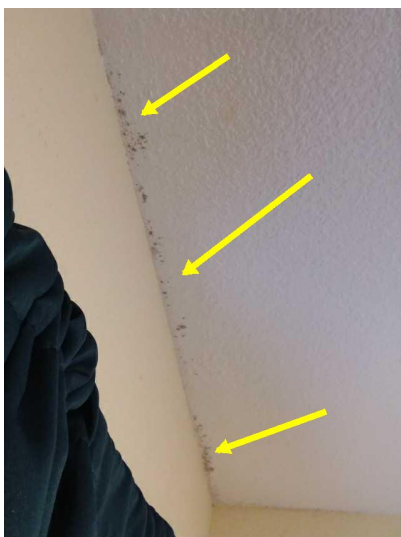
There is mold or mildew within the ceiling area that should be evaluated and treated by the appropriate specialist. All molds flourish in a damp environment and many are commonplace, but some are toxic and pose a health risk.

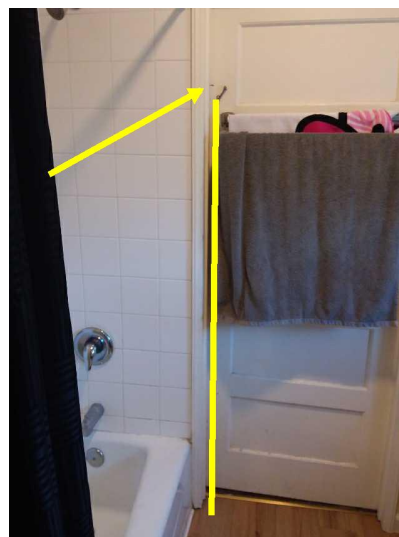
The lock has been installed higher than 48 inches which could impede the exit of a child or short person.

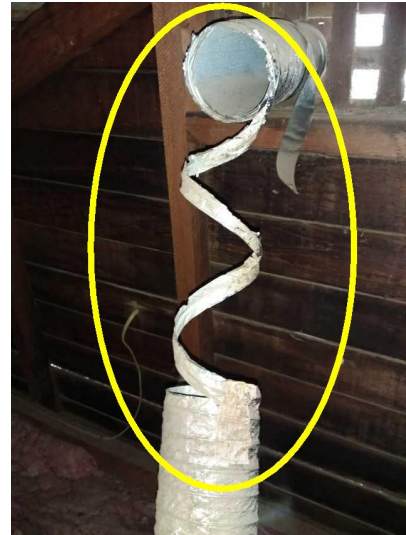
The exhaust duct is separated and should be extended to an exterior port.

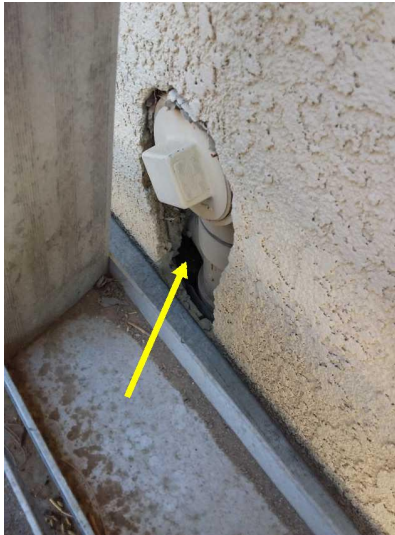
The siding needs typical maintenance such as sealing and painting.

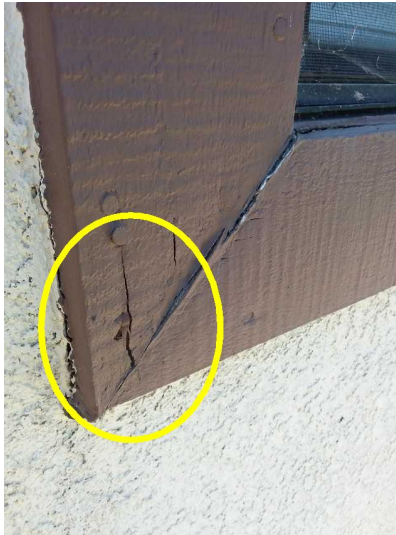
5.2. There is damage to the wood trim that should be evaluated by a termite inspector.

There is damage to the wood trim that should be evaluated by a termite inspector.

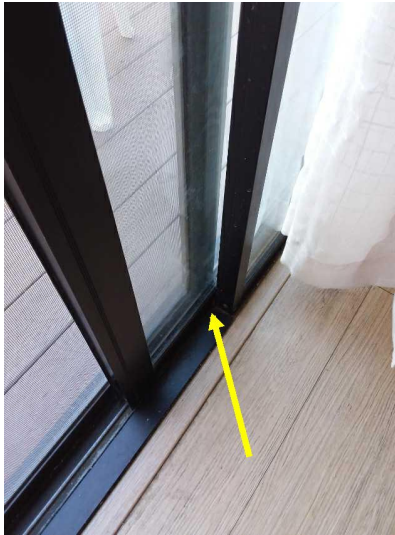
7.2. The sliding glass door or doors are mounted on the outside, which is not as secure as being mounted on the inside.

The sliding glass door or doors are mounted on the outside, which is not as secure as being mounted on the inside.

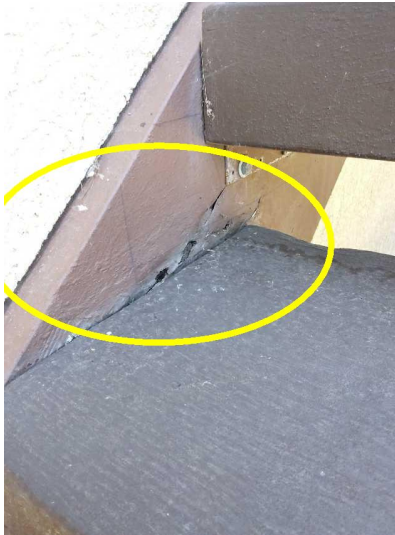
9.2. There is damage to the wood stairs that should be evaluated by the termite inspector.

There is damage to the wood stairs that should be evaluated by the termite inspector.

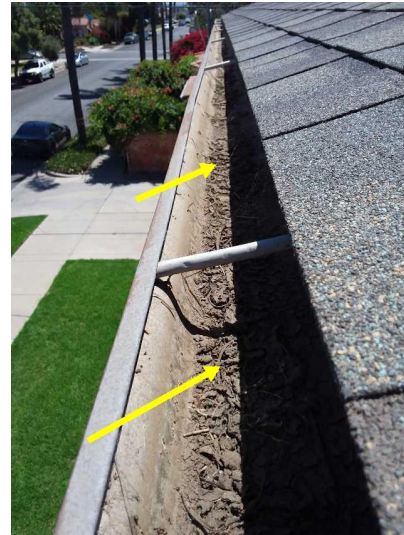
Some of the gutters need to be cleaned to drain properly.

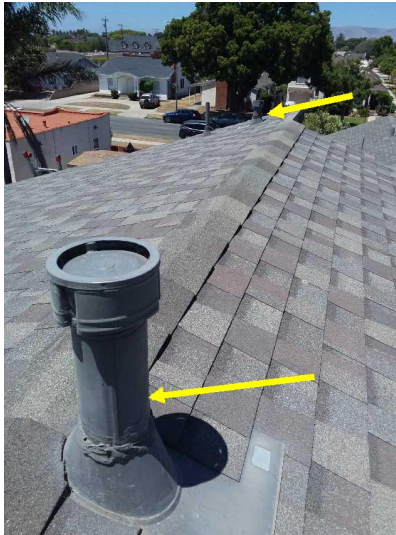
2.5. A rain collar is missing on a heat vent and should be installed.

A rain collar is missing on a heat vent and should be installed.

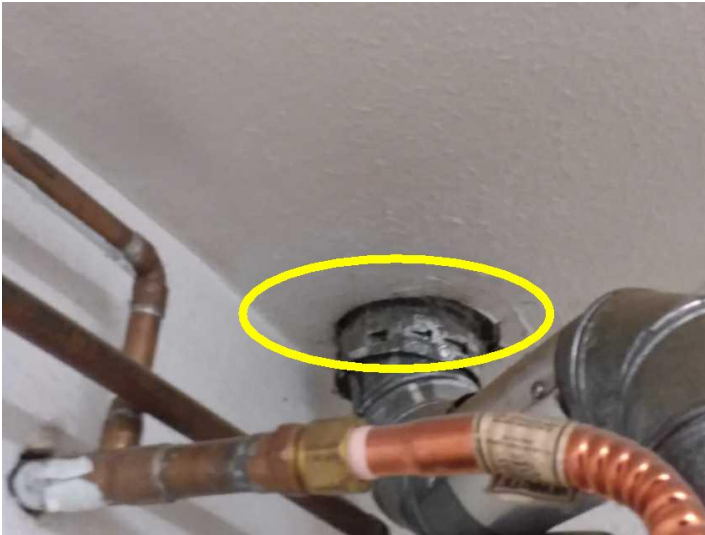
The vent pipe is too close to combustible material, and should be serviced before the close of escrow. A single-walled vent pipe should be six inches away from any combustible material, and a double-walled vent pipe should be one inch away.

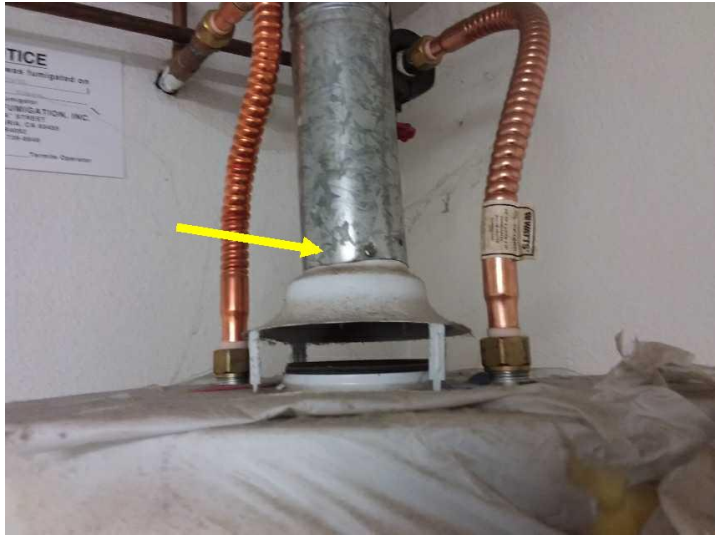
The vent pipe is not properly connected. It is required to have a minimum of 3 fasteners where the pipe connects to the draft hood or other single wall vent pipes.

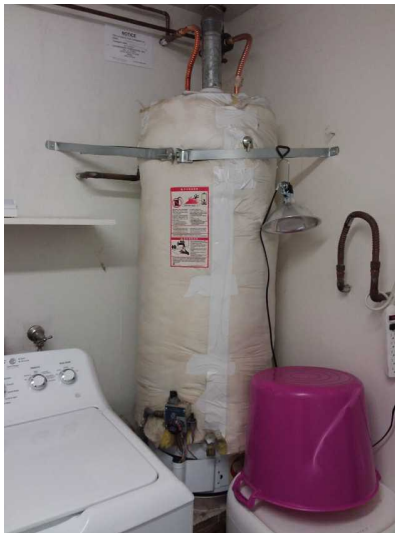
4.12. The water heater is not correctly secured, and needs to be seismically strapped and braced in accordance with local standards.

The water heater is not correctly secured, and needs to be seismically strapped and braced in accordance with local standards.

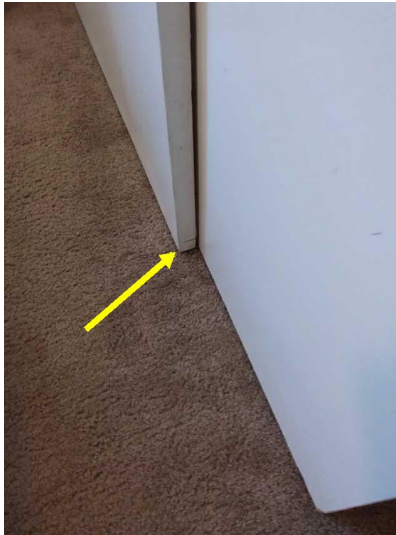
The door guides for the bypass closet doors are missing. The door can become scratched and damaged without the guides.

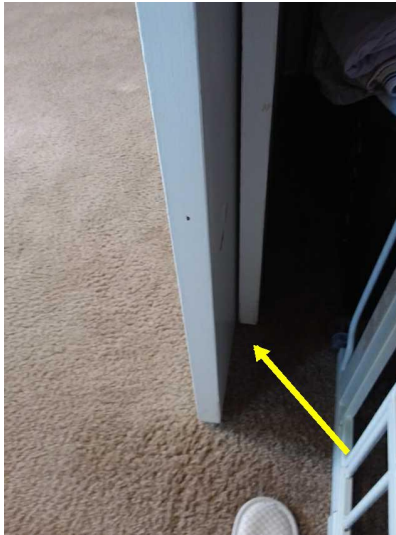
The door guides for the bypass closet doors are missing. The door can become scratched and damaged without the guides.

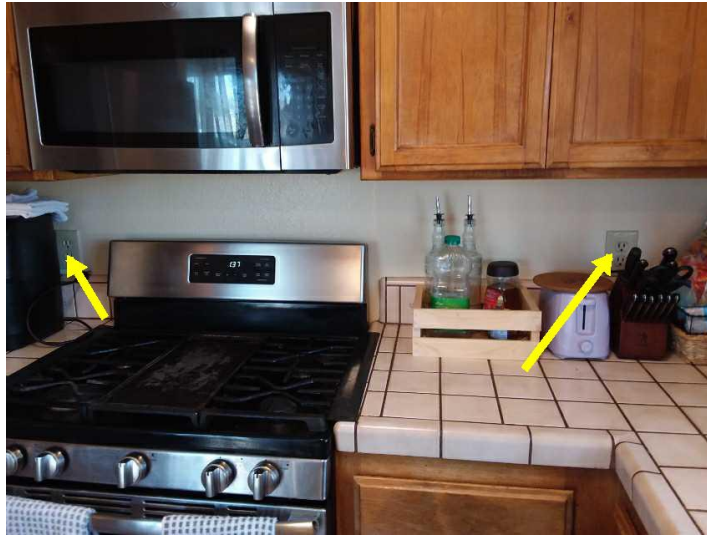
4.2. Some of the outlets at the kitchen counter top are not GFCI protected as required by today standards.

Some of the outlets at the kitchen counter top are not GFCI protected as required by today standards.

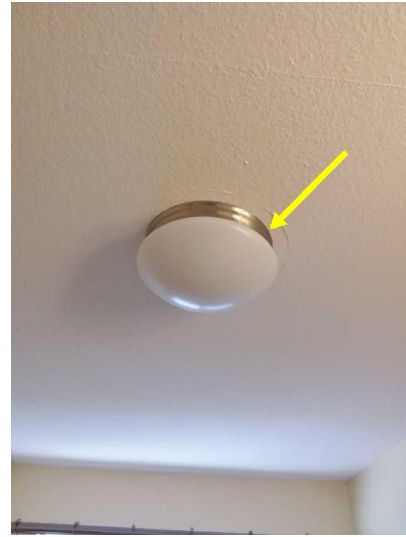
A ceiling light does not respond and should be serviced.

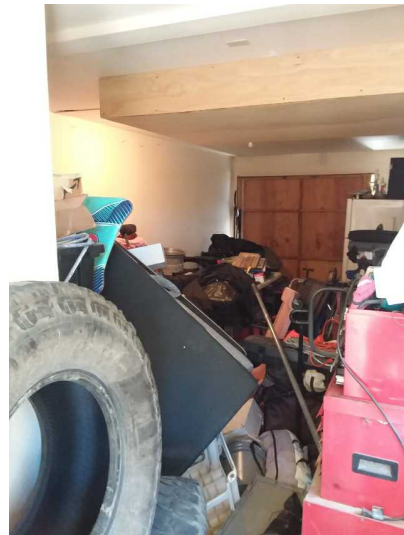
The garage walls are too full or covered to provide a clear view them and other components of the garage.

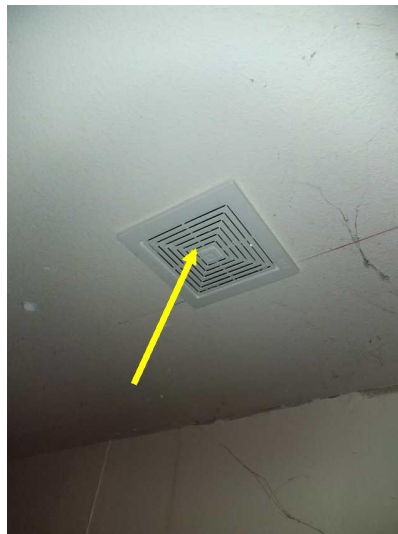
The voids in the ceiling firewall must be repaired, in order to maintain the necessary firewall separation between the garage and the residence.
