# A Buyer's Choice Home Inspections

## PROPERTY INSPECTION REPORT

329 Moonlight Ave SE, Salem, OR 97302

Date of Inspection: 7/9/2026 Time: 9:00 AM

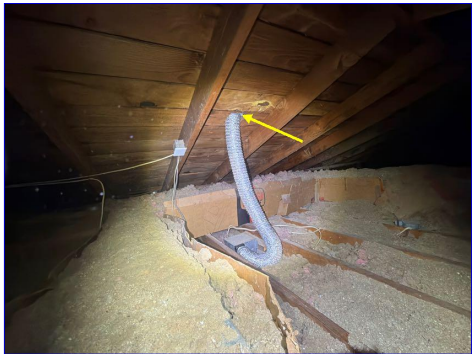
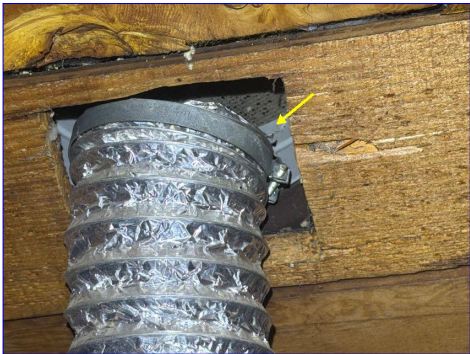
| Page 17 Item: 6 | Attic General Comments/Observations | <ul style="list-style-type: none"><li>The hall bathroom vent fan is improperly vented near or at a hooded roof vent. Bathroom exhaust vents should be sealed to the exterior and vented through hooded vents manufactured for this purpose. Correction advised.</li></ul> |

Bathroom exhaust

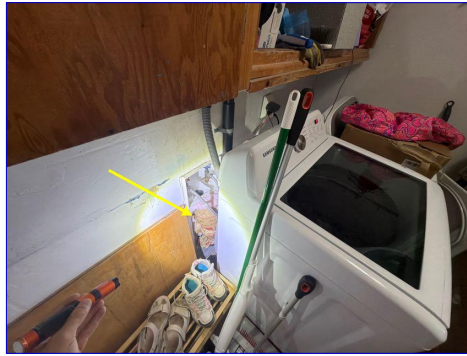
• **The paper facing of the insulation is exposed in the laundry area. Exposed kraft-faced insulation is combustible and should not be left uncovered in occupied spaces. Recommend covering the insulation with an approved thermal barrier, such as drywall, to reduce the potential fire hazard.**

Exposed paper side of insulation

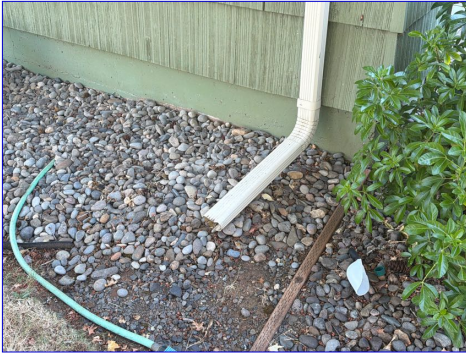
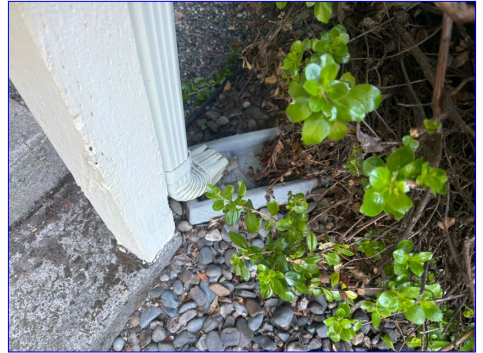
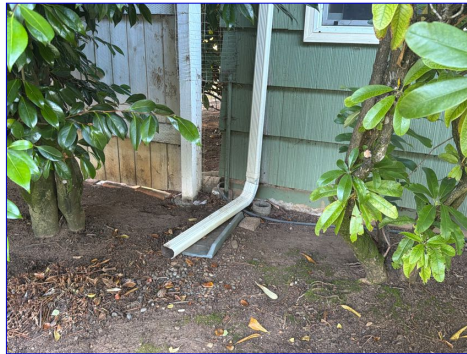
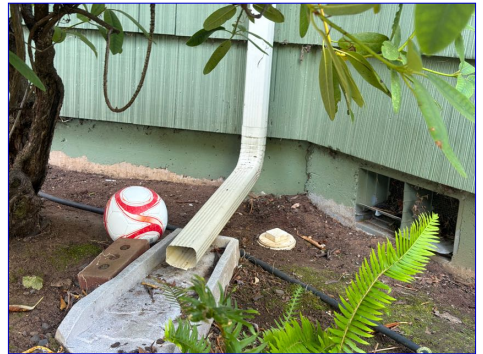
- Downspout(s) extension is too short and downspout(s) discharge water at foundation. Recommend installation of extension to ensure proper drainage away from foundation to prevent seepage.

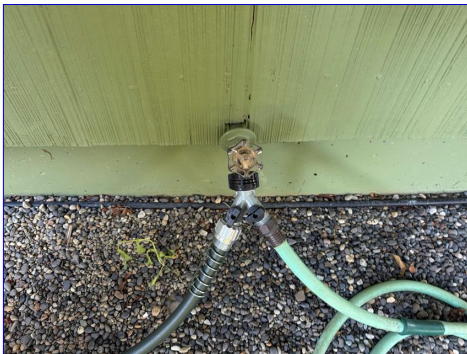
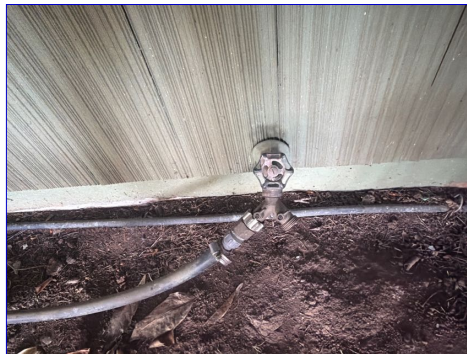
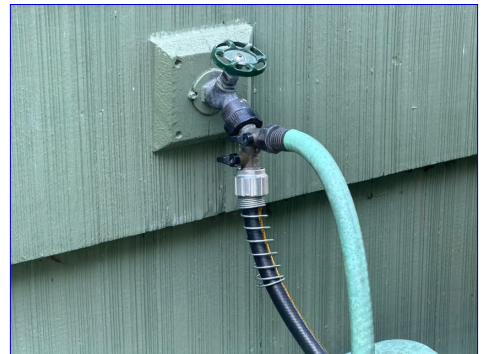
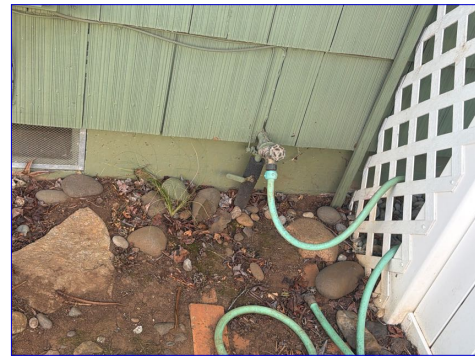
- The north exterior faucet was observed to be leaking at the time of inspection. Recommend having a licensed and qualified contractor make necessary corrections.

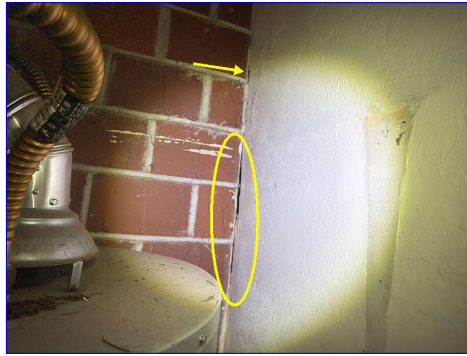
| General Information | | |
|---|---|---|
| Page 13 Item: 4 | Fire Separation Wall | <ul style="list-style-type: none"><li>• Attic access panel/hatch cover is plywood which is flammable. Recommend replacing access panel with a fire rated panel for safety.</li><li>• Holes observed, suggest sealing to restore fire rating.</li></ul> |

Hole in fire separation wall

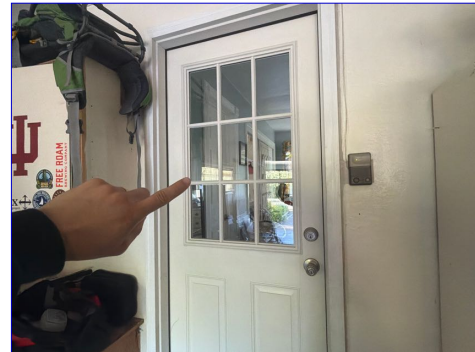
| General Information | | |
|---|---|---|
| Page 14 Item: 5 | Occupant/Fire Door | <ul style="list-style-type: none"><li>• Fire rating is compromised due to a window. This is a safety concern. Recommend replacing door with a fire rated door.</li></ul> |

Window present at occupant door

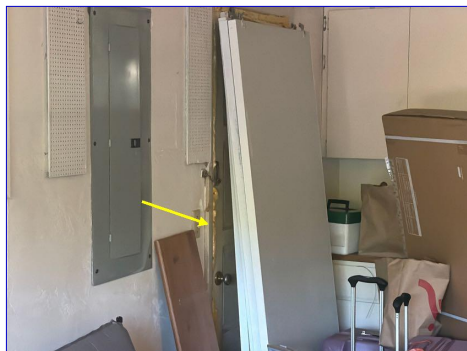
- Unable to operate, blocked by personal property at the time of inspection. Suggest confirming proper operation prior to close.

Door is blocked

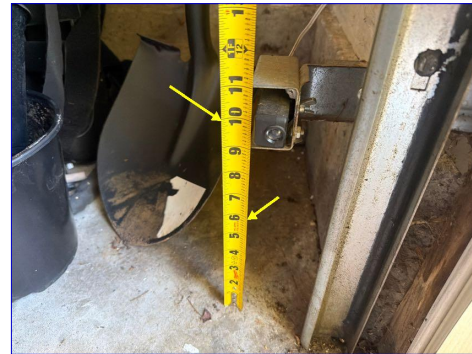
Photo eye sensor is too high

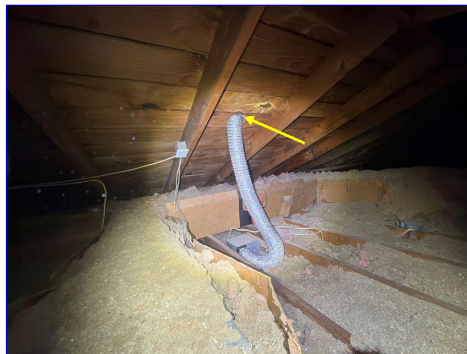
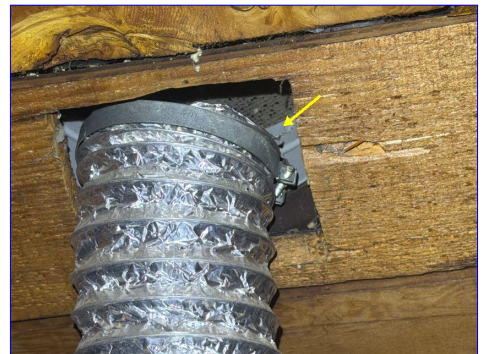
- Although it may be permissible by local code, InterNACHI Standard of Practice states all exhaust vents should exhaust to the exterior to prevent damage and/or deterioration from moisture and/or condensation.
- The hall bathroom vent fan is improperly vented near or at a hooded roof vent. Bathroom exhaust vents should be sealed to the exterior and vented through hooded vents manufactured for this purpose. Correction advised.

Bathroom exhaust

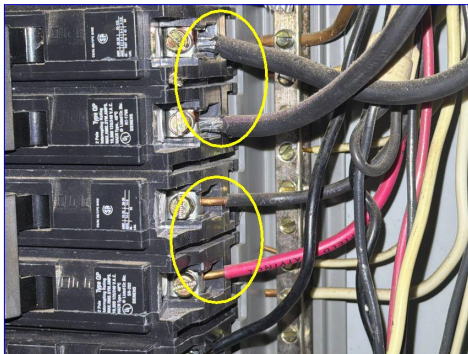
- Combination Service Entrance Device (CSED) with Main Breaker
- The main service disconnect is approximately 200 amps, 240 volts.
- Service entrance cables are aluminum.
- Branch circuit wiring is a mix of copper and aluminum wiring. Buyer is advised that periodic maintenance of aluminum wiring is recommended to prevent "creeping" at electrical connections.
- **AFC** protection in bedroom branch circuits not present in this house. Although **AFC** protection may not have been required when this house was built, recommend consider upgrading all living space circuits by a licensed electrical contractor for safety.
- Strain relief or bushing is missing. Recommend having a licensed electrical contractor further evaluate electrical system and install a strain relief or bushing for safety.
- No thermal anomalies were observed.

Mixed wiring

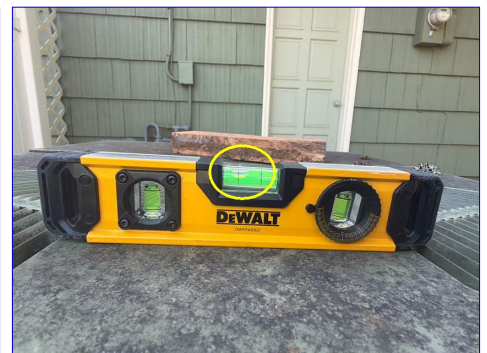
- Air conditioning operating during inspection and appeared to be performing satisfactorily. Buyer is advised to verify satisfactory operation prior to close.
- Condenser is tilted, excessive uneven settlement can cause fractures in refrigerant line fittings and loss of refrigerant as well as shorten the life of the compressor. Unit should be leveled.

Unit is not level

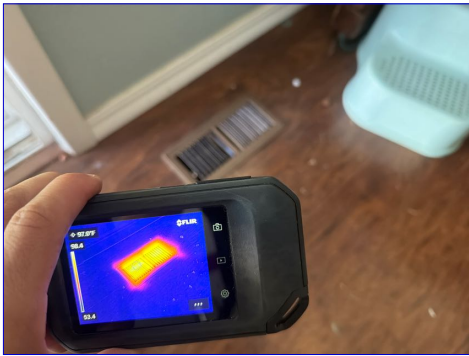
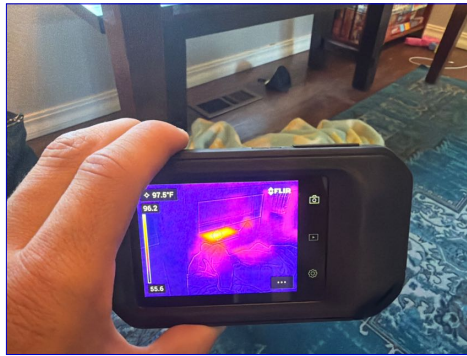
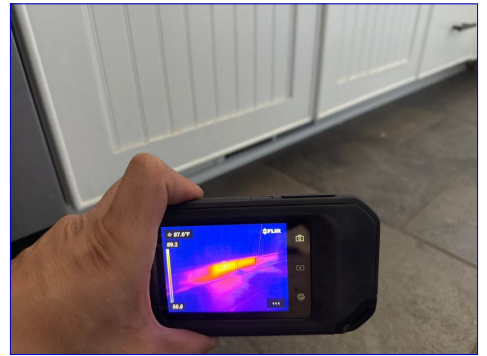
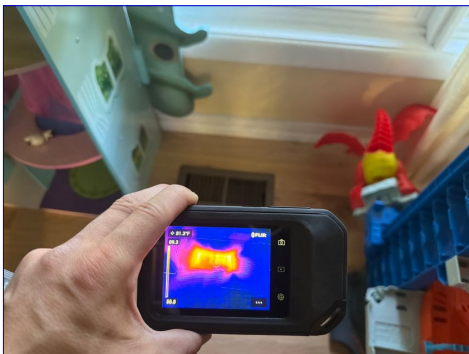
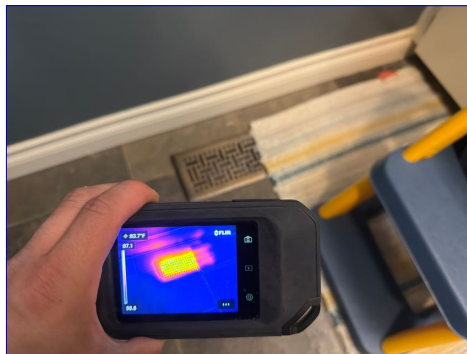
Register

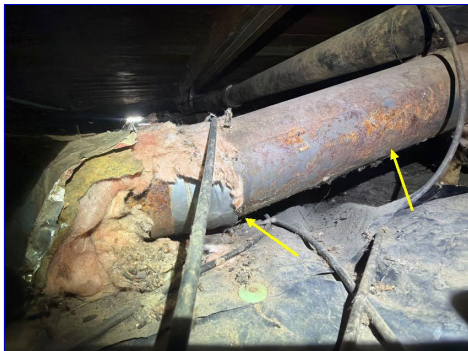
Ductwork

• Some of the ductwork in the crawlspace appears to be damaged, corroded/rusted, and partially disconnected at some joints. This may allow conditioned air to escape and could impact the efficiency and performance of the HVAC system. Recommend having the ductwork evaluated and repaired as needed by a qualified HVAC contractor.

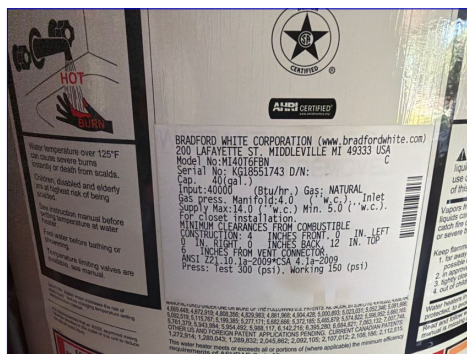
Data plate

**Data Plate:** Approximate Year Manufactured: 2013 • Estimated Gallons Capacity: 50

- Water heaters have a life expectancy of 10 to 20 years with an average lifespan of 8 to 12 years. Based on the age of the water heater, plan for future replacement.

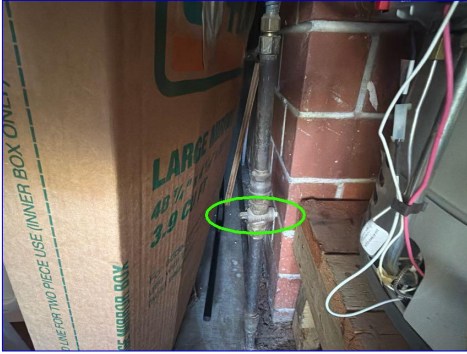
Fuel shut off

- No drip leg or sediment trap present. Recommend having a licensed plumbing contractor install a drip leg or sediment trap downstream of the gas shutoff valve, as close to the appliance as possible to help prevent moisture and/or debris from effecting combustion and burner operation.

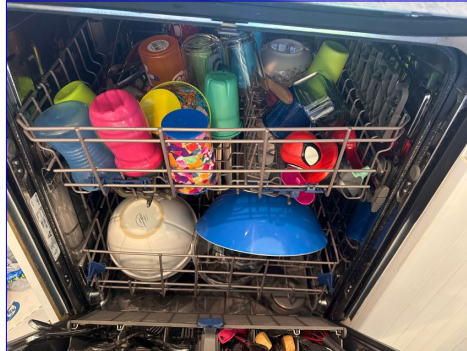
• Dishwasher was full of dishes and/or other personal belongings. Unit was not operated to prevent accidental damage to contents. Recommend confirming proper operation prior to closing.

Unit contains dishes

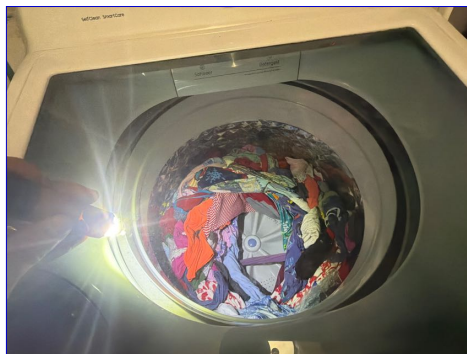
- Unit was full of laundry at time of inspection and not tested. Recommend confirming proper operation prior to closing.

Unit contains laundry

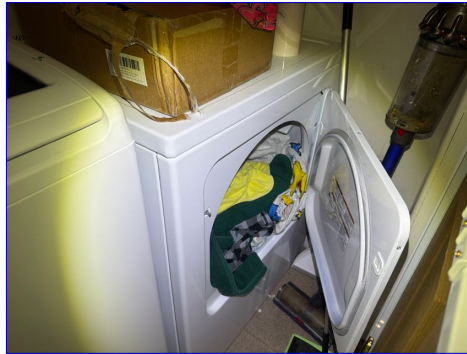
- Unit was full of laundry at the time of inspection and not tested. Recommend confirming proper operation prior to closing.

Unit contains laundry
