## Home Inspection Report

PROPERTY INSPECTED:  
296 Drum Bay Road  
Hague, VA 22469

Date of Inspection: 08/19/2026

Inspection No. 28188-12314

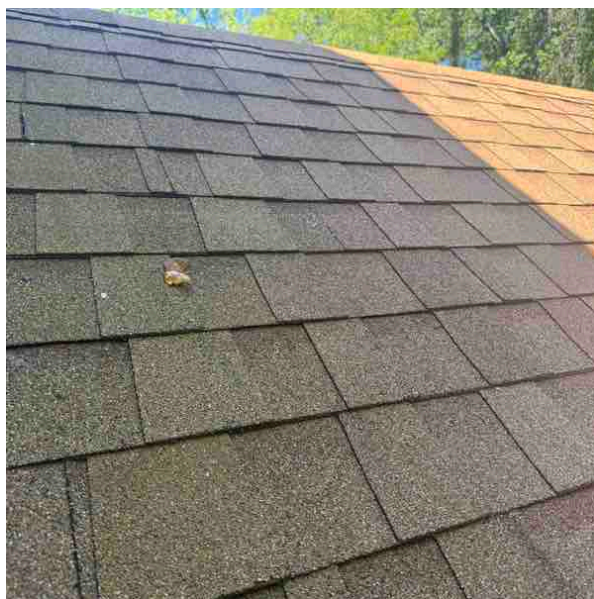
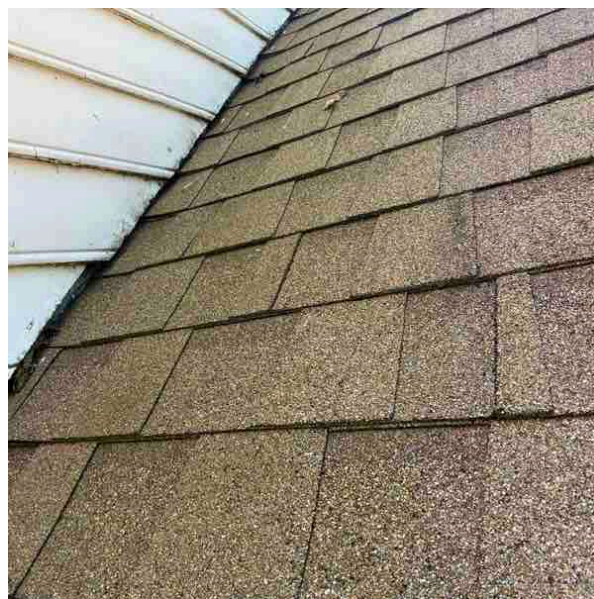
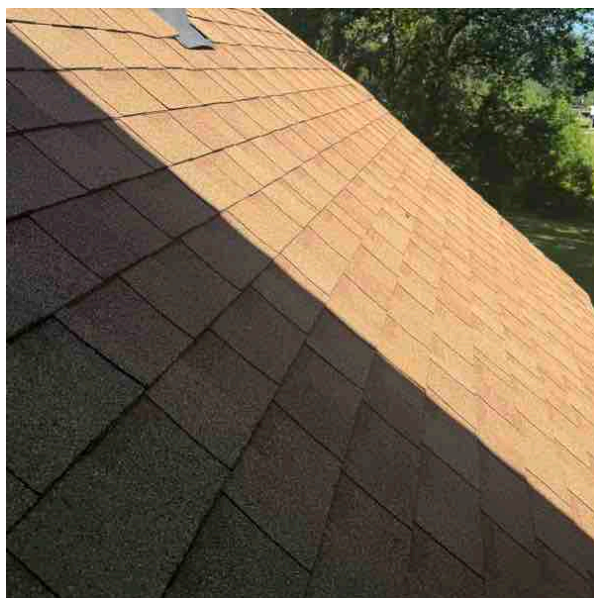
4.3.1 Roof is too steep to safely walk on. Roof was inspected from ground with binoculars and at the edge with a ladder.

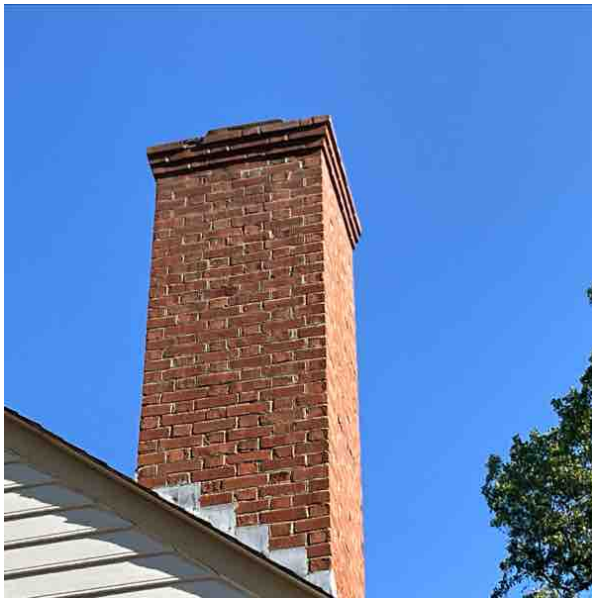
4.7.2 Visible, accessible portions of the chimney exterior were inspected. **(Exterior Rear)**

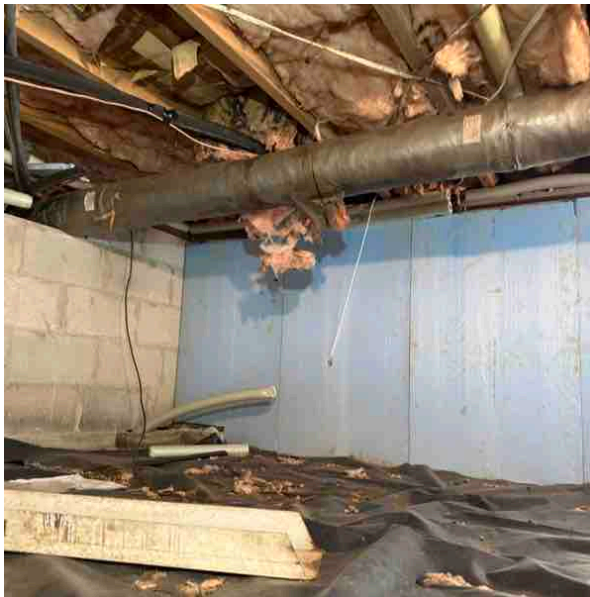
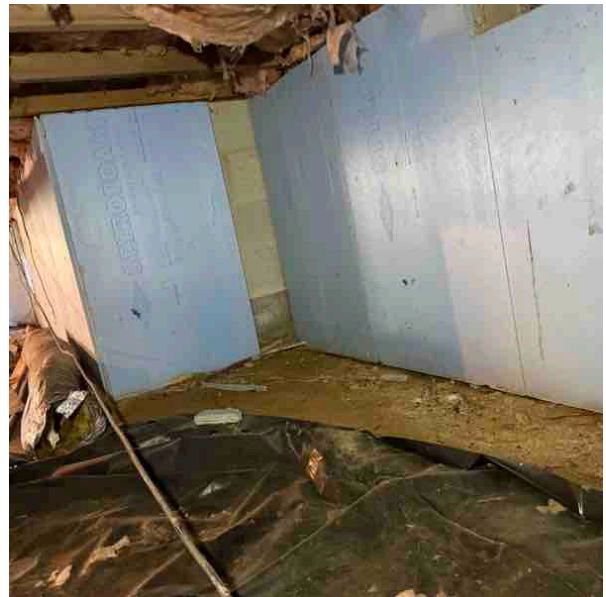
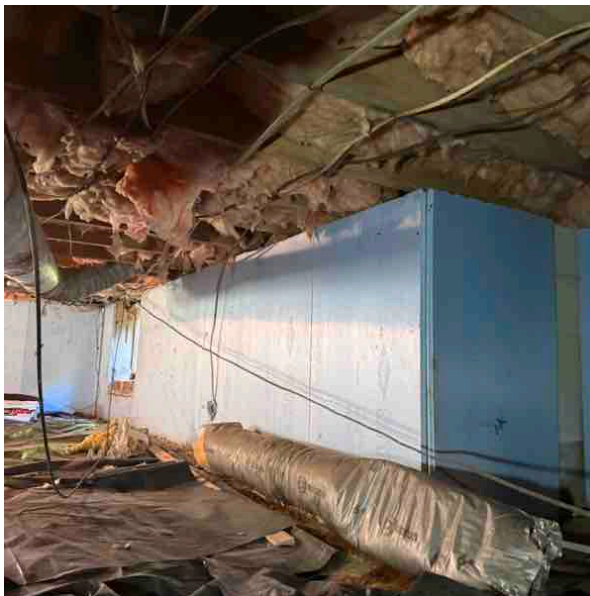
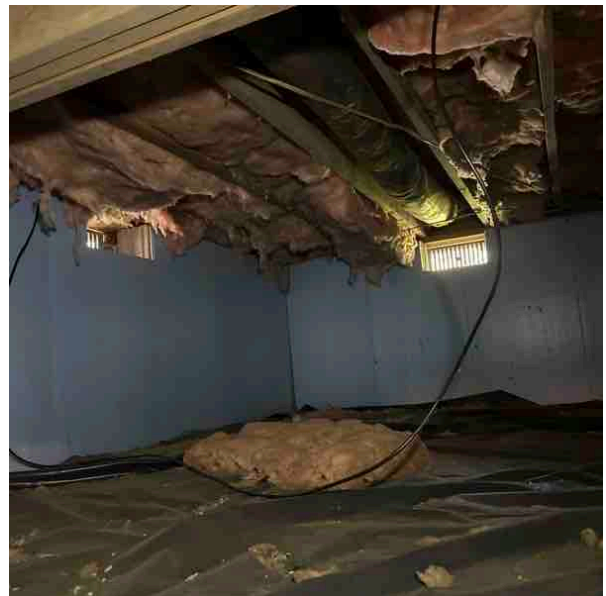
7.3.2 Rigid insulation has been installed on the foundation walls around the perimeter of the crawlspace.

Insulation restricts visual inspection of the foundation walls. There are no indications of settlement visible on the exterior foundation walls.

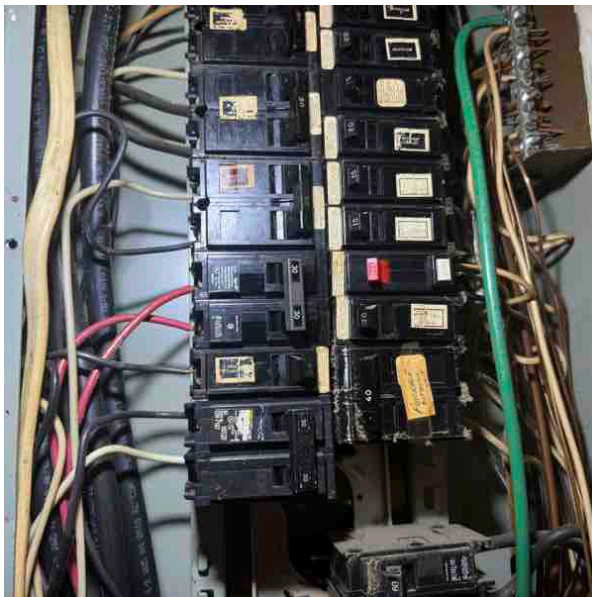
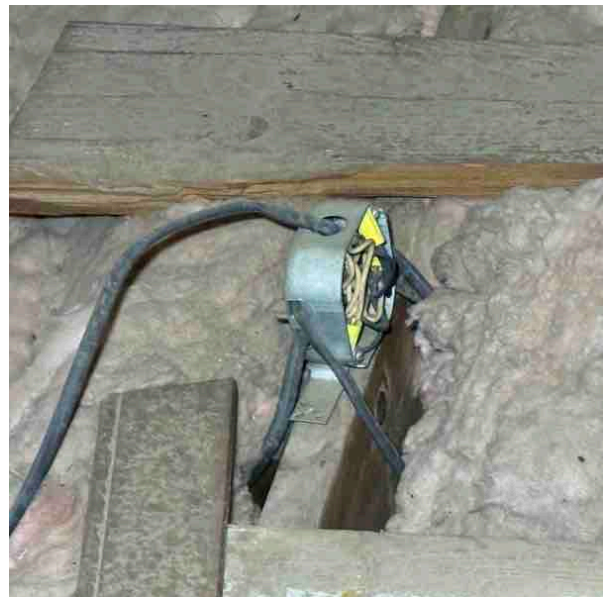
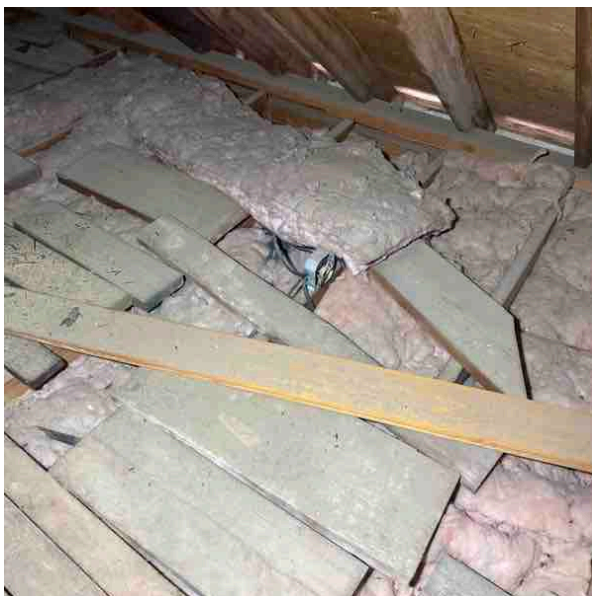
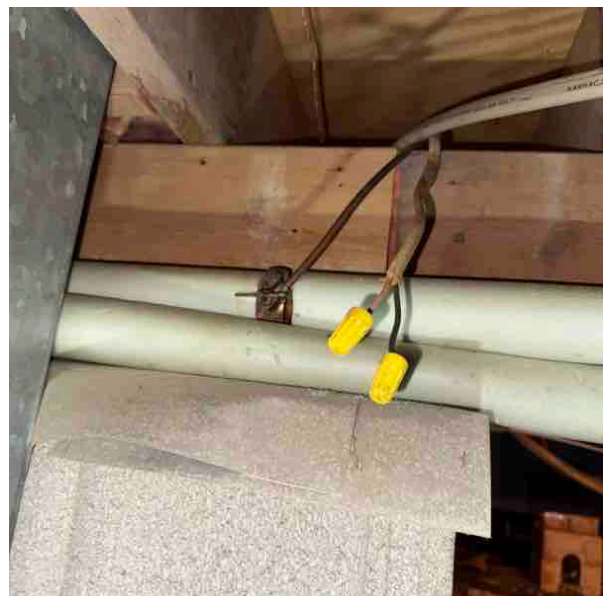
- high heat condition noted on wire connection at breaker for range unit
- cable clamps and knockouts are missing at bottom of panel
- damage is visible on terminals on buss bar in main panel
- improper fasteners are in use to secure cover to panel
- open wiring and open junction boxes are visible at several areas in the attic and crawlspace
- ensure replacement breakers are rated for use in this brand panel

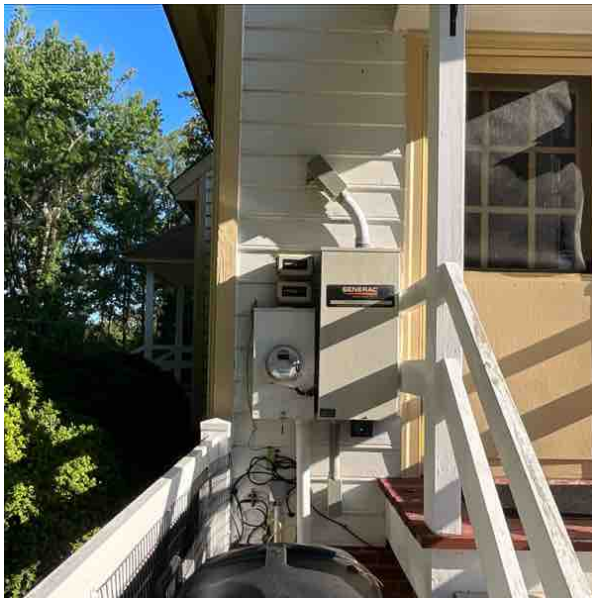
9.2.2 Main House: Electric meter base is located at: side of house (**Exterior Right**)

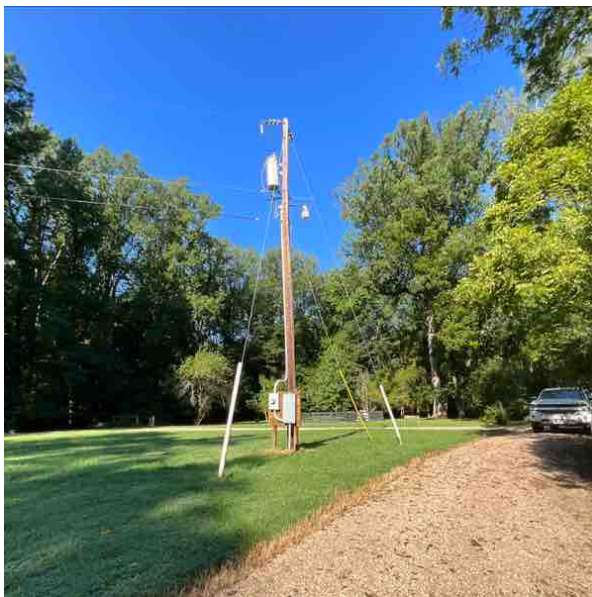
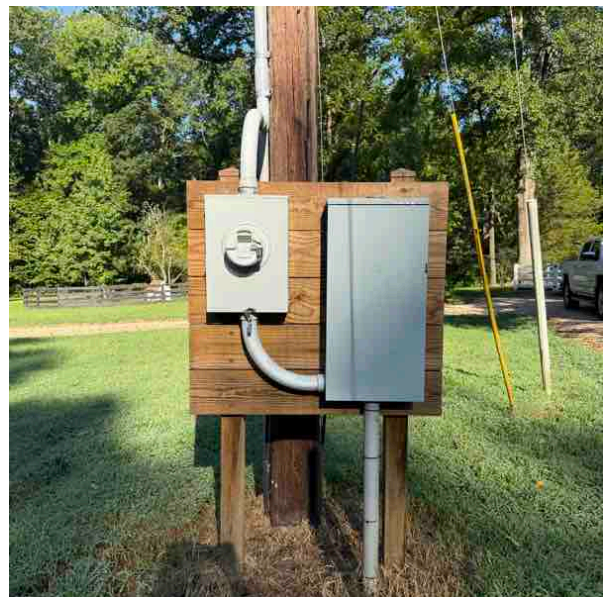
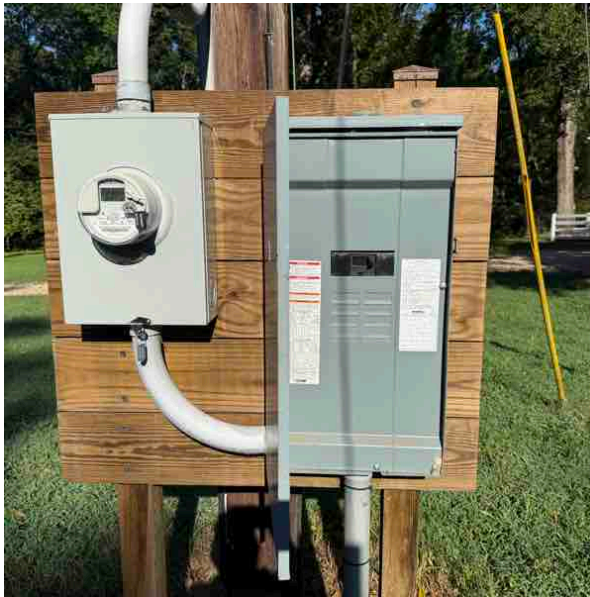
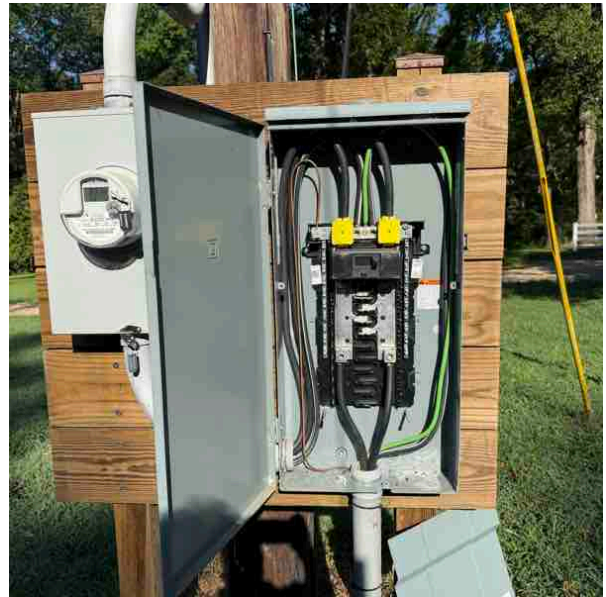
9.2.3 Historic house service entrance: An overhead service entrance cable is present on a utility pole in the yard next to the driveway. A meter base and 200 amp service disconnect are installed on the pole. (**Exterior Rear**)

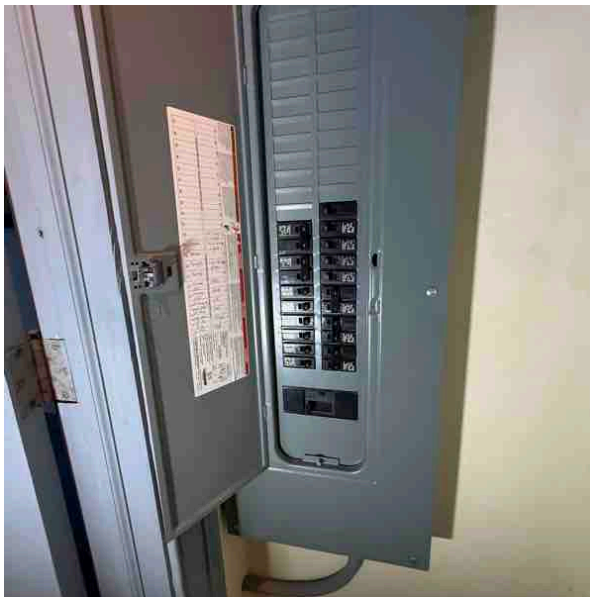
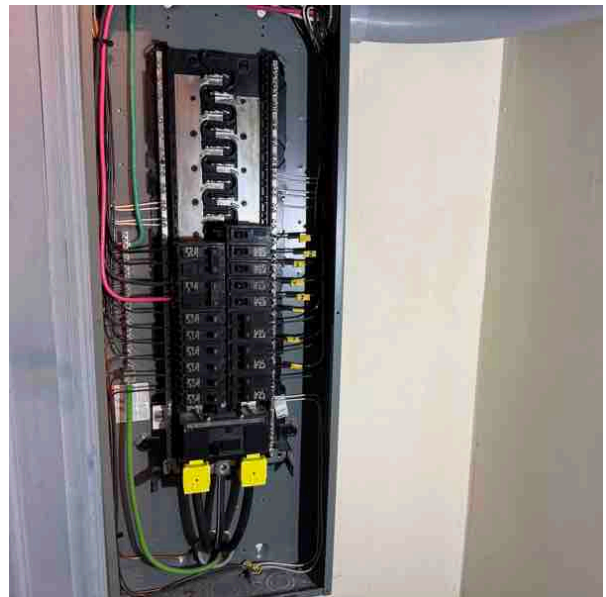
9.4.2 Historic House :Panel cover(s) were removed to visually inspect wiring and breakers on the panel interior.

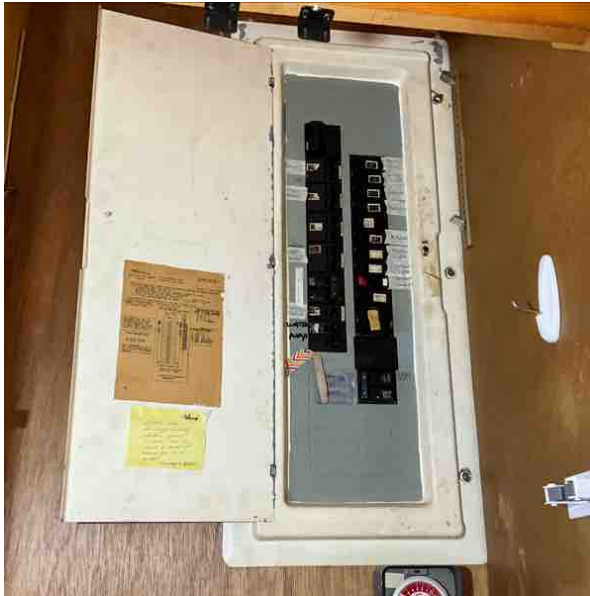
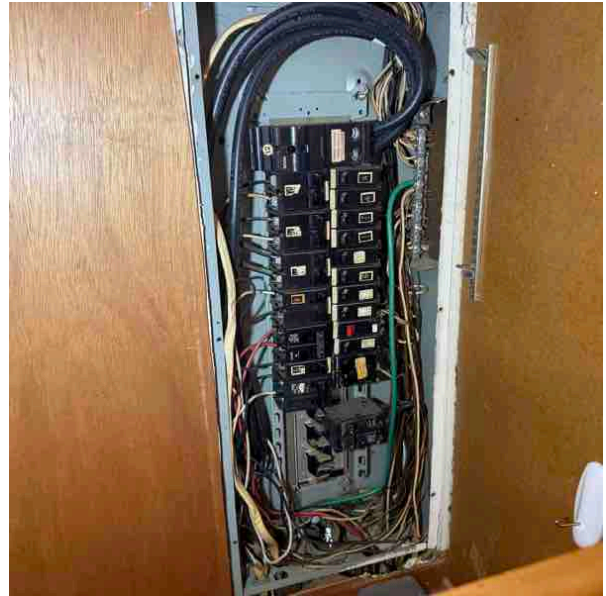
9.4.3 Main House : Panel cover(s) were removed to visually inspect wiring and breakers on the panel interior.  
(Kitchen)

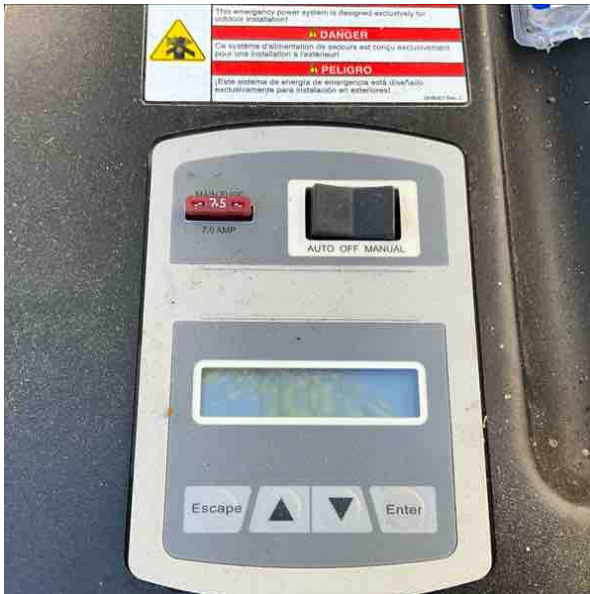
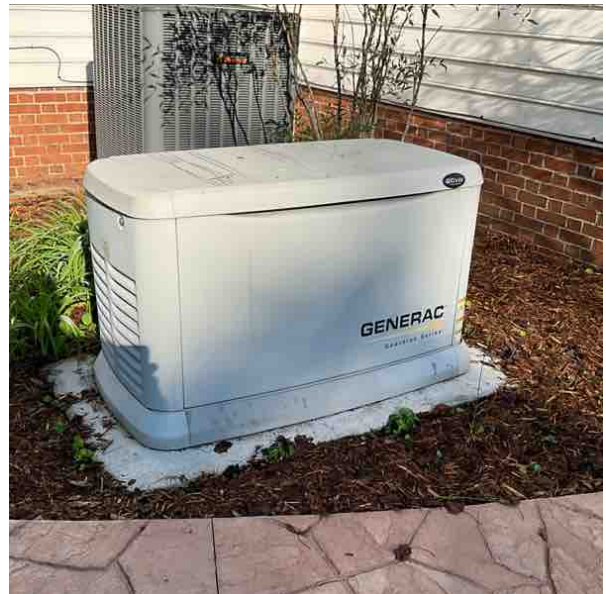
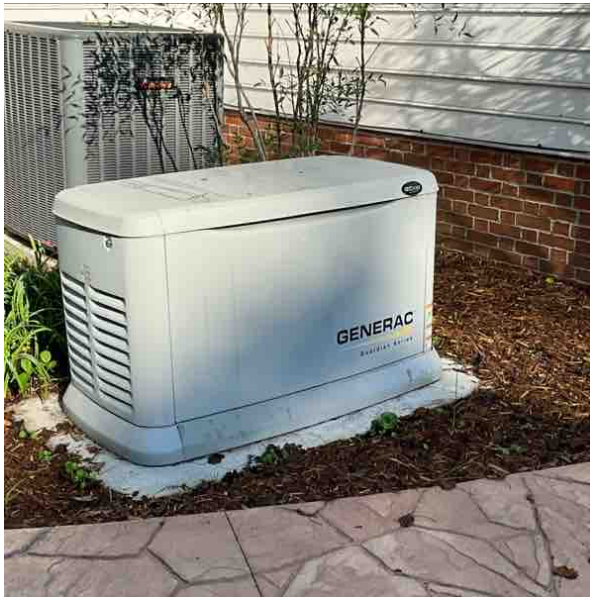
9.5.2 Generator was in the off position upon arrival to the inspection site.

A generator is present but not inspected. Inquire with the owner to determine the name of the service provider that performs annual maintenance on the generator system. (Exterior Rear)

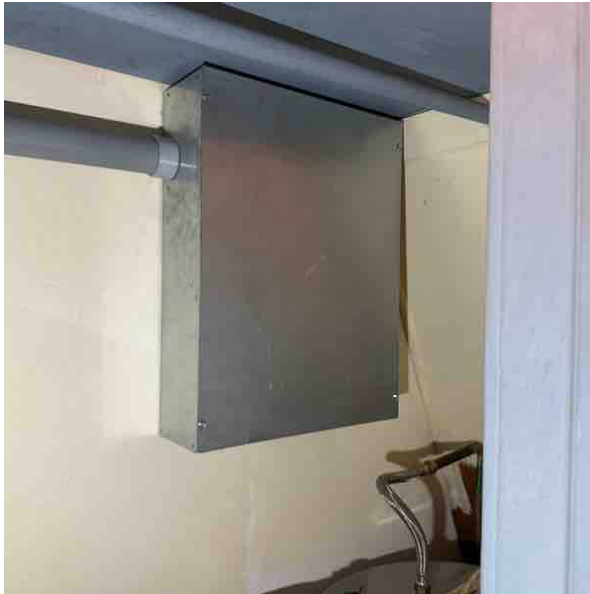
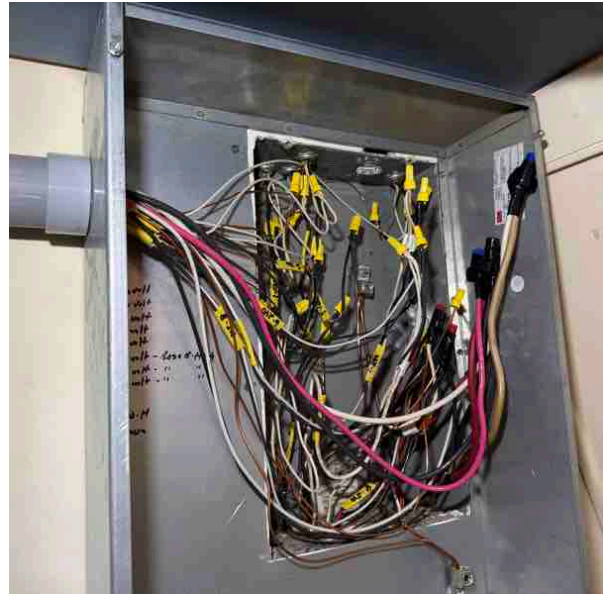
9.7.2 Historic Home : An older panel has been converted to a junction box. A metal enclosure has been installed over the old panel to accommodate wiring and connections when the new panel was installed.

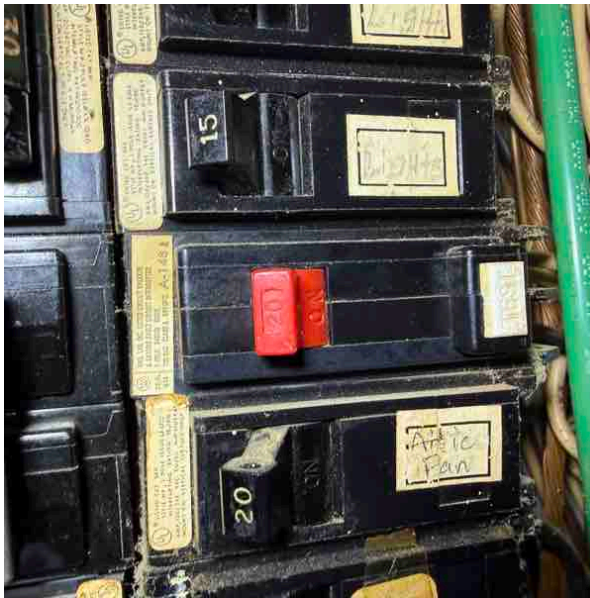
9.11.3 A GFCI breaker in the main service panel protects receptacles at the following areas: guest bathroom, primary bathroom. **(Kitchen)**

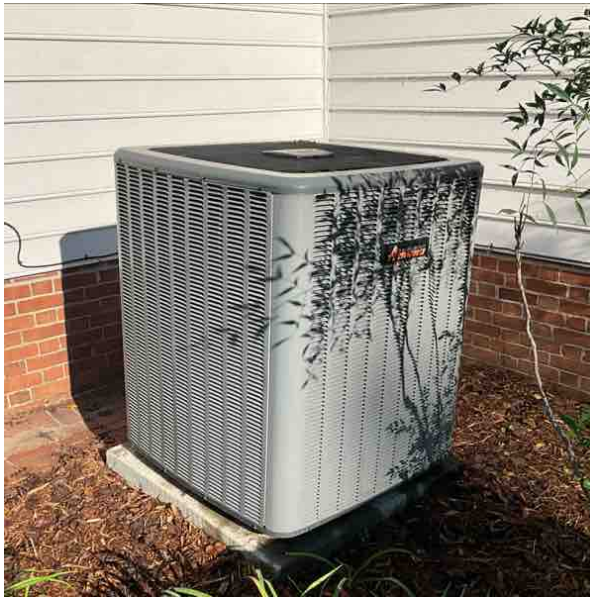
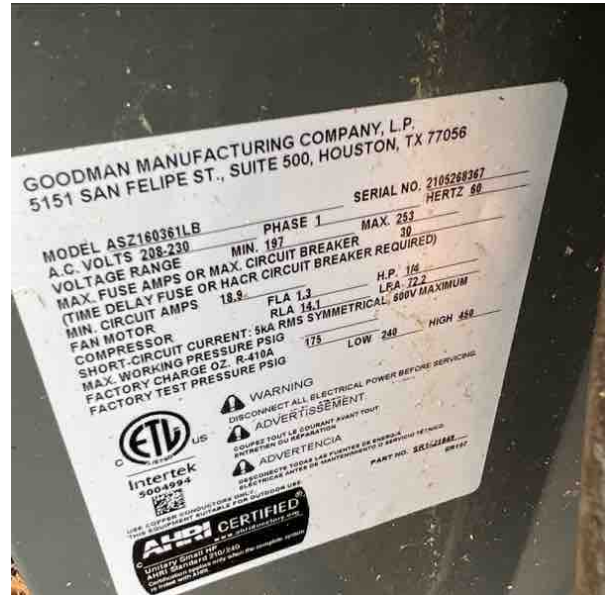
Heat pump system manufacture date: 2021

Heat pump system was operating properly at the time of the inspection. Temperature on the supply registers is 57F degrees during operation in the cooling mode. **(Exterior Rear)**

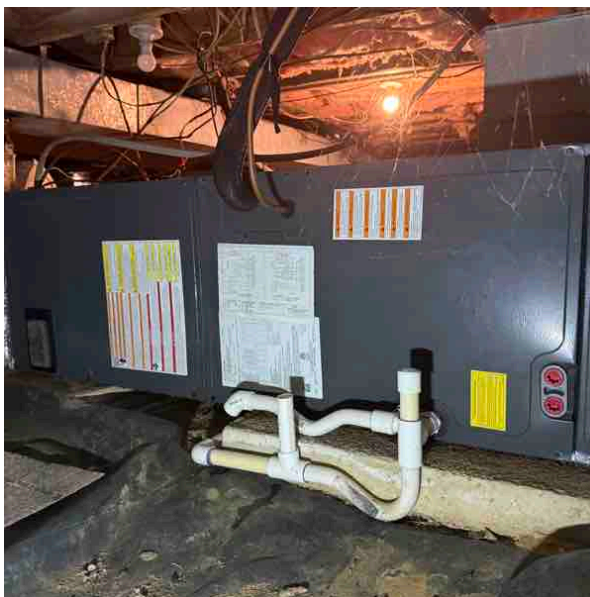
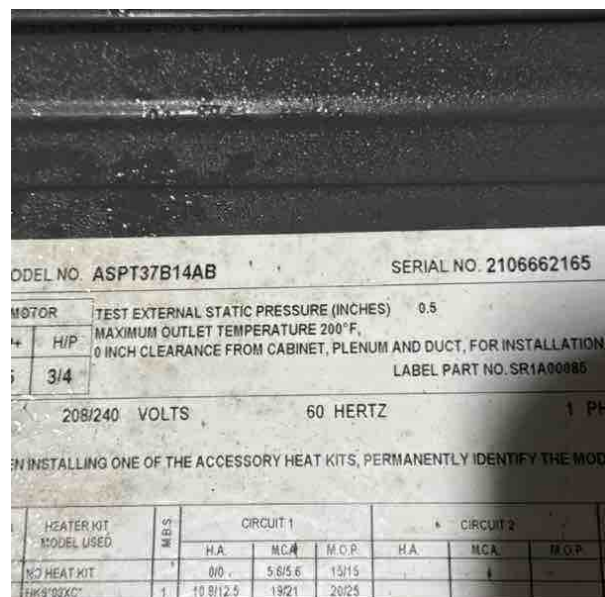
Air Handler brand: Amana

Air handler was manufacture date: 2021

Location: Crawlspace

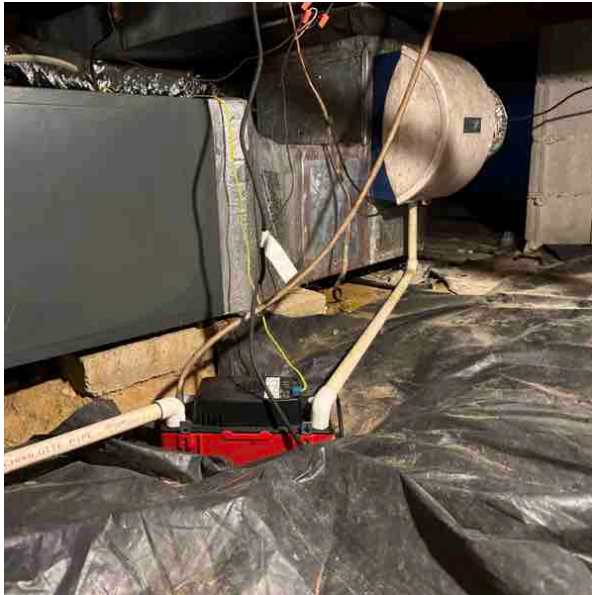
10.9.2 The operation of the humidifier was not tested. Recommend having the unit checked out and serviced the next time the HVAC system is serviced.

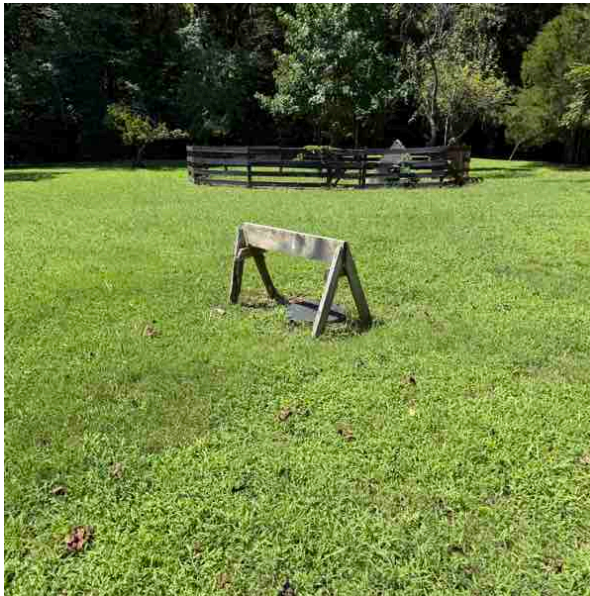
11.13.1 A buried propane tank is present at the side yard. Recommend routine maintenance of propane burning appliance (generator) by a qualified contractor to ensure safe and proper operation. Recommend inquiring with the seller for documentation pertaining to service records and fuel level. **(Exterior Right)**
