# ***Cornerstone Inspection***

## **Property Inspection Report**

***6455 Cormorant Way, Avila Beach, CA 93424***  
***Inspection prepared for: Jim Hilferty***  
***Real Estate Agent: Holly Tibbles - Coast & County Brokers***

***Date of Inspection: 8/25/2026 Time: 9:00 AM***  
***Age of Home: 1994 Size: 1912***  
***Weather: Clear***  
***Order ID: 14158***

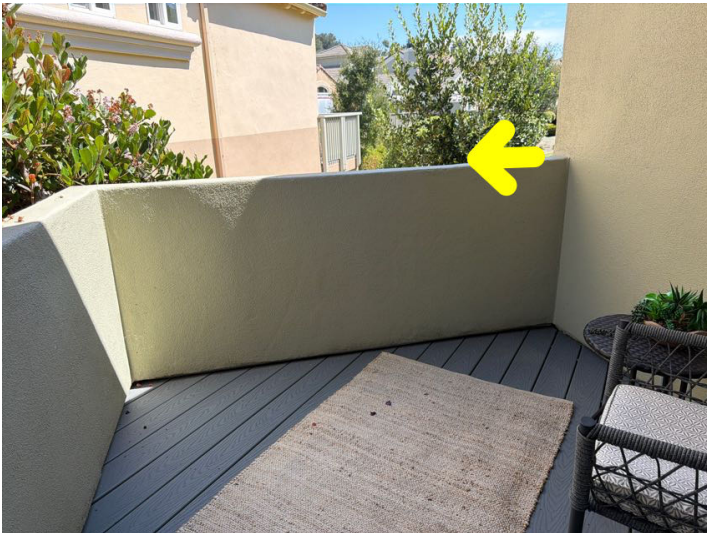
13.1. One or more guardrails do not conform to common safety standards. Common safety standards require them to be a minimum of 42 inches high when the standing surface is 30 inches or more above grade. Also, guardrail pickets should be no more than 4 inches apart for child safety.

One or more guardrails do not conform to common safety standards. Common safety standards require them to be a minimum of 42 inches high when the standing surface is 30 inches or more above grade. Also, guardrail pickets should be no more than 4 inches apart for child safety.

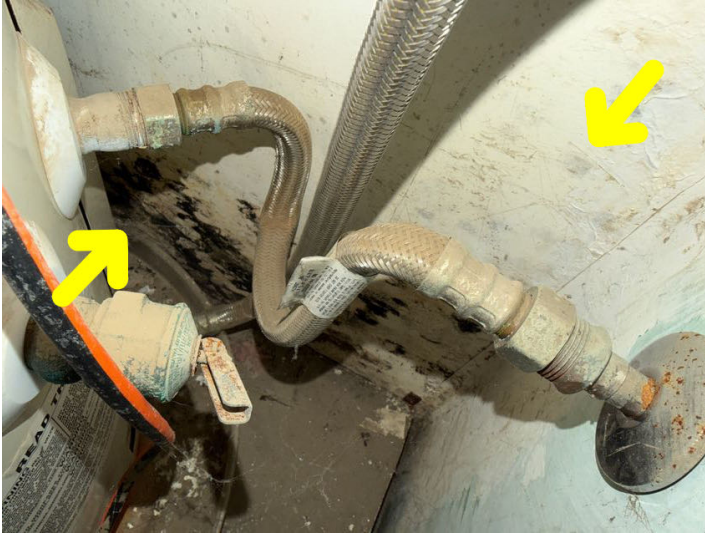
There is a mold-like substance present in the sink cabinet, which should be evaluated by a specialist and serviced as necessary. All molds flourish in a damp environment and many are commonplace, but some are toxic and may represent a health threat.

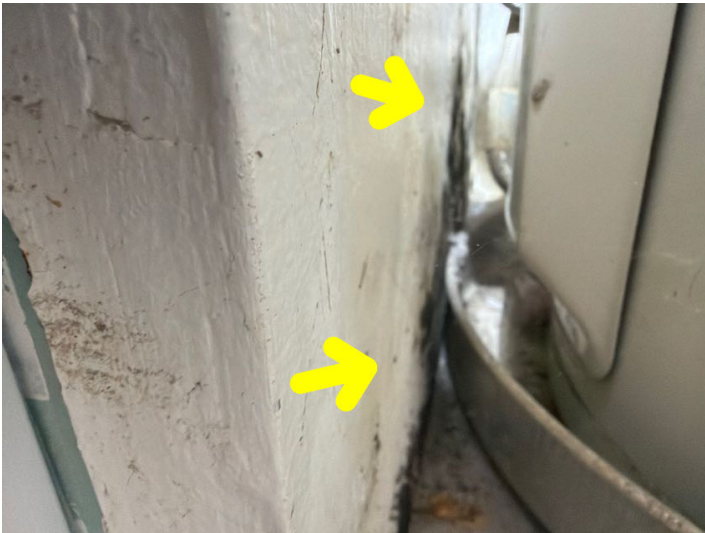
There is a mold-like substance present in the sink cabinet, which should be evaluated by a specialist and serviced as necessary. All molds flourish in a damp environment and many are commonplace, but some are toxic and may represent a health threat.

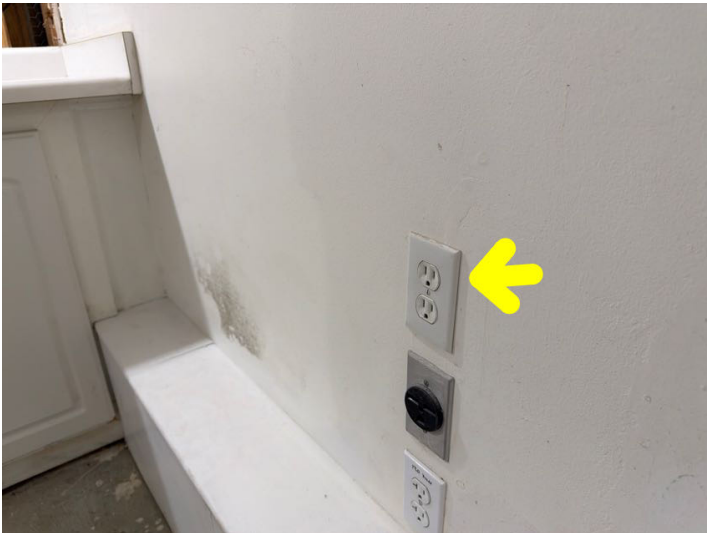
1.14. One or more outlets are not secure, and should be evaluated and serviced by a licensed electrical contractor.

One or more outlets are not secure, and should be evaluated and serviced by a licensed electrical contractor.

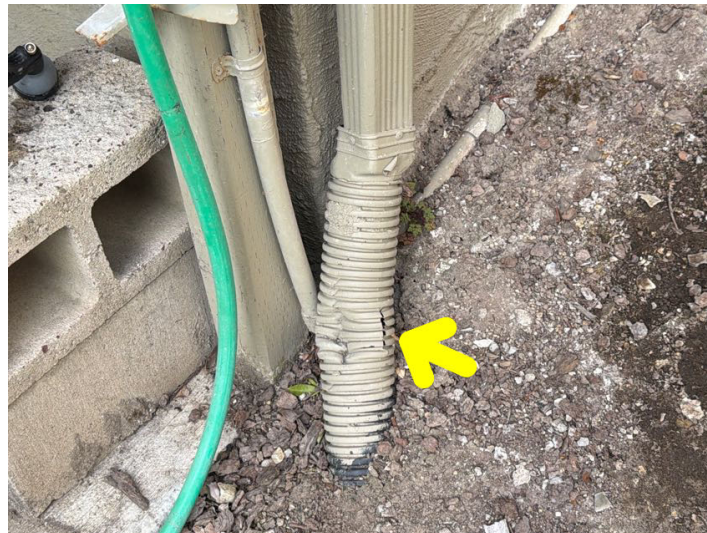
1.1. The gutters need to be serviced, such as reconnecting, sealing separated seams, cleaning, or making sure they are secure.

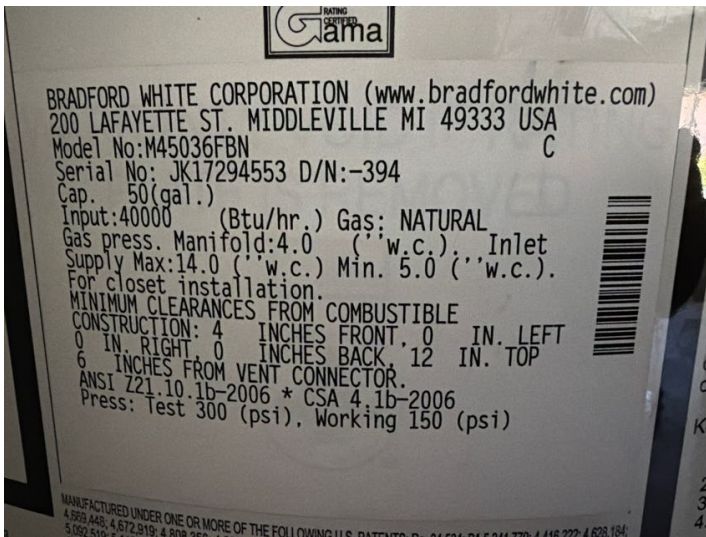
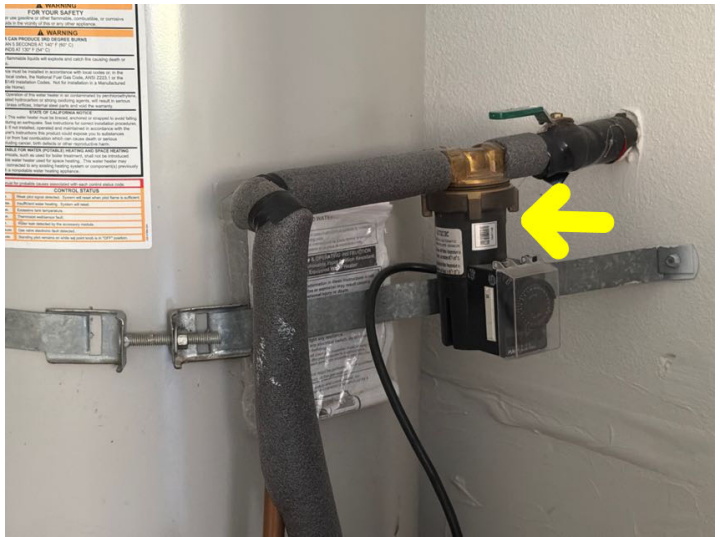
Hot water is provided by a 50 gallon gas water heater that is located in the garage.

The water heater system includes a recirculating pump that we do not have the expertise to evaluate. We recommend having the seller disclose its operation, maintenance history, and relevant documentation.

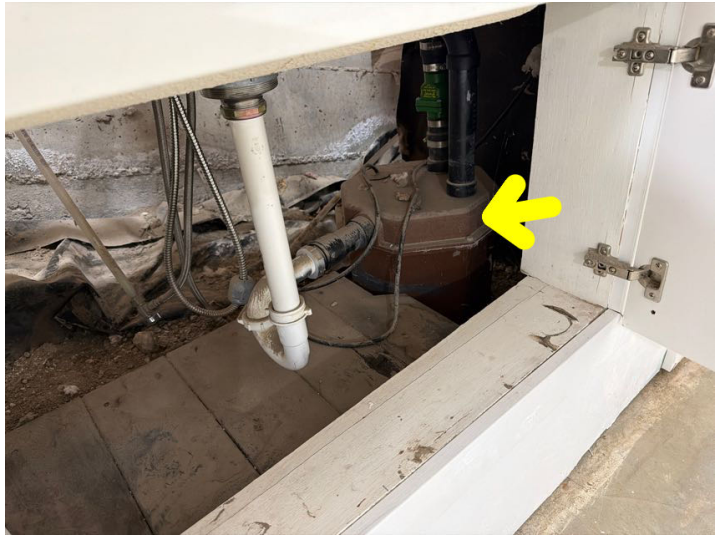
The waste and drainage system includes a sewage ejector system that we do not have the expertise to evaluate. Because part of the living space is located lower than the public street, a sewage ejector is used to pump waste to the street. You should ask the sellers about its operation and when it was last serviced.

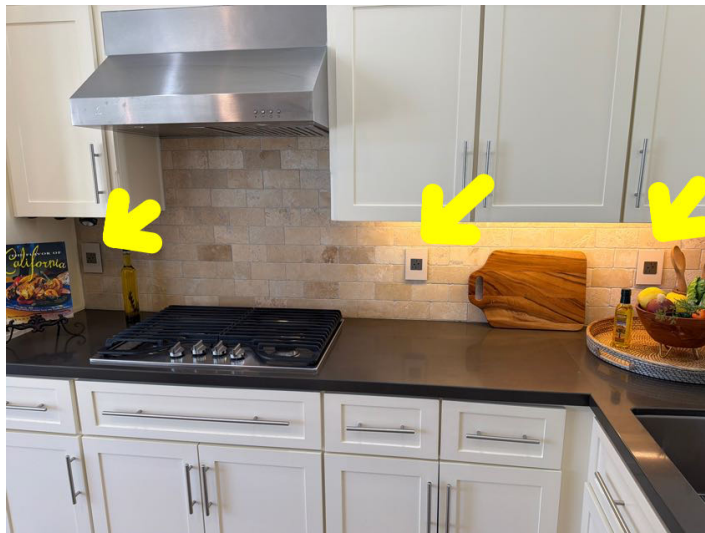
4.2. One or more of the outlets in the kitchen are not GFCI protected, which is mandated by current standards and is an important safety feature.

One or more of the outlets in the kitchen are not GFCI protected, which is mandated by current standards and is an important safety feature.

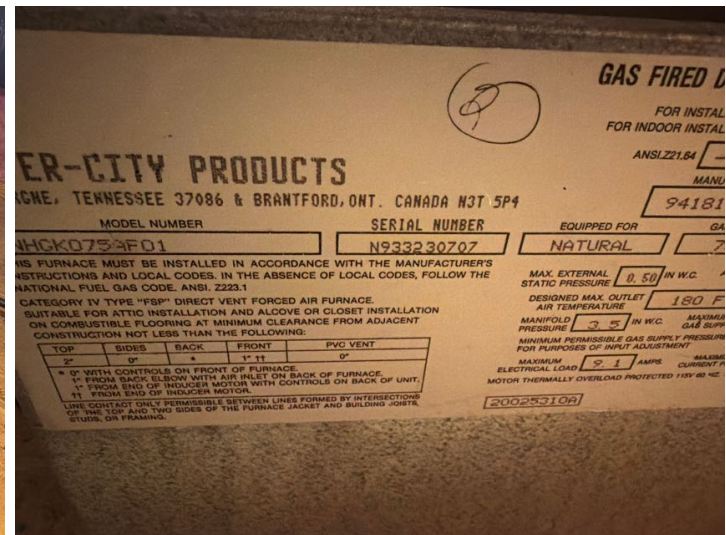
Serial Number N933230707 - Manufactured 1993

| Page 42 Item: 1 | Forced Air Furnace | 1.10. The furnace is functional. However, it is beyond the commonly accepted design life of twenty years, and will need to be monitored more closely for evidence of metal fatigue. We recommend that you have it serviced and evaluated by an HVAC contractor prior to the close of the inspection period. |

The furnace is functional. However, it is beyond the commonly accepted design life of twenty years, and will need to be monitored more closely for evidence of metal fatigue. We recommend that you have it serviced and evaluated by an HVAC contractor prior to the close of the inspection period.

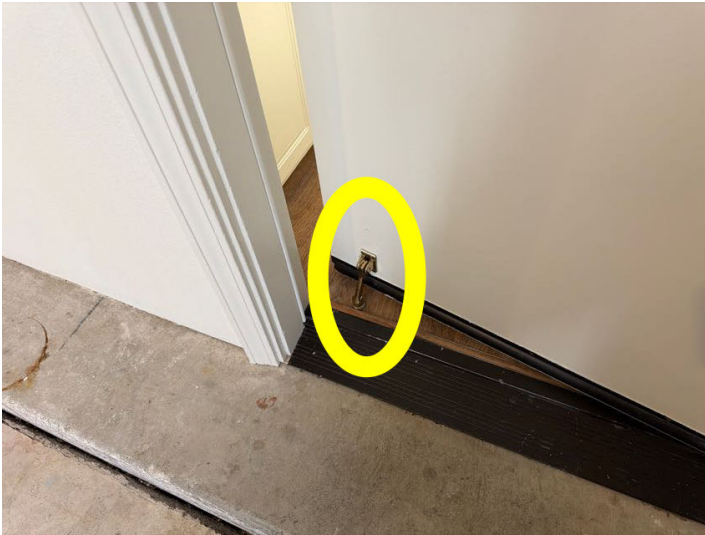
The fire rating of the house entry door has been nullified by the addition of a foot operated door stop, and you may wish to have the door stop removed for optimal safety.
