## Home Inspection Report

**123 Davis Drive  
Reedville, VA 22539**

**Date of Inspection: 09/03/2026**

Inspection No. 28188-12371

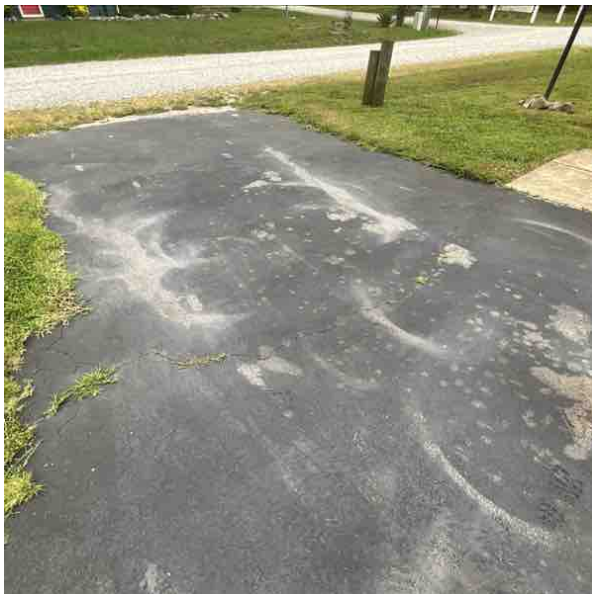
2.3.2 Cracks are visible on concrete driveway. Recommend sealing cracks as part of a normal maintenance routine to limit further deterioration over time.

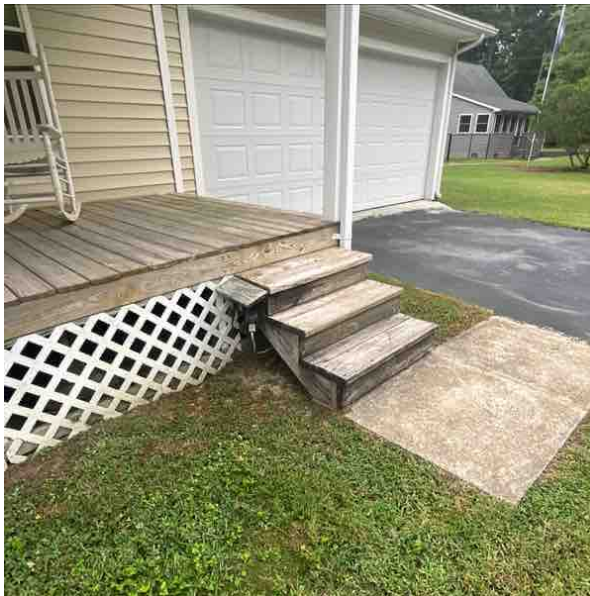
3.6.2 No handrail/guard is present on steps. Recommend installing handrail/guard as a safety upgrade.

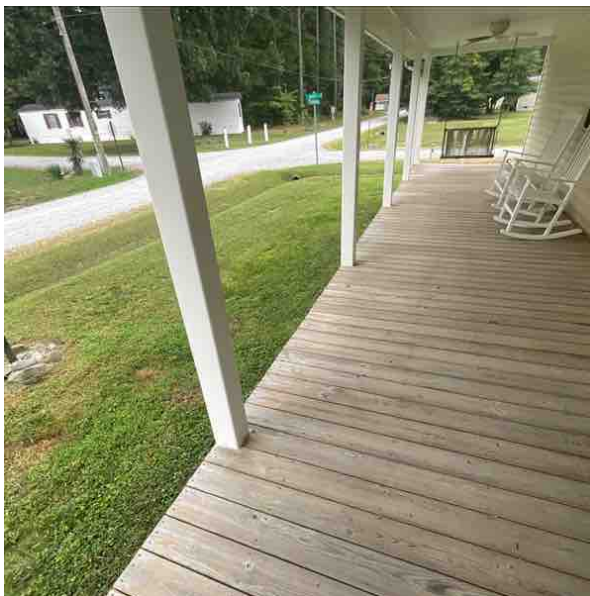
3.6.3 No rail/guard is installed at the front/sides of the porch (typical for a house this age). Recommend installing g an appropriate rail/guard as a safety upgrade.

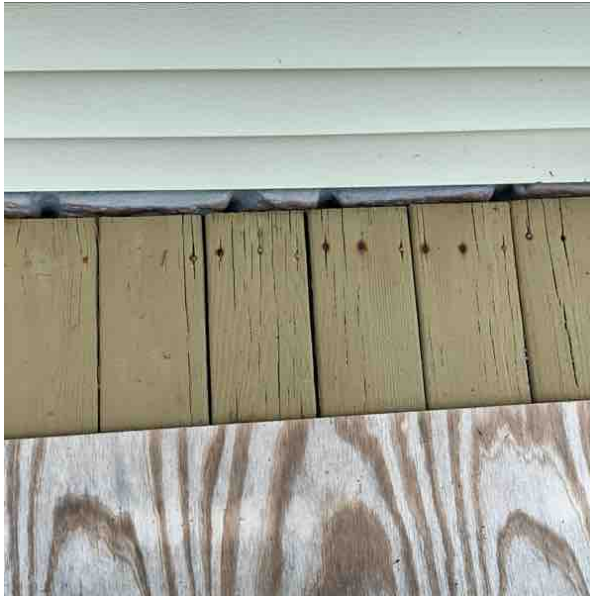
- moisture damage/deterioration is visible on several floorboards
- guardrails are loose

**3.7.1 Inspected****3.7.2 Recommend maintenance/repair of the deck by a qualified contractor:**

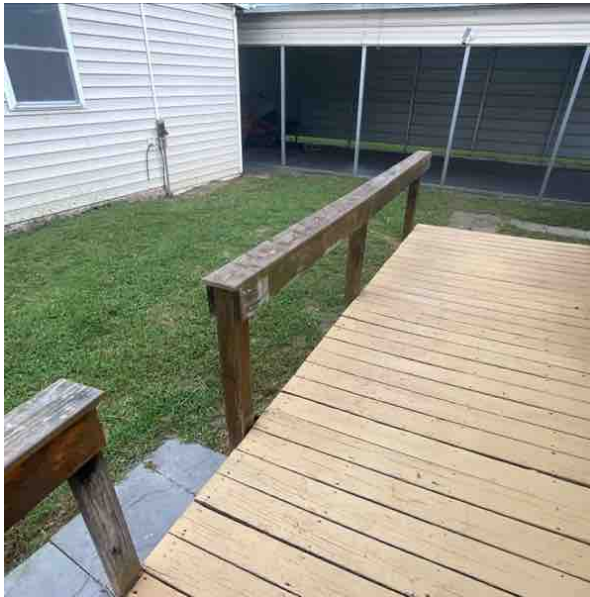
- height of guardrails at deck is considered low
- no balusters are present on guardrails

Recommend contacting a qualified deck builder to determine costs associated with improvements as a safety upgrade.

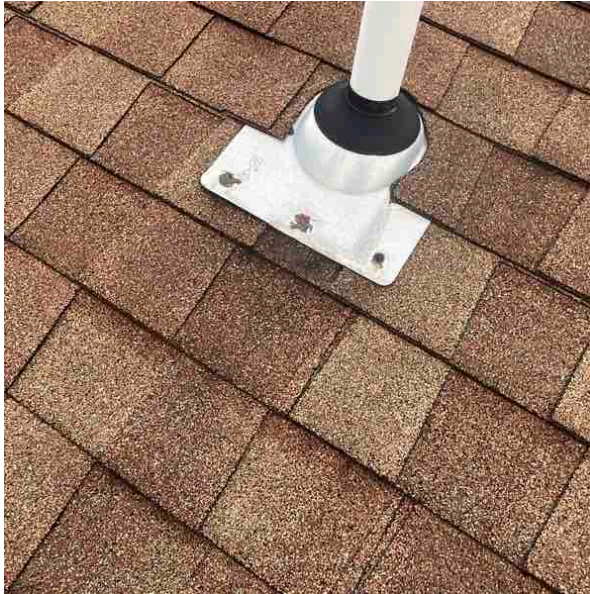
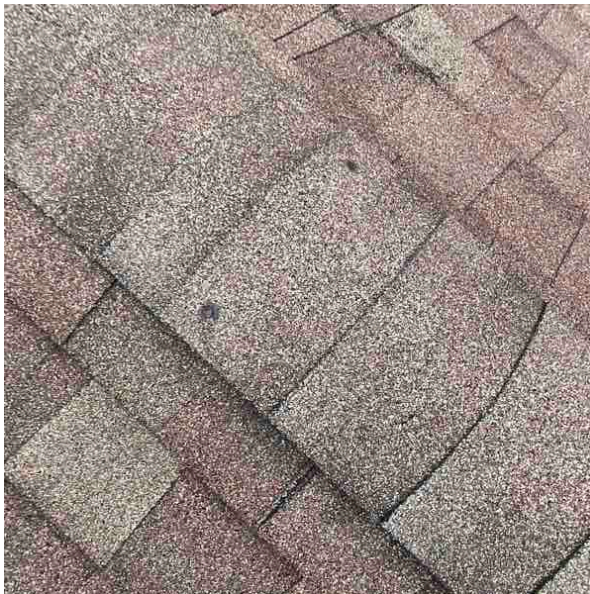
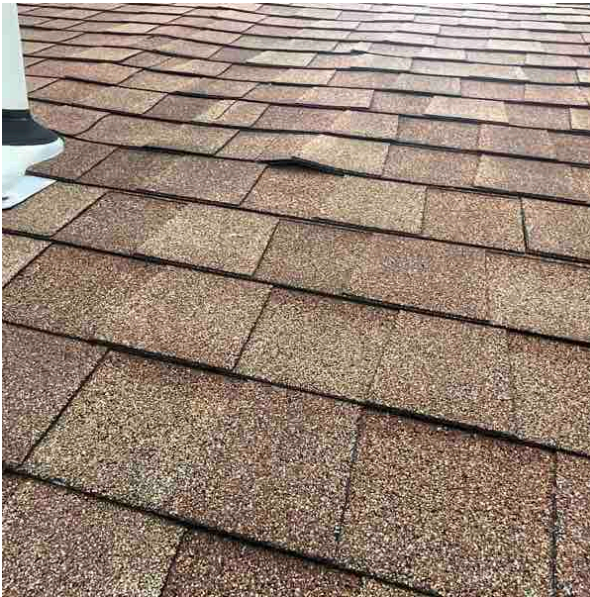
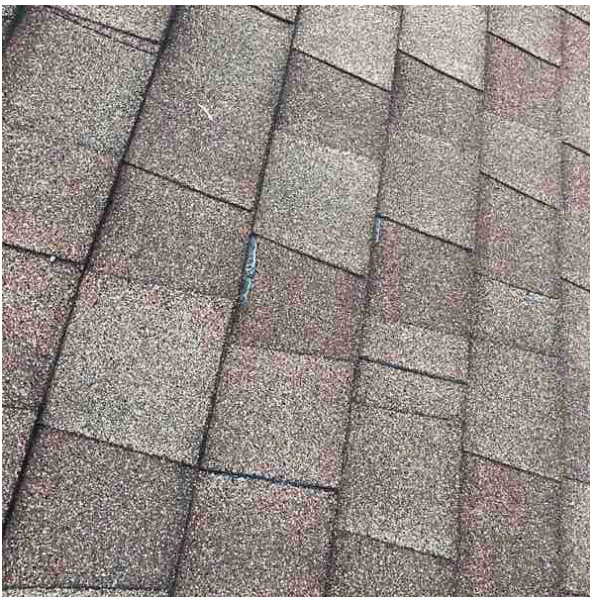
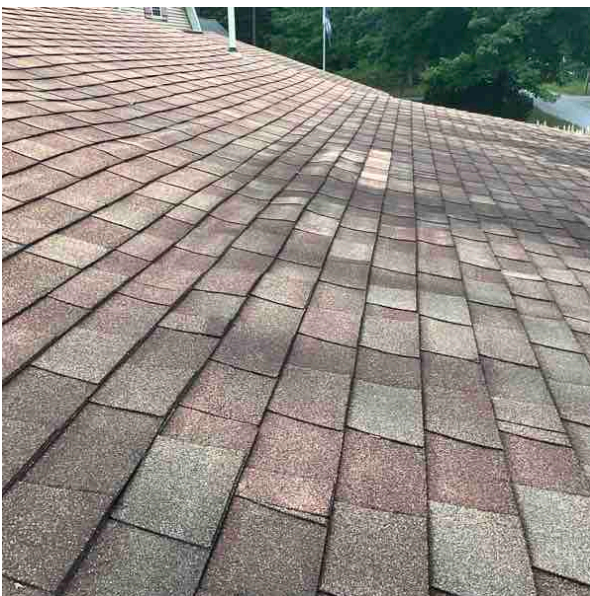
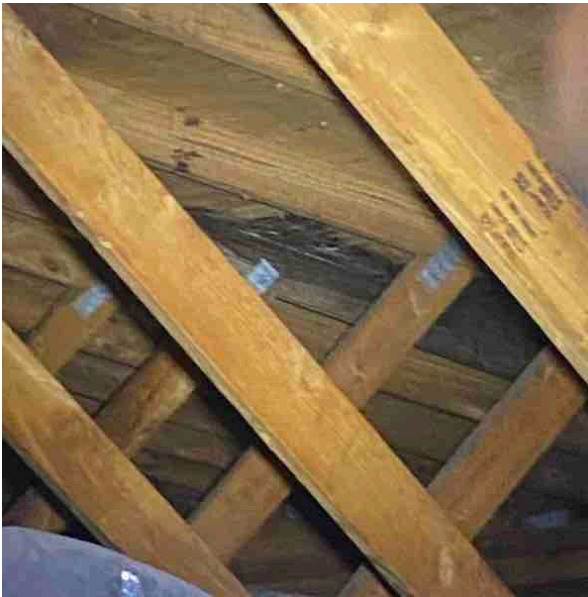
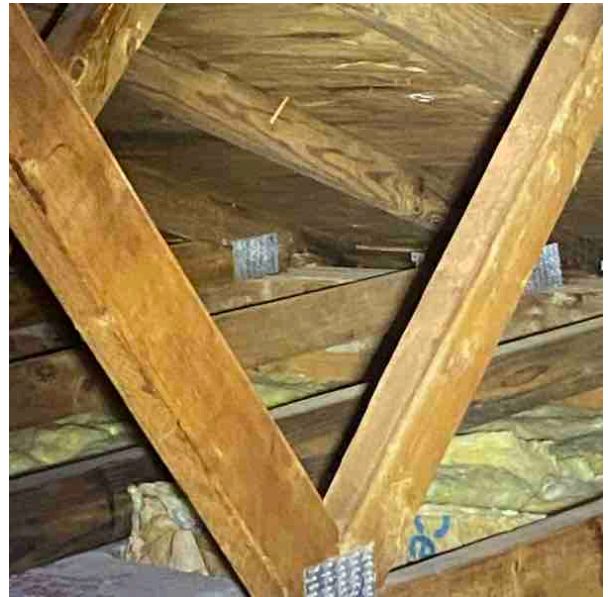
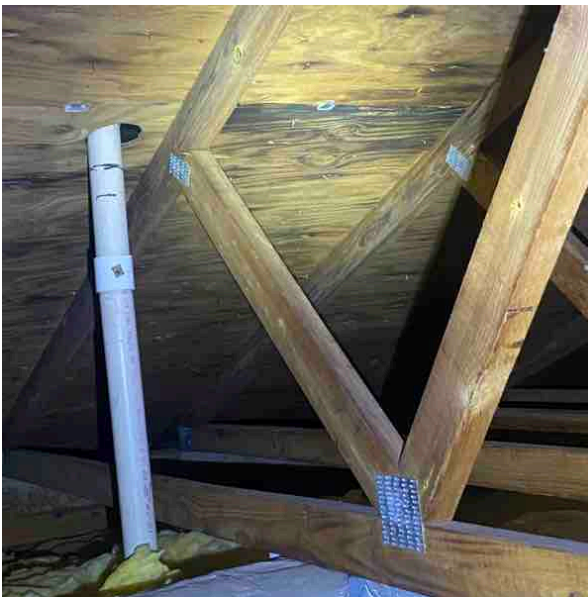
- sheathing is uneven at front roof section, previous repairs on shingles are visible
- Exposed fasteners are visible on flashings/ridge vents
- Wear/damaged shingles are present at several areas on the roof covering, roof appears to be at the end of its typical service life
- Determine if shingles are rated for the low slope section at front of house
- Raised shingle/nail pop is visible at front roof section
- Moisture stains are visible on the roof sheathing at several areas (visible in attic)

**4.3.2 Recommend maintenance and repair of the roof by a qualified roofing contractor:**

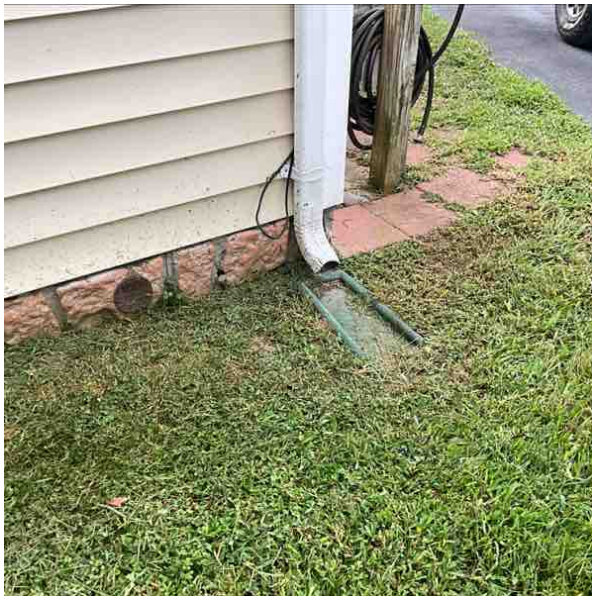
4.5.2 Downspout(s) discharge at or near the foundation. Recommend extending downspouts to discharge storm water away from the foundation.

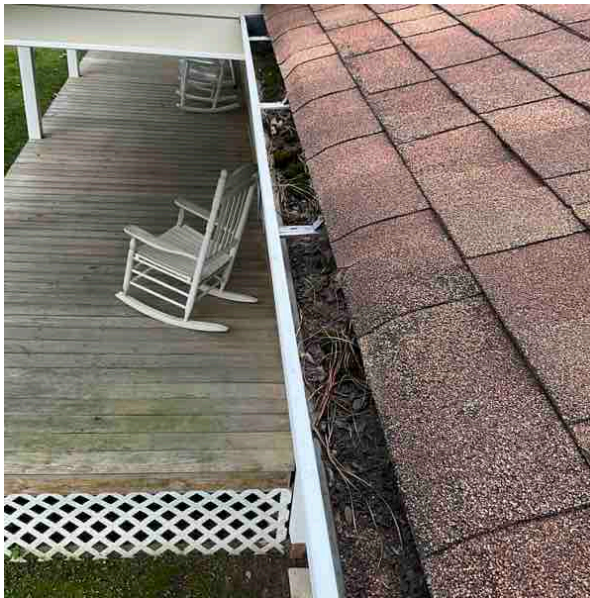
4.5.3 Gutters are full of debris, recommend maintenance\cleaning as needed for proper drainage of storm water from the roof.

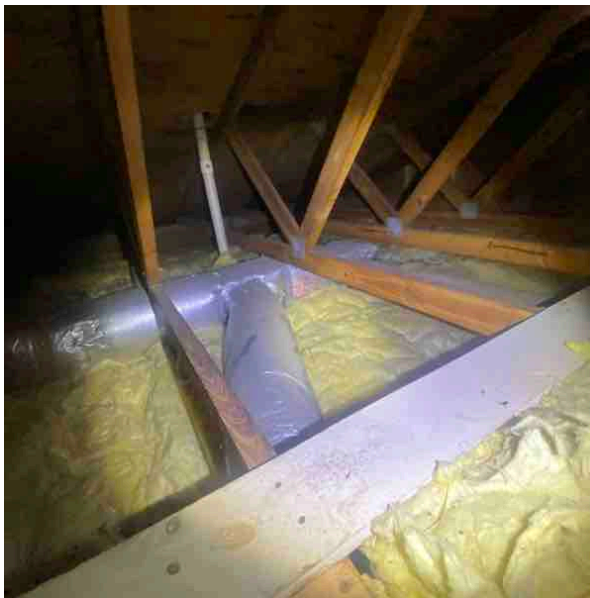
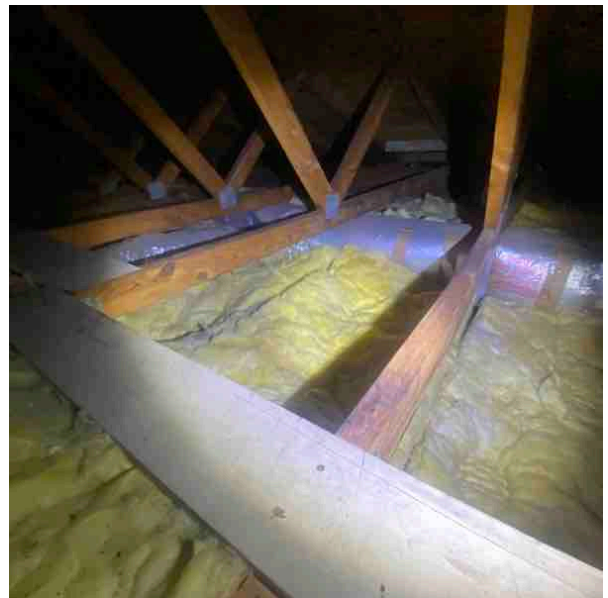
5.3.2 Insulation level is low/settled, which is typical for a house this age. Consider installing additional insulation to improve energy efficiency as an upgrade.

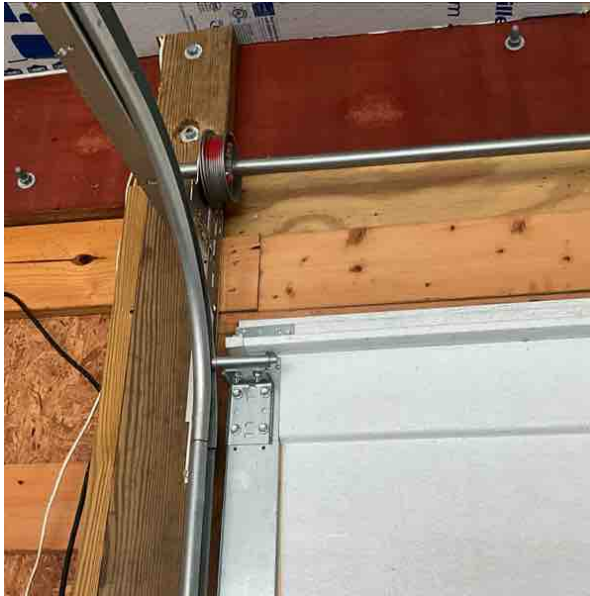
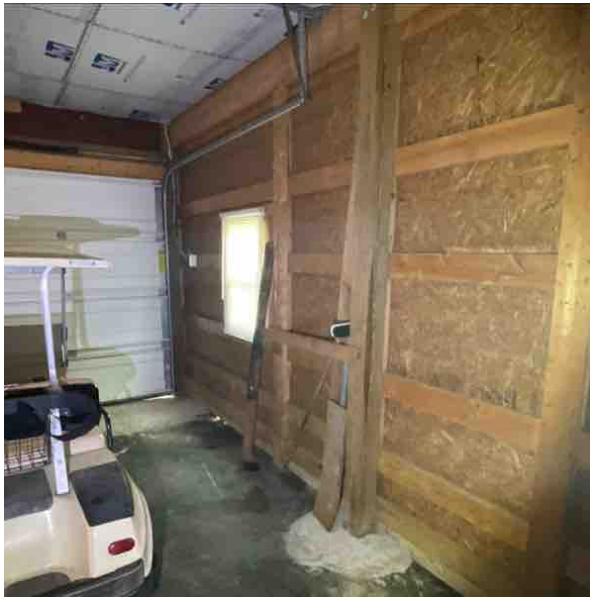
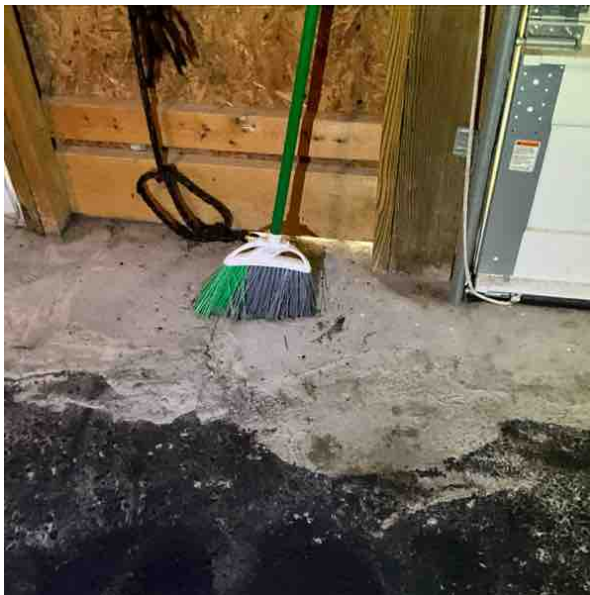
6.1.2 Garage has been constructed over existing asphalt driveway, which is unusual. Several construction practices are nonstandard (header has been cut/modified above garage door, windows do not appear to be properly supported, openings/gaps are visible around bottom of perimeter at several areas), recommend repair by a qualified contractor. If available obtain any permits that may be obtained from the local county records.

6.1.2 **Garage has been constructed over existing asphalt driveway, which is unusual. Several construction practices are nonstandard (header has been cut/modified above garage door, windows do not appear to be properly supported, openings/gaps are visible around bottom of perimeter at several areas), recommend repair by a qualified contractor. If available obtain any permits that may be obtained from the local county records.**

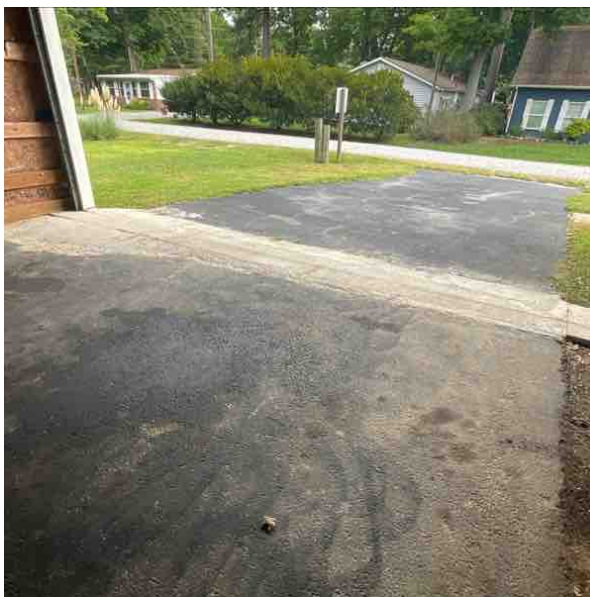
6.1.3 Concrete apron at garage is uneven, which may allow water to enter into the garage/crawlspace, recommend repair as needed.

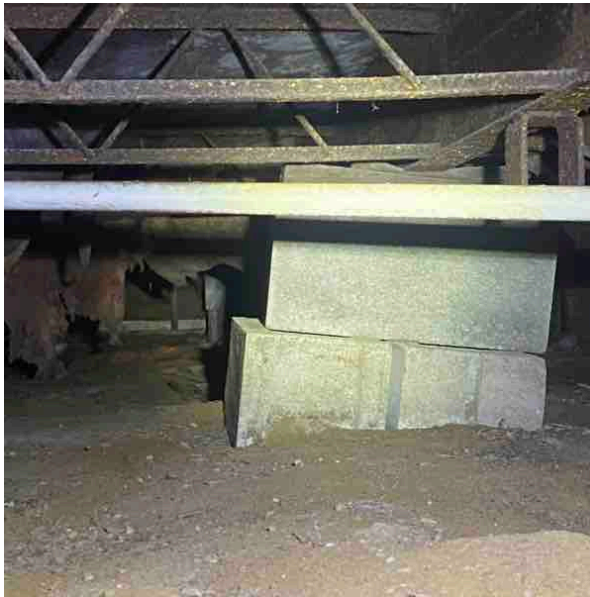
- masonry columns are leaning/out of plumb
- Wood shims are decompressed and do not appear to be effective, floors are uneven at house interior
- Rust/corrosion is visible on steel frame/chassis
- No hurricane tie downs were visible in the crawlspace
- Wood in contact with soil may increase risk of termite activity

**7.2.2 Recommend further evaluation of the foundation/crawlspace by a qualified contractor, the following was observed:**

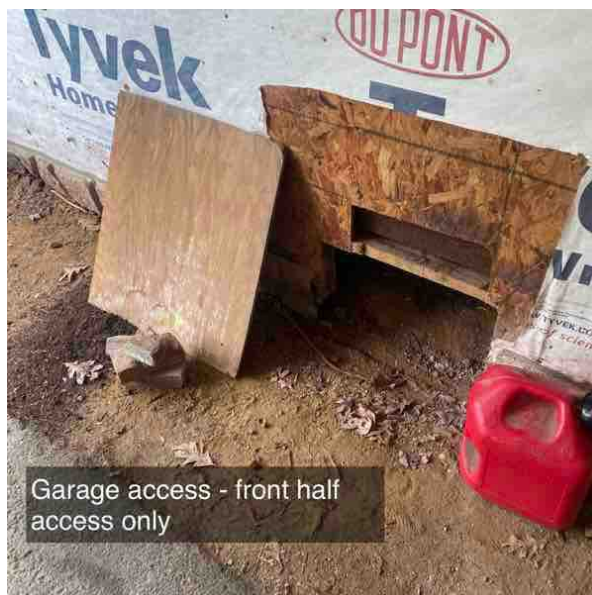
8.4.2 **Crawlspace access is present in the garage. The crawlspace was accessible along the front of the house. Beam sections along the middle of the house/low clearance restricted access to the rear half of the crawlspace. No accessible crawlspace access was present for the rear of the house. Recommend installing access for monitoring/service purposes.**

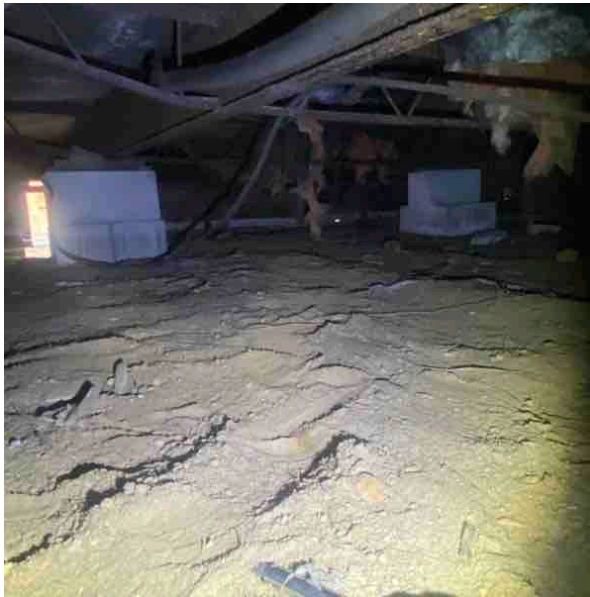
8.6.2 **Insulation is loose/damaged and has fallen in several areas throughout the crawlspace interior. Recommend removal of all insulation that has fallen, secure insulation where loose and install new insulation in areas where missing.**

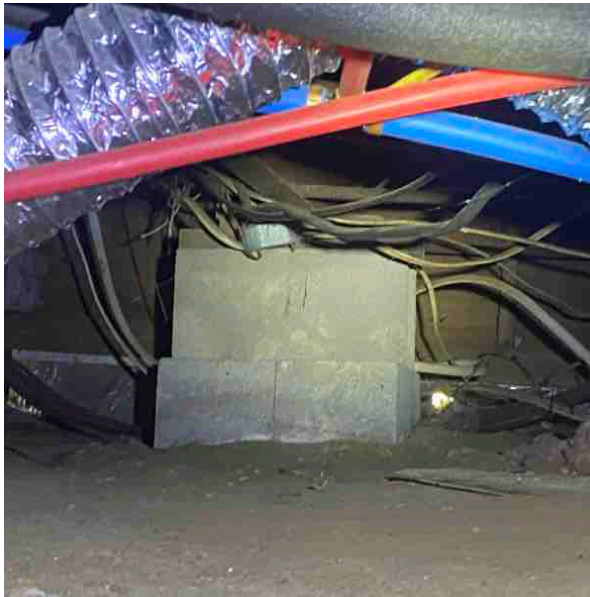
8.7.2 **Belly wrap/vapor barrier is damaged/fallen/missing at several areas throughout the crawlspace, recommend repair/replacement to seal all of the underside of the house to limit risk of moisture related issues over time.**

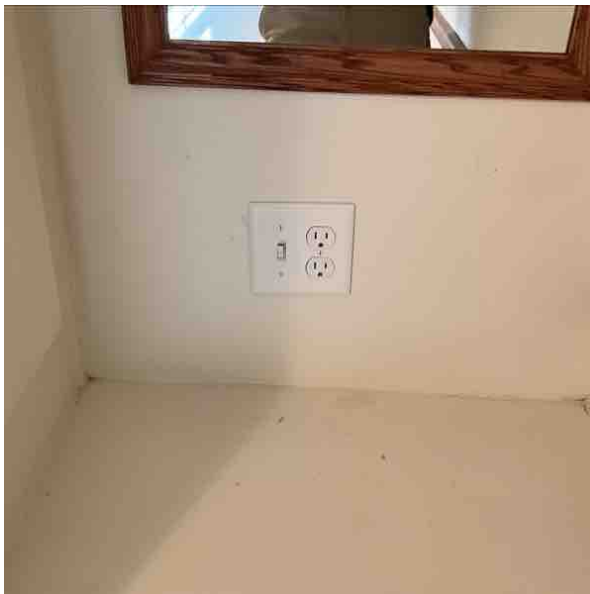
9.1.2 Light switch at office/den does not appear to have a function, recommend determining purpose for light switch.

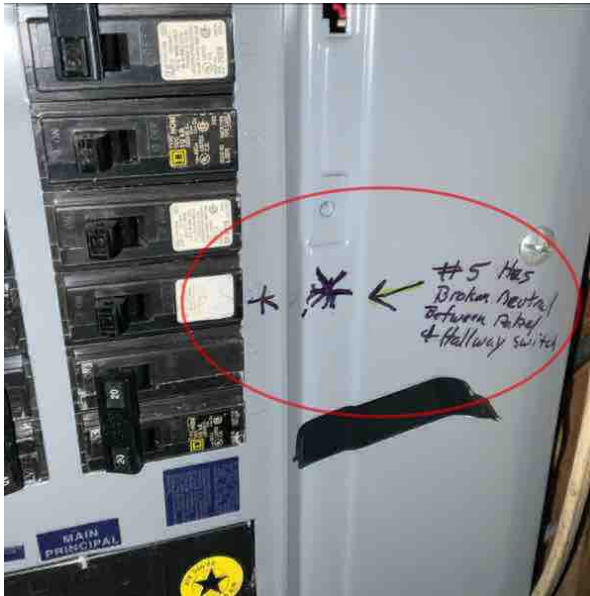
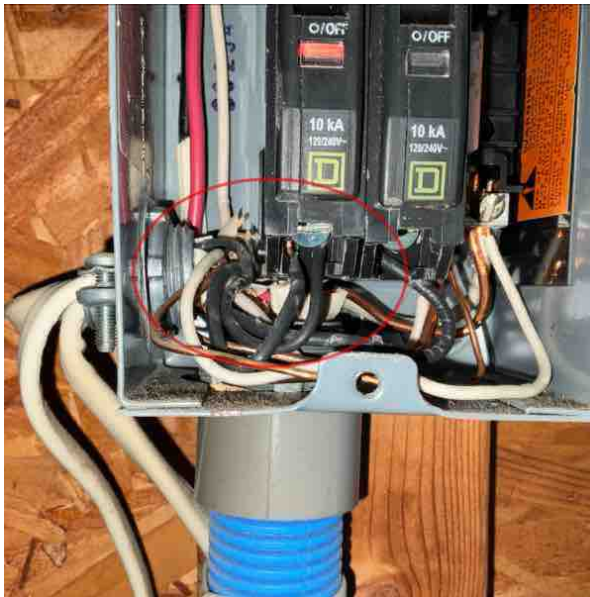
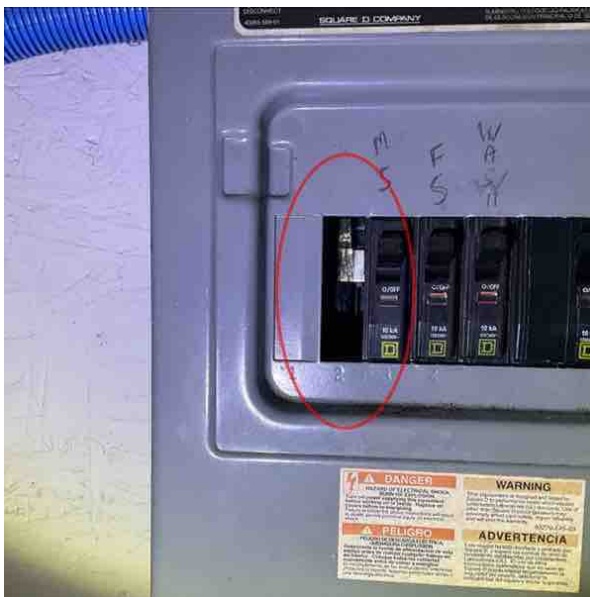
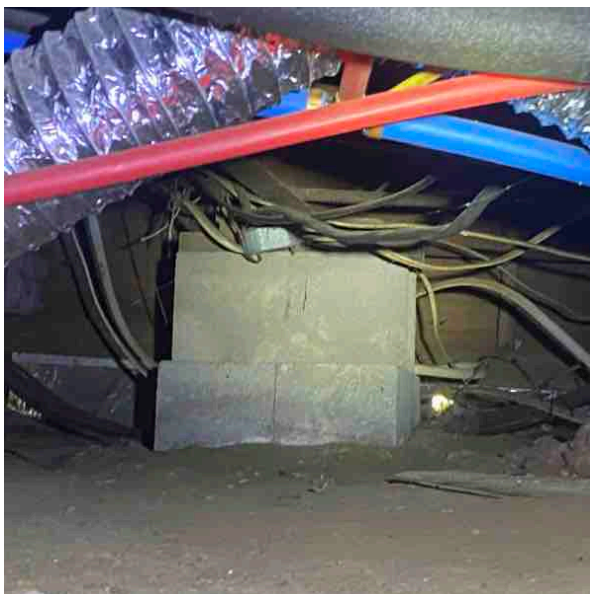
9.5.2 Recommend further evaluation of the electrical system by a qualified electrical contractor, the following items were observed:

- note states "breaker #5 has a broken neutral between panel and hallway switch"
- double tapping is present on breaker(s) at main electrical panel and detached garage sub panel
- junction box is not properly secured/installed at workshop and crawlspace (below office/den)
- Cover is missing on junction box at workshop
- Open wiring is visible above subpanel at workshop
- Block tab is missing on subpanel at work shop
- Sheathing has been excessively removed at outlet in workshop

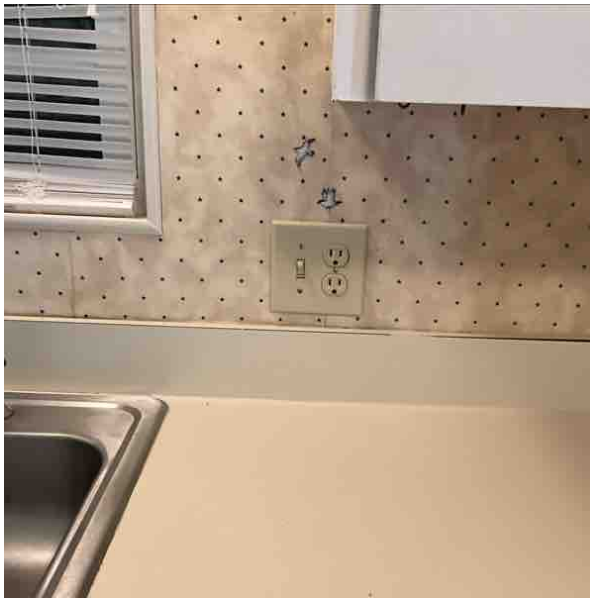
9.10.2 No GFCI protection is present on the receptacles in the garage\kitchen\hall bathroom, which is typical for a house this age. Recommend installation of GFCI protection as a safety upgrade.

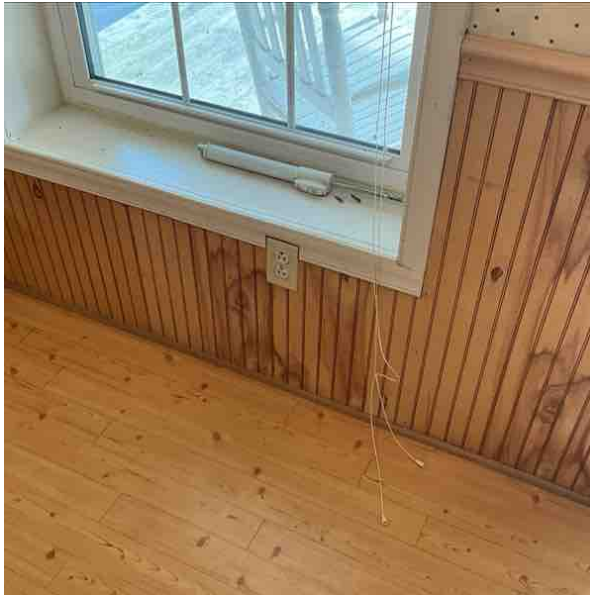
9.10.3 Wiring is reversed on kitchen receptacle below window, recommend repair to limit risk of shock.

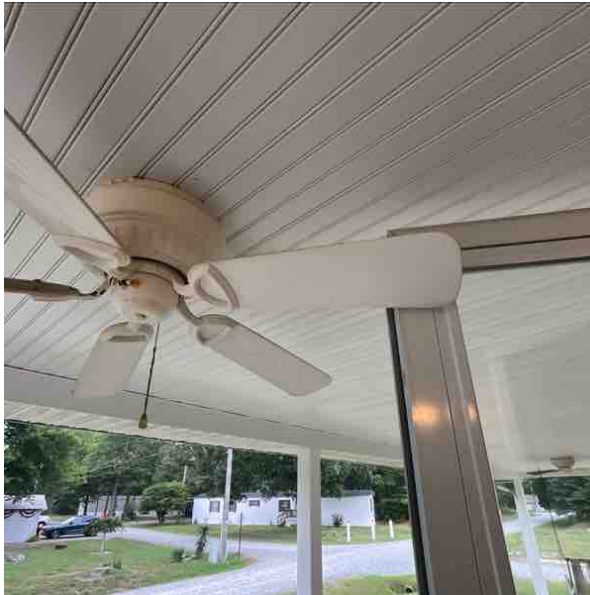
9.11.3 Ceiling fan does not have clearance to front storm door, recommend relocating to limit risk of damage.

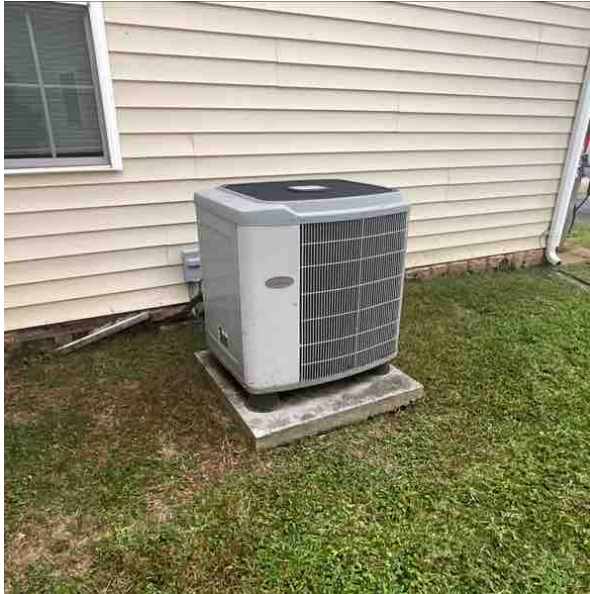
Refrigerant in use for the HVAC system is R-22. This refrigerant has ceased manufacture in 2020 which is likely to increase the cost of repairs. Recommend inquiring with a qualified HVAC contractor for estimate of costs associated with system replacement.

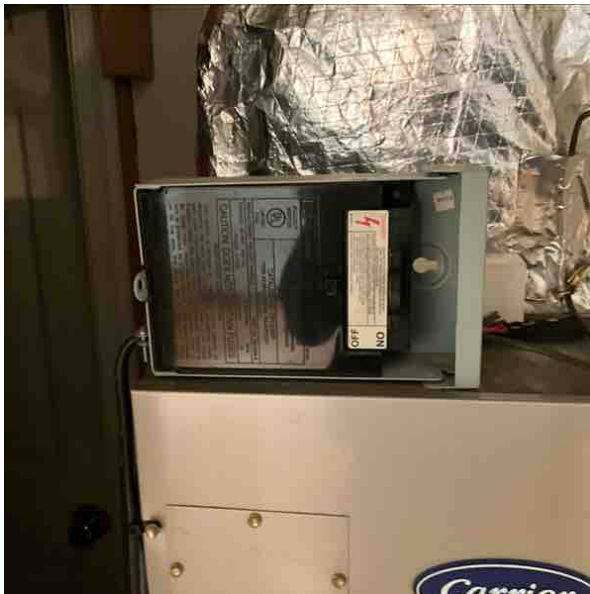
**10.5.3 Recommend inspection, service, and cleaning of the HVAC systems by a qualified HVAC contractor.**

- If the unit has been serviced recently, recommend acquiring the receipts for any work done and service records to determine maintenance history.
- cover is missing on disconnect above air handler

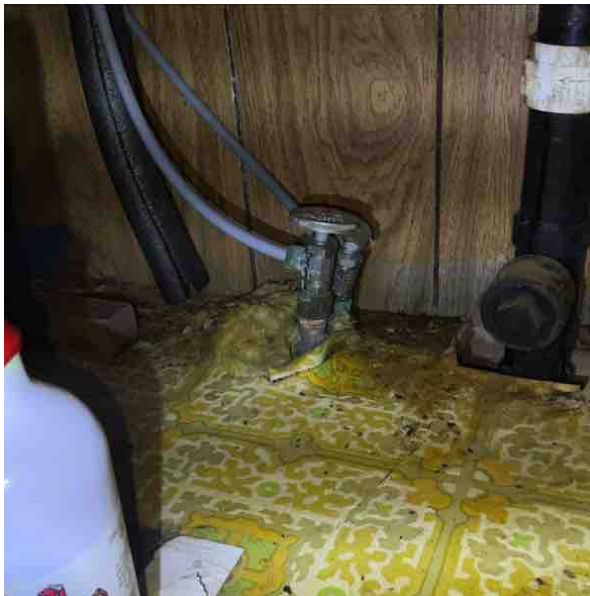
11.3.2 Older Homes - The water supply system is a combination of older galvanized pipe with some replacement copper and PEX pipes. This is typical of a house of this age. Galvanized supply piping eventually corrodes causing a drop in water flow & pressure. Recommend inquiring with a qualified plumbing contractor to determine costs associated with replacement of the pipe.

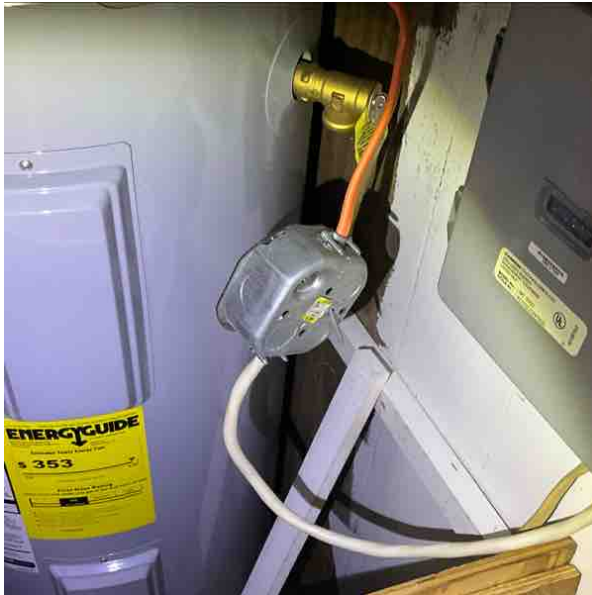
11.5.4 Junction box at water heater is not properly secured, recommend correction for safety.

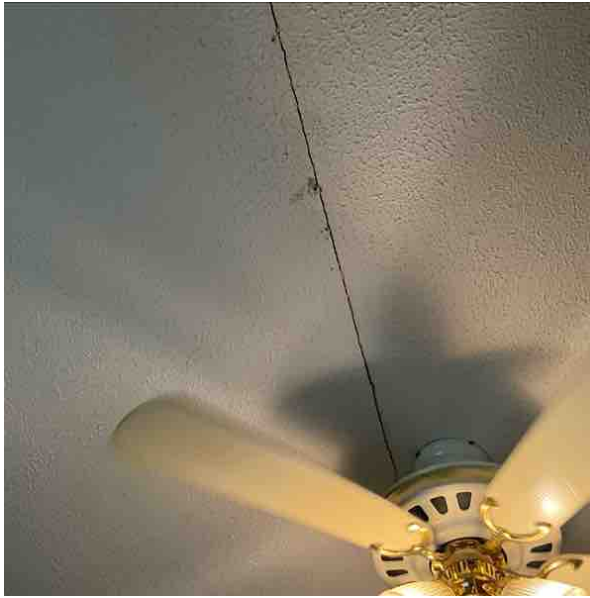
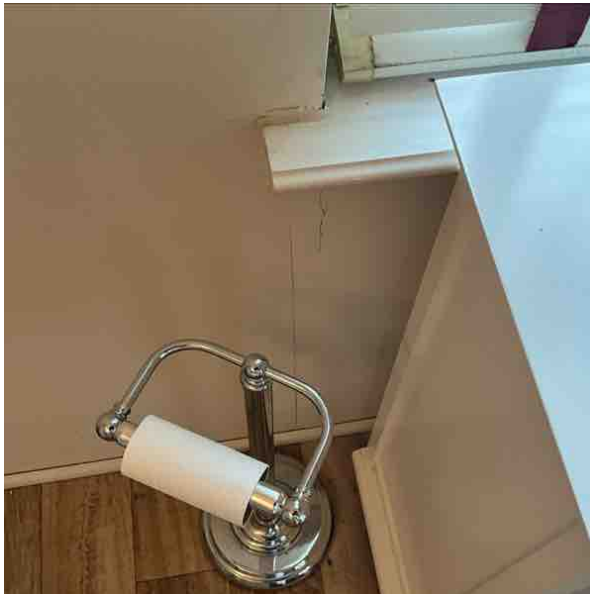
12.2.2 Minor cracks and open seams are visible on walls\ceilings at several areas on the house interior.  
Recommend repair.

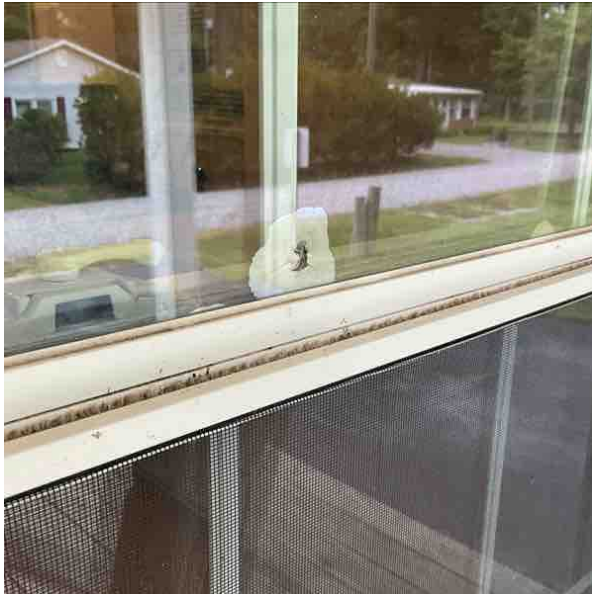
**12.3.2 Glass is damaged at the following areas:**

- kitchen window

Recommend replacement of damaged glass.

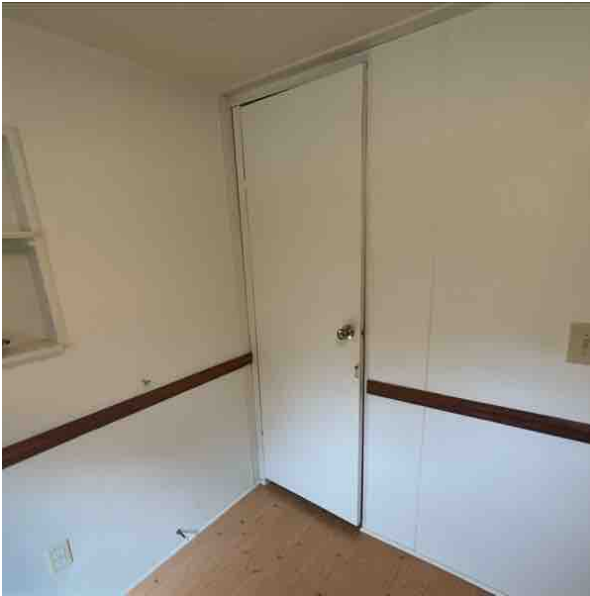
12.4.3 Door binds on the frame and is self closing at office/den. Adjust door to reduce binding on the frame and improve operation.

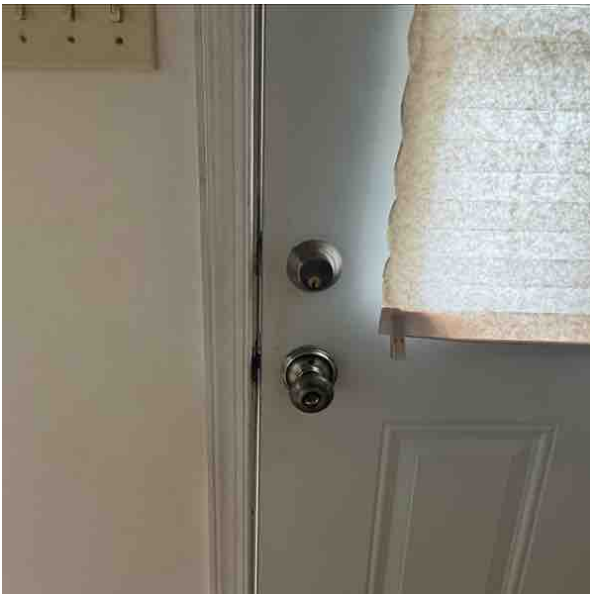
12.5.2 Keyed cylinder lock is in use on the patio door. Recommend replacement with a thumb latch lockset for easy operation in case of emergency.

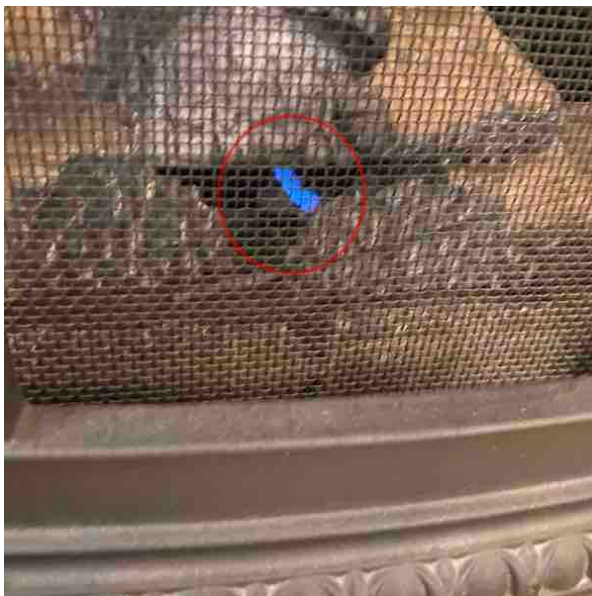
13.1.1 The pilot light was lit but would not stay ignited (unless knob remained pressed) to test operation, recommend maintenance/service to restore proper operation.

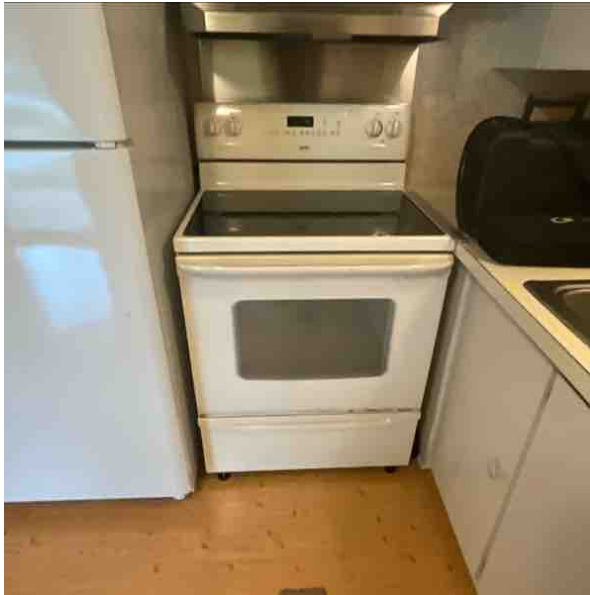
14.3.2 **No anti-tip bracket has been installed at the range unit. Recommend installation of appropriate anti-tip bracket as required to limit risk of tip over when the oven door is open.**

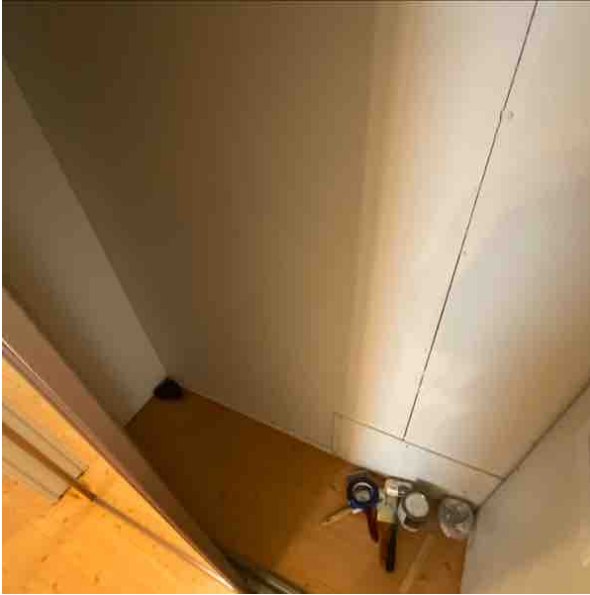
14.6.1 No dryer receptacle is present at laundry room for dryer connection.

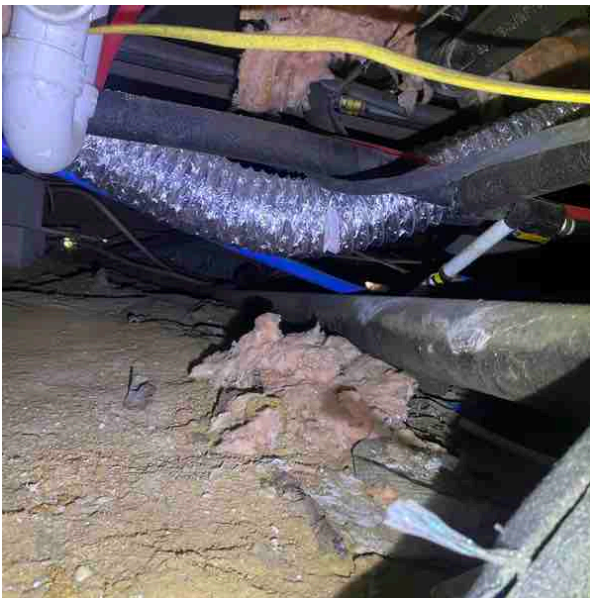
14.6.2 Flexible foil exhaust material is generally not recommended for use for dryer exhaust, recommend replacement with appropriate duct materials for safety.

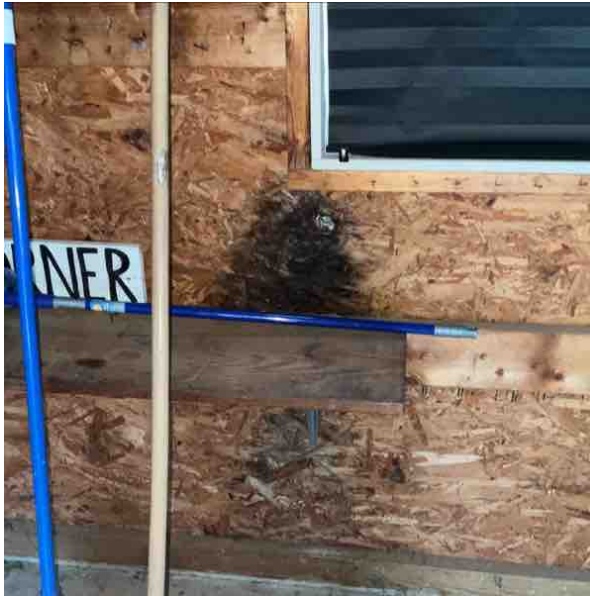
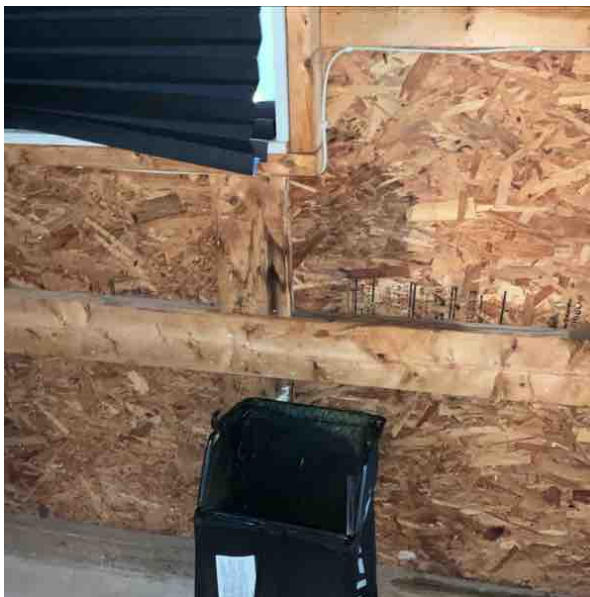
**15.1 Detached Building****15.1.1 Recommend further evaluation and repair of the detached garage by a qualified contractor:**

- moisture stains are visible at bottom corner of windows, which indicates water entry
- Determine if windows are properly framed/installed
- Damage is visible on detached garage door

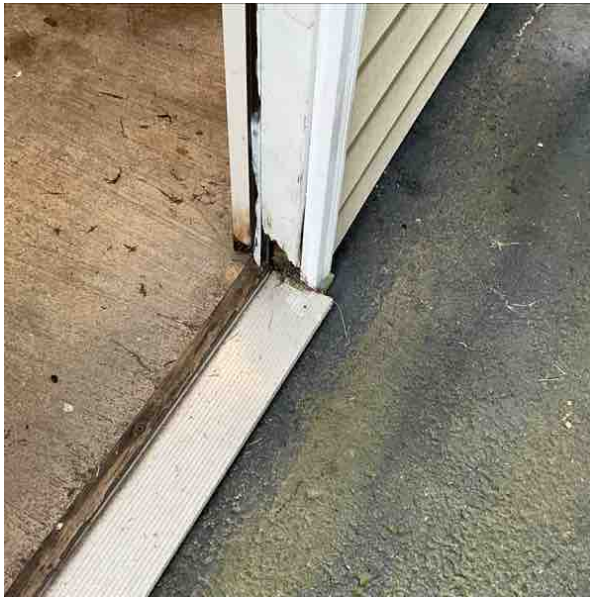
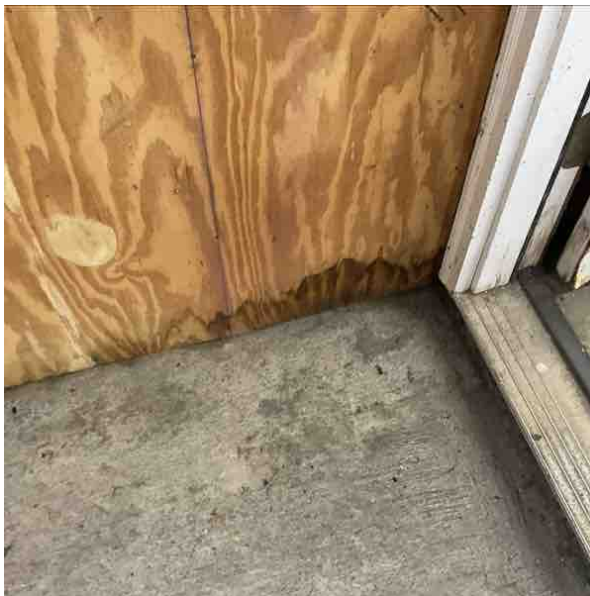
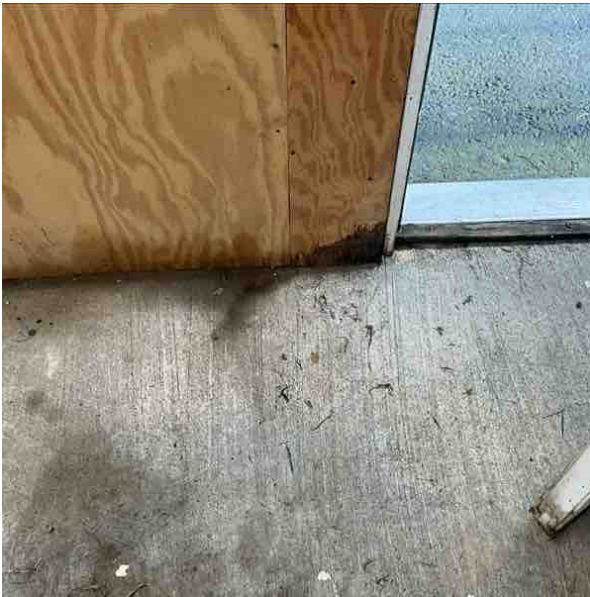
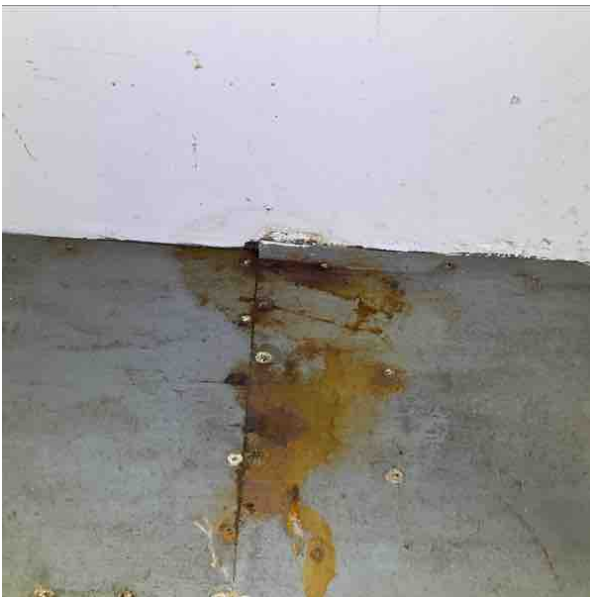
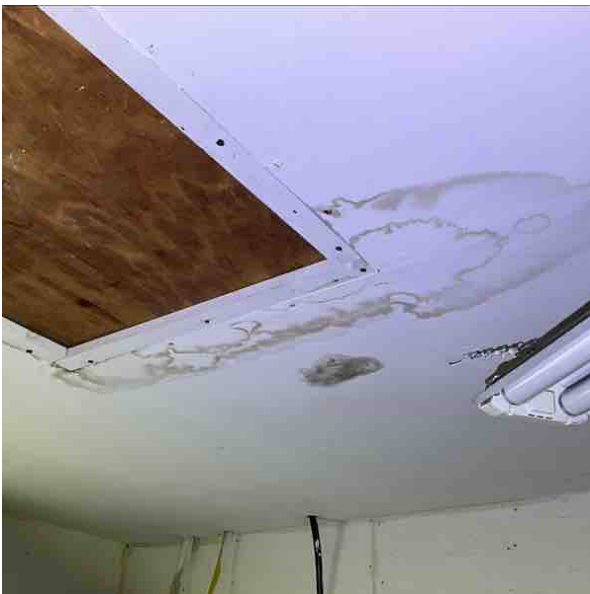
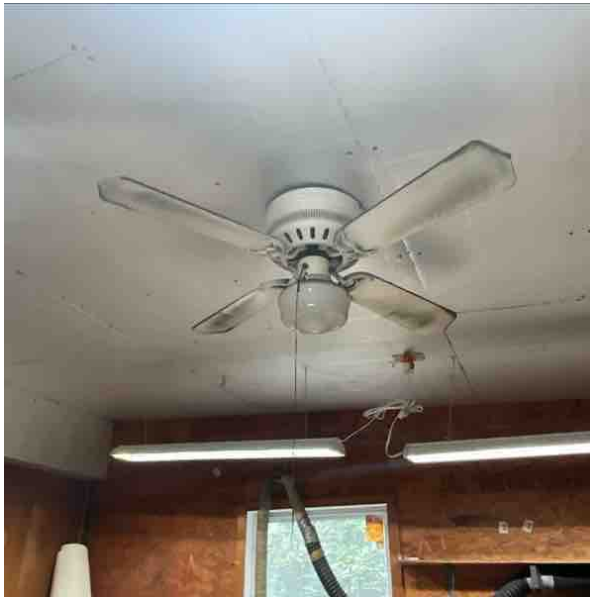
15.1.2 Recommend further evaluation and repair of the workshop by a qualified contractor, the following items were observed:

- moisture damage is visible on the frame/trim/core at the entry door
- Moisture stains are visible on walls/floors/ceiling at several areas throughout the building, which indicates water entry
- Door hardware is missing
- Ceiling fan/light is inoperable at room 2
