# ***Cornerstone Inspection***

## **Property Inspection Report**

***2191 Canvasback Pl, Avila Beach, CA 93424***  
***Inspection prepared for: Jim Efird Jeanette Efird***  
***Real Estate Agent: Holly Tibbles - Coast & County Brokers***

***Date of Inspection: 10/3/2026 Time: 9:00 AM***

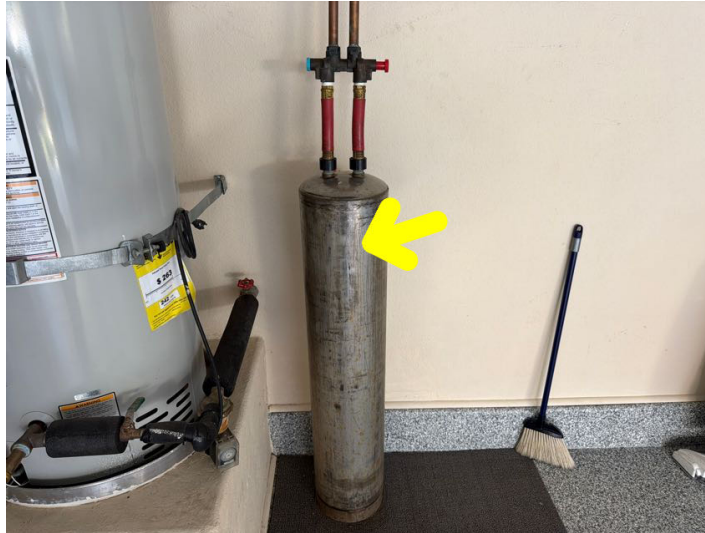
A water softener is present that we do not have the expertise to evaluate except for visible leaks. We recommend having the seller disclose its operation, maintenance history, and relevant documentation.

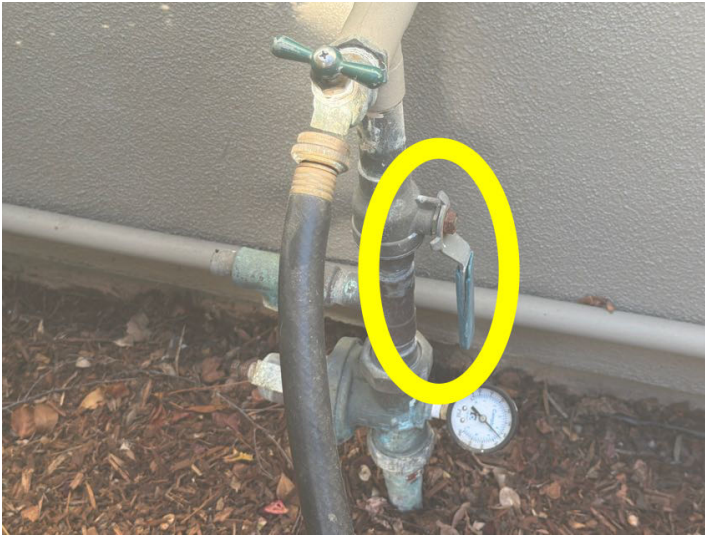
The main water shut-off valve is located at the left side of the home, unit, or building.

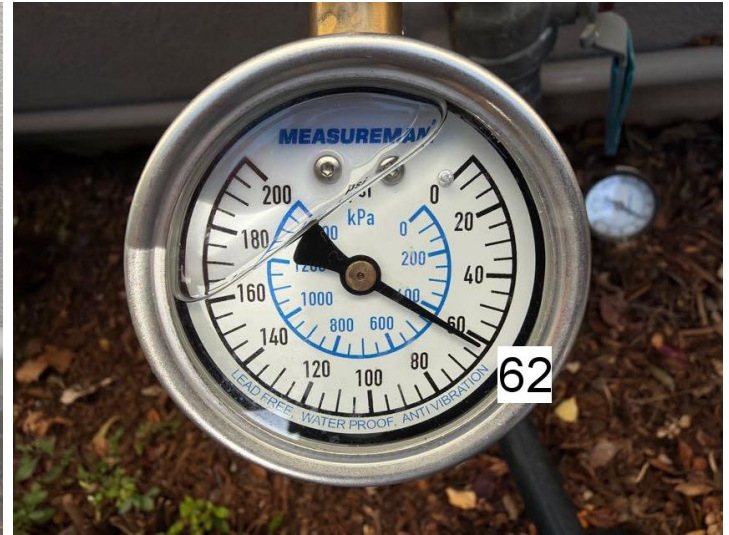
A functional pressure regulator is in place on the plumbing system.

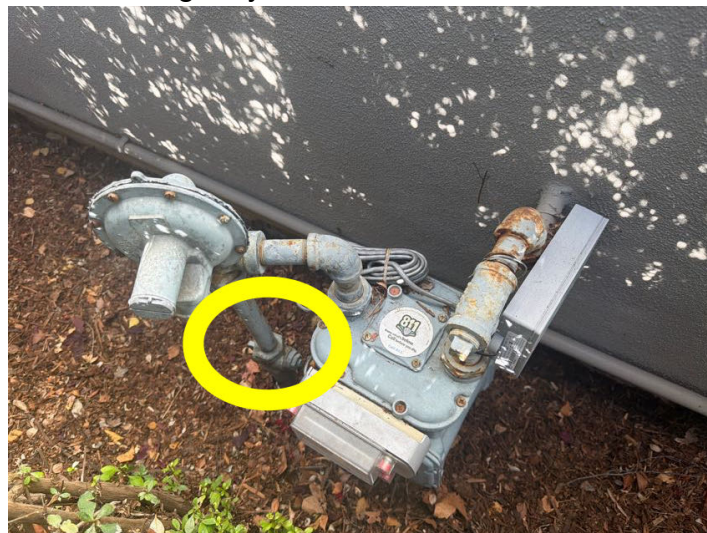
The gas main shut-off is located on the left side of the home, unit or building.

3.4. We recommend that a wrench, designed to fit the gas shut-off valve, be located on or adjacent to the gas meter to facilitate an emergency shut off.

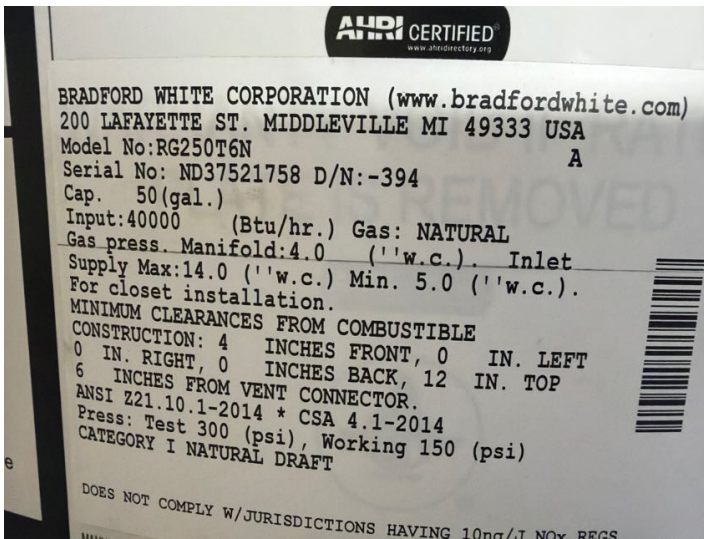
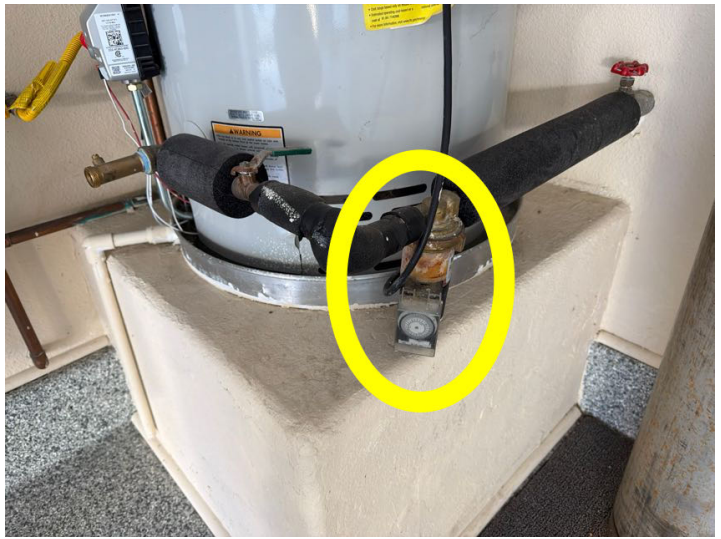
Hot water is provided by a 50 gallon gas water heater that is located in the garage.

The water heater system includes a recirculating pump that we do not have the expertise to evaluate. We recommend having the seller disclose its operation, maintenance history, and relevant documentation.

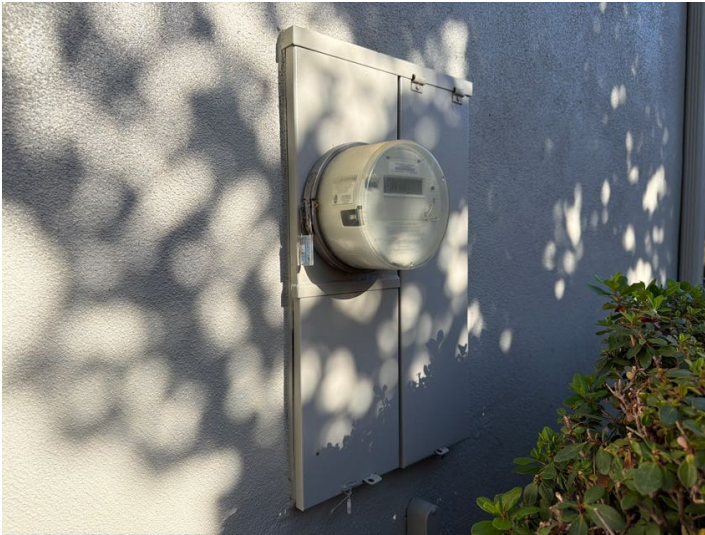
The residence is served by a 100 amp main electrical panel, located at the left side of the home or unit.

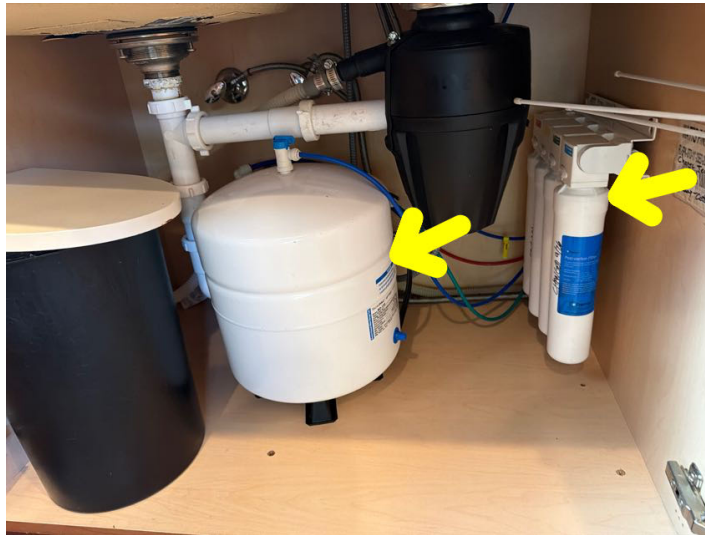
The kitchen includes a reverse osmosis or water filtration system that we do not have the expertise to evaluate. We recommend the seller demonstrate its operation and maintenance history and procedures.

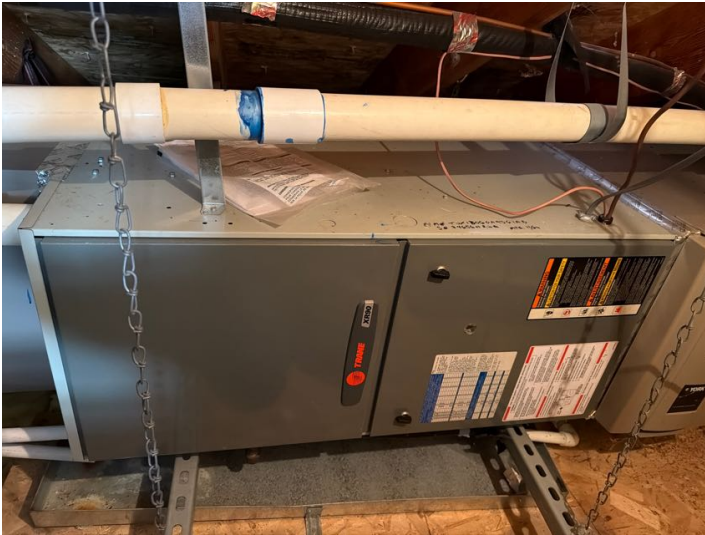
Central heat is provided by a forced-air furnace that is located in the attic.

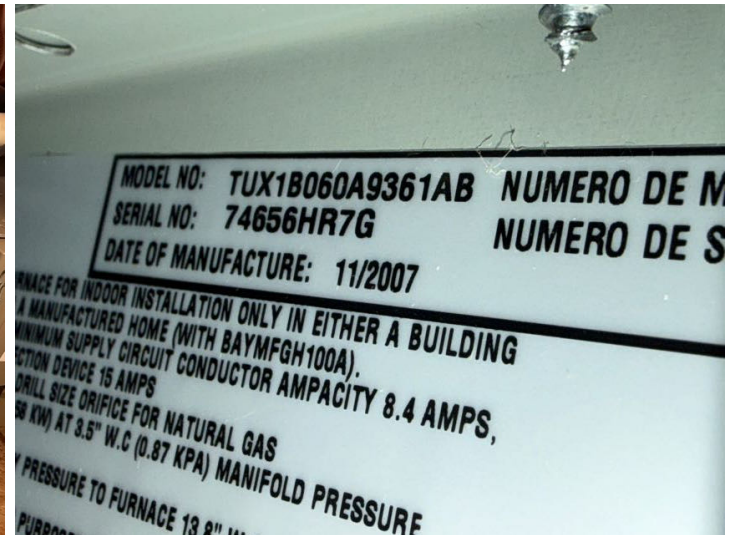
Serial Number 74656HR7G - Manufactured 2007

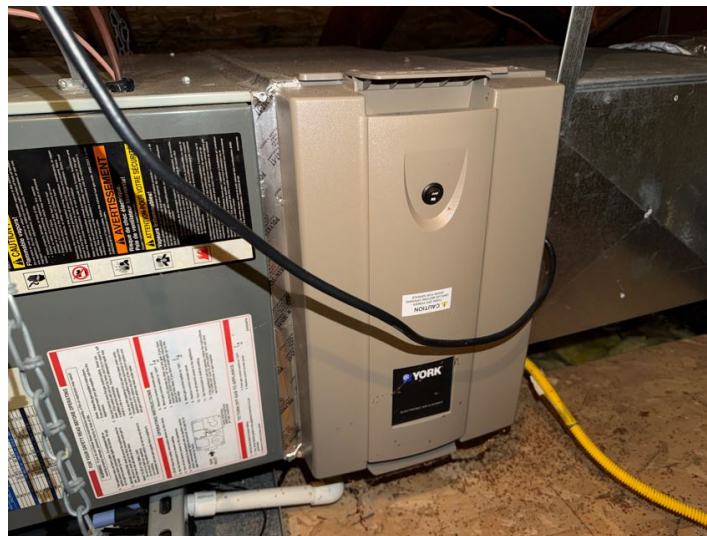
The furnace filter is a specialized unit that should be explained and demonstrated by the seller or the HVAC company that performed the installation. You may also refer to the operation manual that was supplied with the unit.

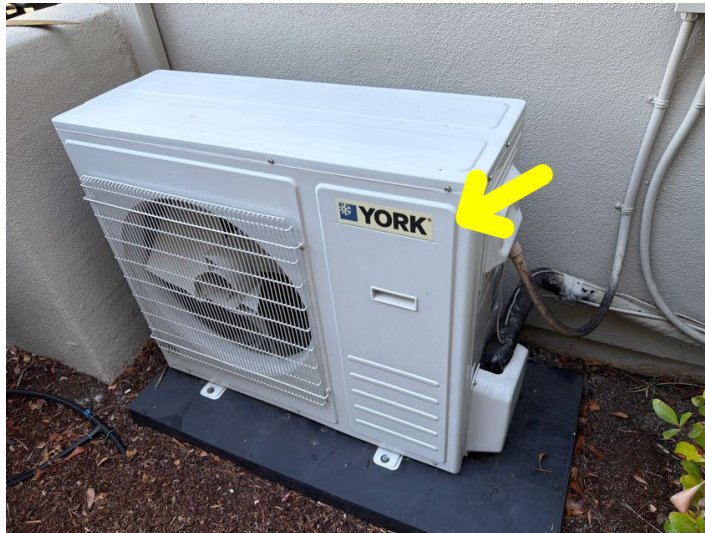
Central heat and air-conditioning are provided by a single split-system, consisting of a furnace with an evaporator coil that is located in the attic and a condensing coil that is located on the exterior.
