# Alliance Inspections

**Report:** Sample Report 1585 E. Anywhere Dr. Altadena, CA

## Confidential Inspection Report

**1585 E. Anywhere Dr.  
Altadena, CA 91001**

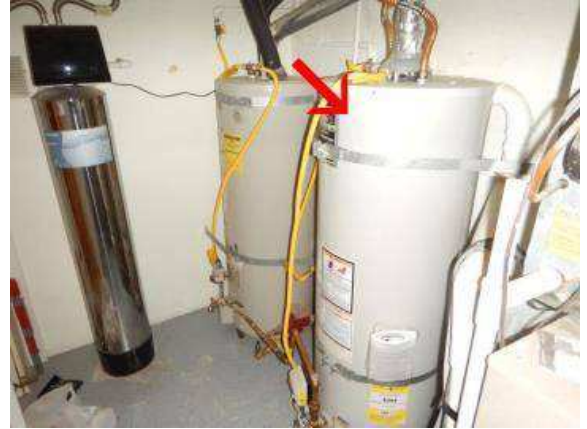
Basement.

**Attention Needed**-Gurgle sound heard when boiling. Indicating rust within tank.

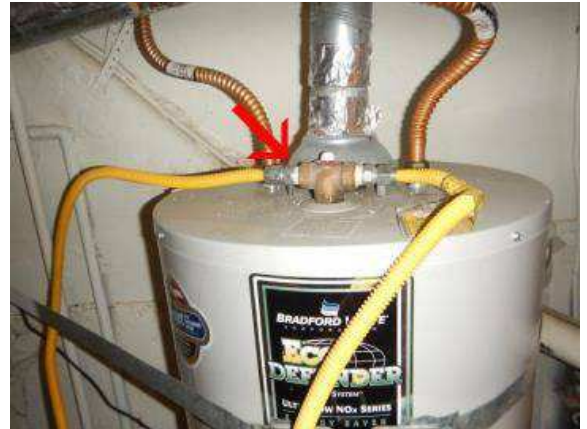
**Attention Needed-** WATTS 210 valve was installed. When a water heater is in a basement or below grade, it may not be possible to arrange for a gravity drain of the T&P valve. A WATTS 210 valve can be installed. The temperature-sensing bulb of the valve goes in the upper portion of the tank and the gas piping runs through the valve. The Watts 210 shuts off the gas if the temperature is excessive. In addition, a separate water-pressure relief valve must be installed in the piping and must drain by gravity to an approved location. Check with the local Administrative Authority having jurisdiction to see if this method is accepted in your area.

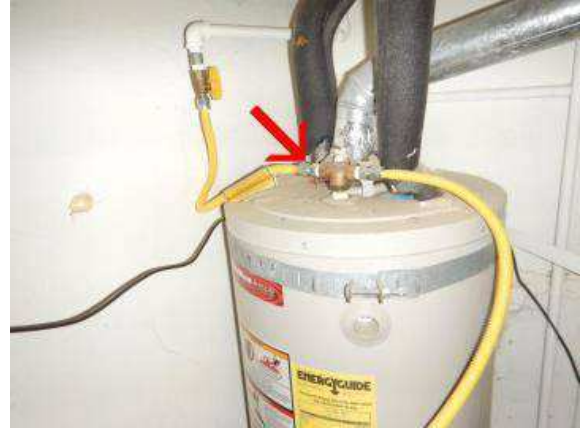
**Attention Needed-** WATTS 210 valve was installed. When a water heater is in a basement or below grade, it may not be possible to arrange for a gravity drain of the T&P valve. A WATTS 210 valve can be installed. The temperature-sensing bulb of the valve goes in the upper portion of the tank and the gas piping runs through the valve. The Watts 210 shuts off the gas if the temperature is excessive. In addition, a separate water-pressure relief valve must be installed in the piping and must drain by gravity to an approved location. Check with the local Administrative Authority having jurisdiction to see if this method is accepted in your area.

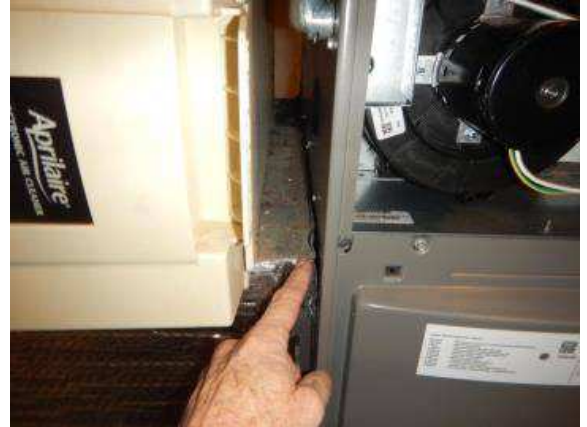
**Unsatisfactory-** The side of the furnace compartment is not sealed properly therefore combustion air is mixing with condition air. This is a potential carbon monoxide hazard and in need of immediate corrections.

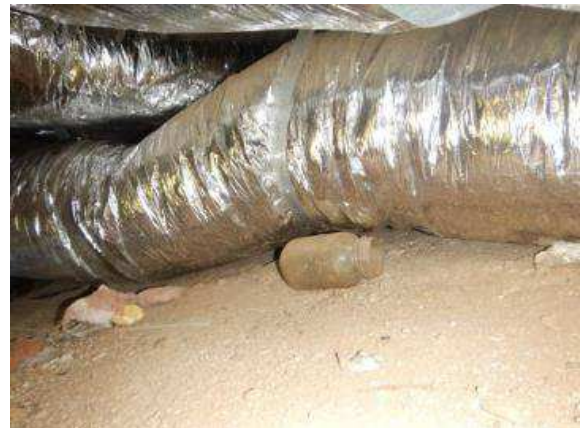
**Attention Needed** -Some portions of the duct work in crawl space are resting onto the soil. To prevent decay ducts should be at least 4 inches above grade.

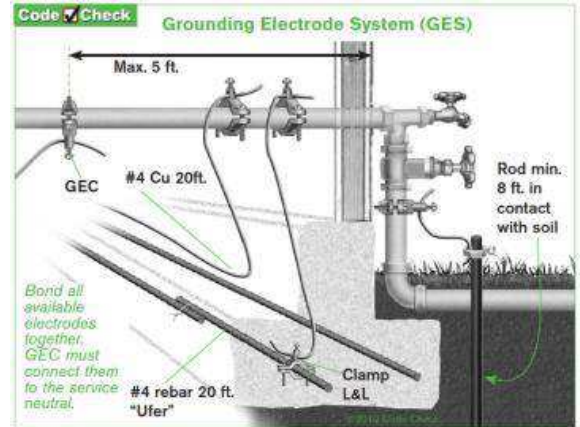
**Attention Needed** - The ground wire attached to the water pipe is on the house side of the meter. There is no jumper installed to allow the removal of the meter and yet allow the electrical ground to be intact. A jumper is needed.

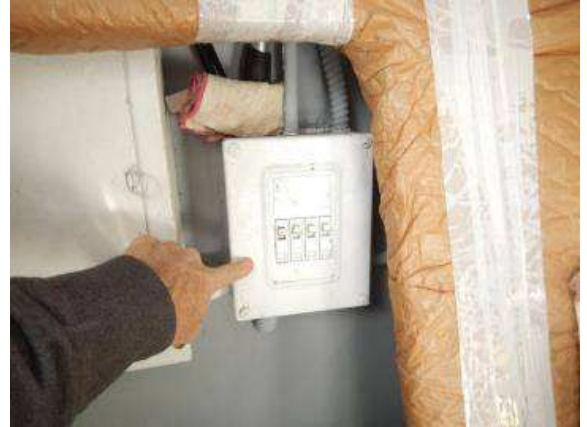
**Unsatisfactory**-Breakers were painted over thus compromising intended function. Replacement should be achieved.

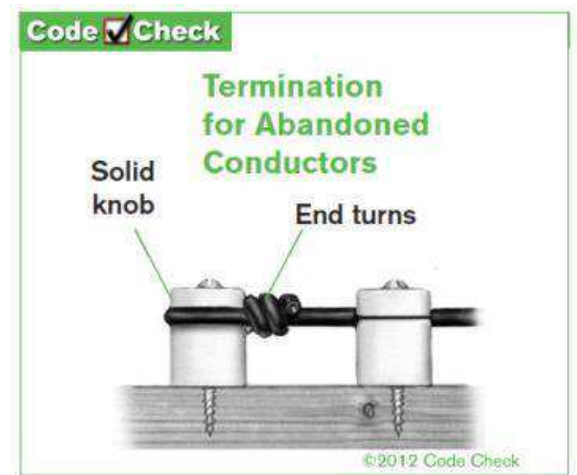
The wiring is a combination of copper conductors Knob & Tube, nonmetallic type and some portions are within conduit.

**Unsatisfactory**- The existing knob and tube wiring is covered with structural insulation. This can be a hazardous condition. Action is required to remove the insulation. The existing knob and tube wiring also shows unallowed splices or routing and damage. Further investigation is needed. Repair or replacement may be necessary.

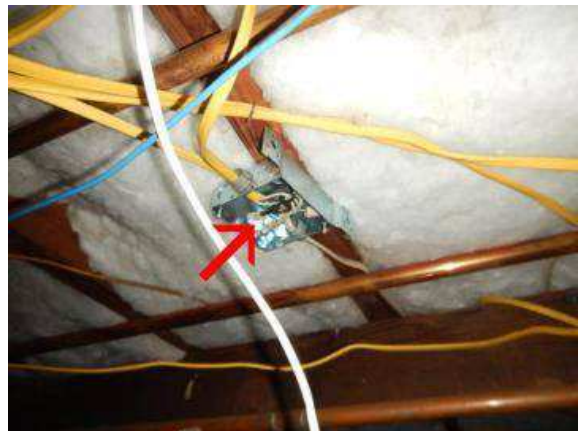
Open electrical boxes viewed in areas, such as, in the crawl space.

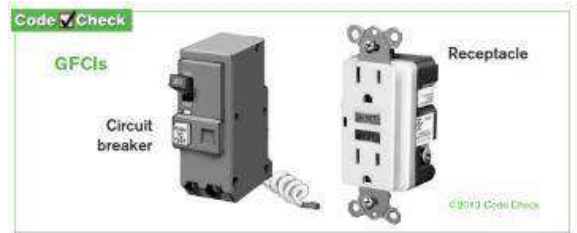
At some areas - This structure is partially protected by using Ground Fault Circuit Interrupt outlets at some of these locations: outlets within 6' of a water source, any outside outlets, in the garage, and any outlets in an unfinished basement. Any areas not protected should be considered for installation as they afford inexpensive protection from electrical shock.

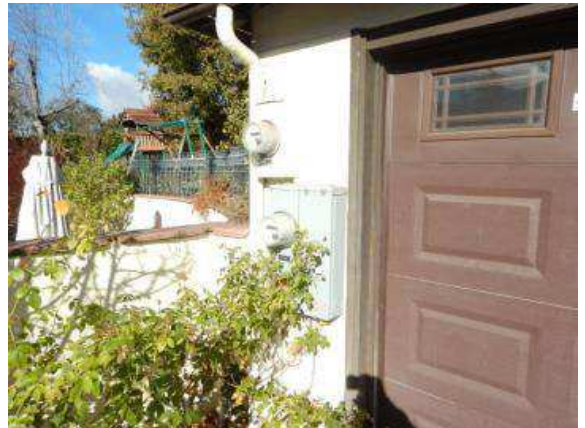
For some reason there are two meters. One does not appear to be in use.

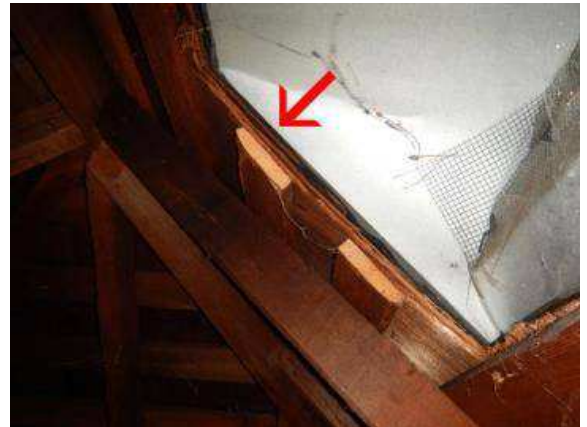
The roof covering on the main structure appears to have more than two layers. This is over the allowable. When the covering needs to be replaced, it will be necessary to peel all layers off before reinstalling.

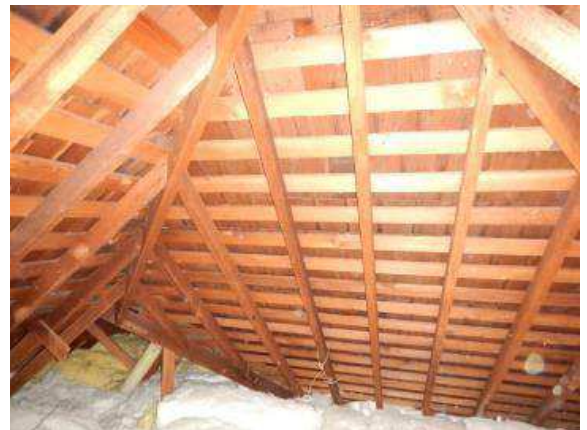
There currently is not any roof sheathing installed. When it comes time to reroof the structure, all existing roof material will need to be removed and plywood sheathing will need to be installed.

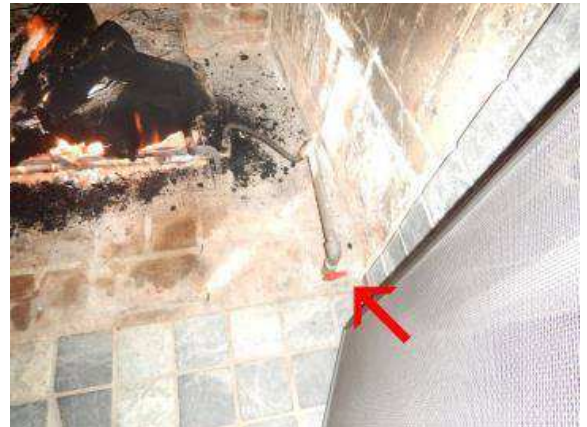
NOTE: Gas valves are not permitted within or close to fire box. Have a licensed plumber make the needed corrections for safety concerns.

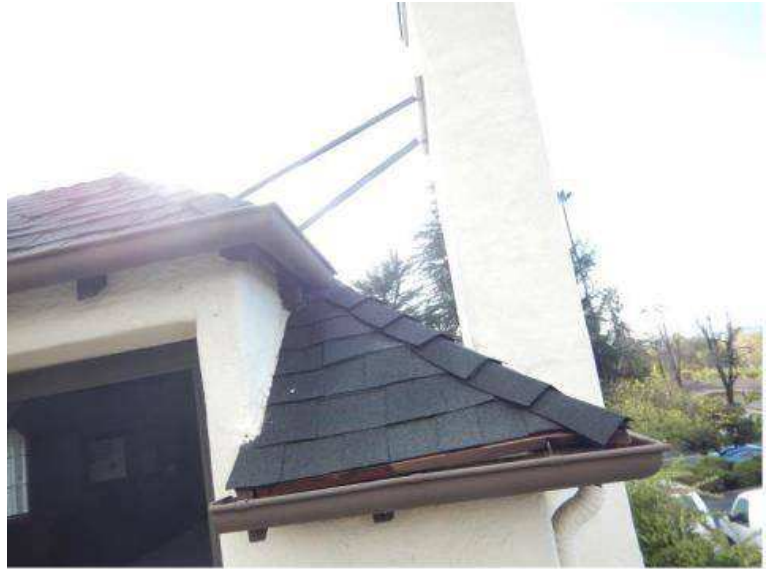
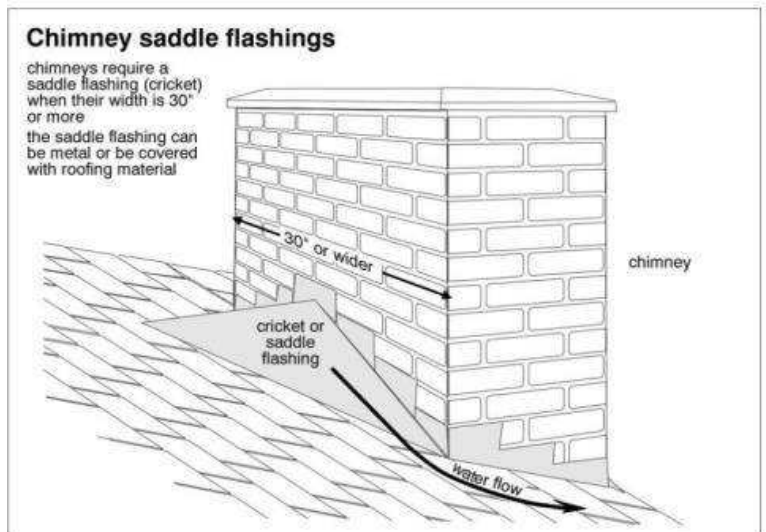
**Attention Needed** - The flashing as installed does not appear to be adequate, due to no saddle flashing.

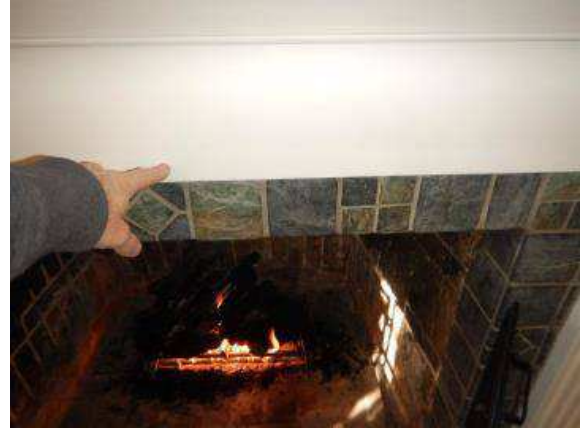
The mantle is not installed to the required clearances from firebox. This is a potential fire hazard and should be corrected.

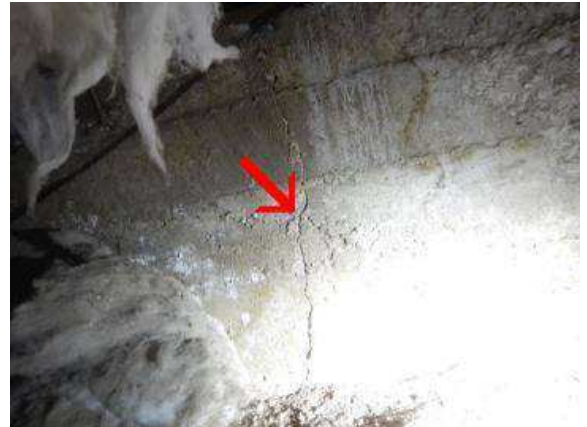
The foundation is performing the job it was intended to in supporting the structure. Yes - Cracking in the vertical foundation walls was noted from the exterior. However at least one or two cracks of 1/4" and wider were noted in the foundation walls. These cracks do appear repairable by epoxy injection and bolt plating. To help prevent any further deterioration of cracking improve adjacent grade. One crack is at right center section of foundation.

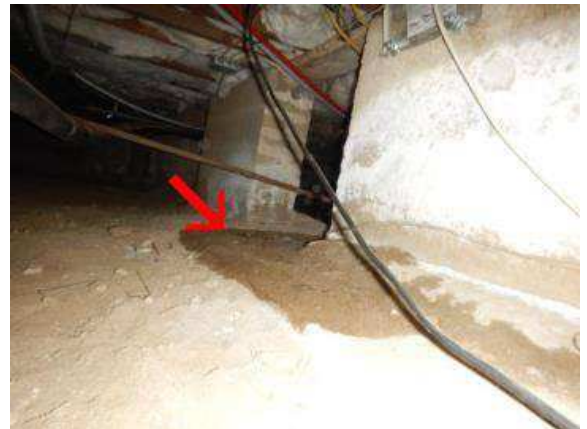
There is evidence of water entry or damage in the crawlspace level. Water entry primarily at back left or under dining area.

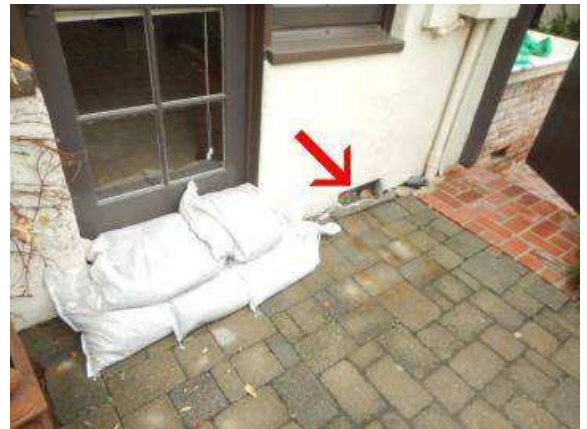
It should be mentioned that at least one of the foundation vent openings, the front one, is even with adjacent grade. This could be a source of water entry into the crawl area. Suggest improvements.

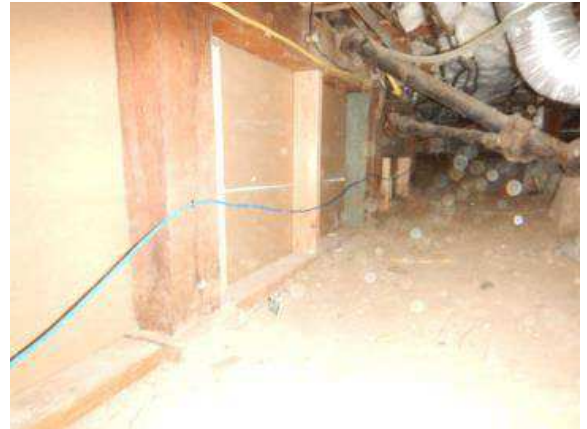
Earth to wood contact noted along basement cripple walls. This can promote wood destroying organisms and should be corrected. Wood should be at least 6 inches clear of any soil.

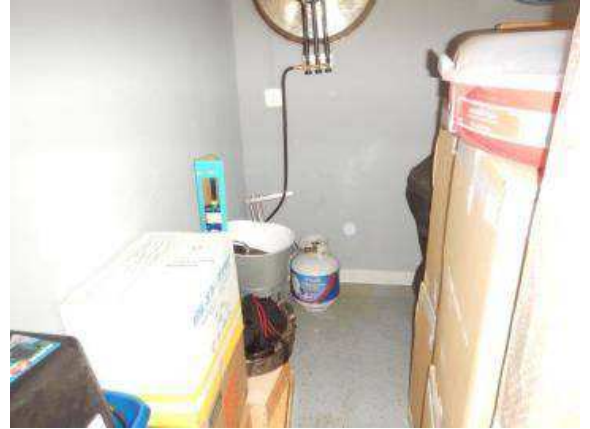
There is evidence of water entry along back side of garage.  
Improve adjacent drainage above.

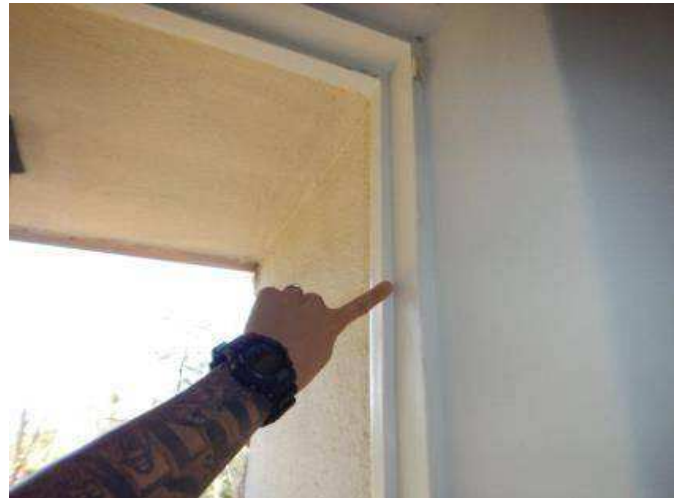
Recommend installing weather stripping to prevent loss of conditioned air or entry of exterior air.

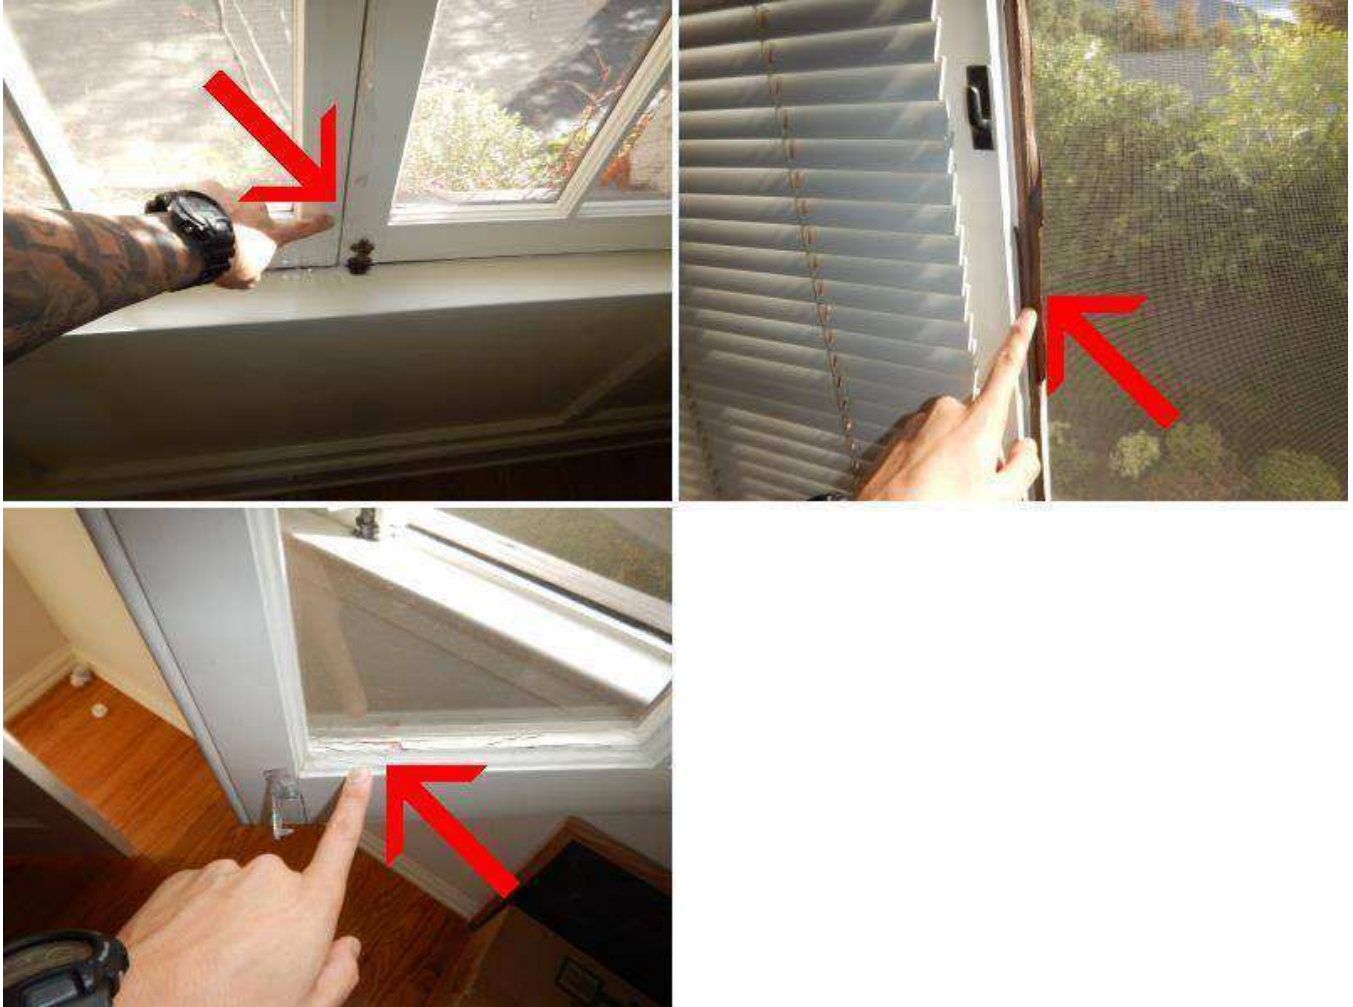
A representative sampling of testing windows was achieved. Those tested were mostly in serviceable condition, however, some showed evidence of wear, peeling paint and some were difficult to operate. Also, recommend installing weather stripping at all windows.

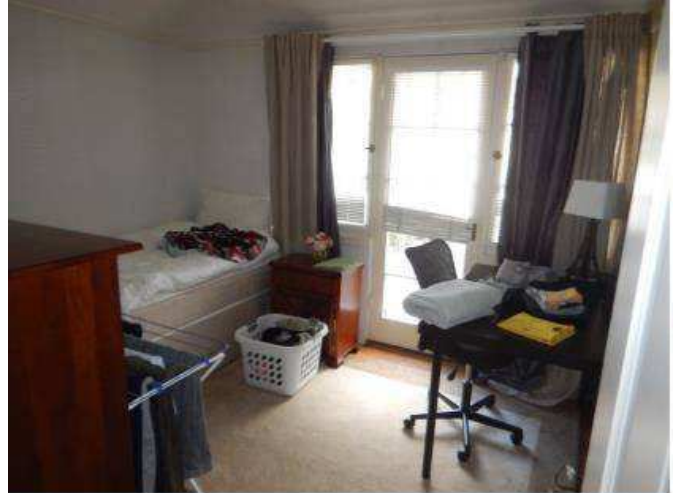
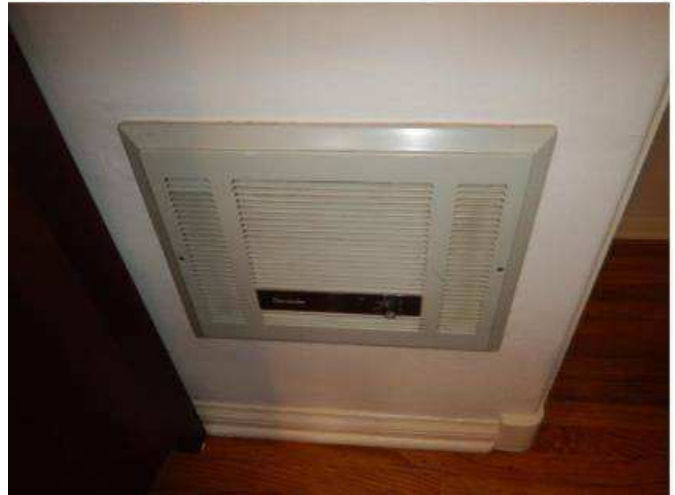
### 2.11 BEDROOM 1 LOWER BACK RIGHT:

Satisfactory, with general wear. This room has an electric heater installed. It appeared to function as intended when tested.

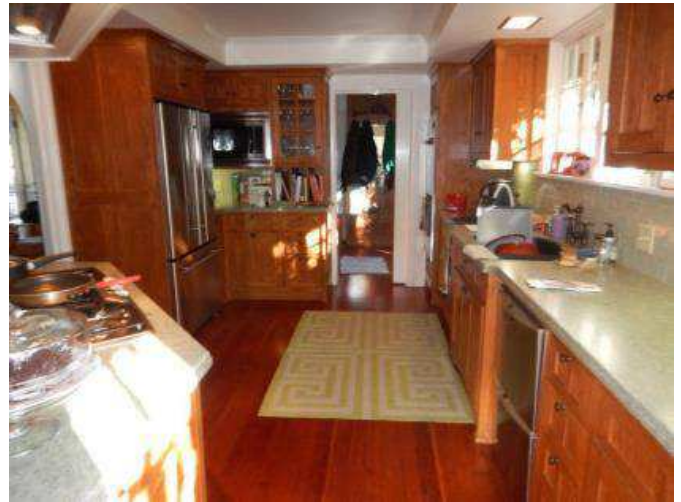
#### 3.1 LOCATION:

Main level rear of house.

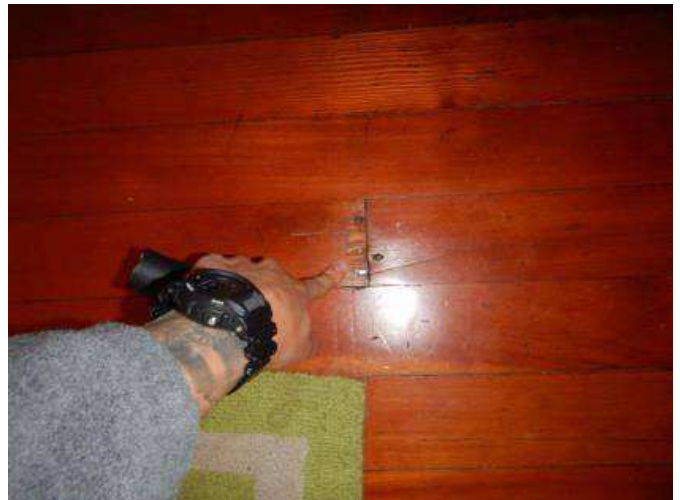
### 3.7 CONDITION:

Satisfactory with some general wear.

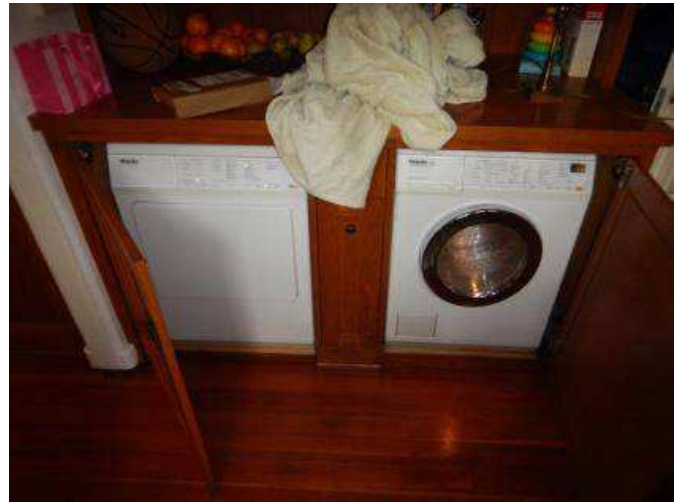
#### 4.1 LOCATION:

Back right, lower level.

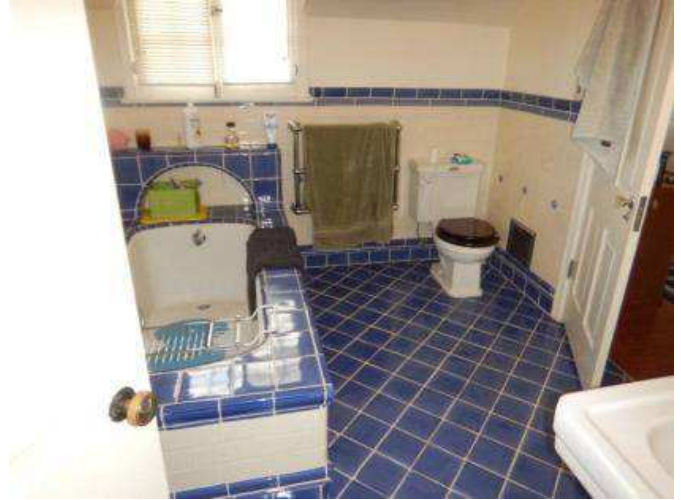
### 5.38 Note:

The water pressure drops when more than one fixture is operated simultaneously.

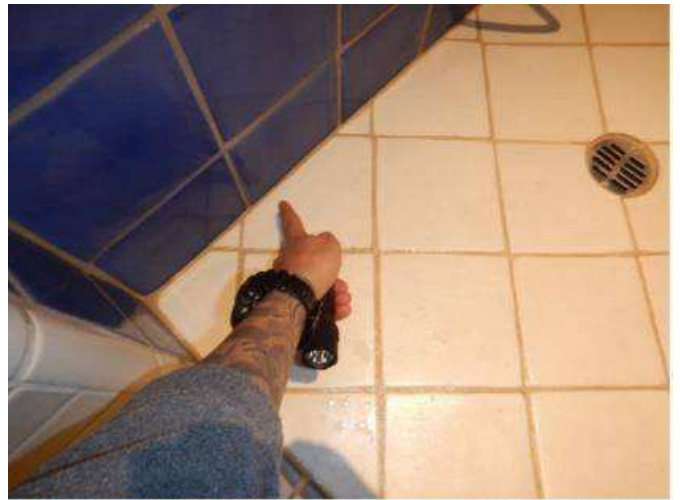
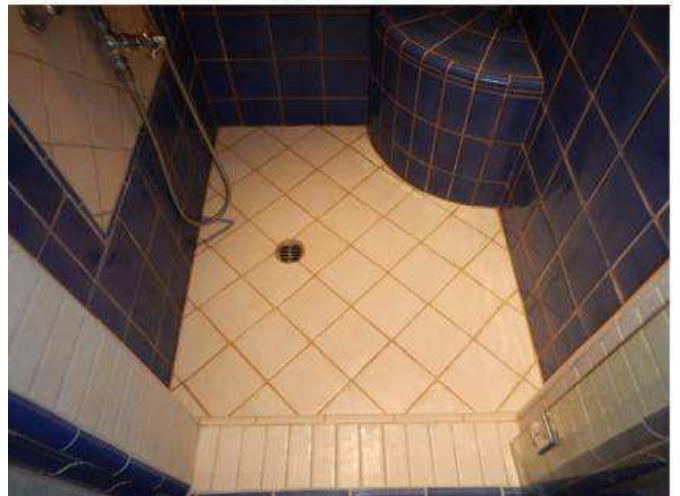
**Attention Needed** - Silicon caulking should have been used along where shower floor meets wall tile and not cement grout. Cement grout makes for an inadequate seal as this material tends to break up in time resulting in a poor water tight seal.

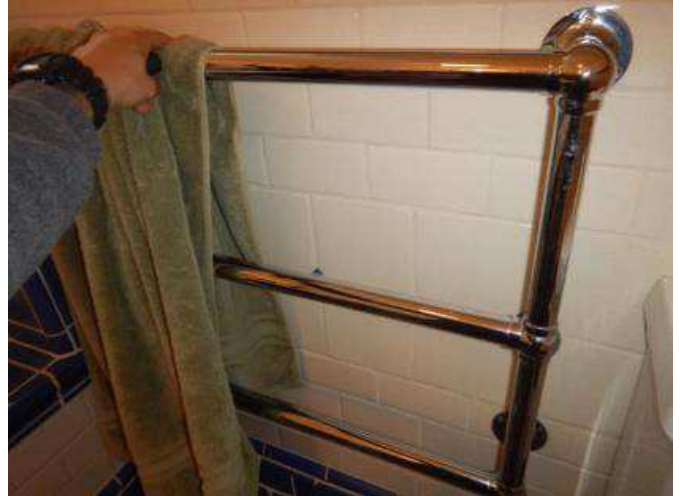
#### 5.47 HEAT SOURCE:

There is a towel heater in this bathroom, however, it is not included as part of this inspection report.

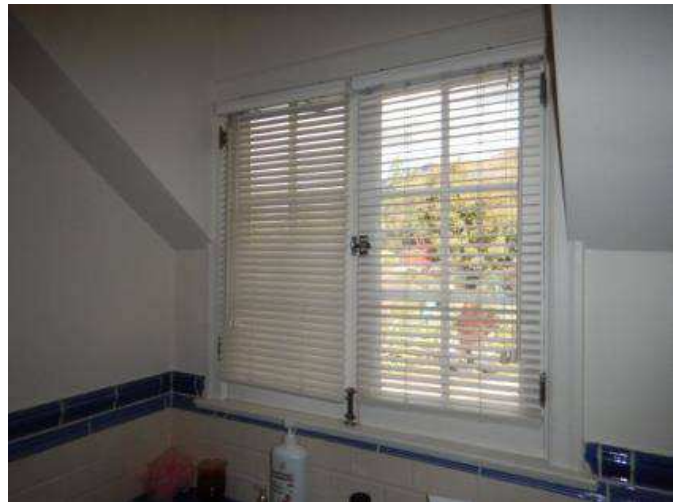
#### 5.49 WINDOW(S):

**Attention Needed** - The window adjacent to tub area does not appear to be of tempered glass. Contact a glazing company for further evaluation and corrections.

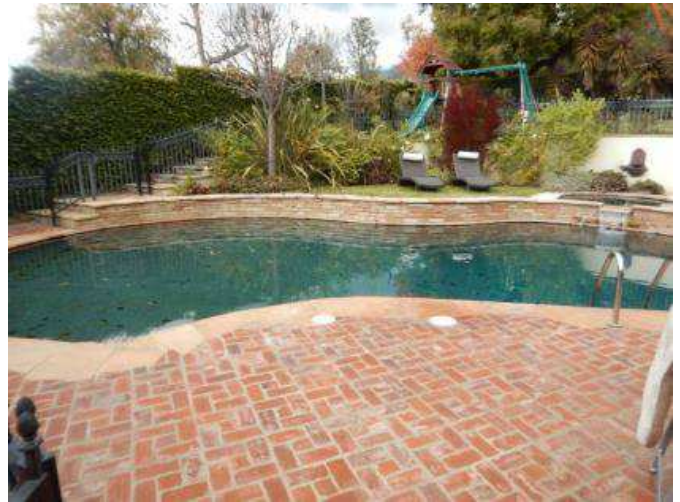
#### 7.1 TYPE:

Aggregate surface (Diamond-Brite, Sunstone, Krystal Krete, Pebble Tec, etc.)

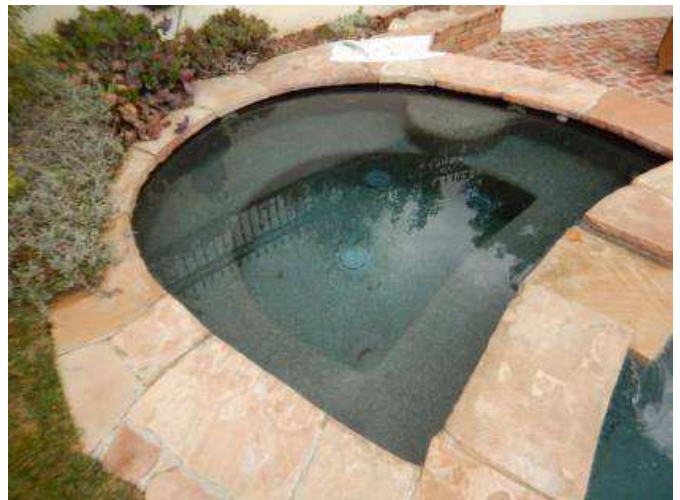
### 7.15 SURFACE:

Aggregate surface.
