INSPECTION SERVICES NORTHWEST

**CONFIDENTIAL INSPECTION REPORT FOR THE PROPERTY LOCATED
AT:**

44325 181th Ave SE, Bellevue, WA

INSPECTION COMPLETED ON: JANUARY 10, 2017

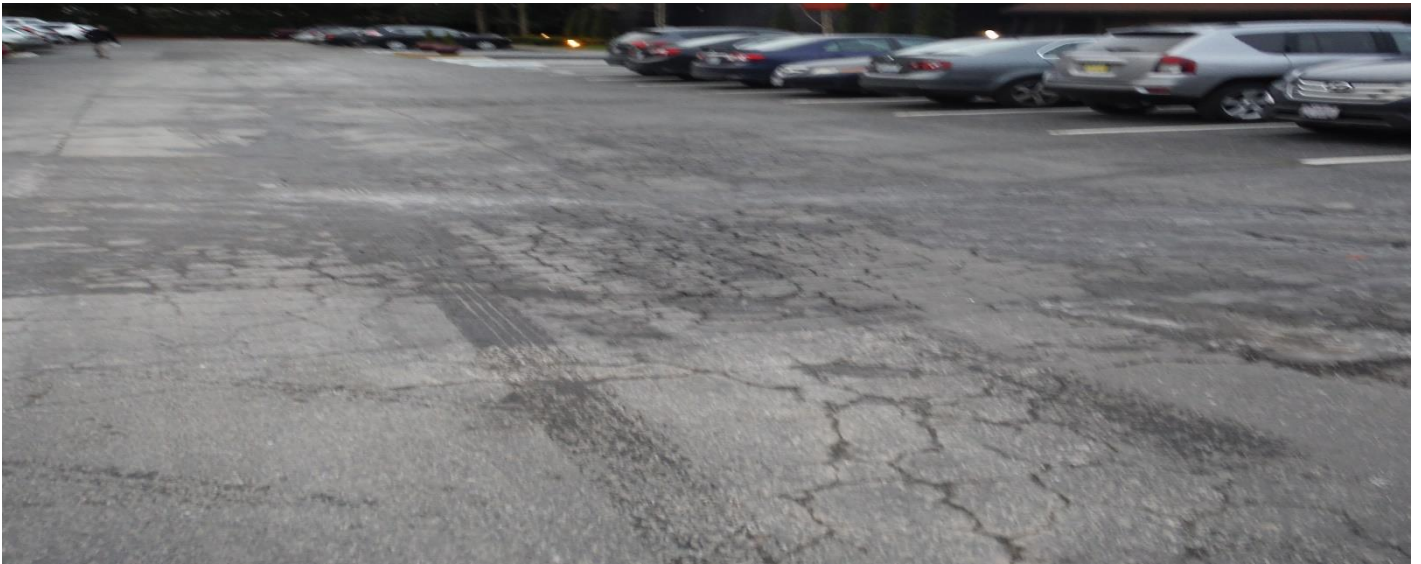
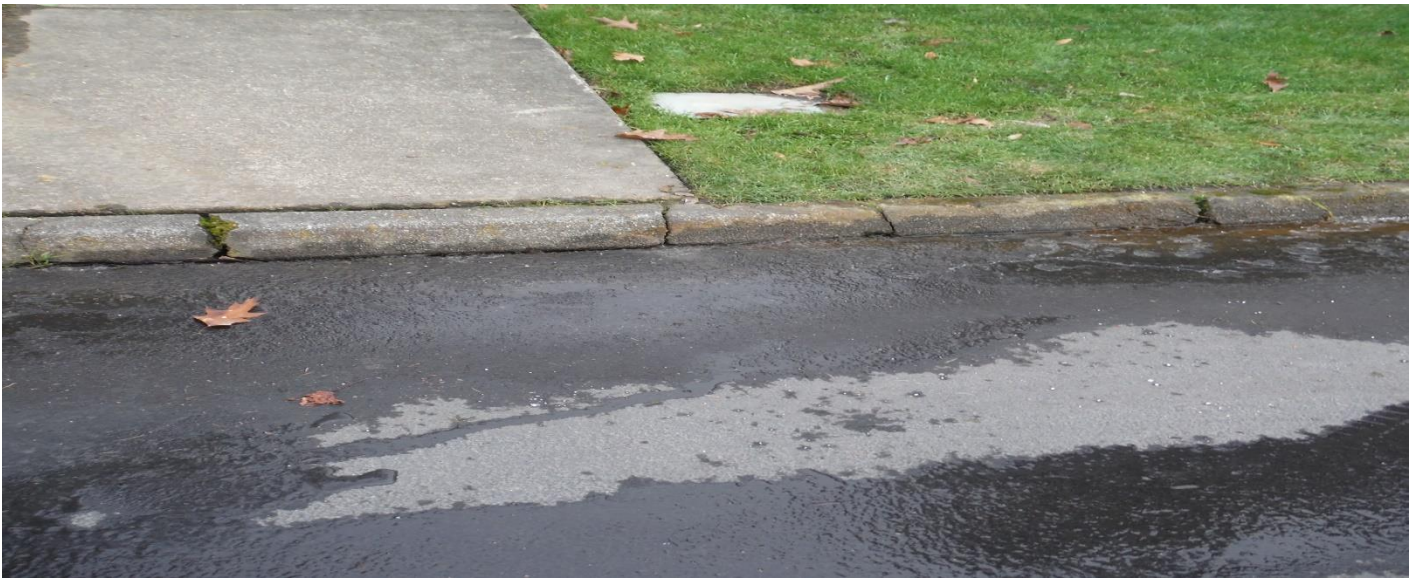
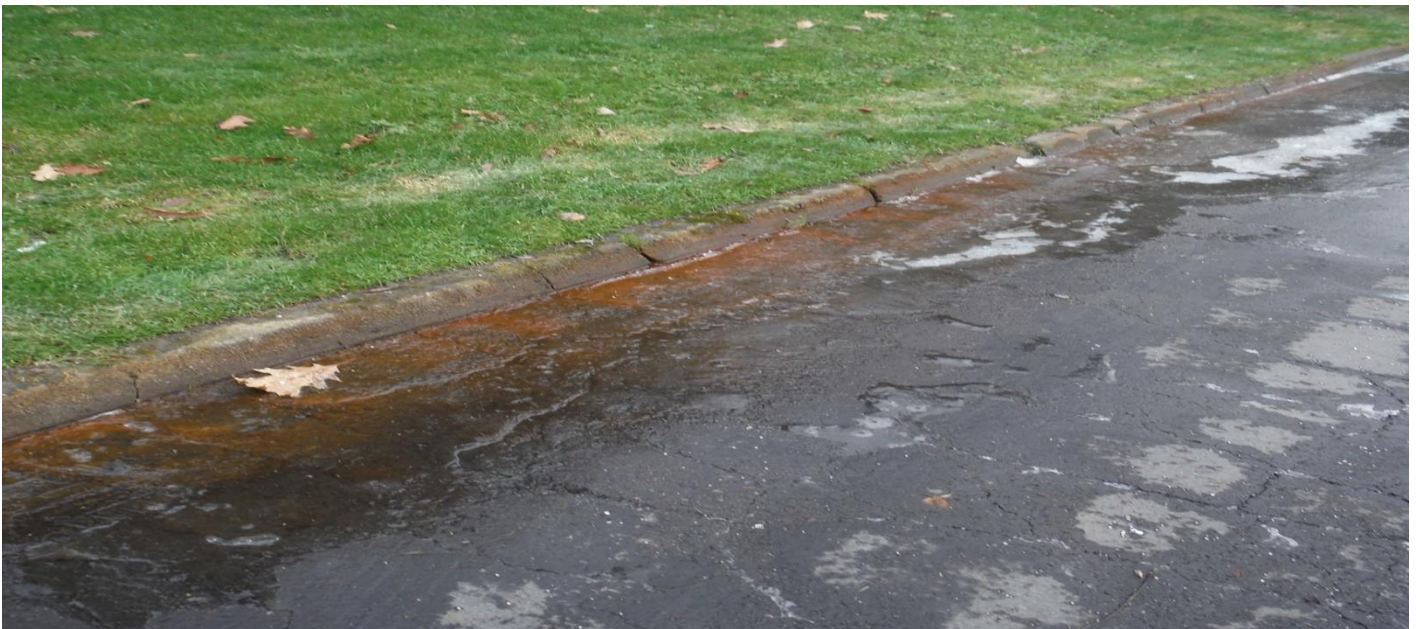
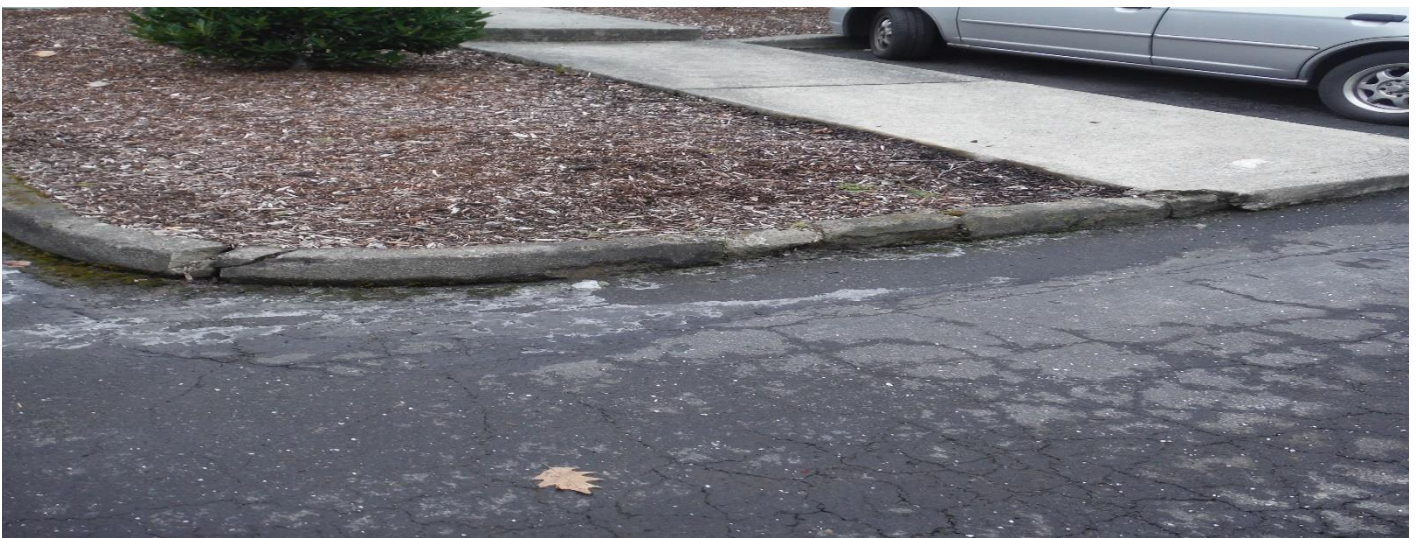
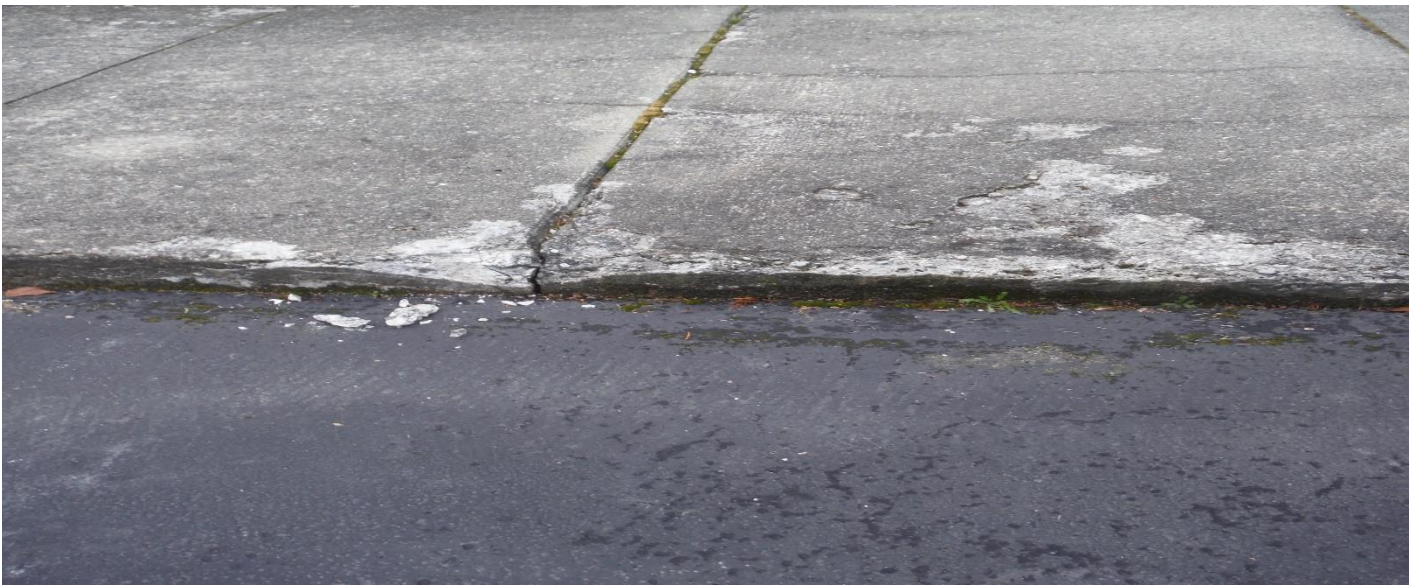
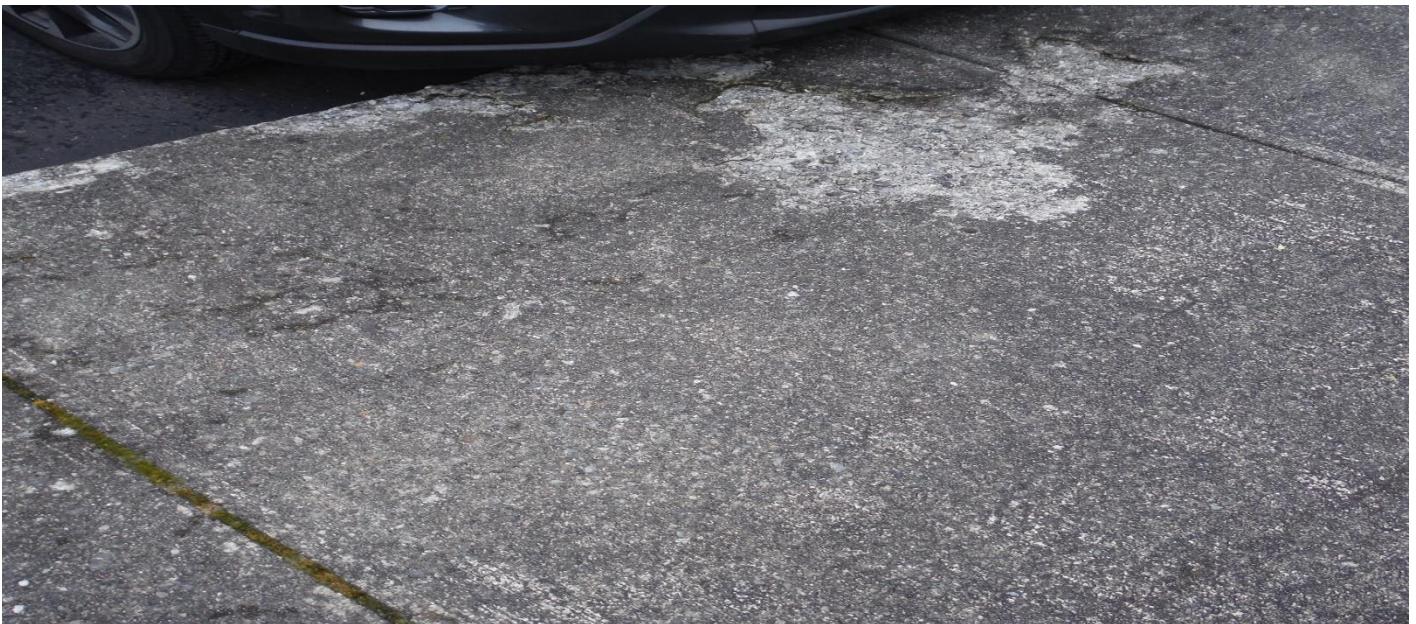
SEVERAL AREAS OF DAMAGED ASPHALT AND CURBING WERE LOCATED IN THE PARKING LOT. SMALL AREAS OF CRACKED AND DAMAGED SIDEWALK WERE ALSO LOCATED. THE PARKING LOT AREA SHOULD BE PROPERLY GRADED. ALL DAMAGED PAVING MUST BE REPLACED, THE PARKING STALLS REPAINTED AND EXISTING CURBING SHOULD BE REPLACED AS NEEDED. CRACKED AND DAMAGED SIDEWALKS SHOULD ALSO BE INSPECTED AND REPAIRED OR REPLACED AS NEEDED. REPAIR ALL TRIP HAZARDS AND ENSURE ALL RUNOFF IS PROPERLY ROUTED AWAY FROM THE STRUCTURE.

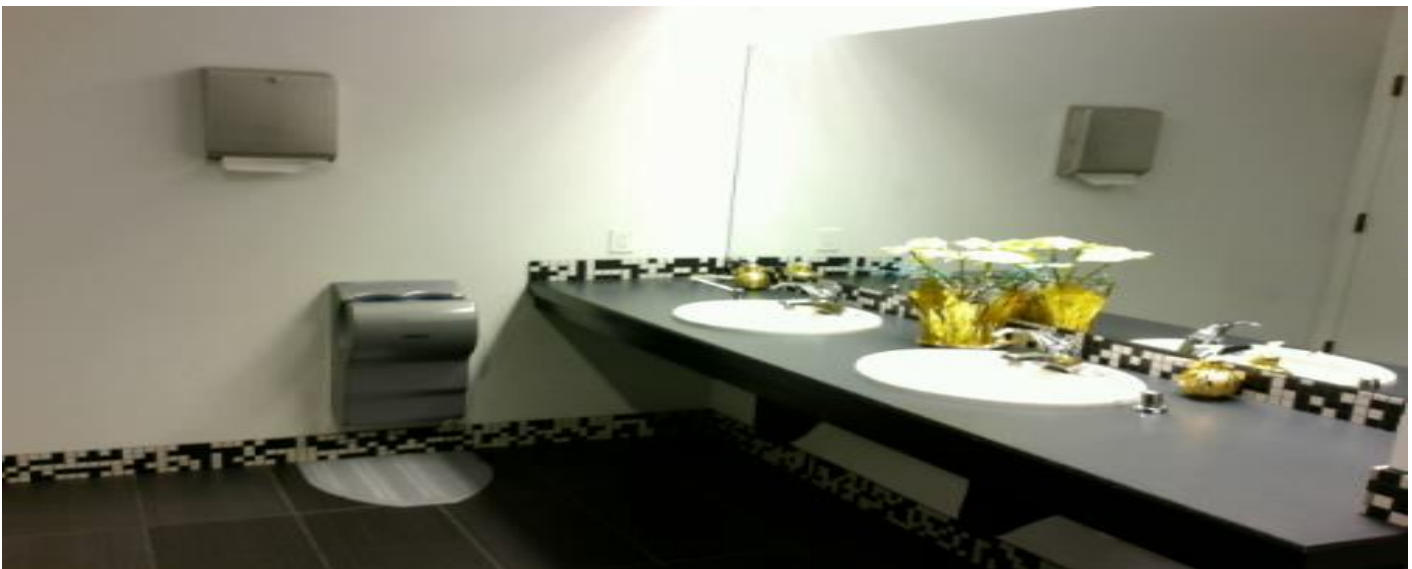
SECTION 9: BATHROOMS: THE HANDICAP STALL IN THE 3rd FLOOR MENS BATHROOM IS MARKED OUT OF ORDER. PERFORM ALL REPAIRS AS FOUND TO BE REQUIRED.
