A Buyer's Choice Home Inspections

PROPERTY INSPECTION REPORT

3330 NE Dorchester Way, Corvallis, OR 97330 Inspection prepared for: Andaman Rosse Real Estate Agent: -

Date of Inspection: 10/23/2025 Time: 2:30 PM Age of Home: 1970 Size: 912 Order ID: 181

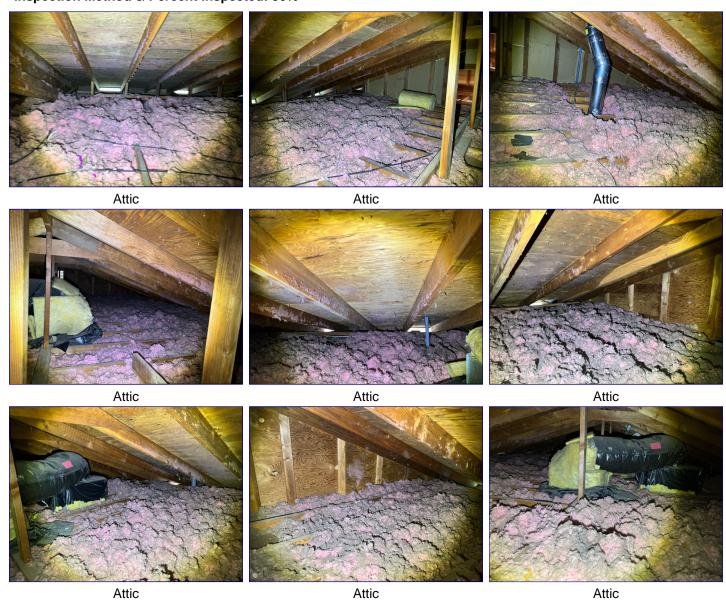
1. Attic Observations

Access Location & Access Type: Garage • Plywood Door Inspection Method & Percent Inspected: 90%

• Microbial growth or possible mold growth observed in west and northern areas of the Attic. Mold can only be confirmed with laboratory testing. Recommend having a qualified, contractor perform mold spore air testing and tape/swab sample of observed growth.
