# Island County Official Inspection Form

Location: 4901 THISTLE LN  
FREELAND  
Tax ID: S6205-00-08009

### ON-SITE WASTEWATER TREATMENT SYSTEM INSPECTION REPORT

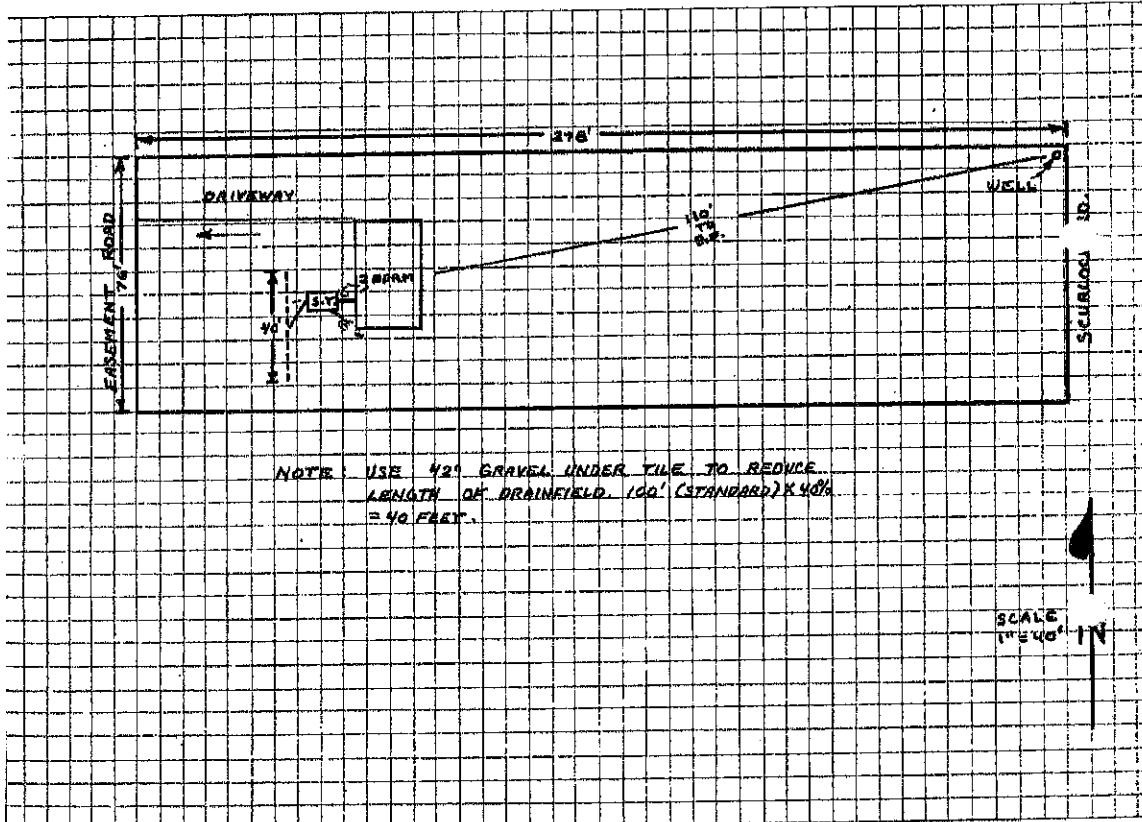
INDICATE THE FOLLOWING IN SPACE PROVIDED BELOW (Use Symbols  $\Delta$  for soil log and  $O$  for perc holes)

(b) Location of property lines, wells, banks, hightide line, waters of State, roads, large trees, house, drainfield, french drain and slope of land.

### Soil Log #1

<u>SOIL TYPES</u>	<u>DEPTH</u>	<u>PERCOLATION TESTS</u>	<u>DEPTH</u>
a. Loam	0 - 8"	Hole #1 under 2 Min./per inch	
b. Sand (some gravel)	8 - 72"	Hole #2 under 2 Min./per inch	
c. _____	_____	Hole #3 under 2 Min./per inch	
d. _____	_____	AVERAGE RATE: under 2 Min./per inch
