# **Cornerstone Inspection**

## **Property Inspection Report**

**689 Woodland Dr, Arroyo Grande, CA 93420**  
**Inspection prepared for: Nancy Lacsamana**  
**Real Estate Agent: Shannon Bowdey -**

**Date of Inspection: 3/11/2025 Time: 9:00 AM**  
**Age of Home: 1976 Size: 2954**  
**Order ID: 11854**

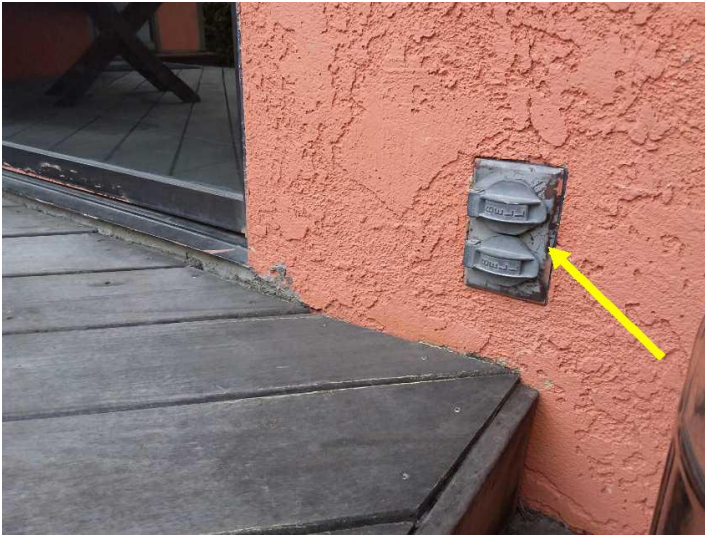
Some of the exterior outlets do not have ground-fault protection, and should be upgraded to include this modern safety feature.

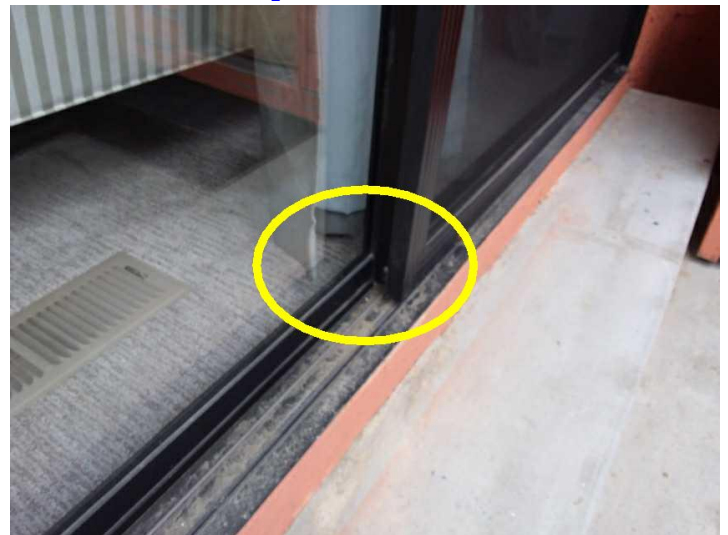
The sliding glass door or doors are mounted on the outside, which is not as secure as being mounted on the inside.

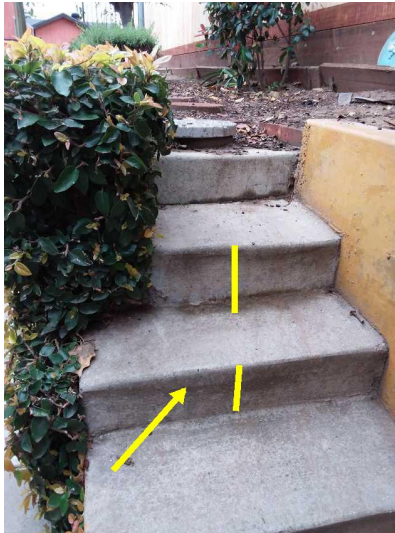
Some of the steps have unequal treads or risers. Steps are required to be uniform to prevent trip-hazards. The rise of any step should be no less than four inches and no greater than seven inches, and the run should be no less than eleven inches. Also, the dimensions of the largest step should not exceed that of the smallest by more than three-eighths of an inch.

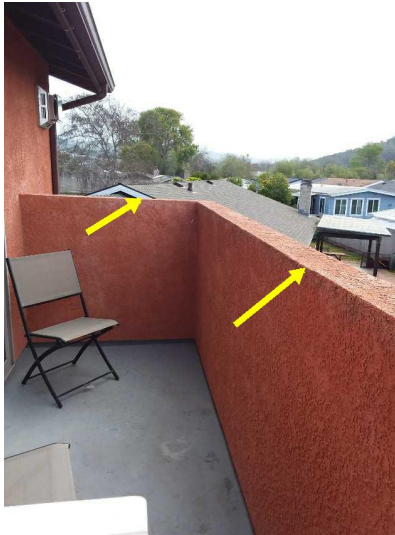
The balcony guardrail is an adequate height and in acceptable condition. However, standards for guardrails are not uniform. Nonetheless, common safety standards require them to be a minimum of 42 inches high when the standing surface is 30 inches or more above grade.

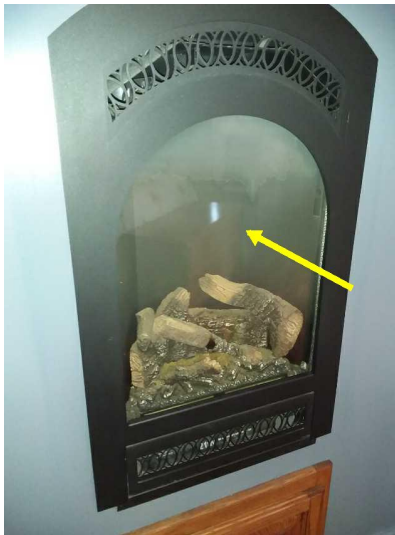
The fireplace glass is functional, however does not have a protective screen, which is required by current standards and should be installed for optimal safety.

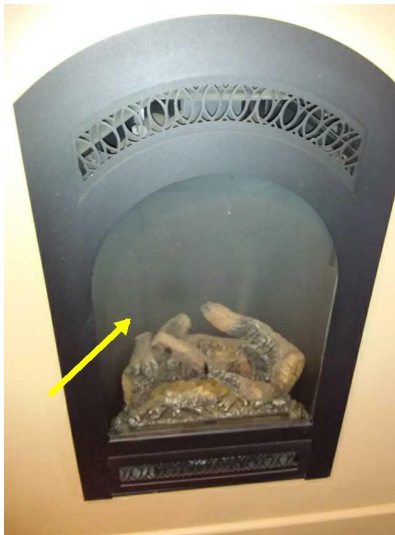
The fireplace glass is functional, however does not have a protective screen, which is required by current standards and should be installed for optimal safety.

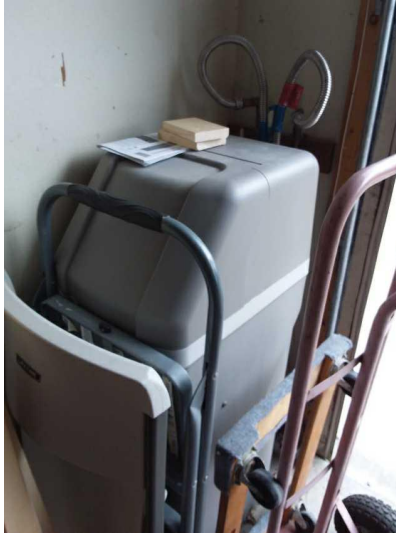
A water softener is present that we do not have the expertise to evaluate except for visible leaks. We recommend you ask the sellers if the unit was professionally installed and its service history.

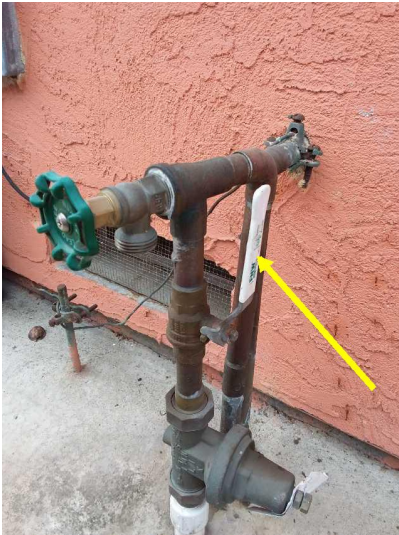
The main water shut-off valve is located at the right side of the house.

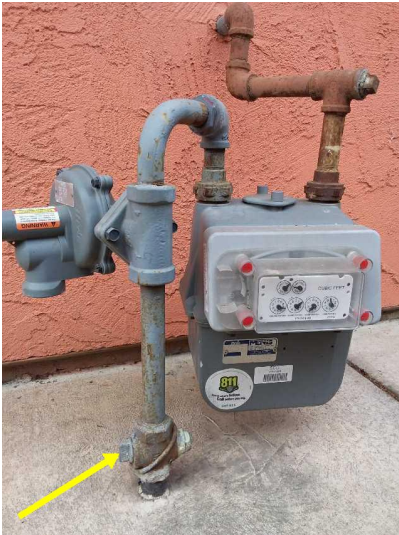
The gas main shut-off is located on right side of the home, unit or building.

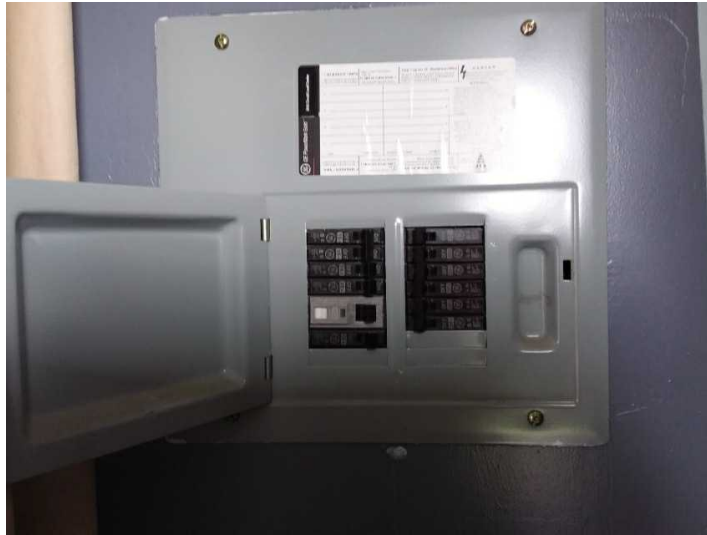
Various circuits within the sub-panel are not labeled, and should be serviced by an electrician so that the appropriate load calculations and breaker sizes could be determined.

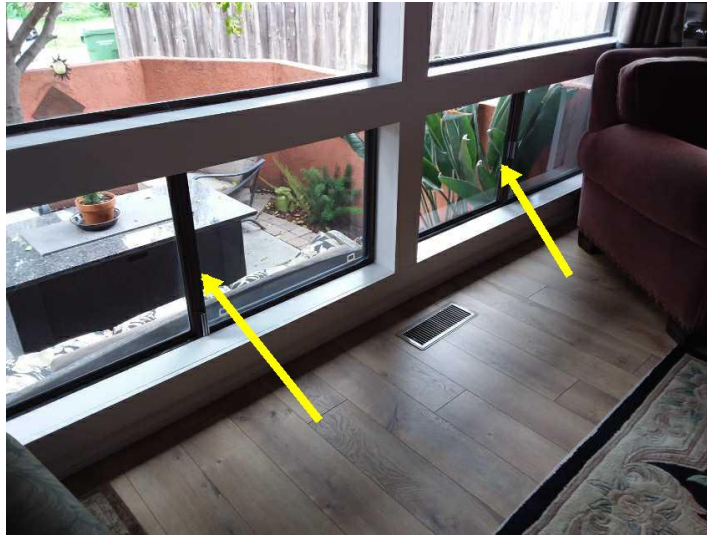
There's one or more windows installed within 18 inches of the finished floor that current standards require such windows to be tempered or safety glass.

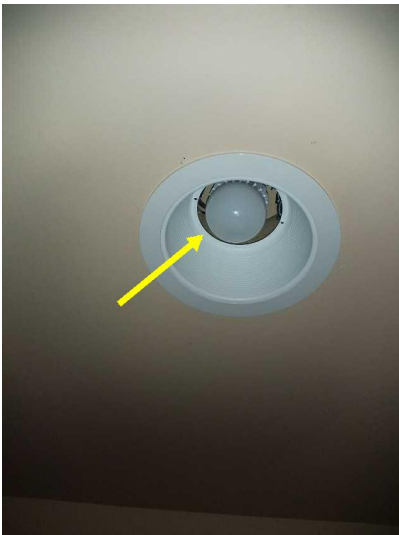
A ceiling light does not respond, and should be serviced.

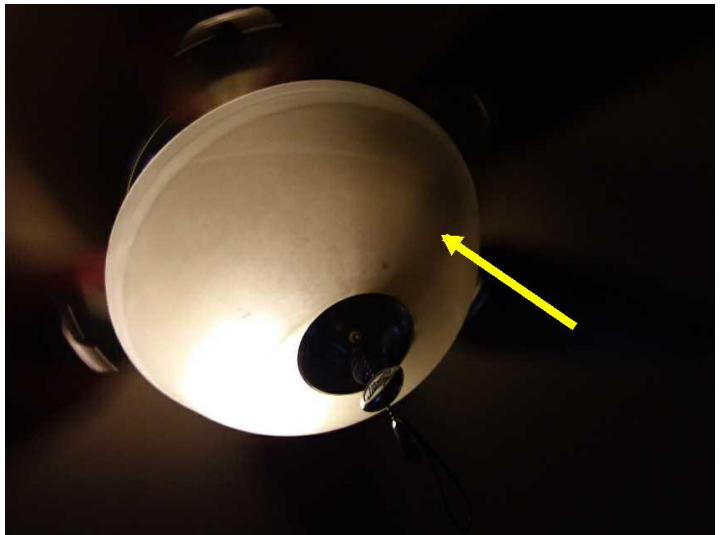
A ceiling light does not respond, and should be serviced.

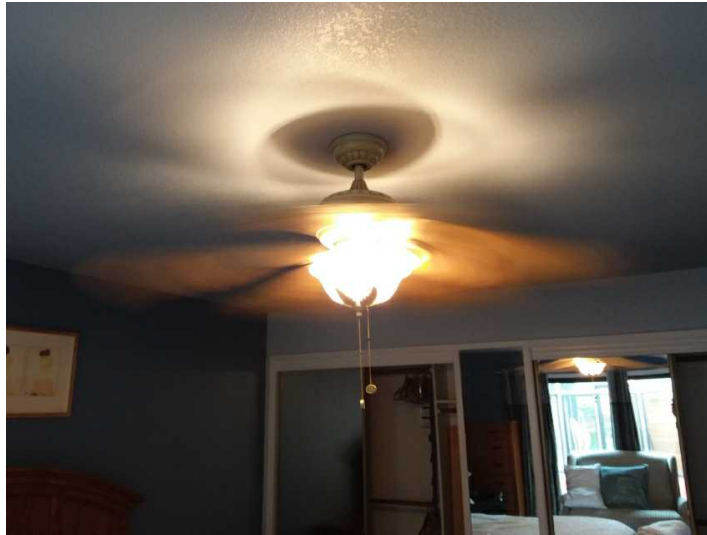
The ceiling fan is functional but rocks at high speeds and should be serviced so the fan operates smoothly.

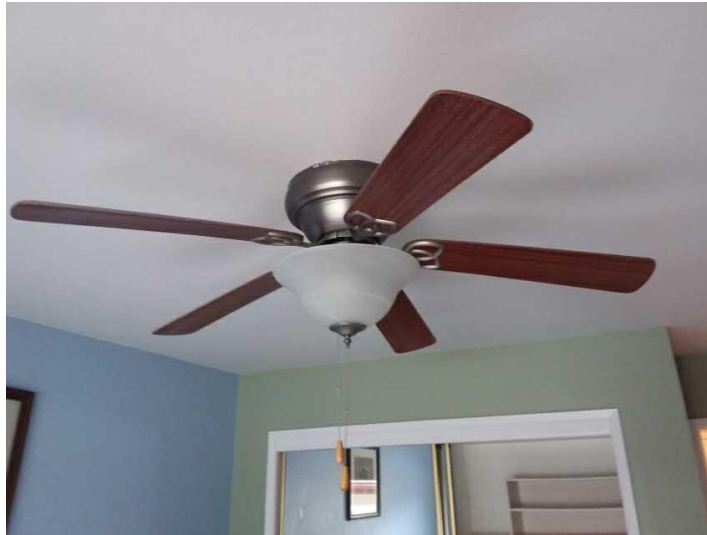
We were unable to activate the ceiling fan and light, which could be controlled by a remote. Please consult with the seller regarding this issue.

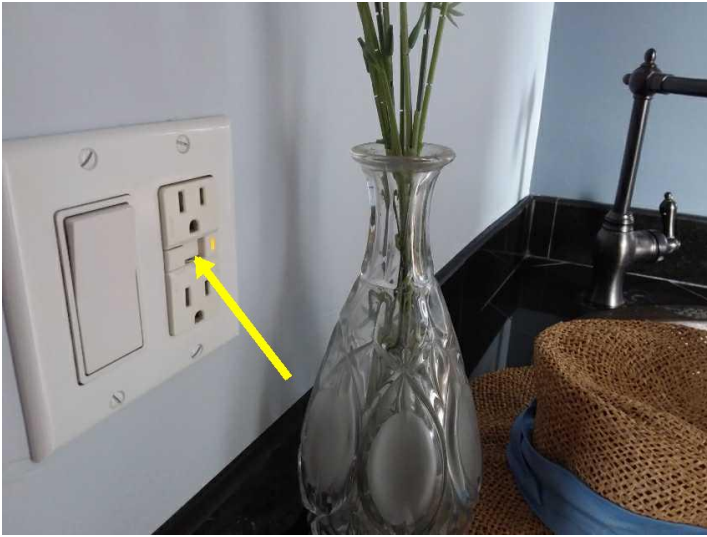
The outlet in the bar sink does not reset which should be evaluated and serviced by a licensed specialist.

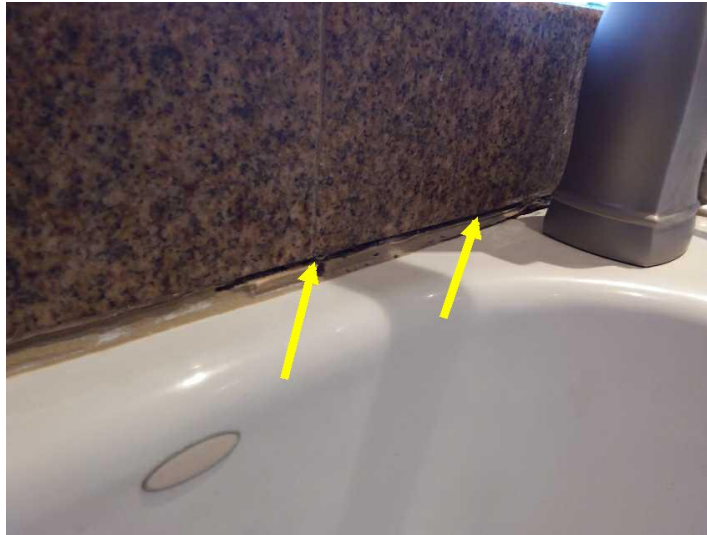
A separation between the counter top and the backsplash should be sealed.

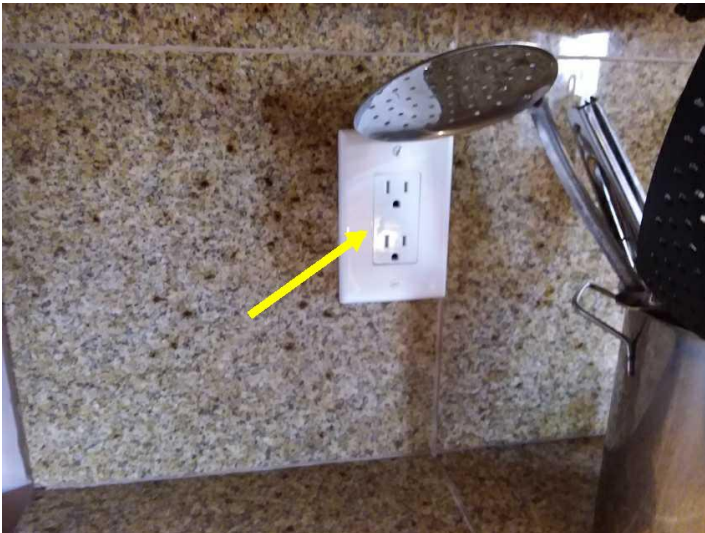
Some of the outlets at the kitchen counter top are not GFCI protected as required by today standards.

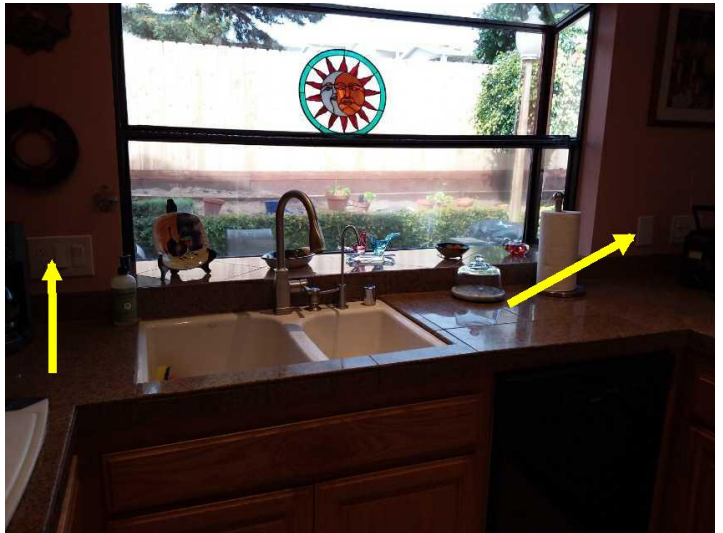
Some of the outlets at the kitchen counter top are not GFCI protected as required by today standards.

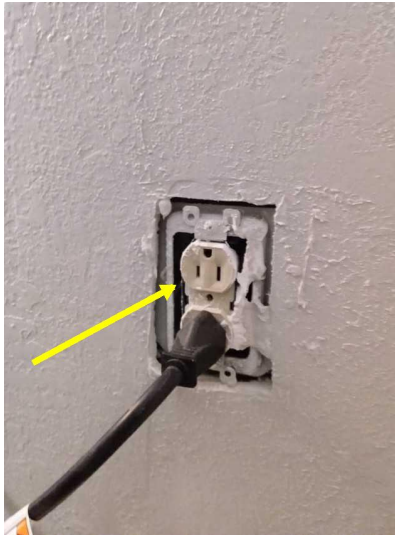
The wall outlet is functional, but should be upgraded to have ground-fault protection.

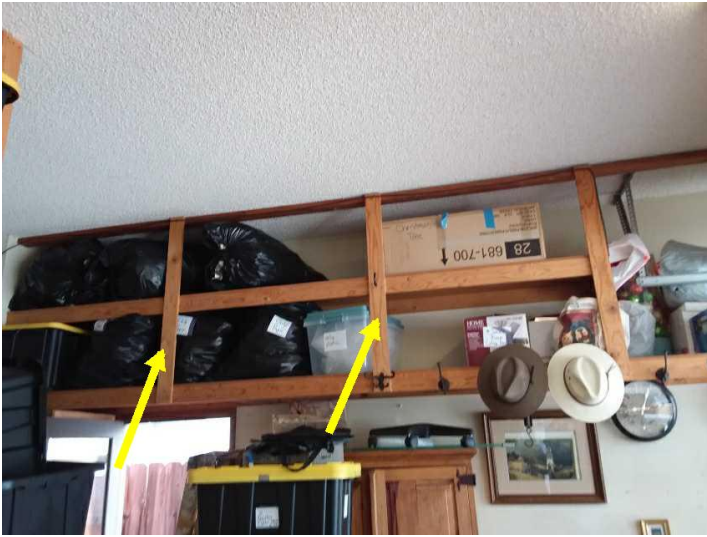
The storage space may have been added without the benefit of a permit, which could stress the roof framing. You may wish to verify this with the sellers. Regardless, you should limit the storage to lightweight items.

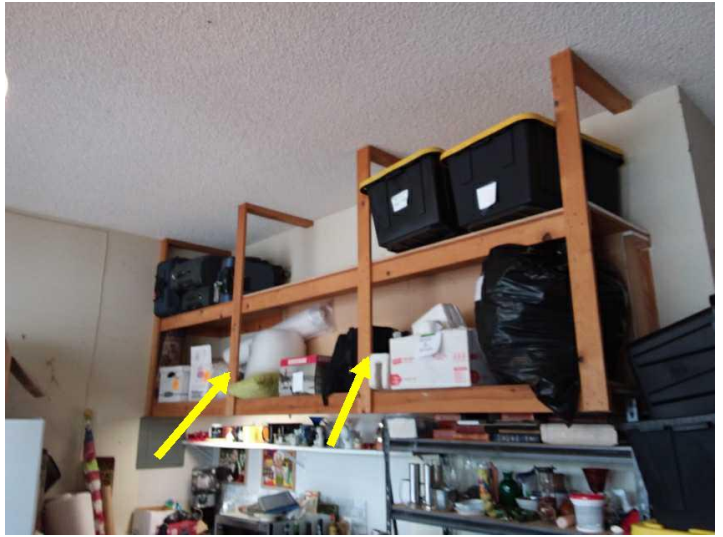
The storage space may have been added without the benefit of a permit, which could stress the roof framing. You may wish to verify this with the sellers. Regardless, you should limit the storage to lightweight items.
