# A Buyer's Choice Home Inspections

## PROPERTY INSPECTION REPORT

859 Mule Deer Pl NW, Salem, OR 97304  
Inspection prepared for: Andaman Rosse  
Real Estate Agent: -

Date of Inspection: 1/27/2026 Time: 8:00 AM  
Age of Home: 2002 Size: 2474  
Order ID: 212

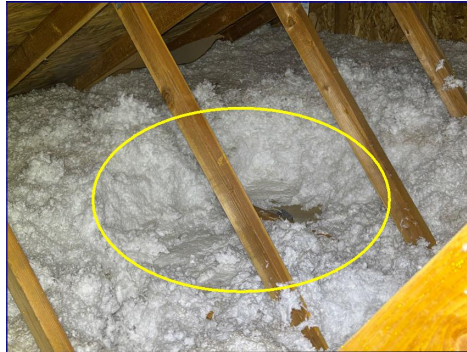
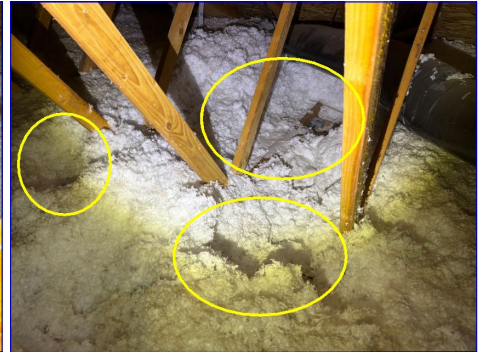
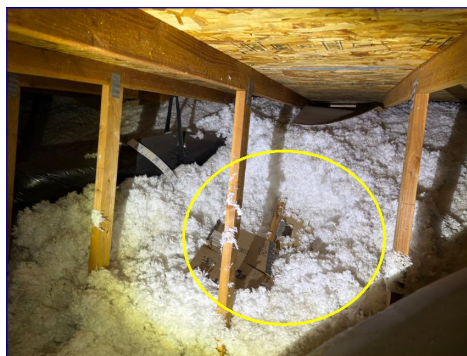
<b>Attic</b>		
Page 15 Item: 4	Insulation	<ul style="list-style-type: none"> <li>Insulation has been compressed or relocated in the specified areas. This will decrease the R value of that insulation area, leading to temperature regulation issues. Recommend correction.</li> </ul>

Disturbed insulation

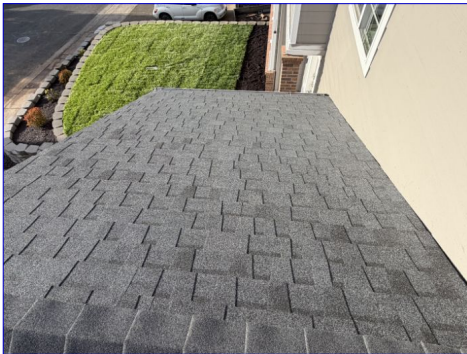
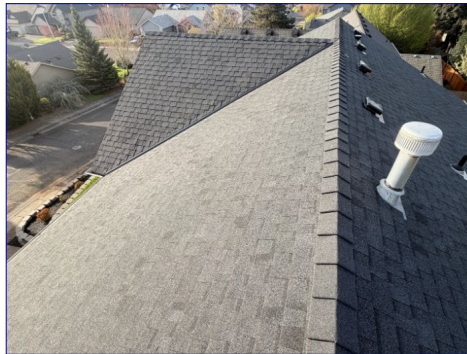
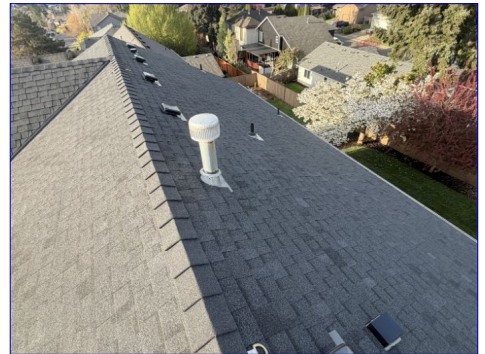
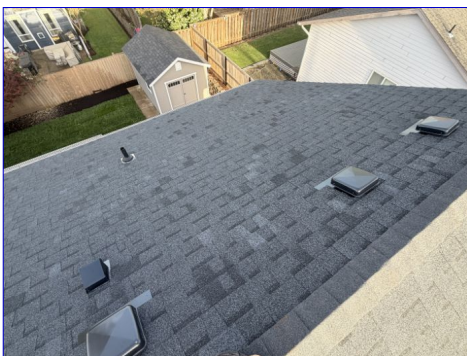
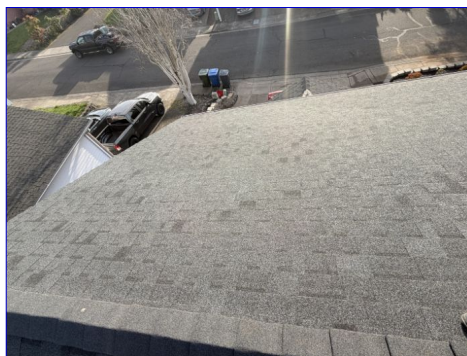
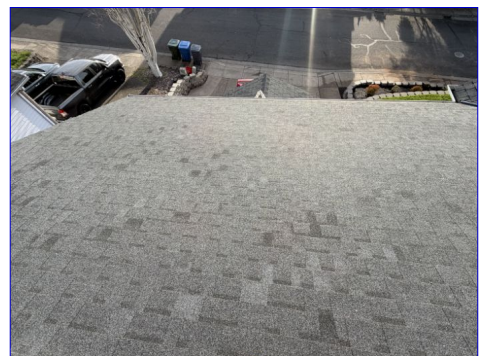
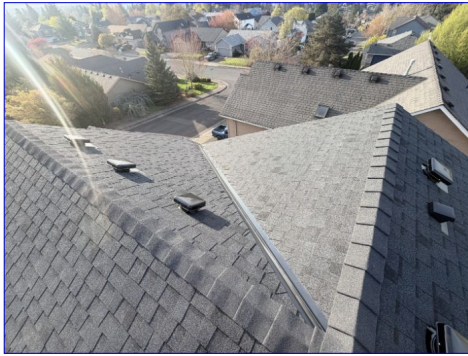
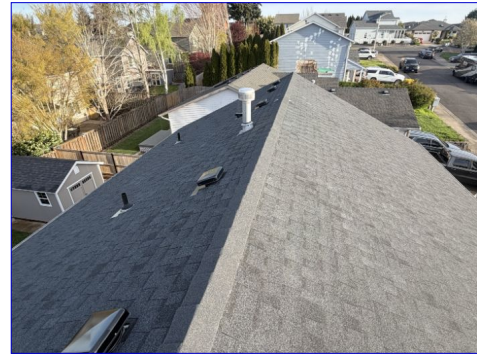
- Any installation that relies on a sealant to prevent moisture intrusion will need to have new sealant applied on a regular basis. Sealant eventually dries, shrinks and cracks
- Roof is in good condition and appeared serviceable.

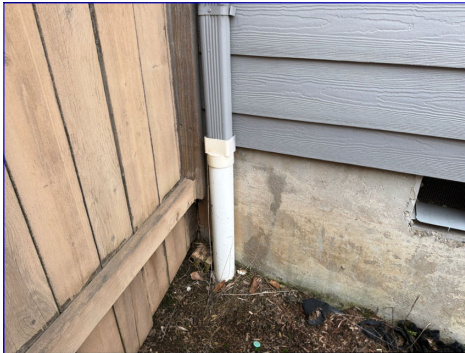
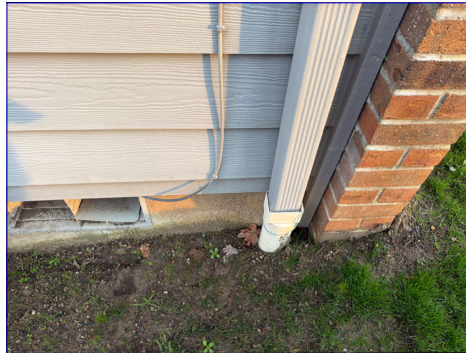
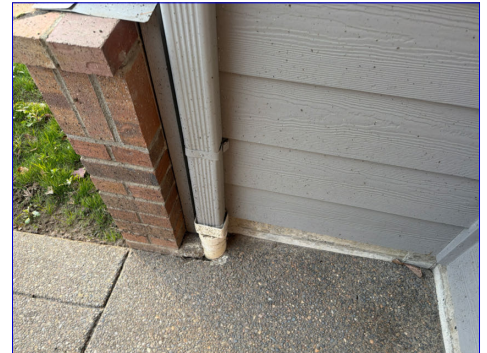
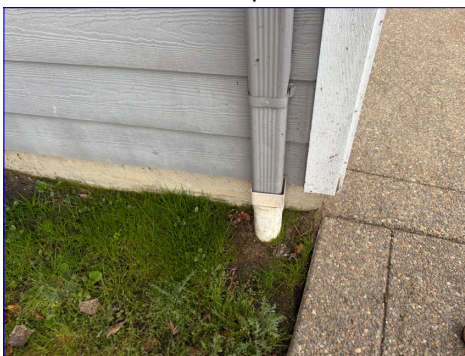
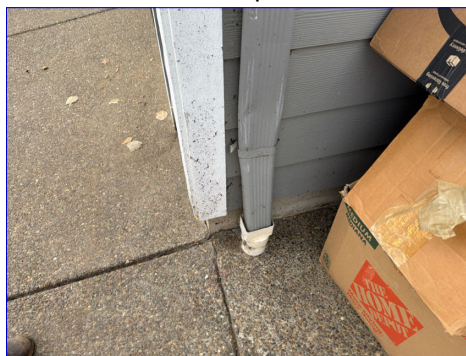
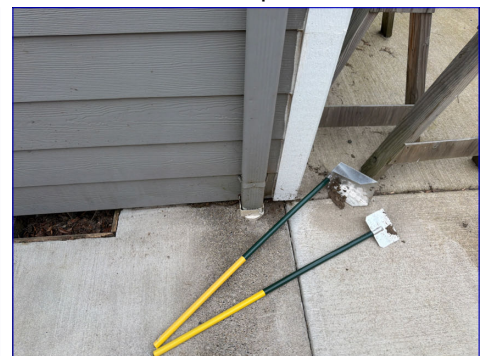
- Downspout(s) discharge water at foundation. Recommend installation of extension to ensure proper drainage away from foundation to prevent seepage.

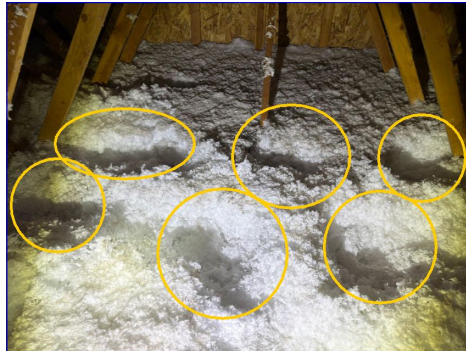
• Insulation has been compressed or relocated in the specified areas. This will decrease the R value of that insulation area, leading to temperature regulation issues. Recommend correction.

Disturbed insulation

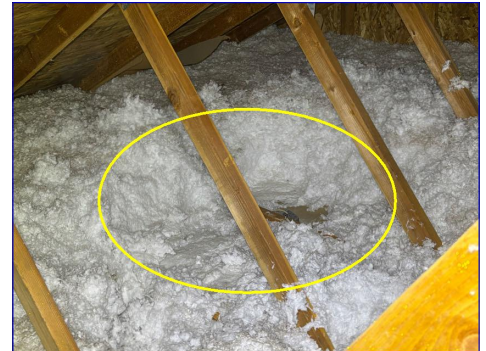
Disturbed insulation

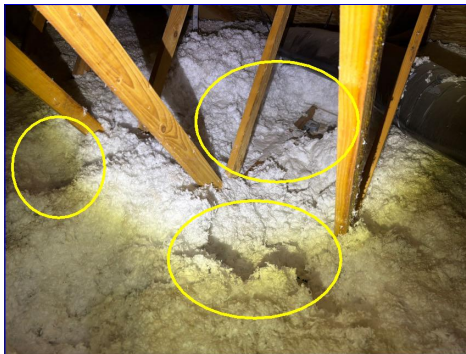
Disturbed insulation

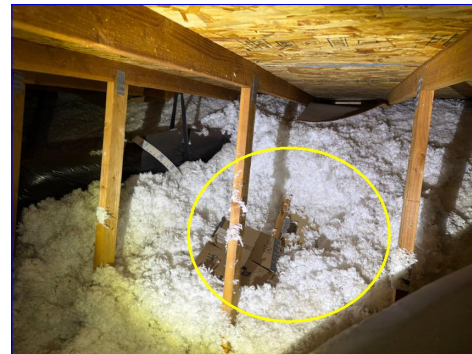
Disturbed insulation

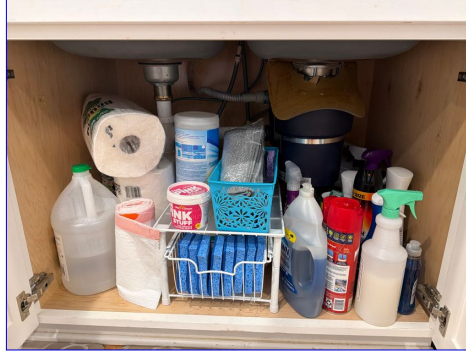
- Limited review due to obstruction due to personal property stored in under sink cabinet.

Limited review

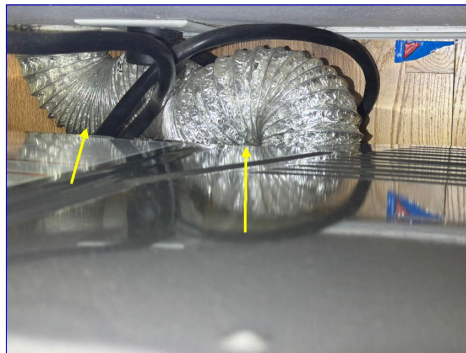
- Although once considered acceptable, flexible, ribbed vents are a potential fire hazard and should be replaced.
- Lint build-up noted. Suggest cleaning ducting regularly to prevent lint build-up, which is a serious fire hazard.

Flexible foil

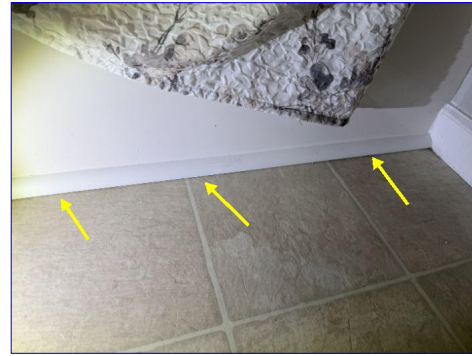
- Caulk needed around tub to prevent moisture intrusion to the floor and surrounding.

Needs caulking

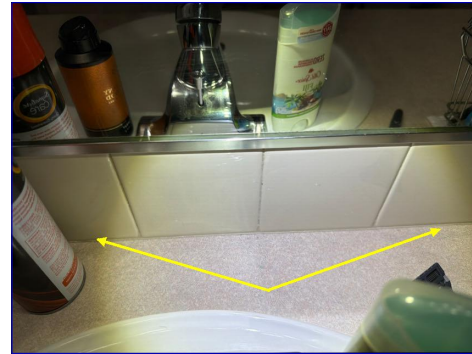
- Caulk needed along edge of counter and wall

Split caulking

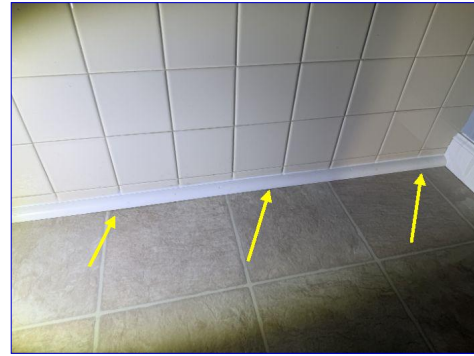
- Debris was ejected from the jets during operation, recommend having circulation system professionally cleaned prior to use.
- Caulk needed around tub to prevent moisture intrusion to the floor and surrounding.

Needs caulking
