# A Buyer's Choice Home Inspections

## PROPERTY INSPECTION REPORT

3077 NW Lisa Pl, Corvallis, OR 97330  
Inspection prepared for: Andaman Rosse  
Real Estate Agent: Andaman Rosse -

Date of Inspection: 5/7/2026 Time: 9:00 AM  
Age of Home: 1976 Size: 3360  
Order ID: 275

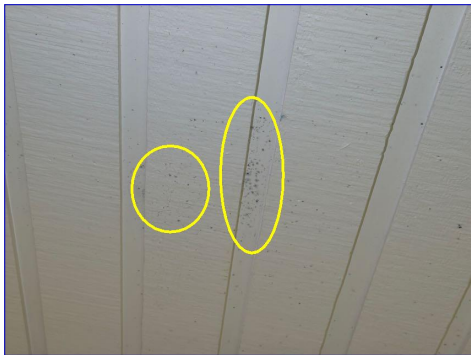
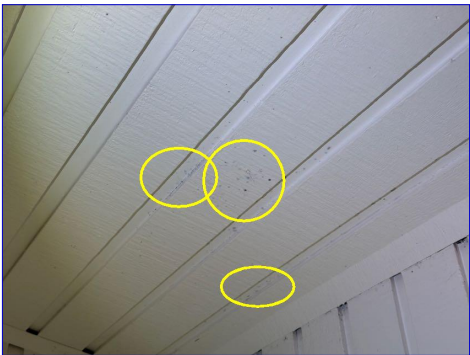
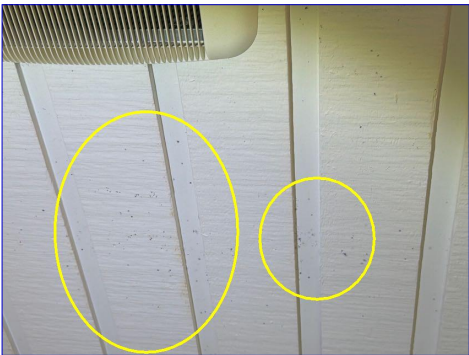
Possible microbial growth (Primary bathroom)

• Microbial growth or possible mold growth observed in the areas noted. Mold can only be confirmed with laboratory testing. Recommend having a qualified, contractor perform mold spore air testing and tape/swab sample of observed growth.

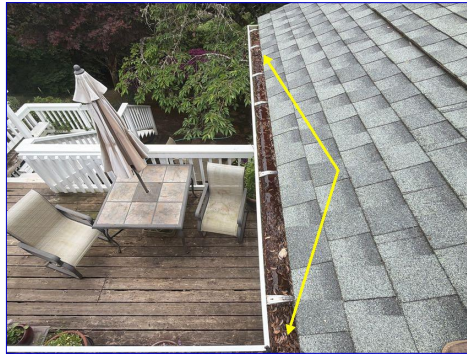
Standing water

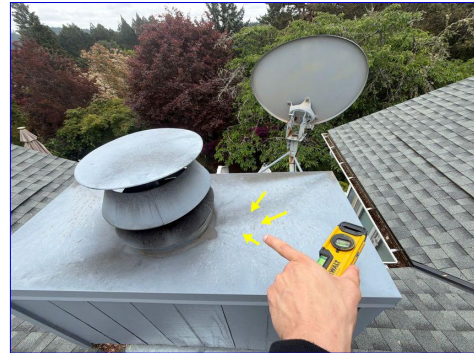
Negative slope (south side)

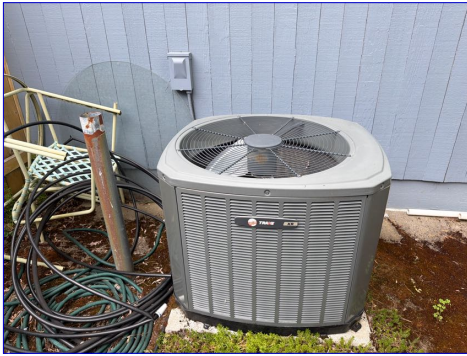
Condenser unit

• Condenser is tilted, excessive uneven settlement can cause fractures in refrigerant line fittings and loss of refrigerant as well as shorten the life of the compressor. Unit should be leveled.

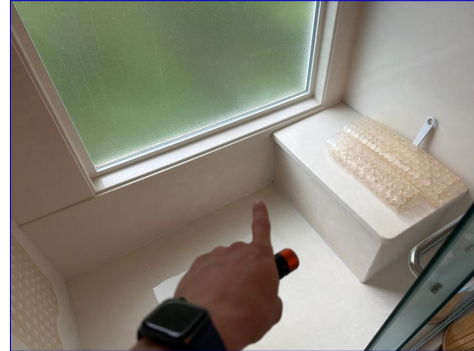
- Caulking needed.

Split caulking

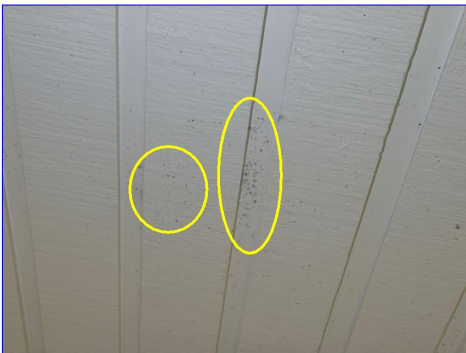
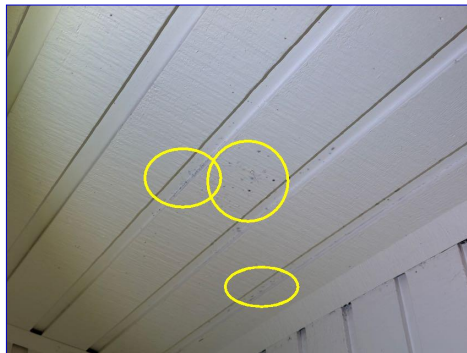
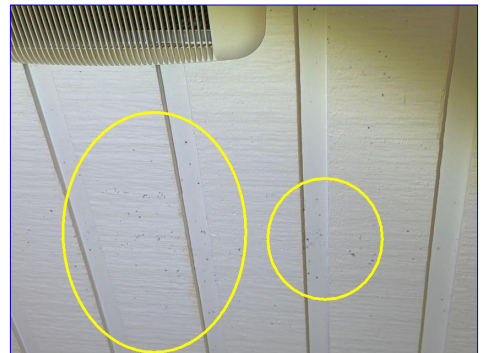
- Microbial growth or possible mold growth observed in the areas noted. Mold can only be confirmed with laboratory testing. Recommend having a qualified, contractor perform mold spore air testing and tape/swab sample of observed growth.

Possible microbial growth (Primary bathroom)
